EL05-2015 Implementation
Assistance
Program

**Tools to Improve PCC Pavement
Smoothness During Construction
(R06E)**

FIELD REPORT: PENNSYLVANIA EQUIPMENT LOAN

The equipment loan was performed in September/October 2015 on a project near Pine Grove, PA. Table 1 summarizes the pertinent project details.

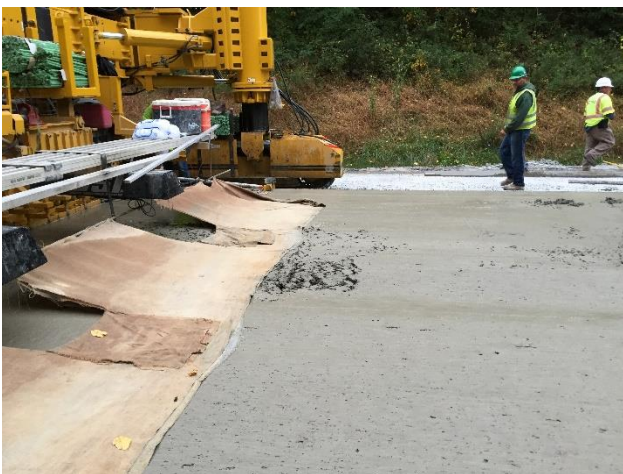
Figure 5. Isolated Areas of Mixture Exhibited Poor Finishing Characteristics

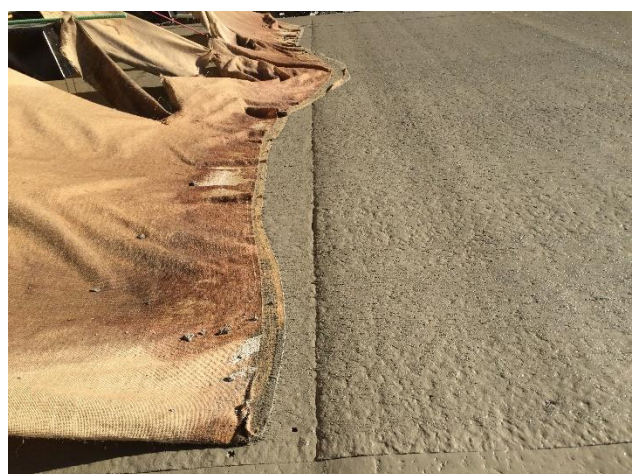
Figure 6. Close-up of Profile Feature Created by a Paver Stop (mitigated by hand finishing)

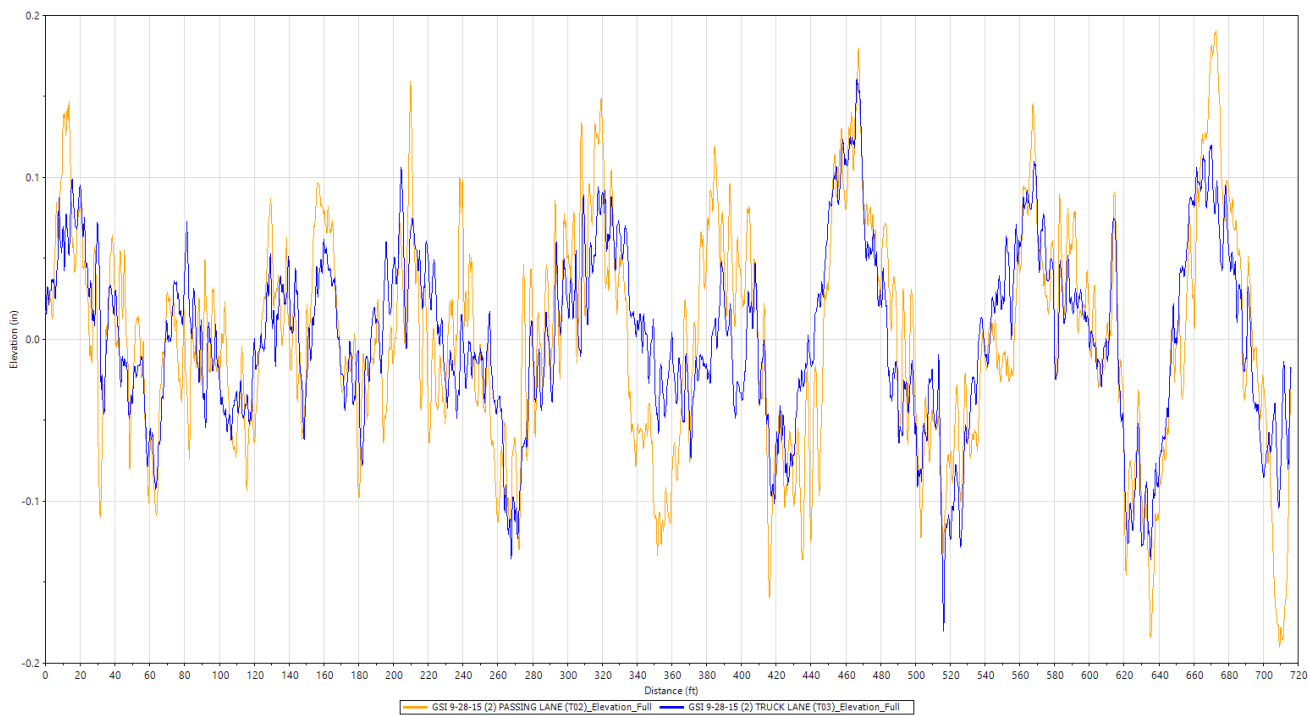
- i. The magnitude of profile deviation (dips and bumps) for the passing lane on 28SEP2015 is visibly greater than the truck lane (Figure 10), while the same comparison for 26SEP2015 shows a much closer agreement between the raw profile data (Figure 11).

Figure 10. Profile deviations in the passing lane (yellow) are visibly greater than the truck lane (blue) on 28SEP2015.

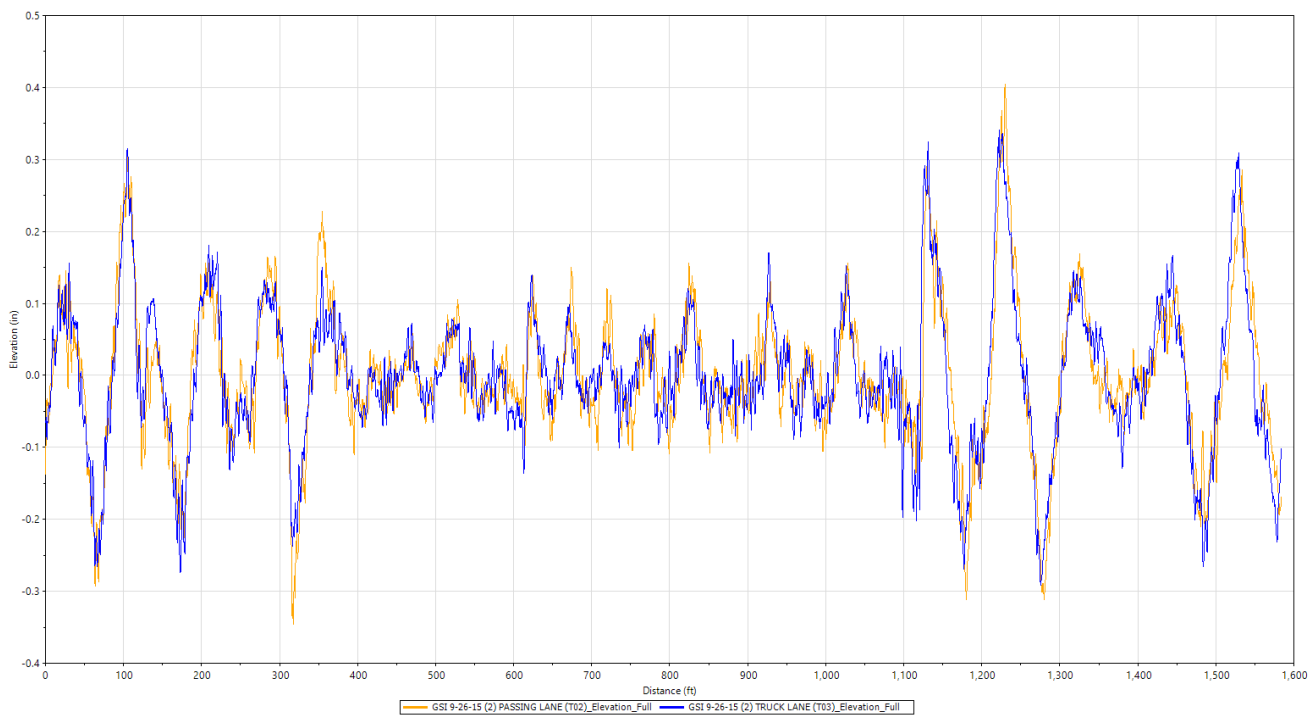
Figure 11. Profile deviations for the Passing Lane (yellow) and Truck Lane (blue) are more closely matched on 26SEP2015.

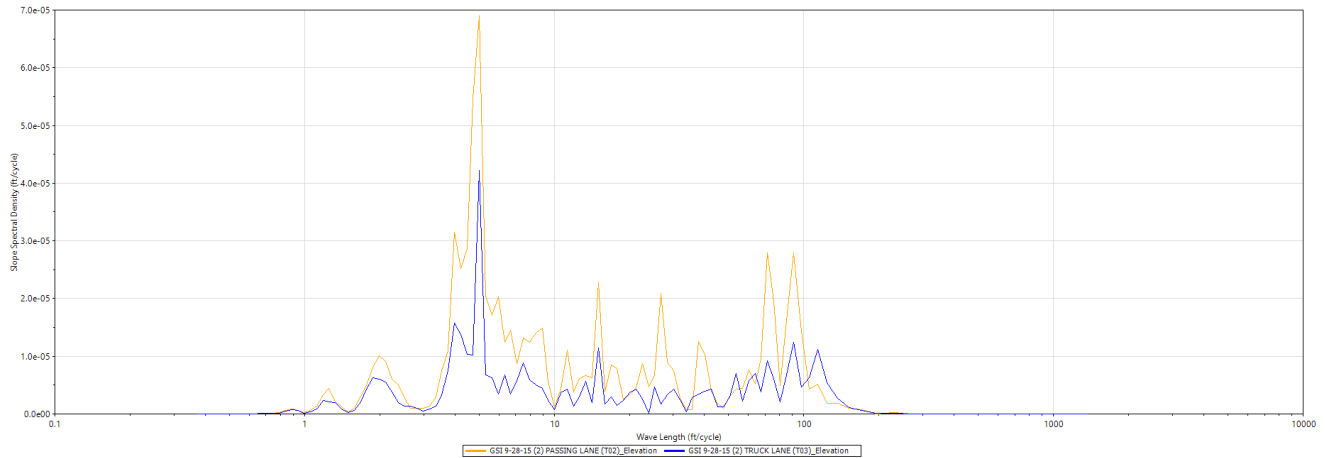
- ii. Looking at the same profiles, the power spectral density (PSD) analyses show that the difference in roughness between the passing lane and truck lane is coming from multiple wavelengths relevant to IRI (3-100 ft range) on

28SEP2015 (Figure 12), whereas on 26SEP2015 (Figure 13) the contribution from various wavelengths is very similar for the passing lane and truck lane.

Figure 12. PSD for 28SEP2015 shows the differences in the contribution to roughness in the passing lane (yellow) than truck lane (blue) at the 4', 5', 15', 27', 70' and 90' wavelengths.

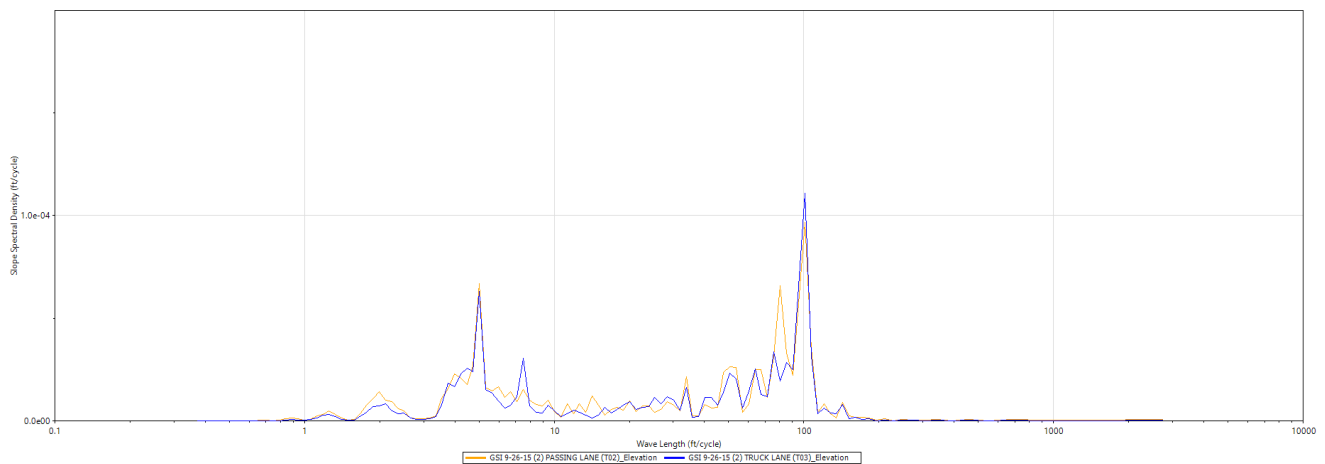
Figure 13. PSD for 26SEP2015 shows the contribution to roughness at various wavelengths is very similar for the passing lane and truck lane.

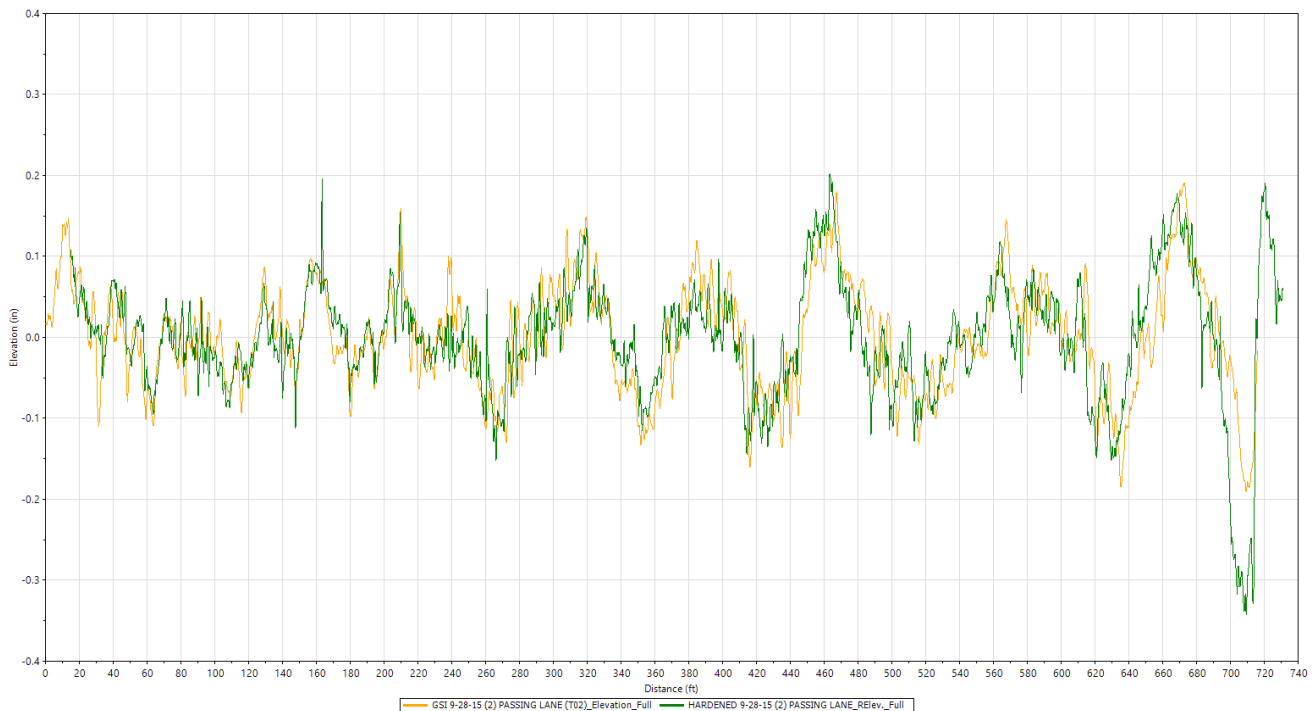
- 2) The real-time results in the passing lane were much more different than the hardened results in the passing lane than in the truck lane.
 - a. Even though the IRI results between real-time and hardened profiles are different, the data shows that they parallel each other closely (Figure 14), indicating that the difference is not likely due to RTP measurement error.

Figure 14. Comparison of Real-Time (yellow) and Hardened Profiles (green).

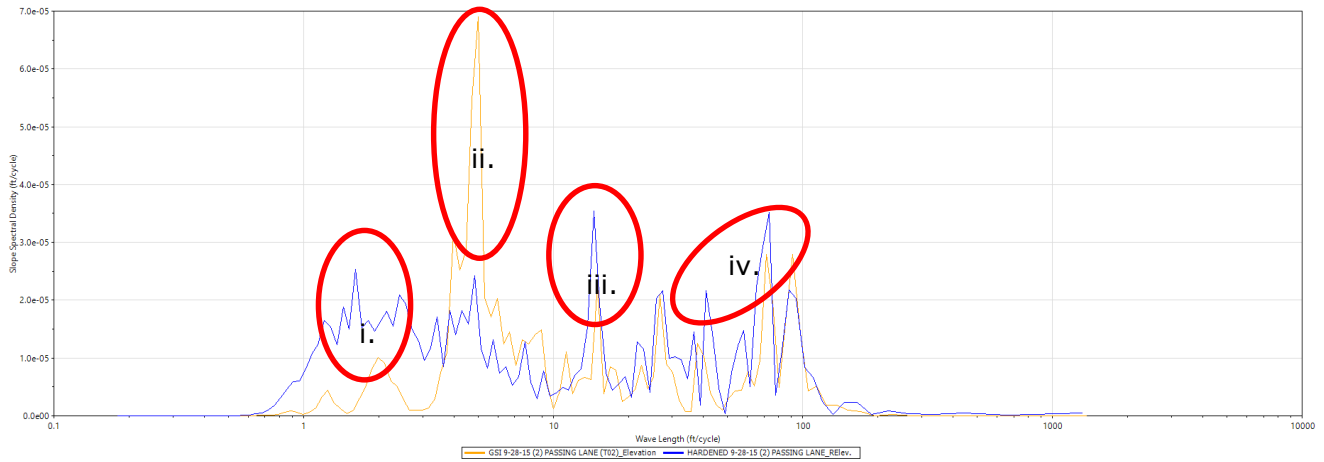
- b. Building upon the previous observations a PSD plot from 28SEP2015 (Figure 15) shows differences between the wavelengths contributing to roughness in the passing lane for the GSI real-time data and hardened data. The following observations can be made from this PSD analysis:
 - i. Shorter wavelength roughness in the hardened profile is likely from macrotexture (burlap drag and tining) applied behind the GSI sensors.
 - ii. Real-time roughness at the 5' wavelength was significantly reduced by hand finishing.
 - iii. Joint spacing had a larger influence on roughness in the hardened profile than in the real-time profile, this is likely a result of curling and warping of the slabs.
 - iv. The source of roughness present in the hardened profile at longer wavelengths needs additional investigation.

Figure 15. PSD plot showing contribution of different wavelengths to roughness for GSI (yellow) and hardened (blue) profile data for 28SEP2015.

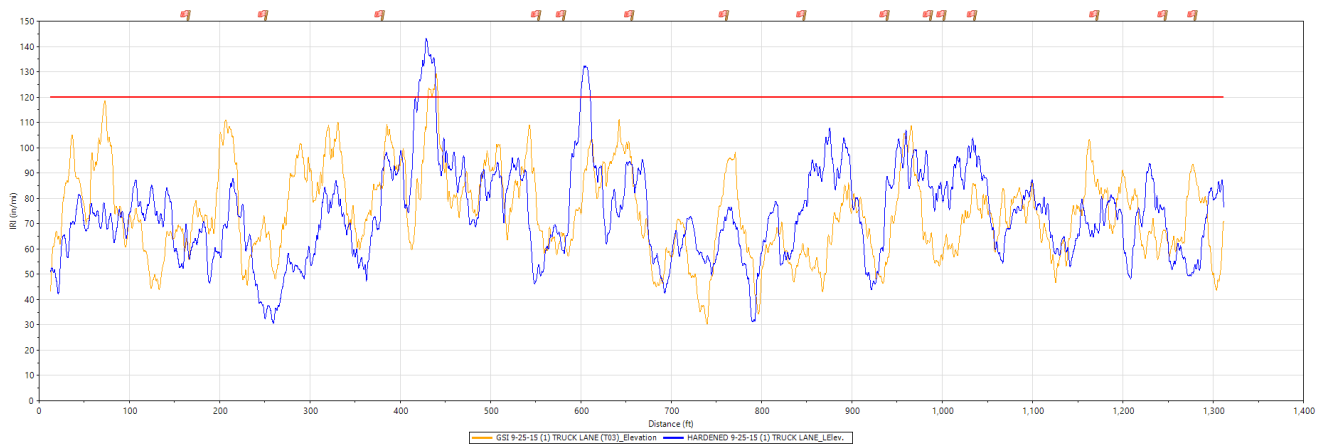
The GSI was used to log paver stops. These events were transferred to ProVAL in an attempt to determine if paver stops were a contributing factor to localized roughness. Figure 16 shows a continuous IRI analysis from 25SEP2015 with a threshold value of 120 in/mi (red line) and a baselength of 25'. Event flags shown across the top of the graph indicate paver stops. No clear correlation can be made between paver stops and localized roughness from this analysis.

Figure 16. Localized roughness analysis (continuous IRI with 25' baselength) showing paver stops as red flags along top of graph. (Note: GSI data in yellow, hardened profile data in blue.)

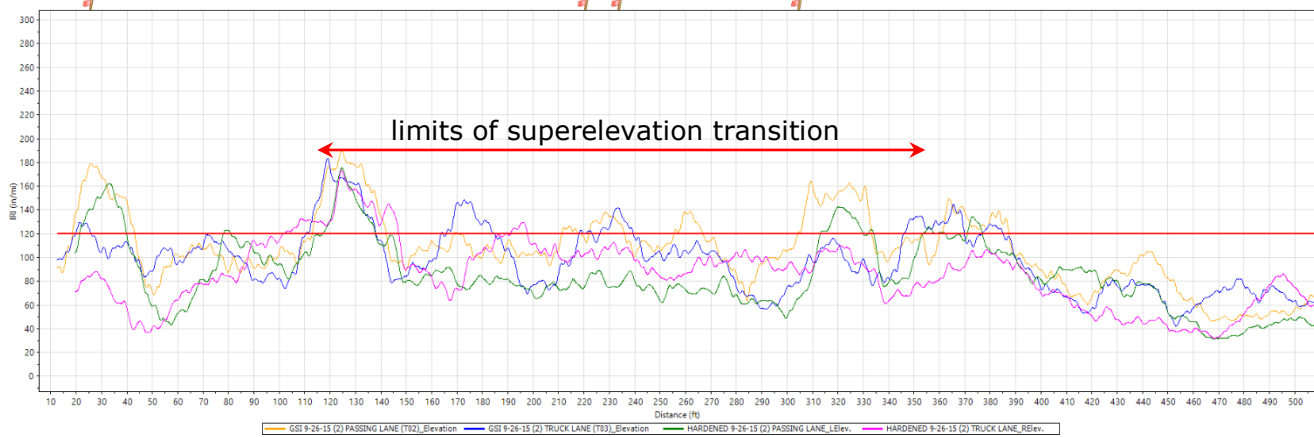
Superelevation transitions are typically more difficult to maintain smoothness through, because the head height is changing from one side of the paver to the other. The analysis shown in Figure 17 demonstrates this common trend. Localized roughness is generally lower in the areas of normal cross-slope.

Figure 17. Localized roughness analysis (continuous IRI with 25' baselength) showing higher roughness through the superelevation transition.

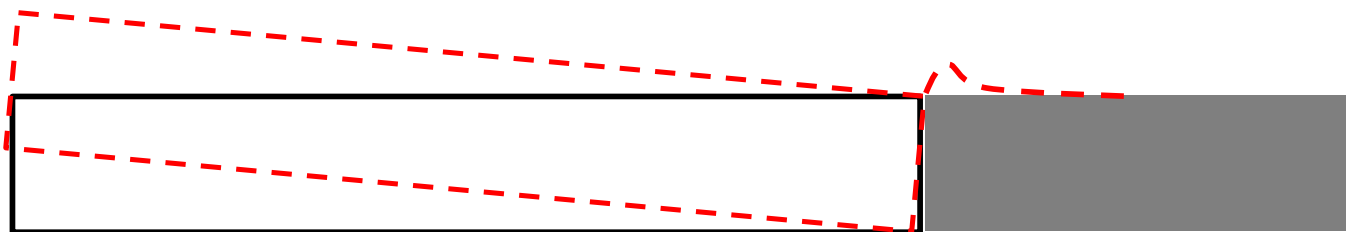
Notes from the on-site observation indicated some wet loads of concrete and a concurrent adjustment to the paver's angle of attack (added lead/draft as shown in Figure 18) on 26SEP2015. Adding lead/draft to the paver generally helps to fill surface voids because more pressure is imparted to the surface. But, this increased pressure at the trailing edge of the pan makes the paver more sensitive to changes in the concrete workability and uniformity. The impact on localized roughness from these two factors can be seen in Figure 19 as the localized roughness increases where the wet loads were encountered, and then gradually decreases after the lead/draft is reduced.

Figure 18. Illustration of adding lead/draft to the paver (dashed red lines indicate lead/draft added and "concrete boil" from added pressure at the back of the pan).

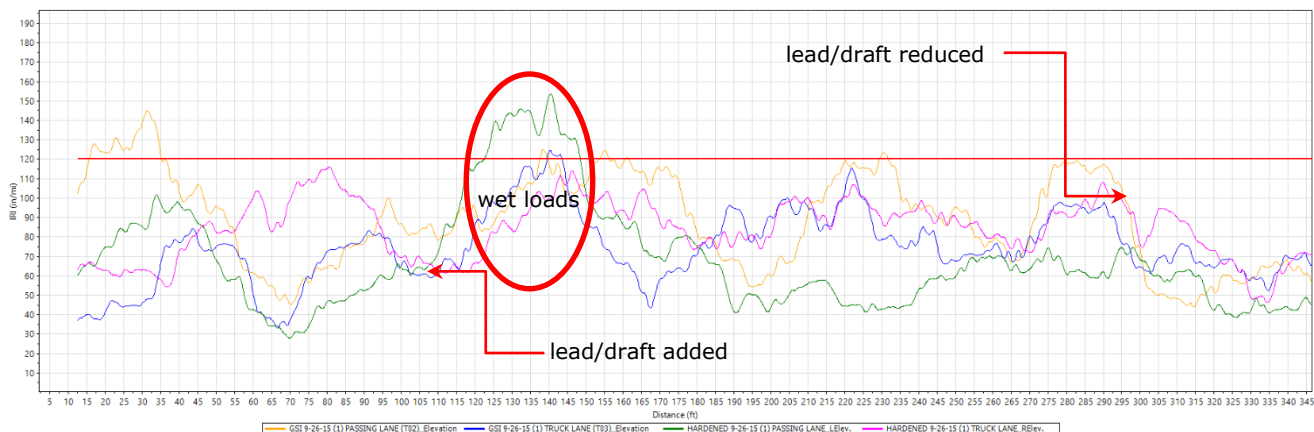
Figure 19. Localized roughness analysis (continuous IRI with 25' baselength) showing increased roughness from wet loads and added lead/draft followed by a decrease after a reduction in lead/draft (Note: GSI shown in yellow and blue, hardened shown in green and pink).

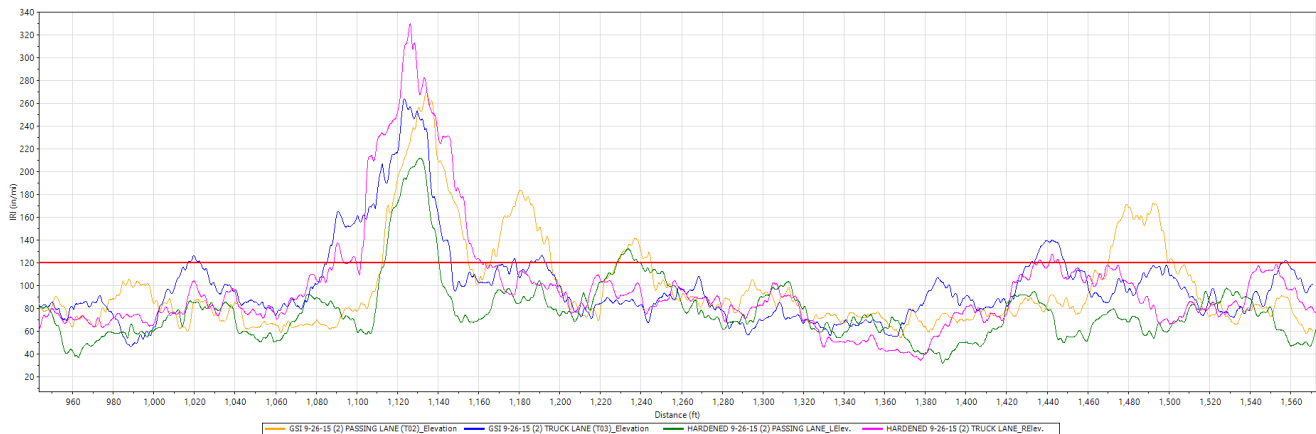
During paving on 26SEP2015, a dowel basket in the truck lane was dislodged by the paver. Although removed and replaced, this event caused a sizable bump and dip which resulted in localized roughness (Figure 20), and was not fully corrected with hand finishing.

Figure 20. Localized roughness analysis (continuous IRI with 25' baselength) showing an "event" caused by a dislodged dowel basket (Note: GSI shown in yellow and blue, hardened shown in green and pink).
