Forensic Investigation of West Des Moines Street Projects

Thomas Van Dam, Ph.D., P.E.
Principal

IA Better Concrete Conference - 2025

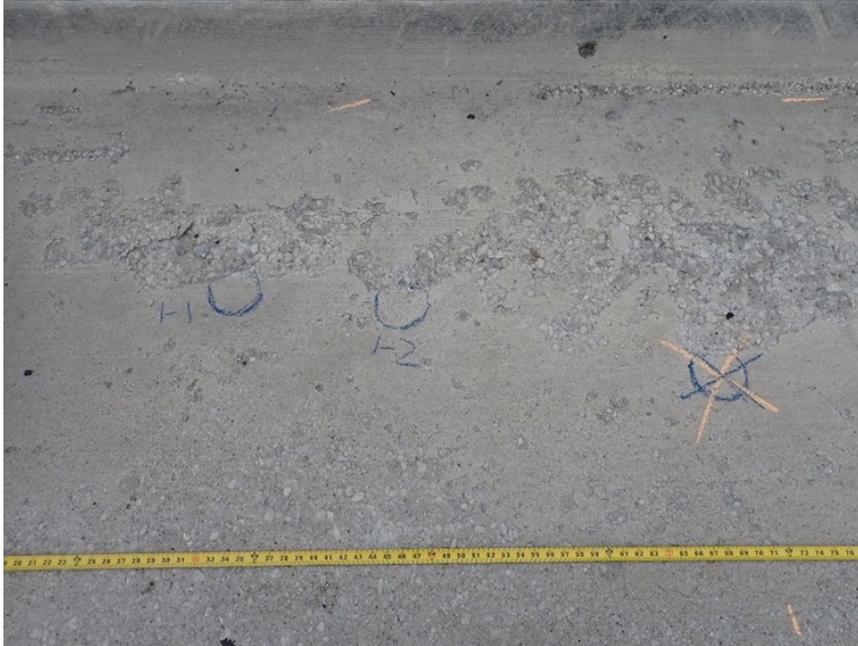
Bad

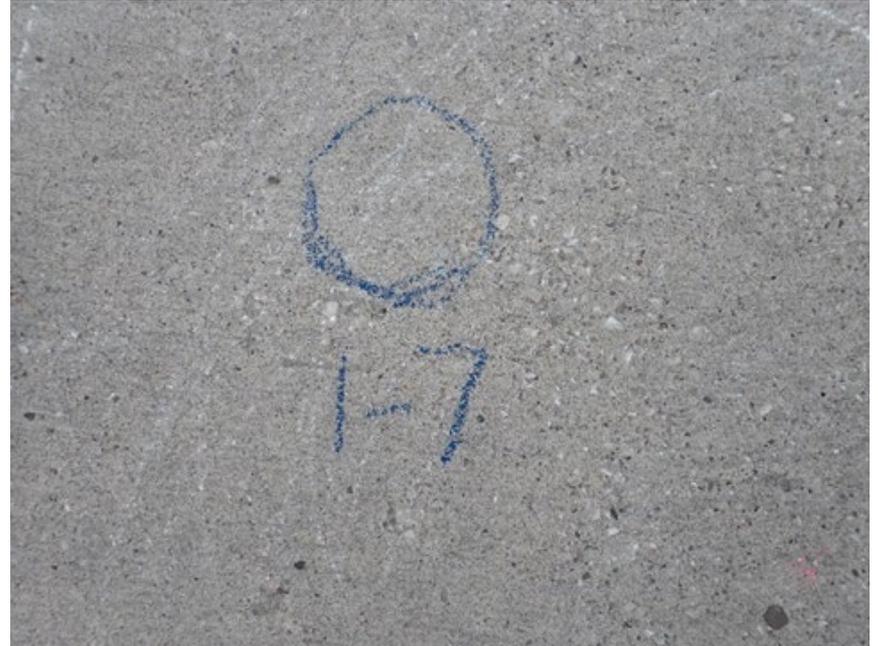
Good

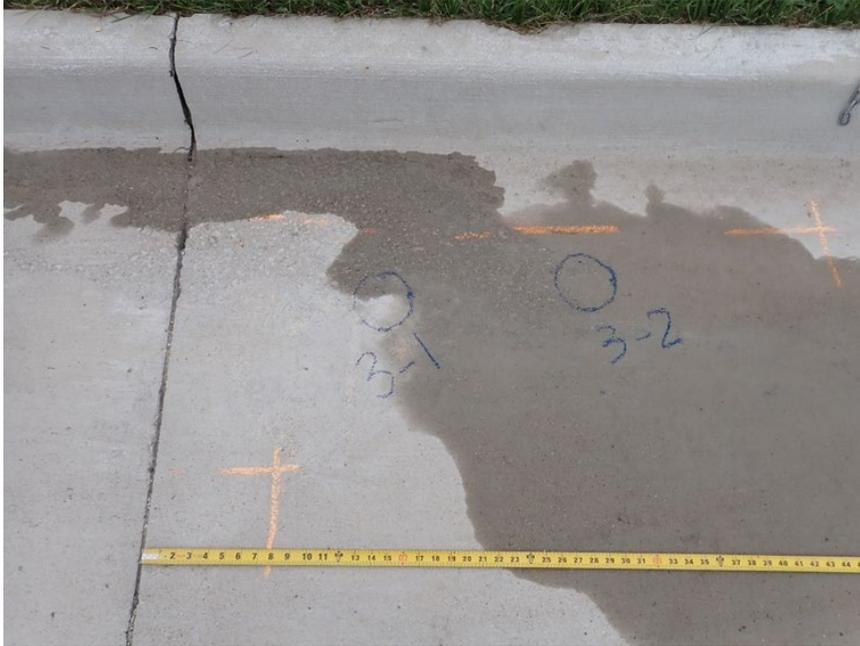
Bad

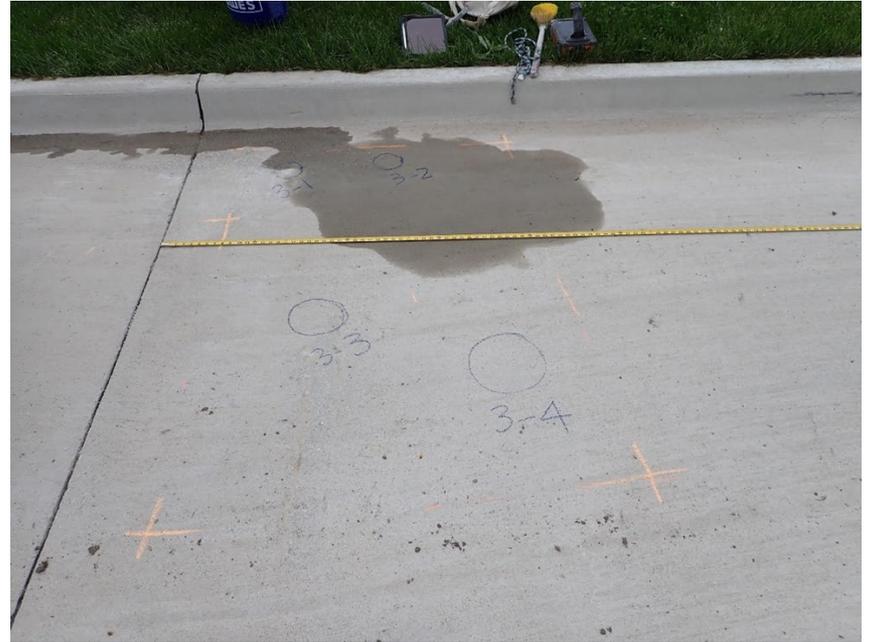
Good

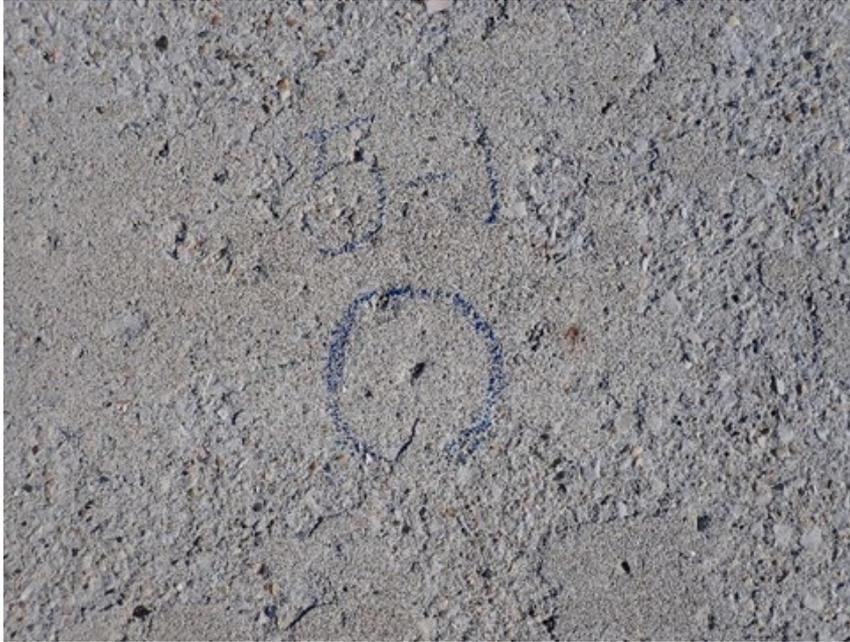
Bad

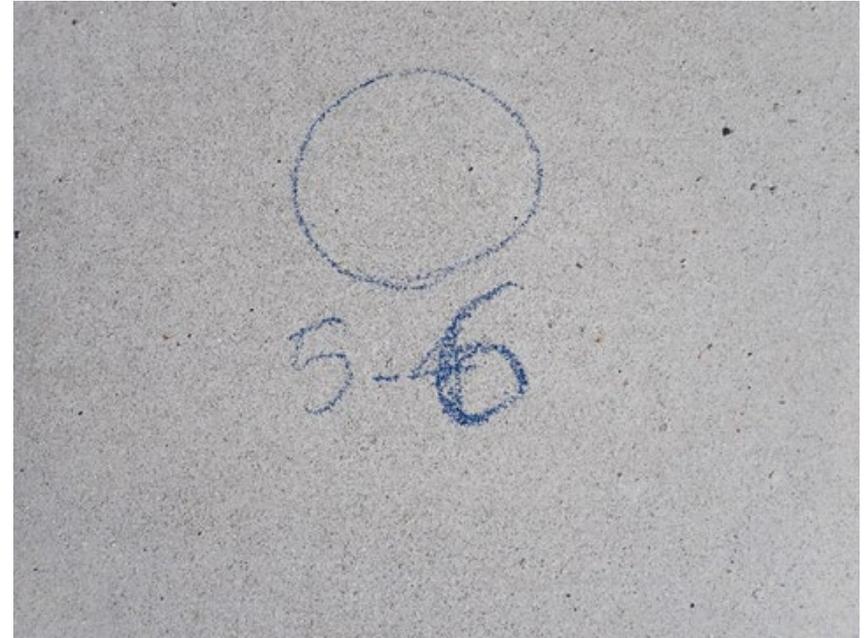
Good

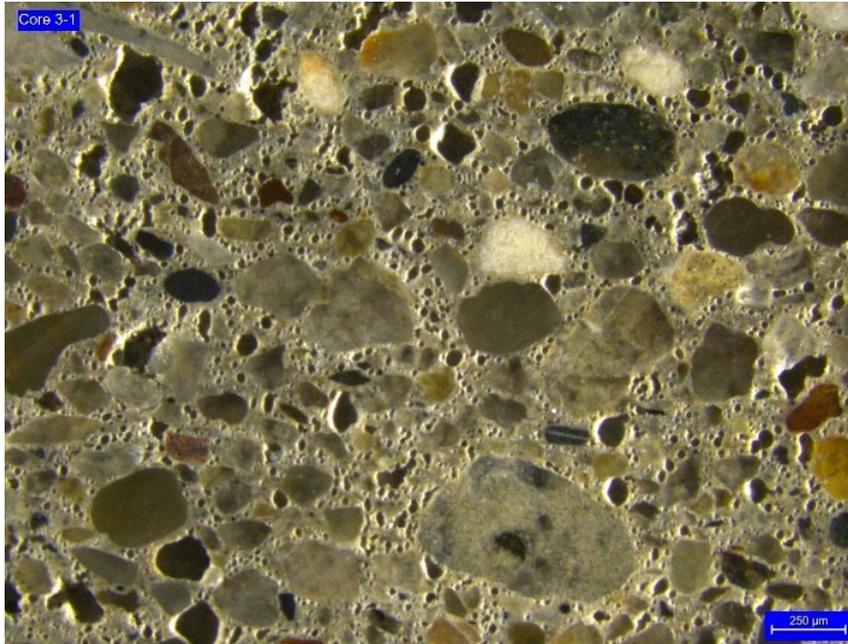
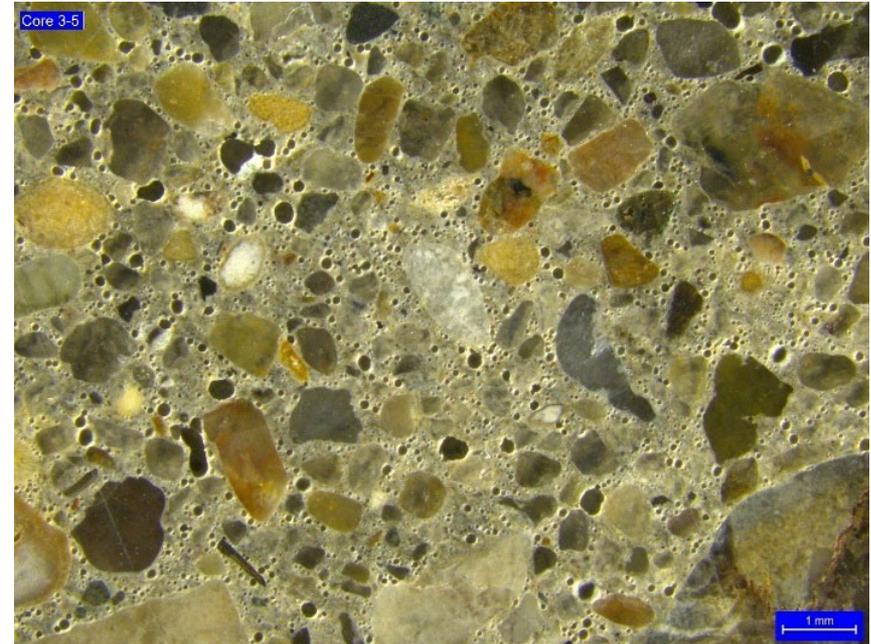
Project No. 3: Air is Highly Irregular

Figure 1. Typical air-void system in Core 3-1 (left) and Core 3-5 (right); images taken at the same magnification for comparison.

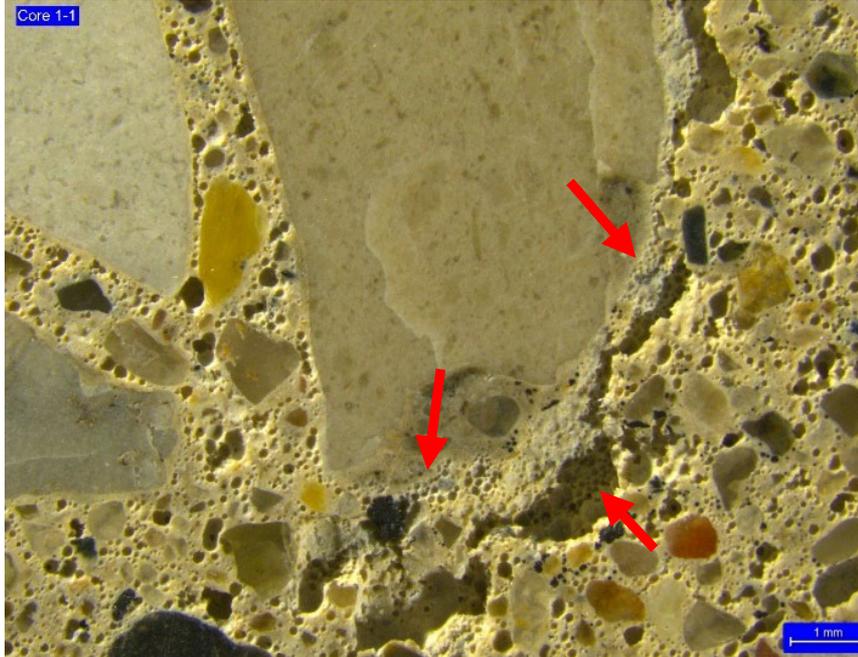
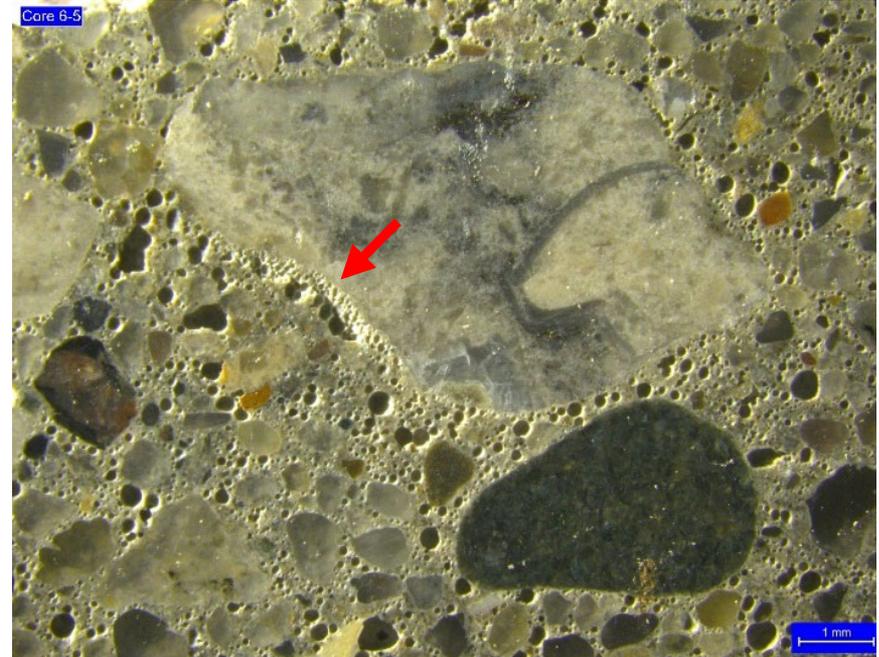
Air-Void Chains, Clustering, and Water Gain Voids

- Voids consist of small to coarse spherical entrained air and irregular water gain voids
 - Air void chains and clusters were frequently observed in all examined cores
 - The volume of air voids varied significantly between the examined cores and was often high
- Cement-sized and finer limestone fines in the paste
 - Expected for Type II cement
 - May also be crusher fines from the coarse aggregate
 - Seems to be concentrated with fly ash in some cases

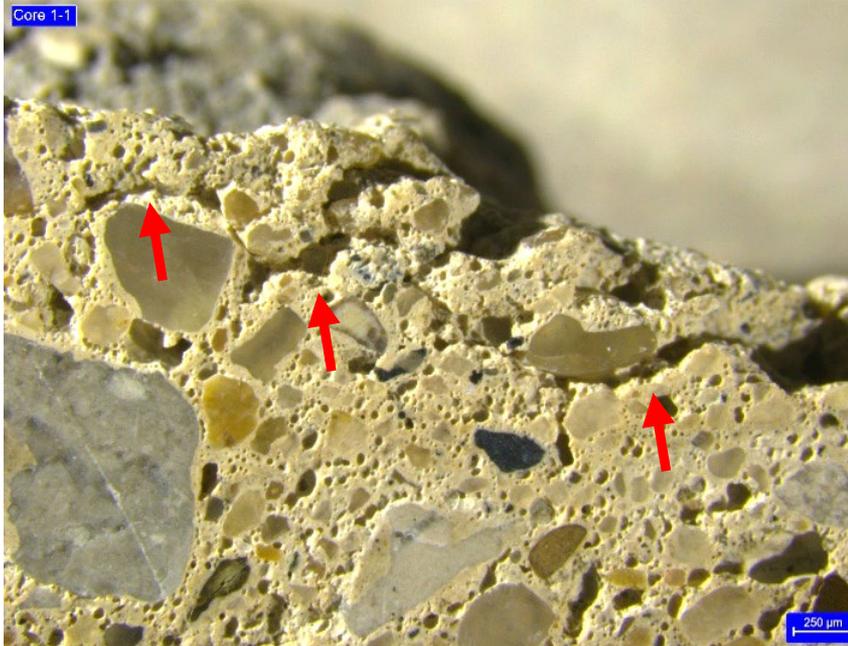
Core 1-1: Near Surface

Figure 1. Near-surface of Core 1-1 contained an incipient spall (arrows).

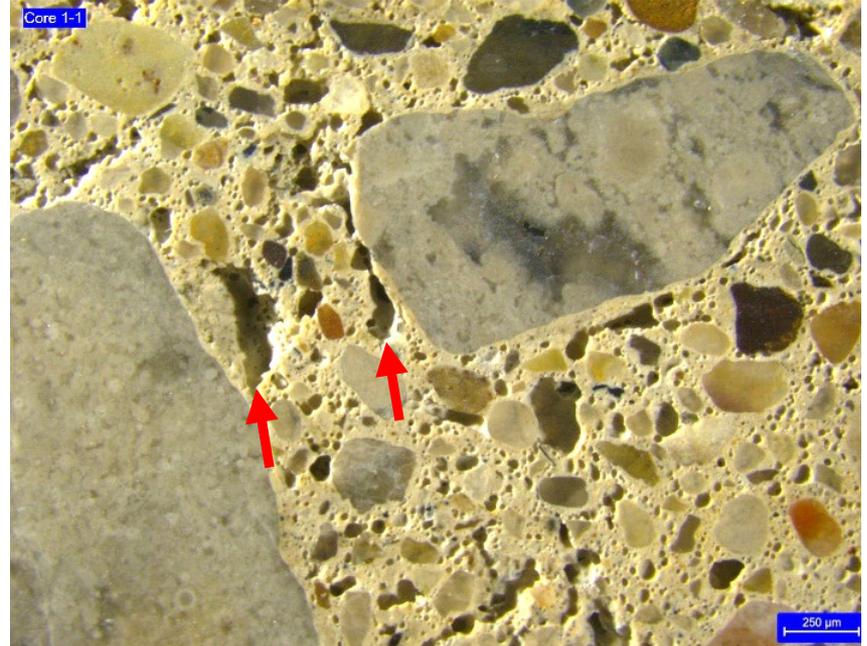
Figure 2. Vertically oriented water gain voids (arrows) near-surface of Core 1-1.

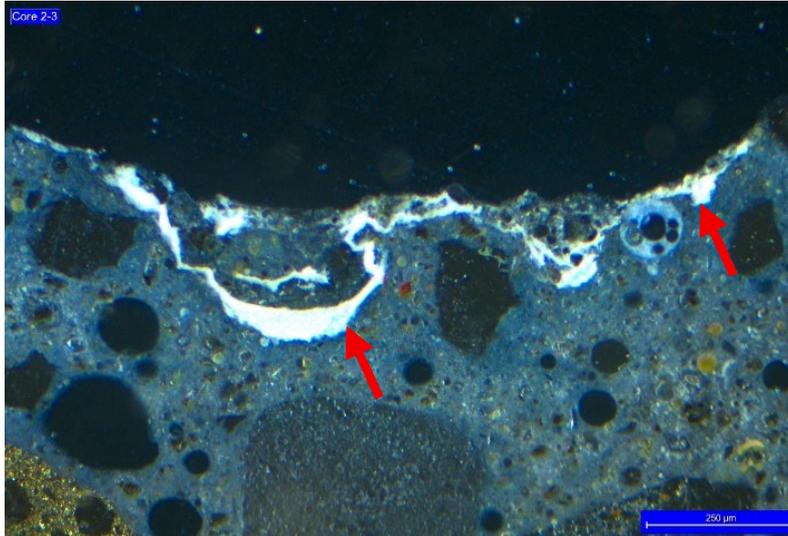
Figure 1. Discontinuous white material (arrows) along the top surface of Core 2-3 may represent a topically applied curing compound or sealer; pictured in thin section under oblique (reflected) light.

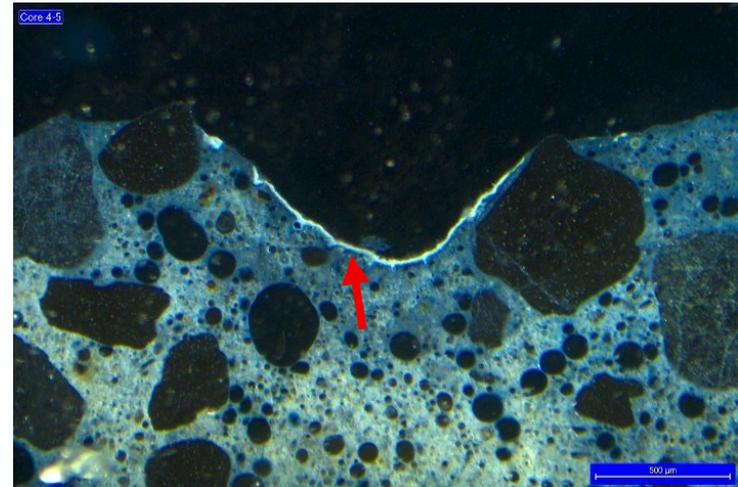
Figure 2. Discontinuous white material (arrow) along the top surface of Core 4-5 represents a possible curing compound or sealer; pictured in thin section under oblique (reflected) light.

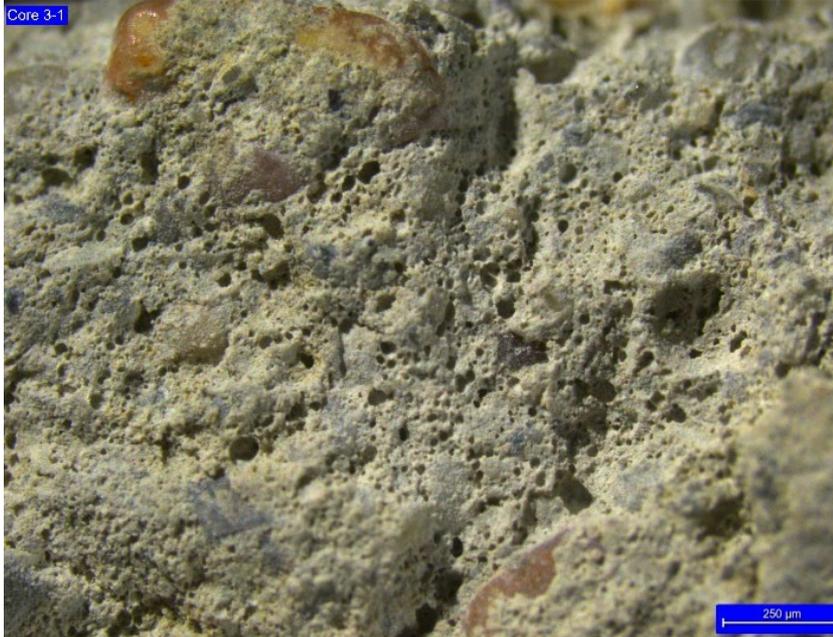
Core 3-1: Air at Surface is Scary

Figure 1. Abundant entrained air voids observed on the as-received top surface of Core 3-1.

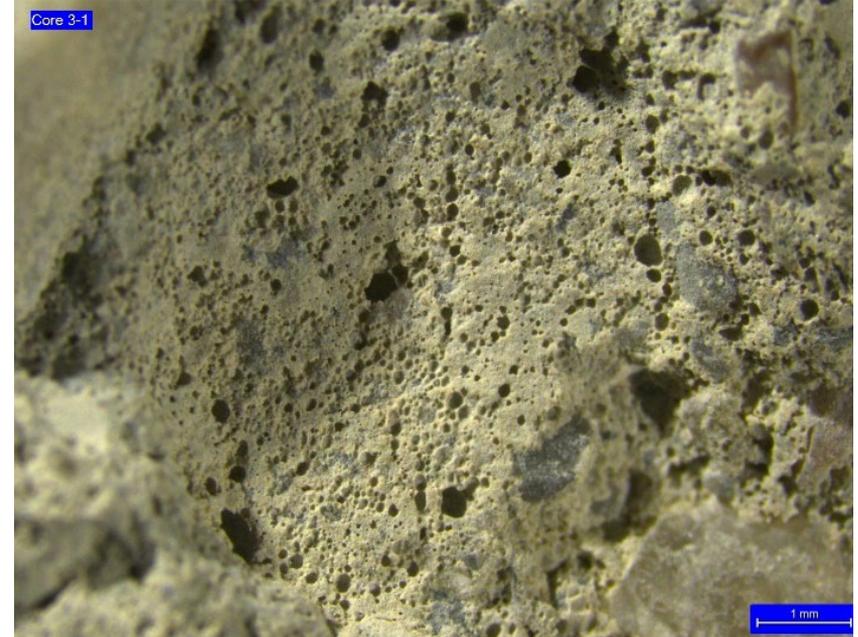
Figure 2. Abundant air voids lining aggregate sockets from aggregates plucked from the surface in Core 3-1.

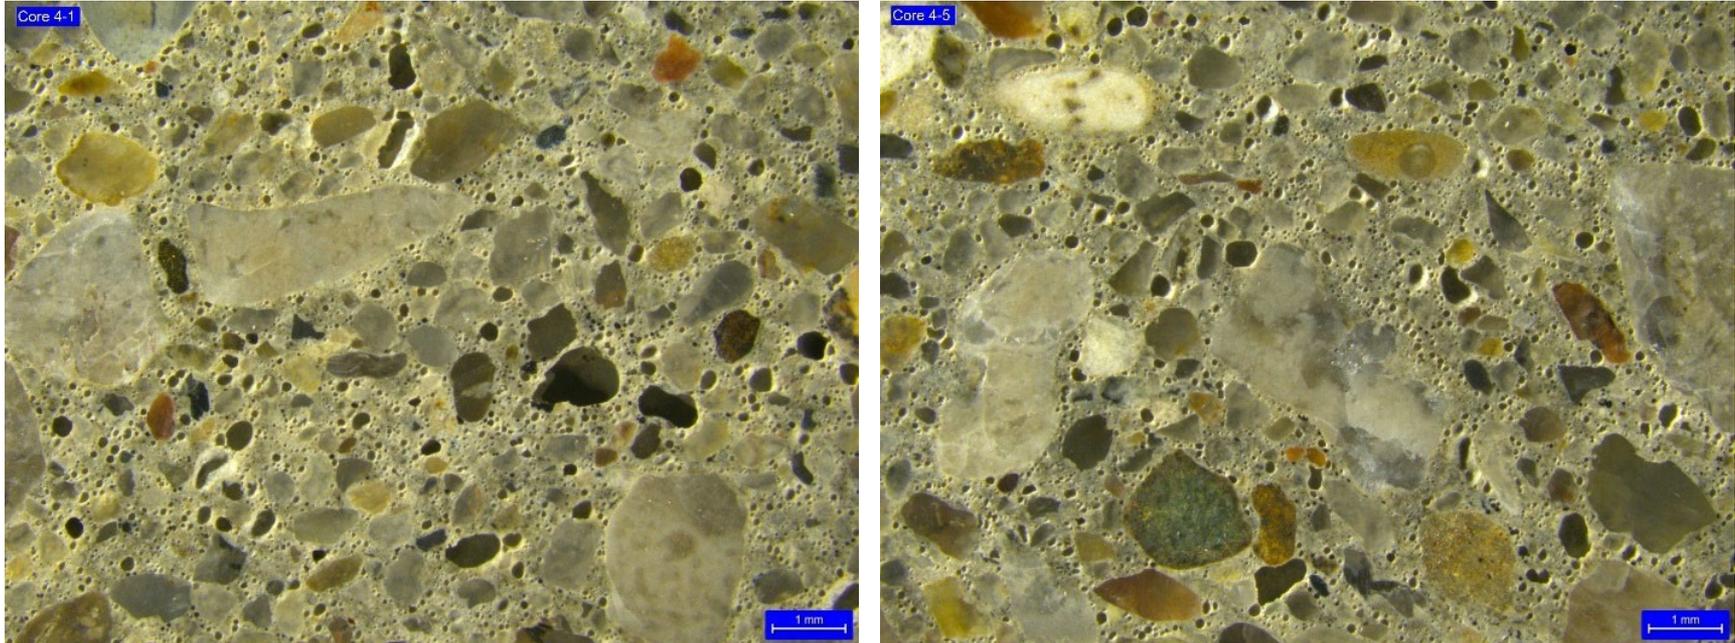
Project 4 – Air-Void System at Depth

Figure 1. Typical air-void system of Core 4-1 (left) and Core 4-5 (right); images are taken at the same magnification for comparison.

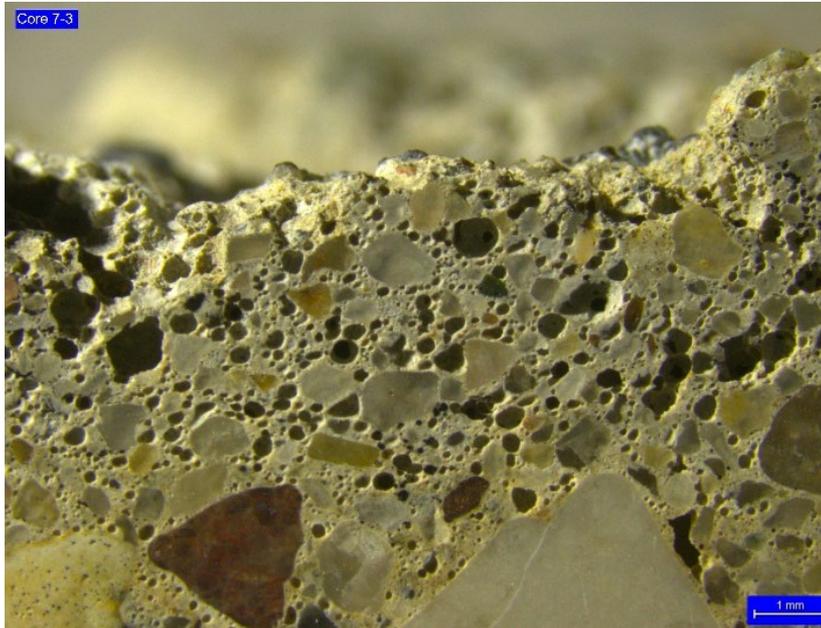
Core 7-3: Near-Surface Air Void Clustering

Figure 1. Increased air content along the surface of Core 7-3.

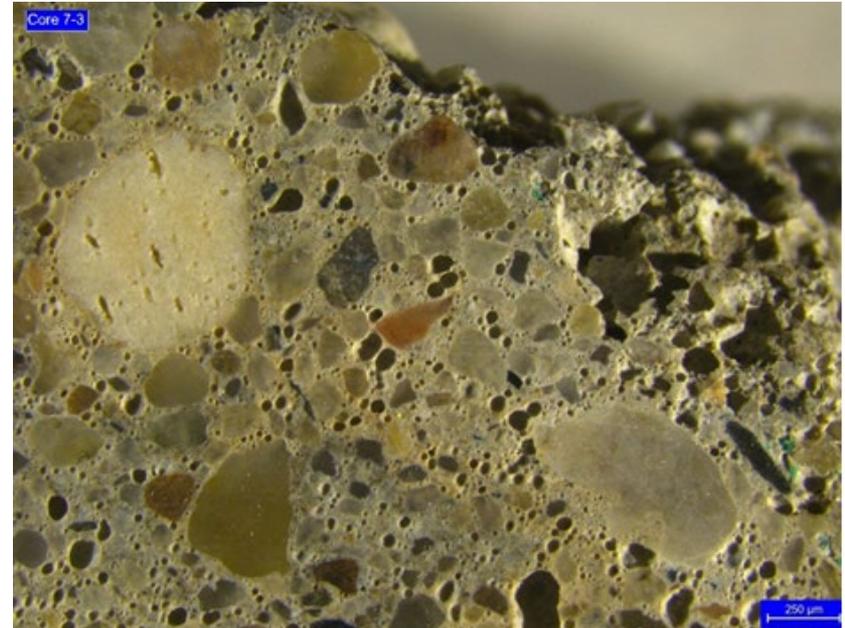
Figure 1. Air void cluster along the spalled surface in Core 7-3.

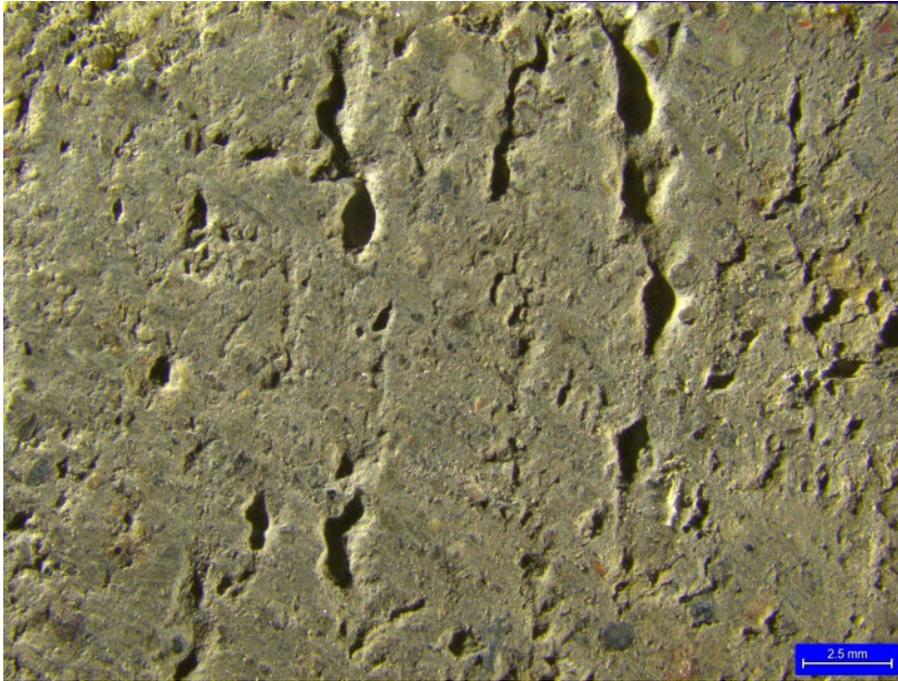
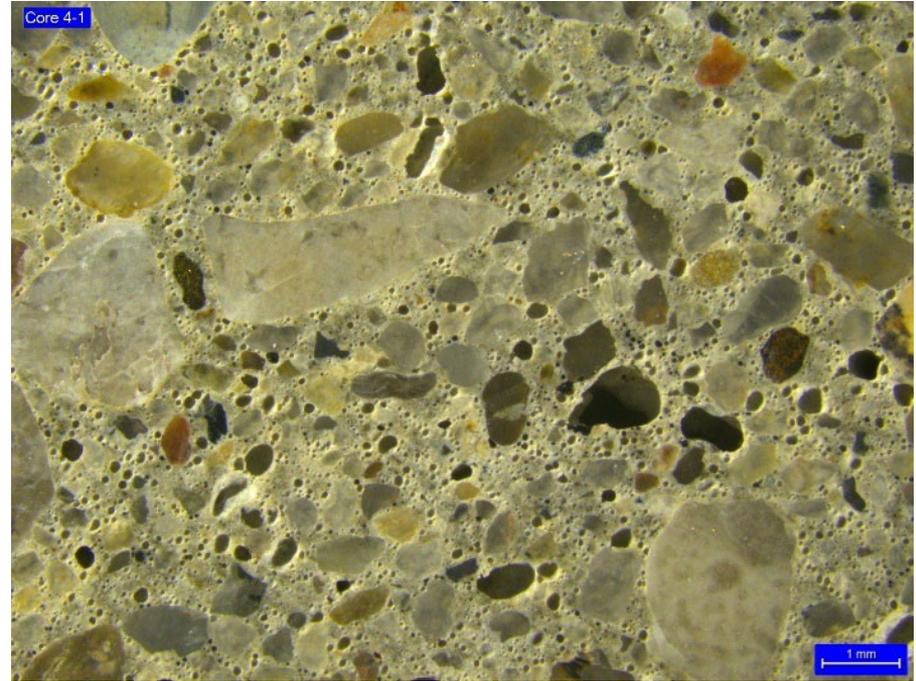
Workability Issues

- Near surface regions often had higher w/cm and less air than bulk concrete
 - More often observed in “poor” areas
 - Observed microcracking often observed more in “poor” areas
- Evidence of curing compound not always observed, and at times only observed in the “good” areas
- Textural features on the surface of some cores suggest difficult in finishing and larger compaction voids throughout the thickness suggests the concrete was losing workability at the time of placement
