Investigation of West Des Moines Pavements Constructed with Type IL Cement

NCC Spring Meeting

San Diego, CA | April 7, 2026

Leif G. Wathne, PE
Tom Van Dam, PhD PE

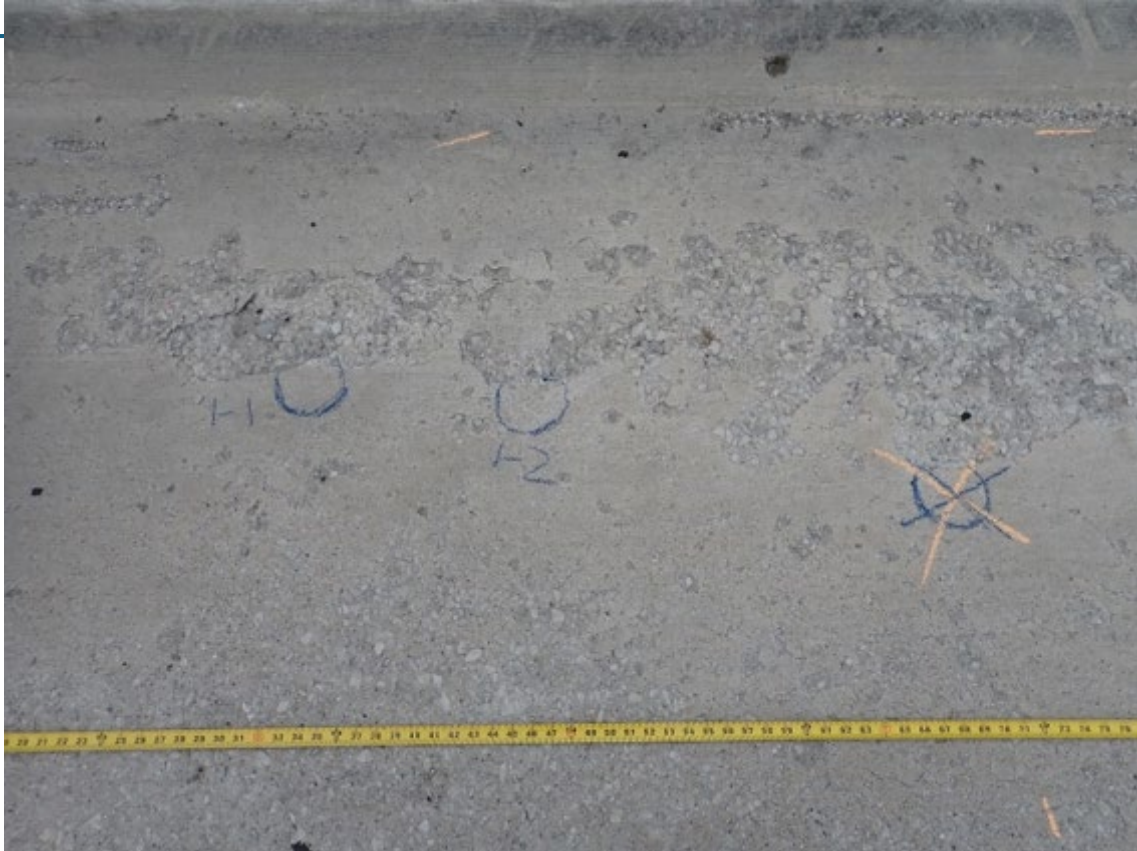
Representative Conditions: Project No. 1

poor

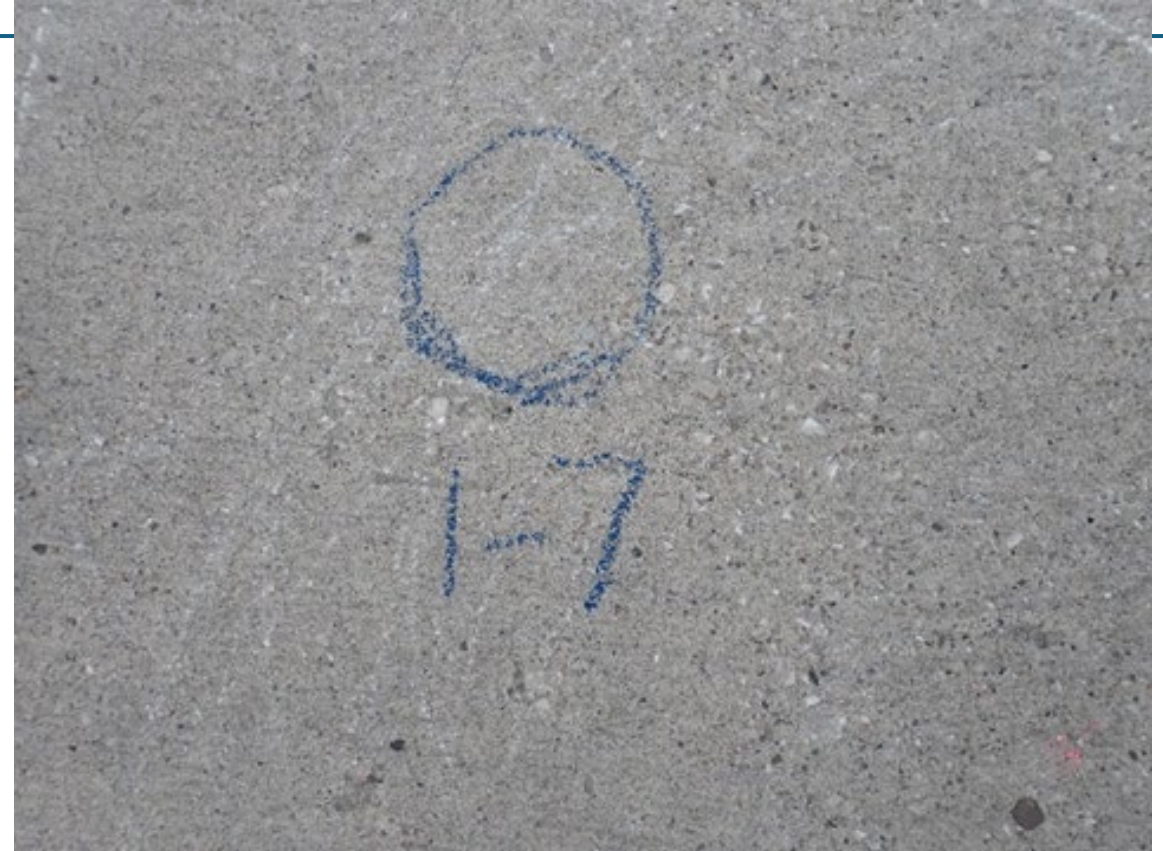
Good

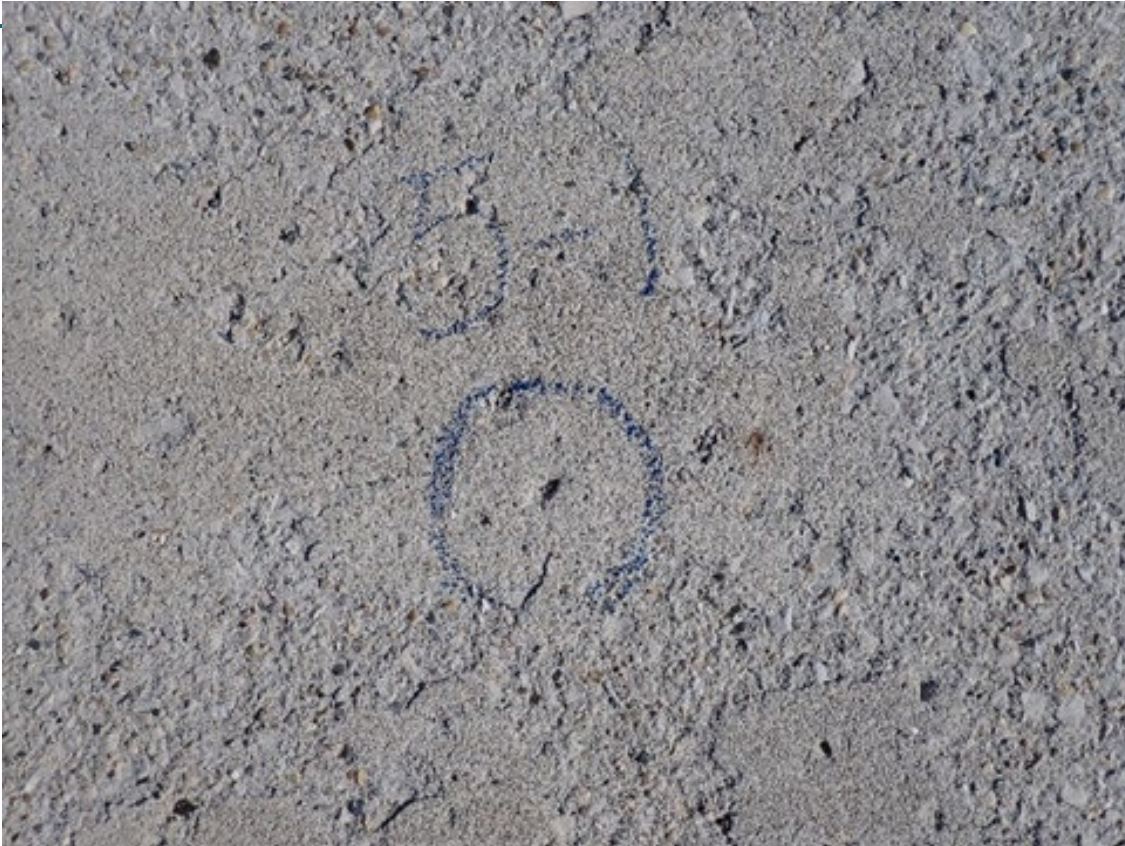
Representative Conditions: Project No. 5

Poor

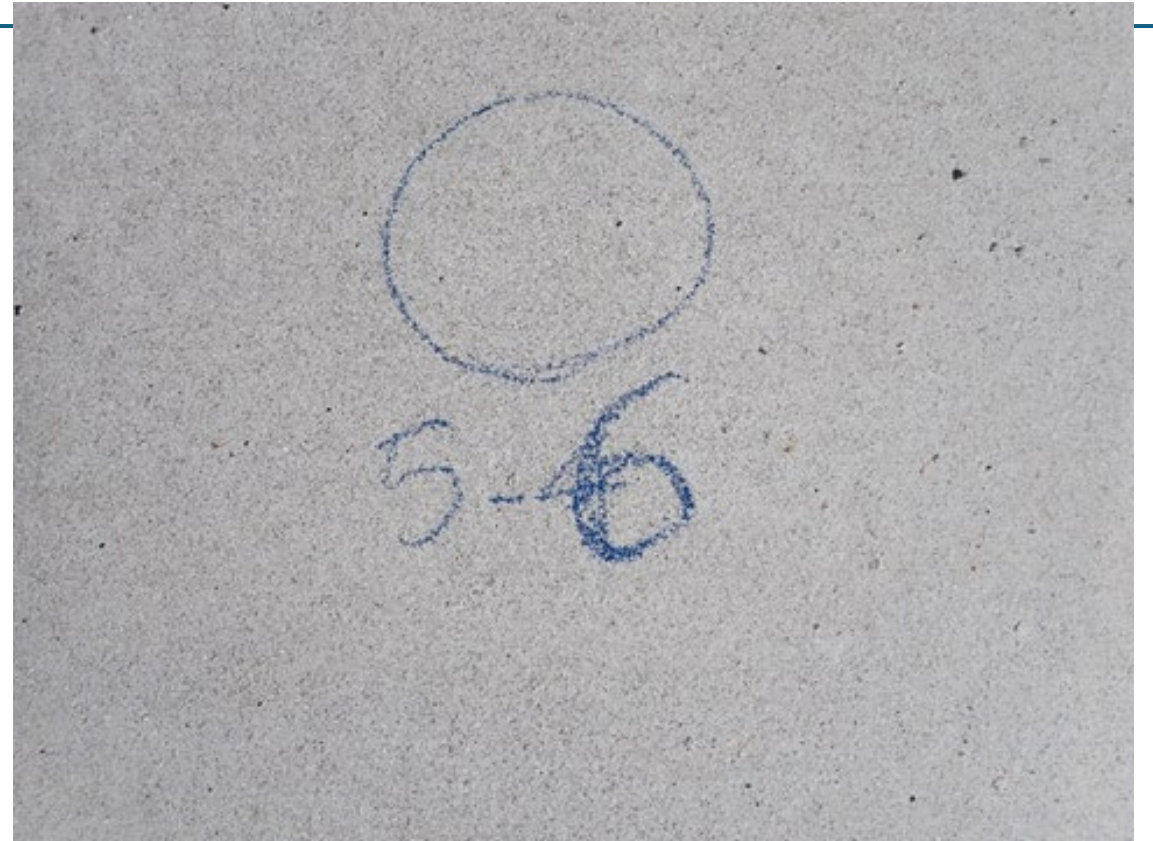
Good

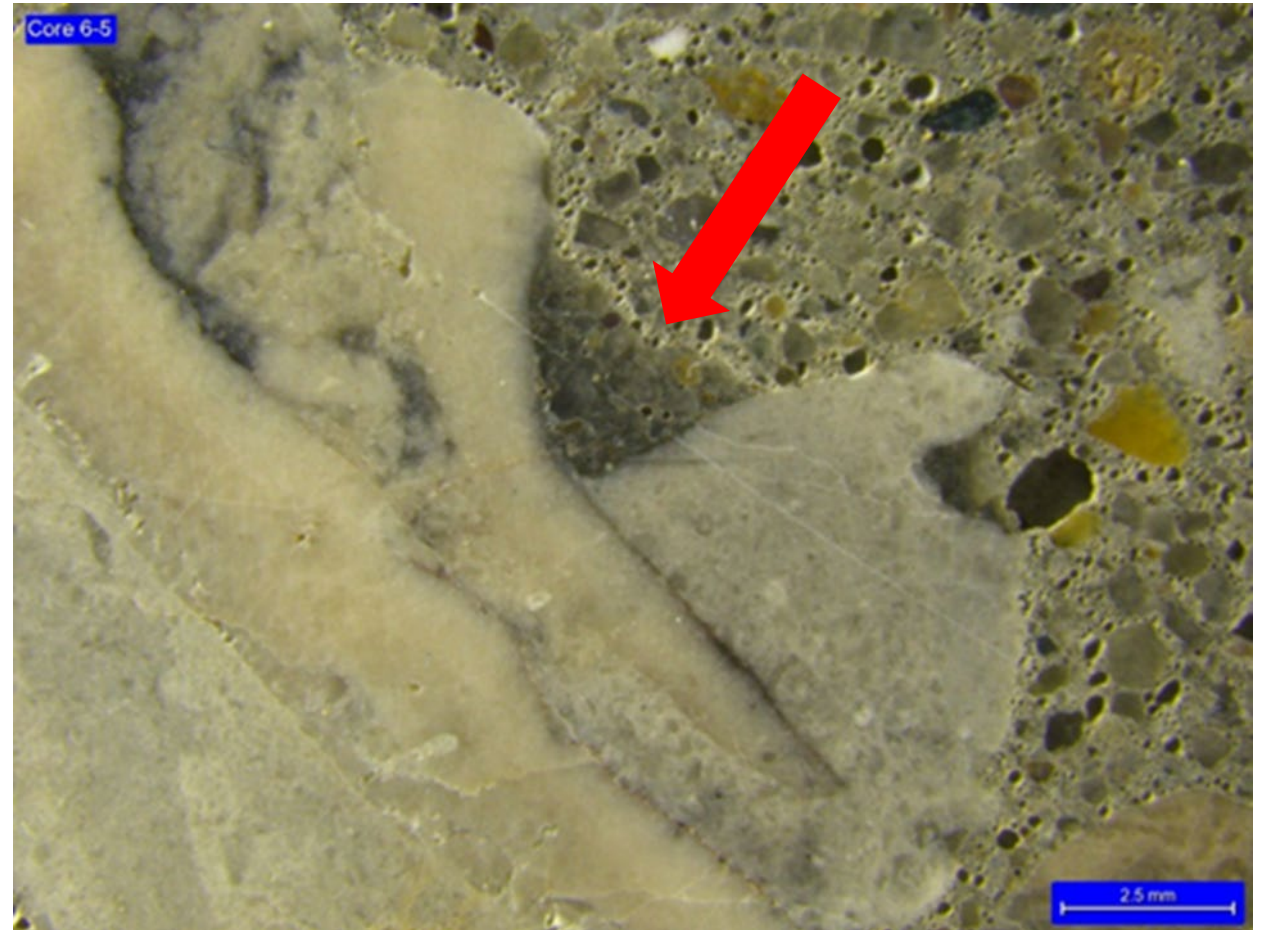
Optical Microscopy – General Observations

- Samples are compositionally similar, containing crushed limestone in an air-entrained, portland limestone cement and fly ash paste
- Dark grey veneers were frequently observed at the interface of the coarse aggregate particles with the paste in all examined cores
 - Indicative of incomplete initial mixing and/or late addition of water

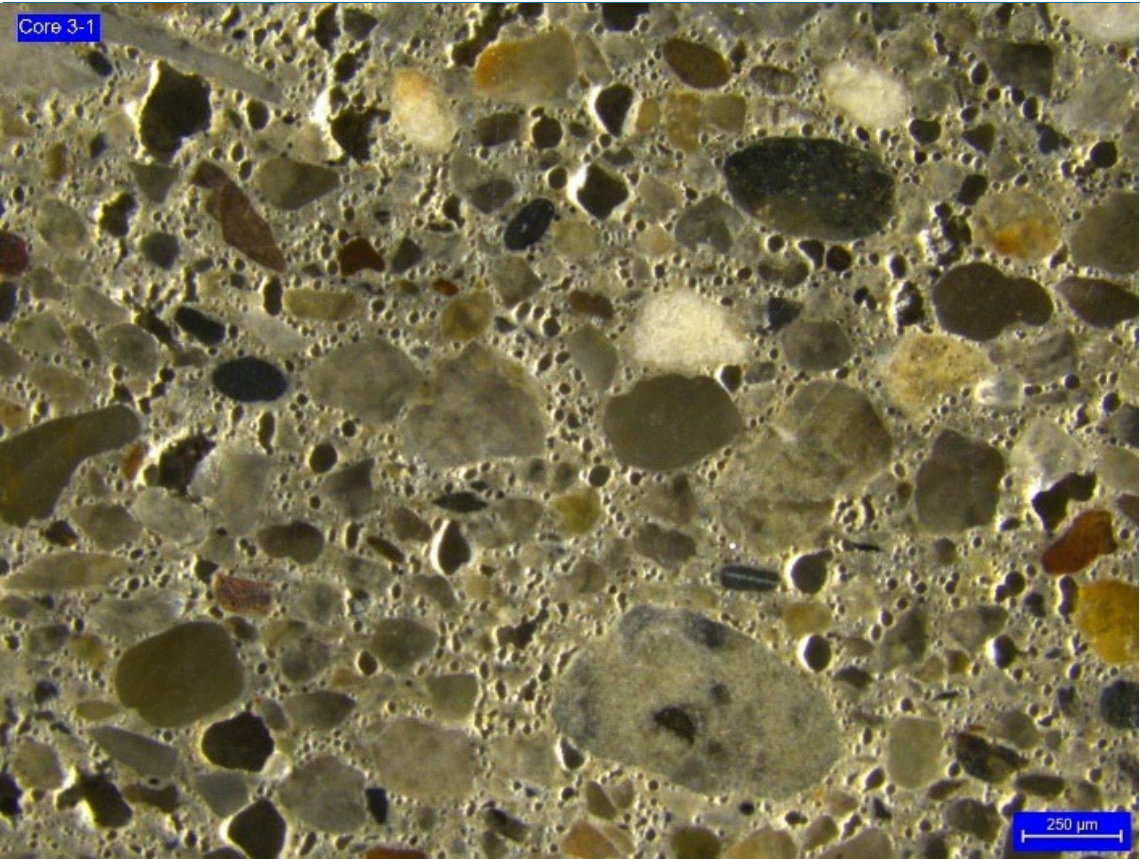
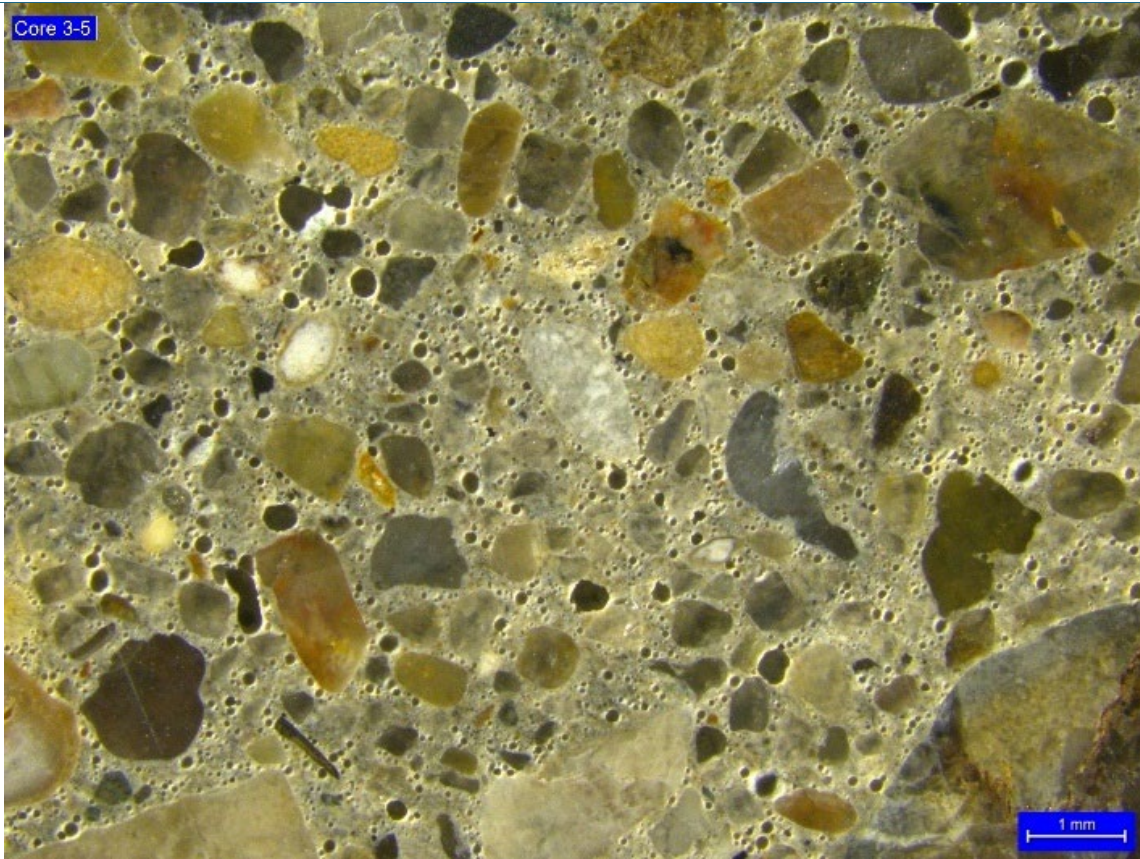
Air Void System is Irregular

- Voids consist of small to coarse spherical entrained air and irregular water gain voids
 - Air void chains and clusters were frequently observed in all examined cores
 - The volume of air voids varied significantly between the examined cores and was often high
- Cement-sized and finer limestone fines in the paste
 - Expected for Type IL cement
 - Crusher fines from the limestone coarse and intermediate aggregate likely contributing

- Target less air...perhaps 5% to 8% (instead of 6% to 10%)
- Start measuring **unit weight** in addition to air tests, just prior to placement at point of discharge (after last addition of water)

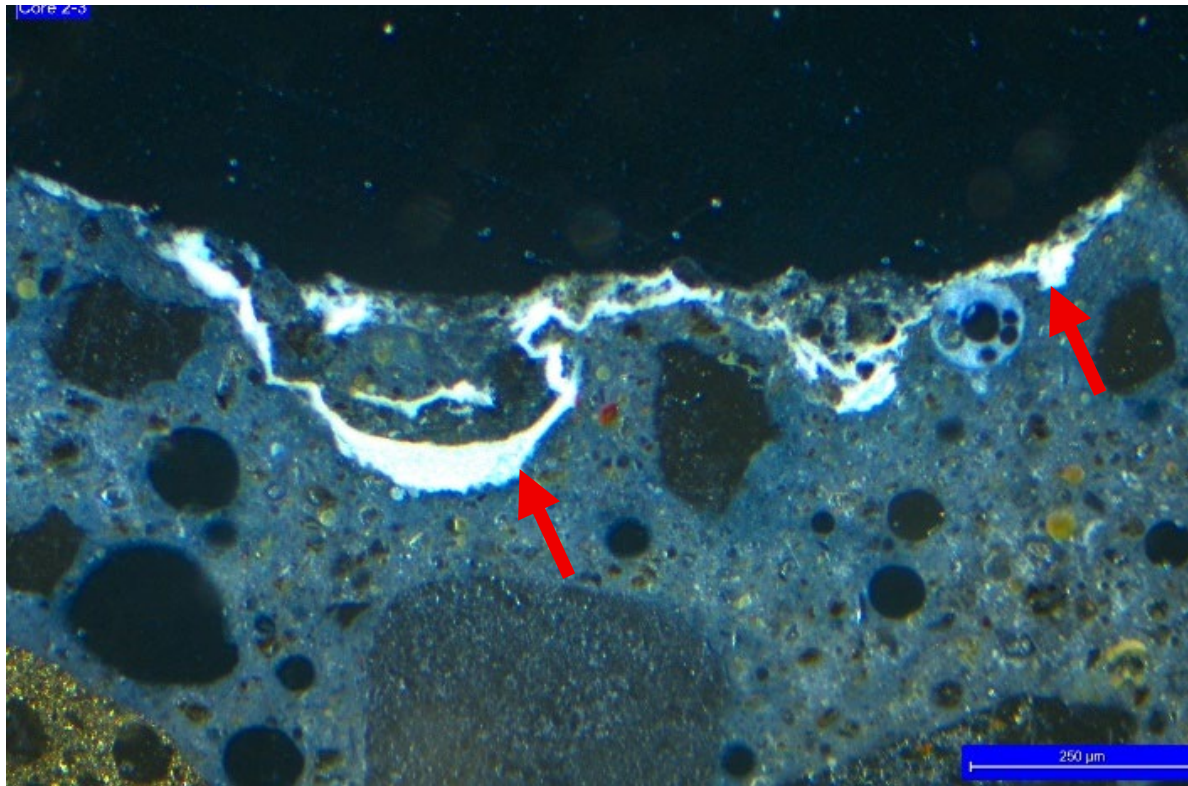
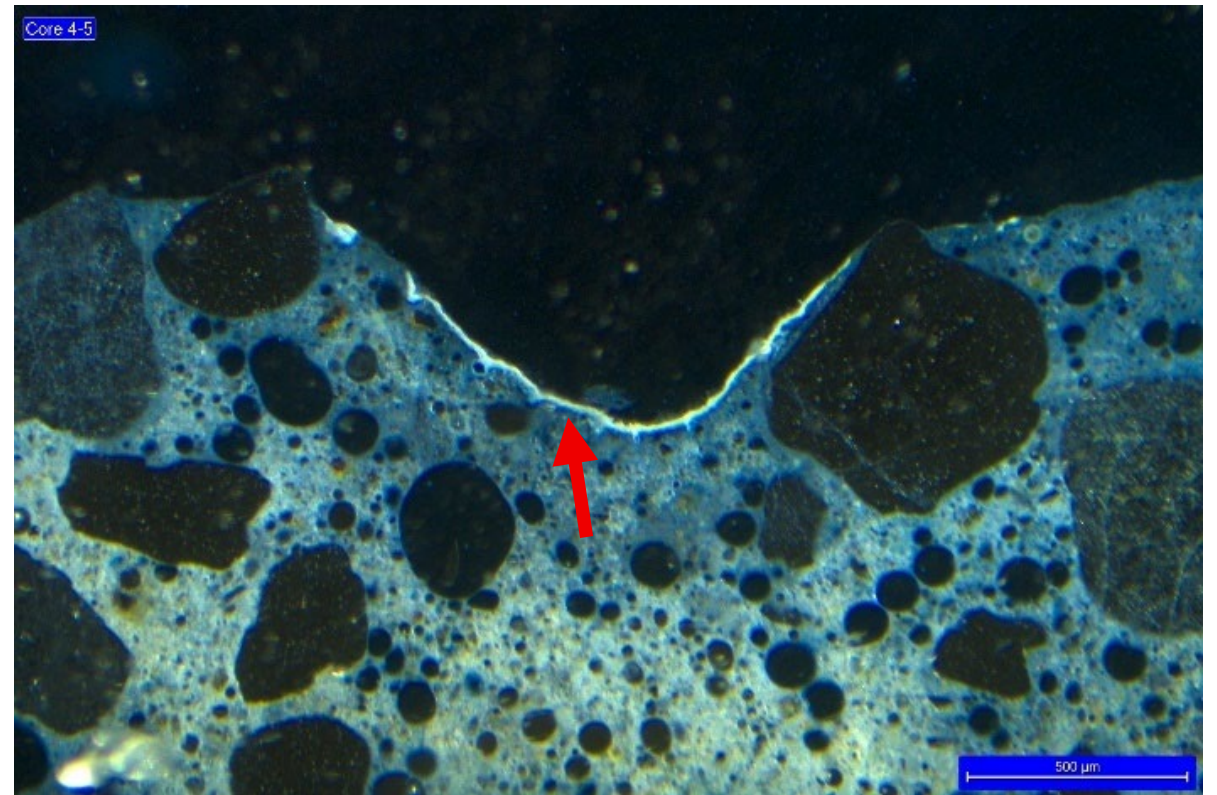
Surface Coating and Curing Compound

- Near surface regions often had higher w/cm and less air than bulk concrete
 - More often observed in “poor” areas
 - Observed microcracking often observed more in “poor” areas
- Evidence of curing compound not always observed, and at times only observed in the “good” areas
- Textural features on the surface of some cores suggest difficulty in finishing and loss of workability at the time of placement

- Emphasize best practices for finishing
 - In general, Type IL will have a slower bleeding rate, discourage addition of water to surface
- Enforce best practices for curing (initial and final)
 - Apply final cure as soon as soon as finishing is complete
 - Ensure cure meets specifications
 - Monitor evaporation rate
 - Consider evaporation retarders
- Educate field personnel about changes and proper way to respond

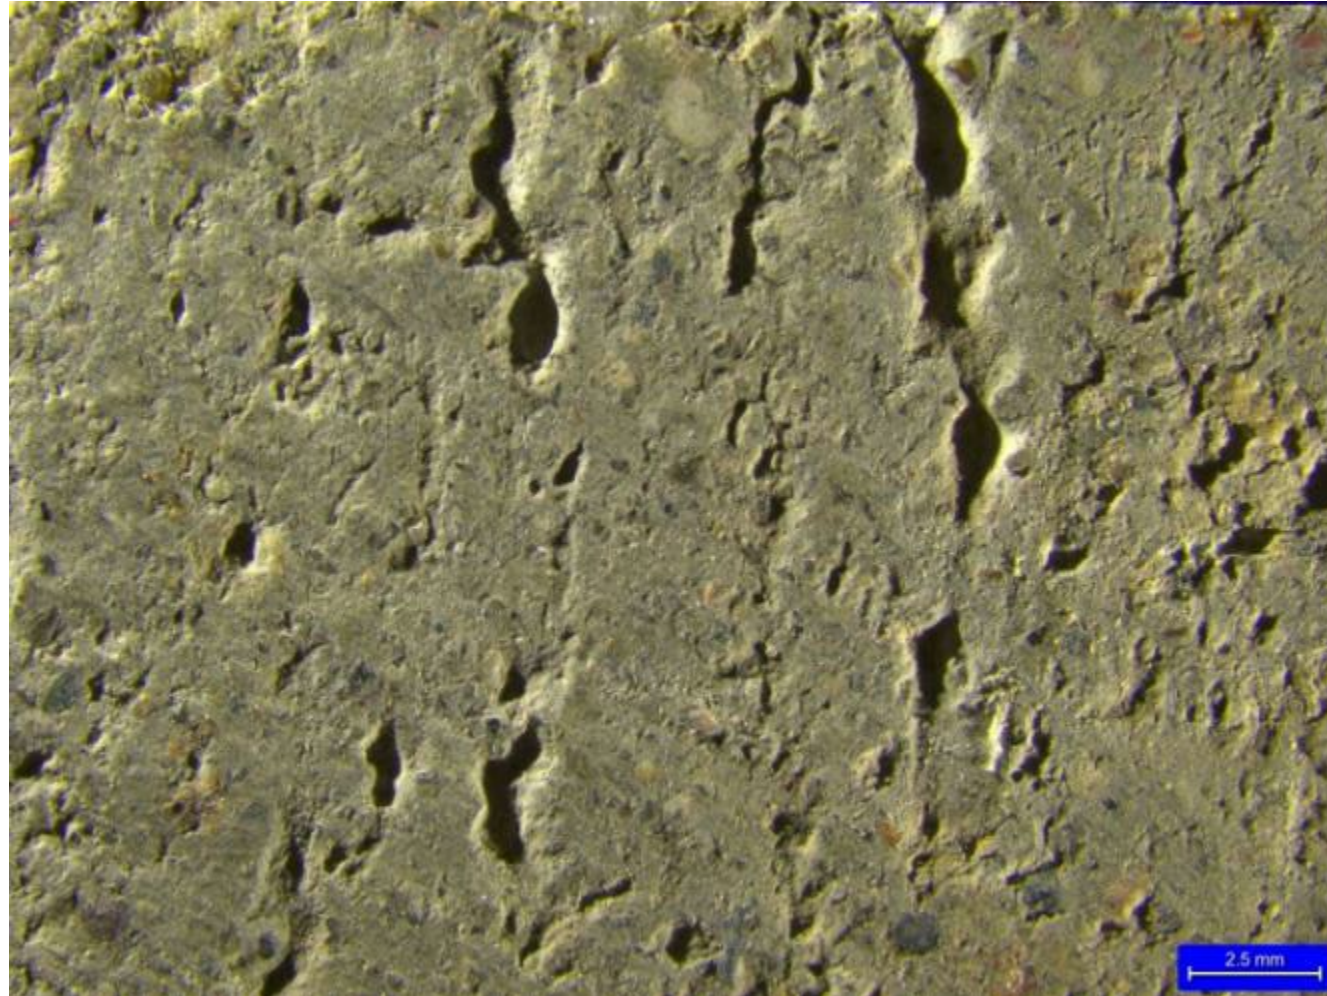
Workability Issues Also Observed

- Evidence that workability was a challenge on some projects impacting consolidation and finishing
- Finishing and poor curing has had a role in the weak surface
 - Surfaces often had different characteristics than bulk concrete as a result of finishing practices and poor curing
 - Finished in bleed water and in one case, the “poor” section had been rained on
