Caltrans Research: Chain Wear

Spring 2026 NC² Meeting

Chain Requirements & Accelerated Pavement Wear

56A0418-001 FIELD EVALUATION OF PCC SURFACE HARDENERS AND POLYESTER INLAYS FOR 03-NEV-80

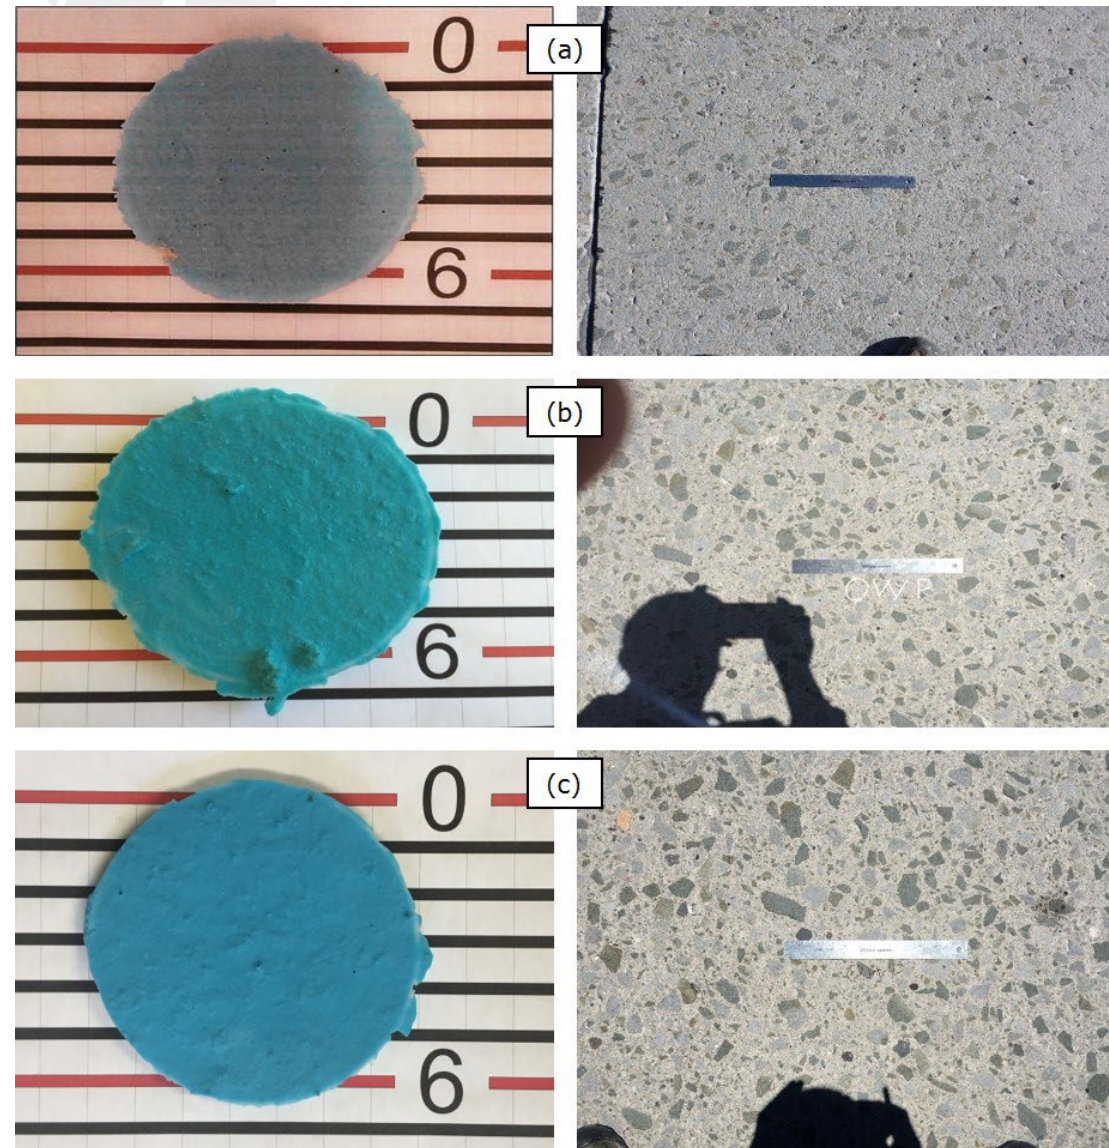
Section A: (a) 2015, (b) 2016, (c) 2017

Section	2015	2016	2017
A	Macrotexture from grinding observed	Exposed aggregate & smooth, polished surface	Missing cement paste & exposed aggregate
Control R1	Grooves clearly observed	Grooves showed evidence of wear	Missing cement paste & exposed aggregate
B	Grooves or grinding observed	Sections with no grooves (only grinding) showed exposed aggregate & smooth, polished surface	Missing cement paste & exposed aggregate
Control R2	Macrotexture from grinding was observed	Exposed aggregate & smooth, polished surface	Missing cement paste & exposed aggregate
C	Macrotexture from grinding was observed	Exposed aggregate & smooth, polished surface	Missing cement paste & exposed aggregate

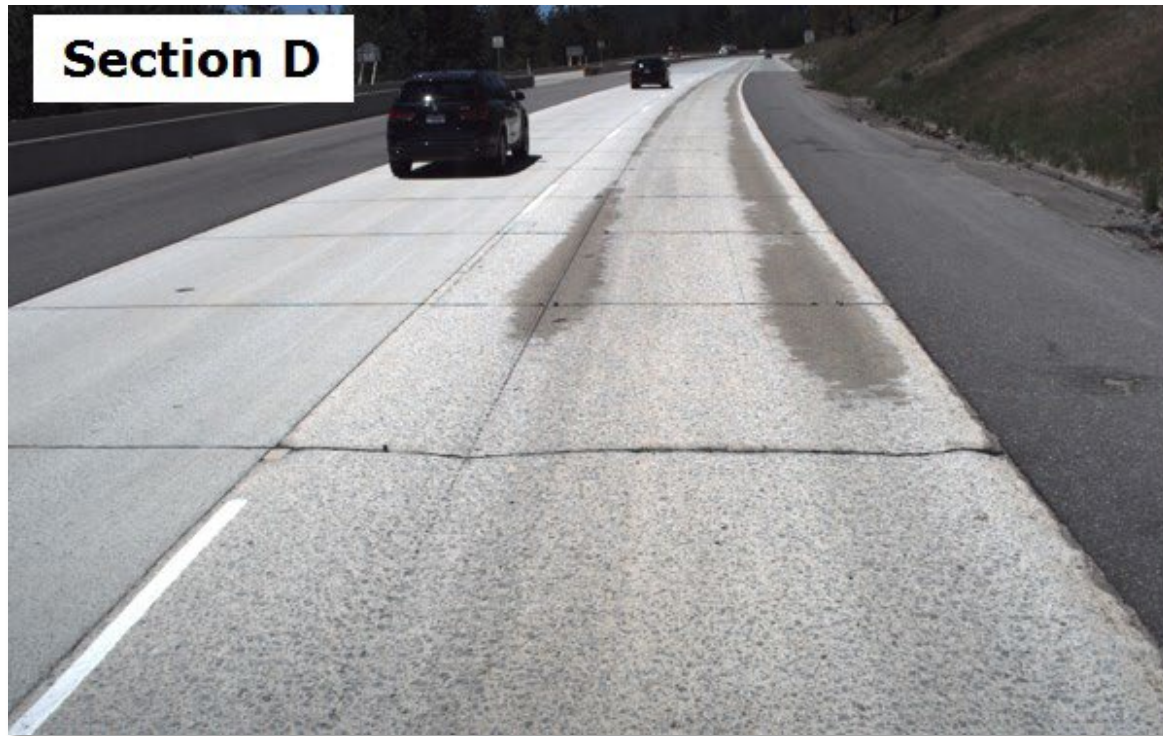
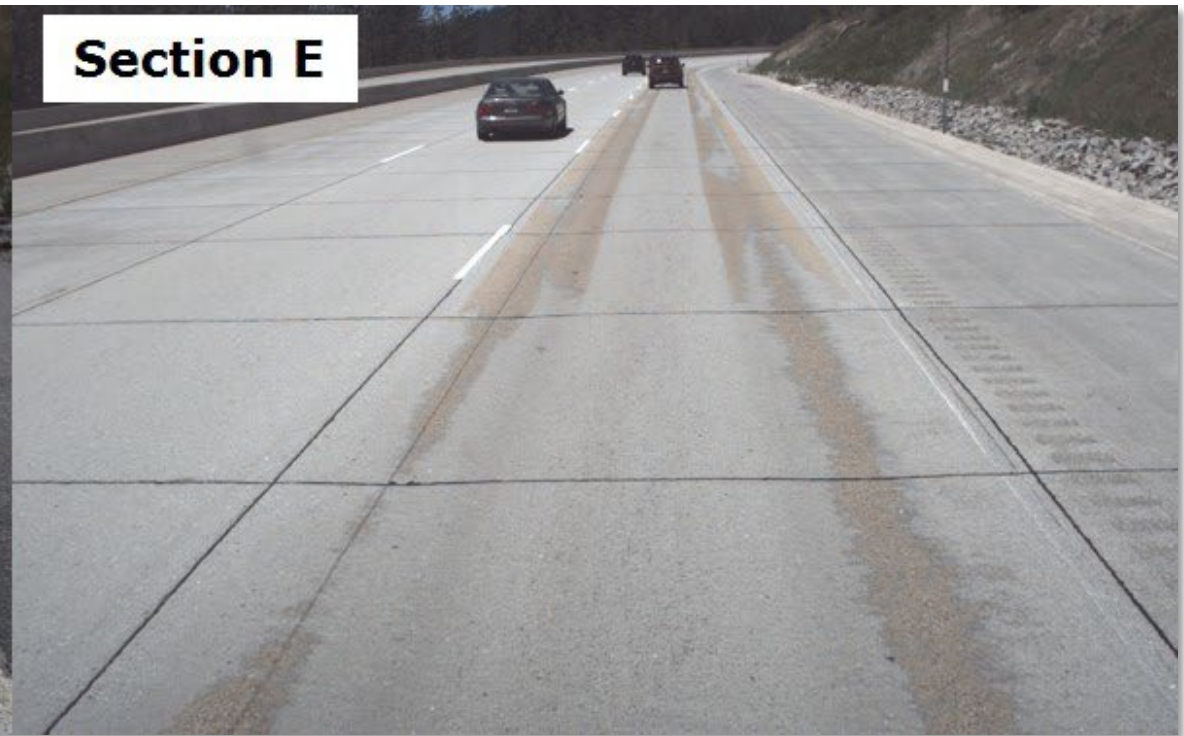
Example surface wear after two winters

- The 2015 polyester concrete inlays (“fill” or “grind/fill”) were essentially worn away after two winters in service (by 2017).
- It is important to note that sections were exposed to approximately 1.8 times more chained trucks than the surface hardener sections.

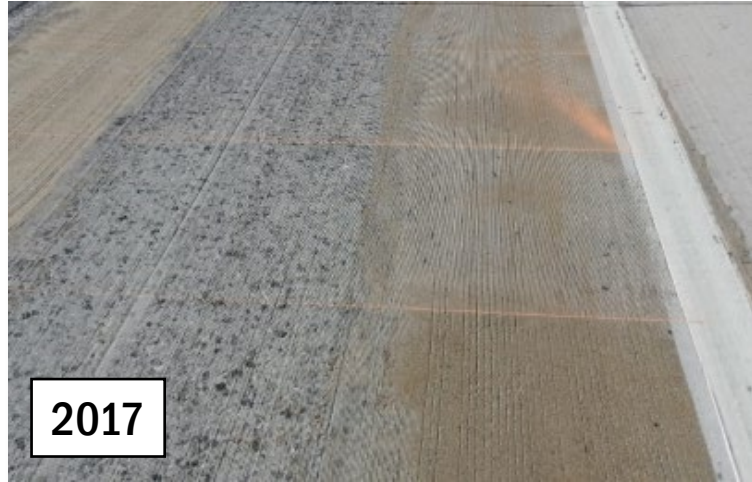
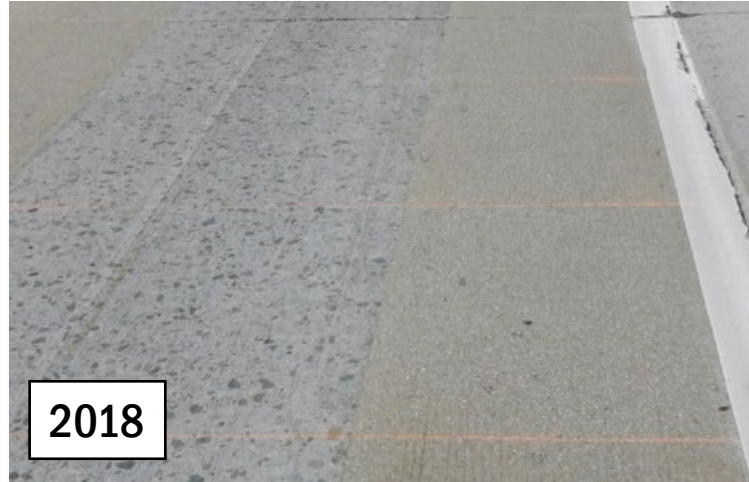
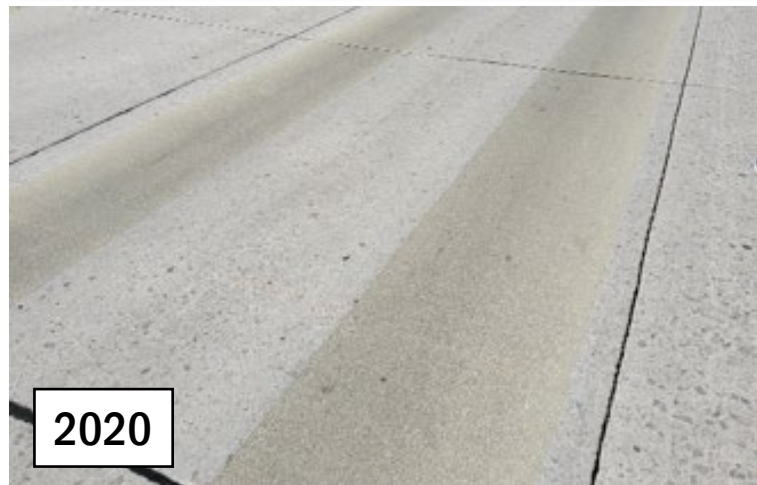
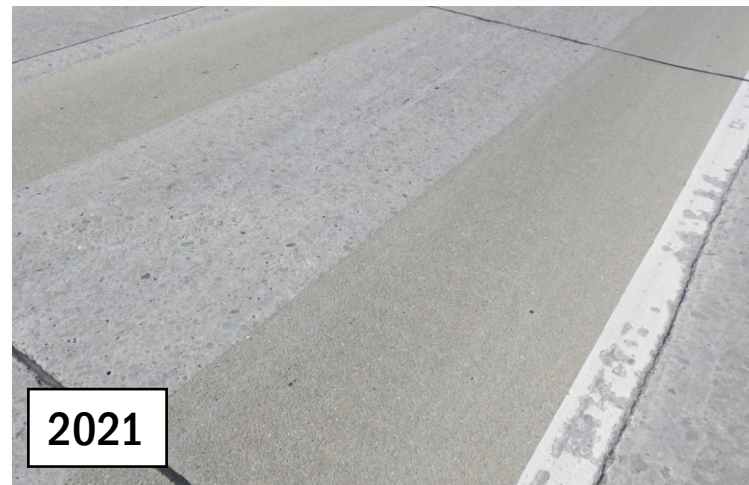
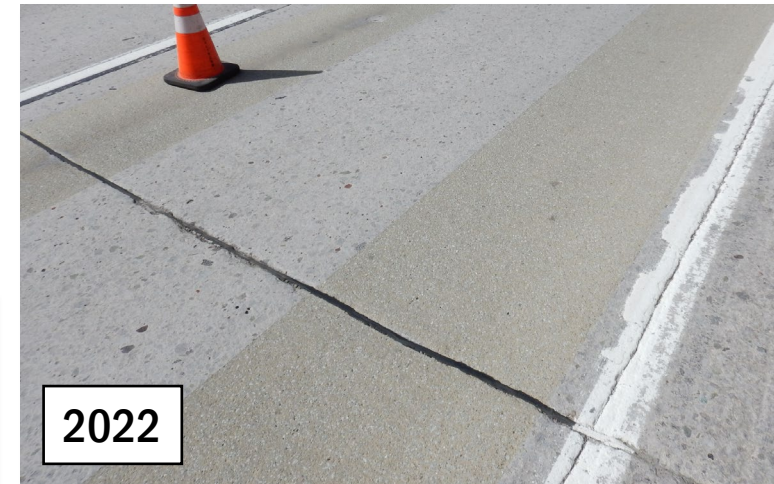
- Example surface wear progression (Section G1)

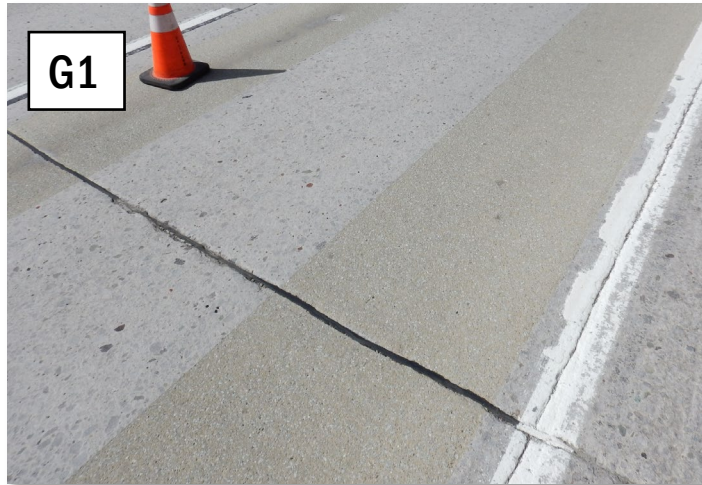
Type 1 Resin

Granite

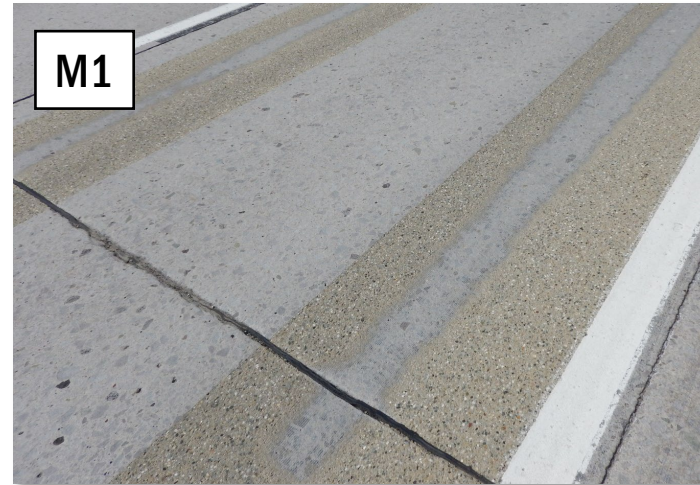
M1

Type 1 Resin

Sand

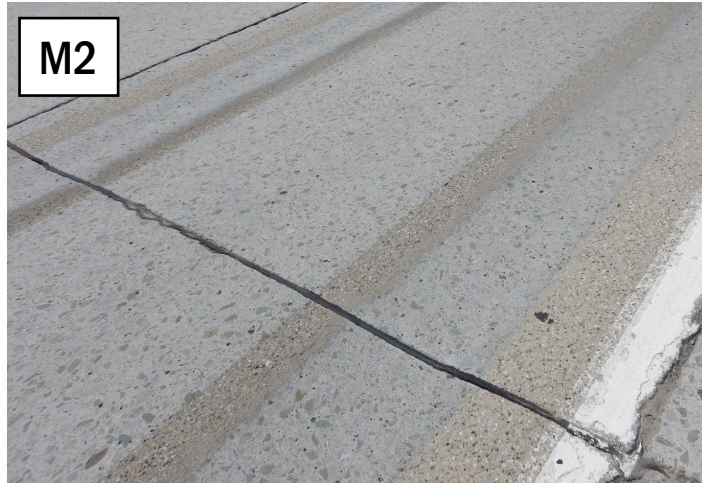
Type 2 Resin

Sand

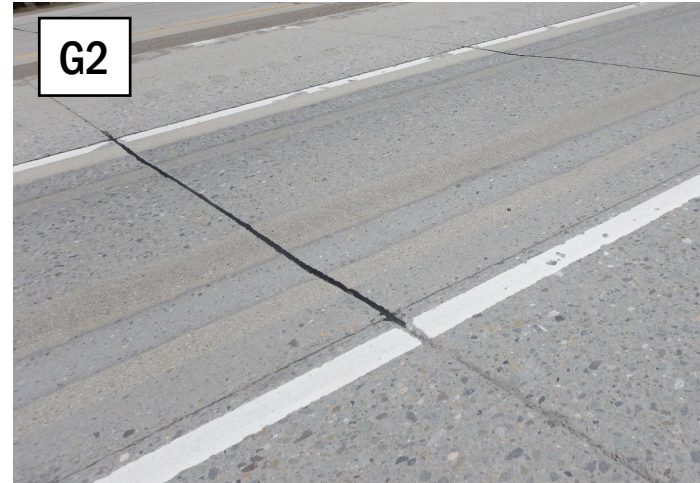
G2

Type 2 Resin

Granite

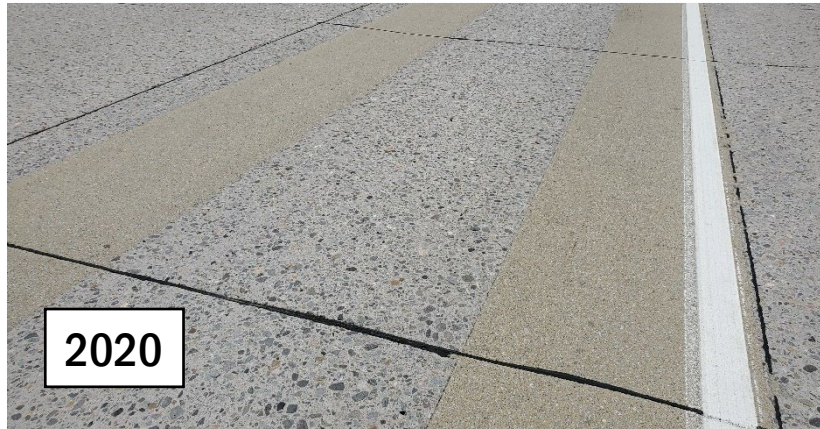
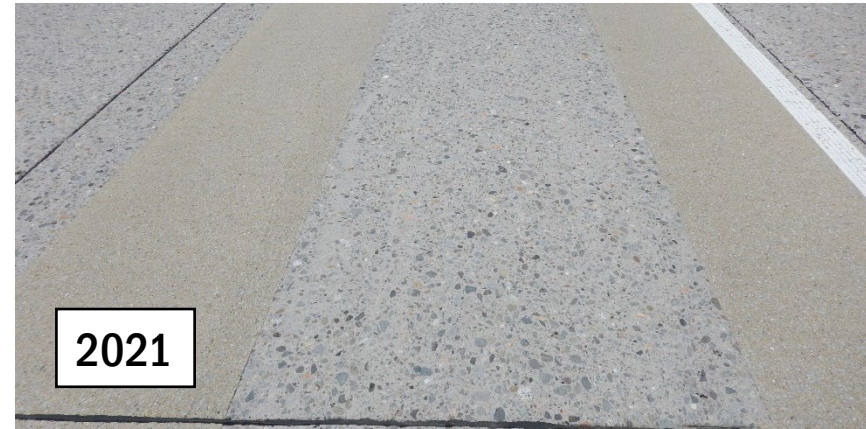
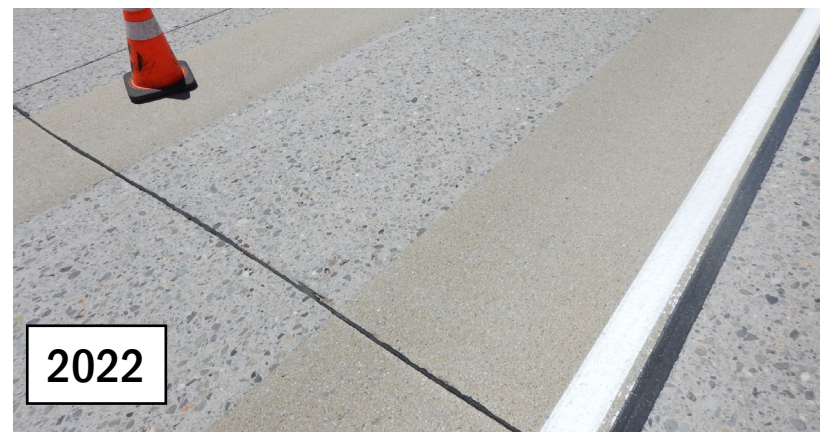
- Example surface wear progression (Section L1 – Downhill)

- The average inlay wear was 0.34 in. (L1), 0.36 in. (L3A), and 0.50 in. (L3B).
- Data suggest tire chains cause more wear in uphill segments than downhill segments
 - L1 had similar or less wear than L3A and L3B
 - L1 exposed to ~1.6 times more chained trucks
- After 3rd winter, underlying concrete was visible in isolated areas

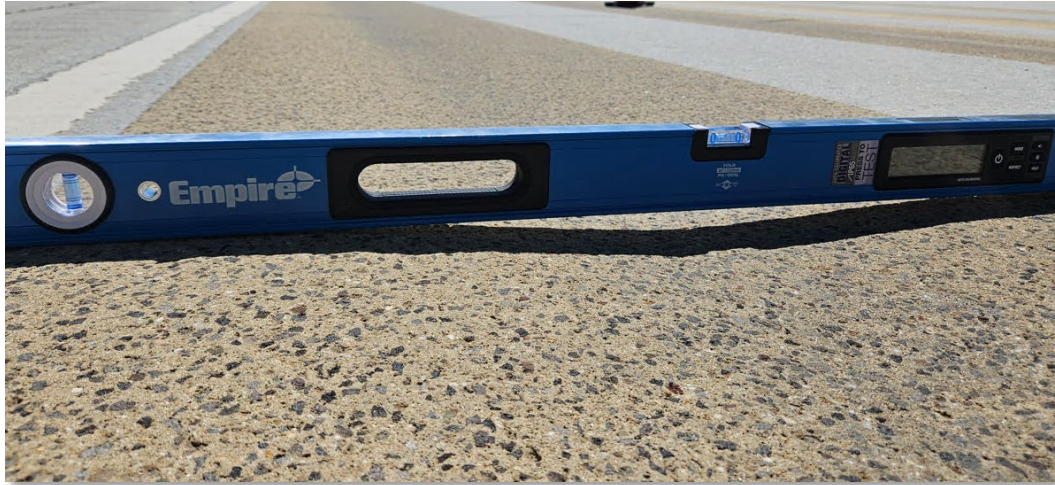
L3A

- **Experimental vs. PPC Inlays**
 - Standard Inlays (L3A, L3B) had significantly higher wearing rates compared to Experimental Inlays (F2, F3, F4) and experienced significantly less chained truck traffic

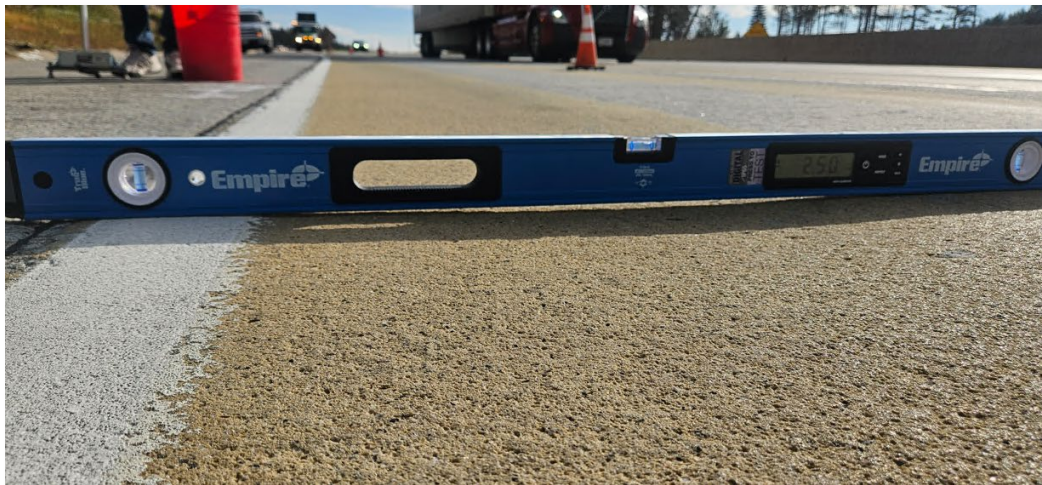
F3 (Polyester + Bauxite)

- **Section F3 (Polyester + Bauxite):** Averaged 0.26 in. cumulative wear. The left wheel path showed more advanced wear. Some right wheel path areas appear to have been re-inlaid.

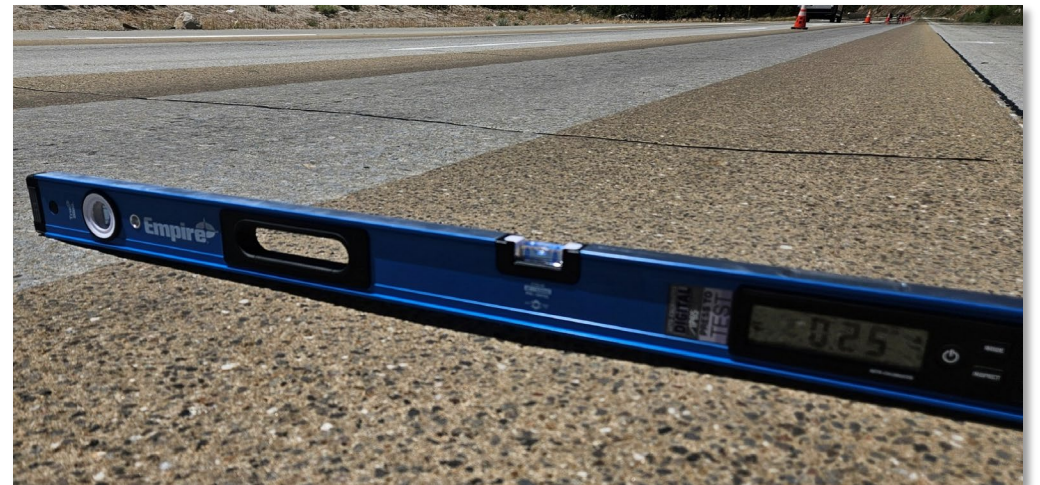
F4 (Epoxy + Sand)

- **Section F4 (Epoxy + Sand):** highest experimental wear (0.51 in. avg. cumulative). Defined wear channels were present, but no underlying concrete was exposed. Uphill grade and exposed to highest chain truck traffic of all 2023 sections.
