# **STRATEGIES FOR CONCRETE PAVEMENT PRESERVATION**

**Volume III: Case Studies**

**June 2026**

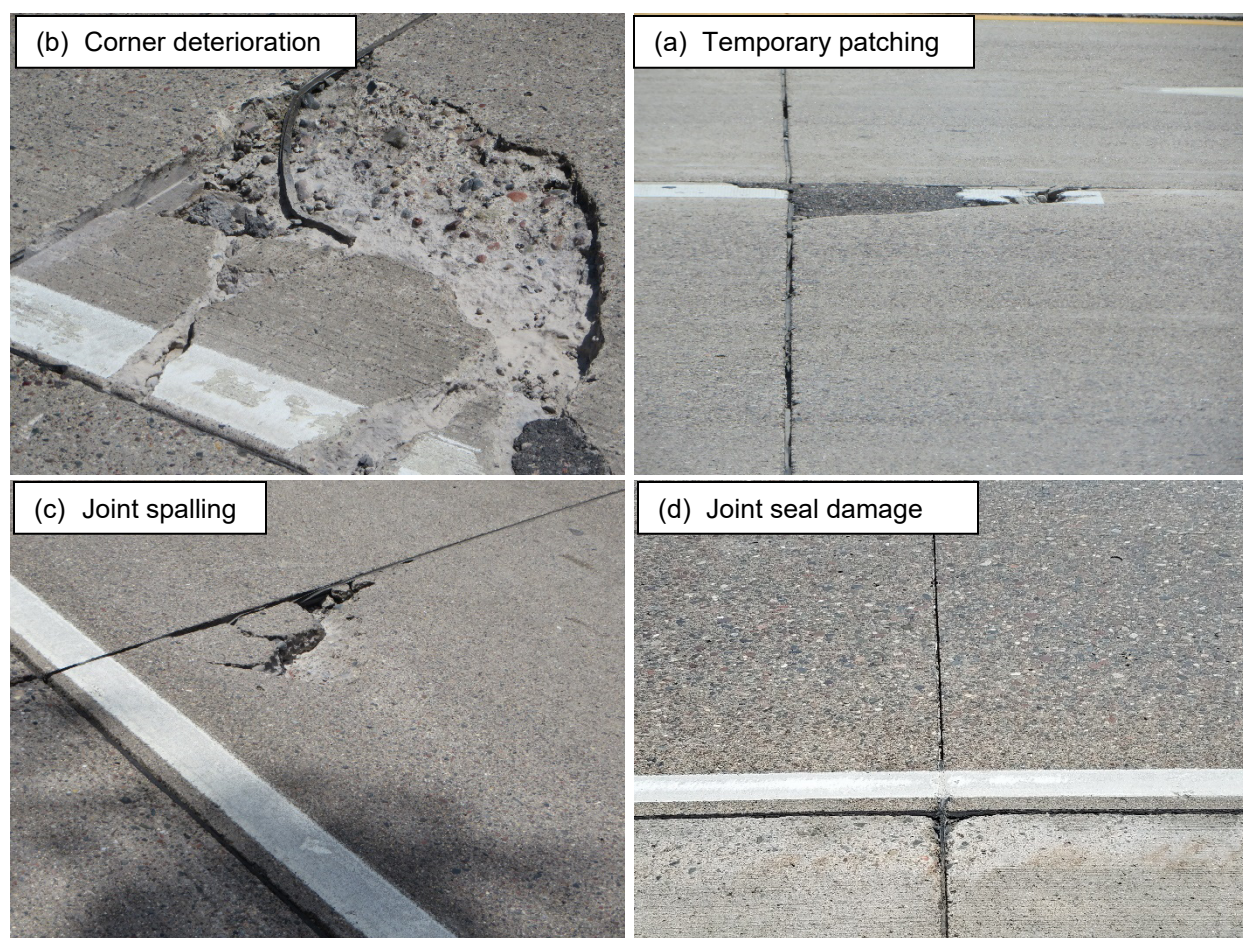
A field visit during the summer of 2018 revealed that the entire section was still in generally good condition, with sporadic presence of joint and corner deterioration, with temporary patching to address some of these distresses. The joint sealant appeared to be missing or damaged at a few locations. Figure 2-5 shows an overview of I-35W, and figure 2-6 presents some photographs of typical distresses observed.

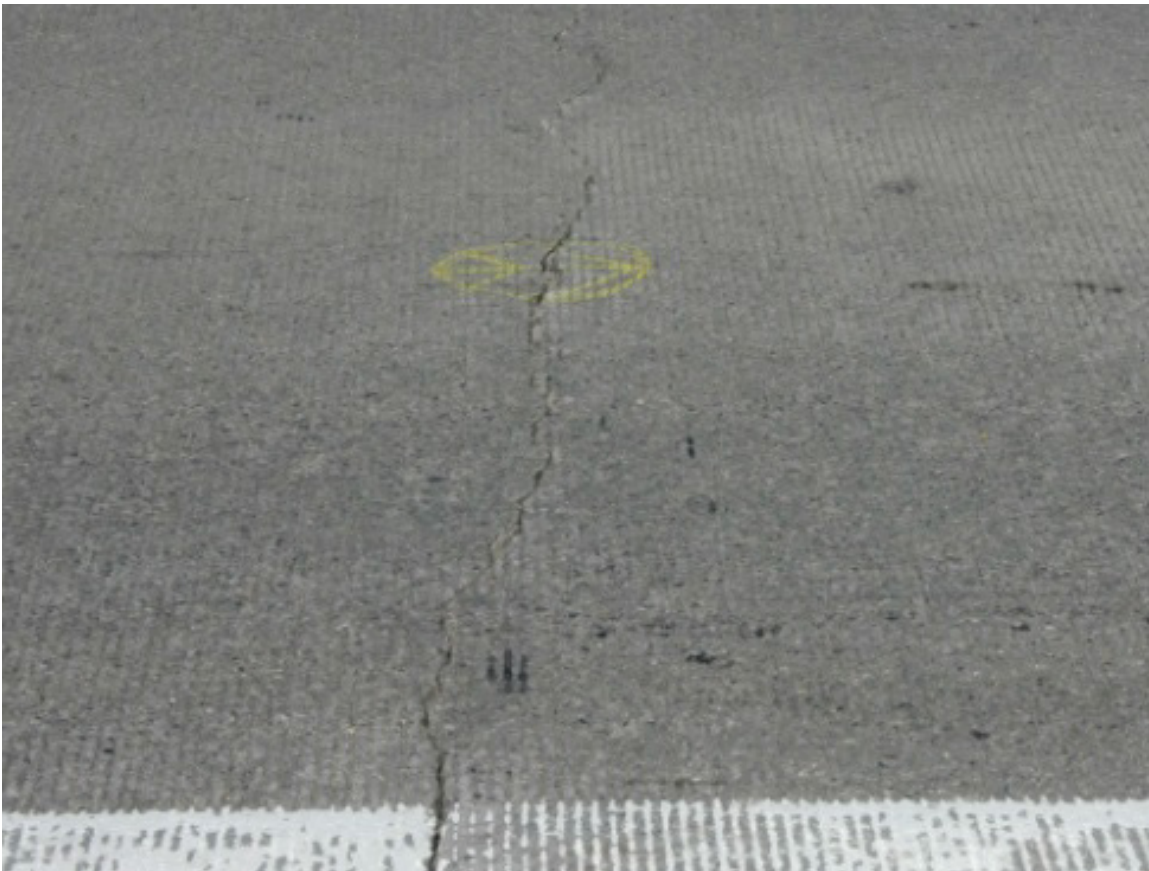
**Figure 3-5. Low- to medium-severity transverse cracking in 2011.**

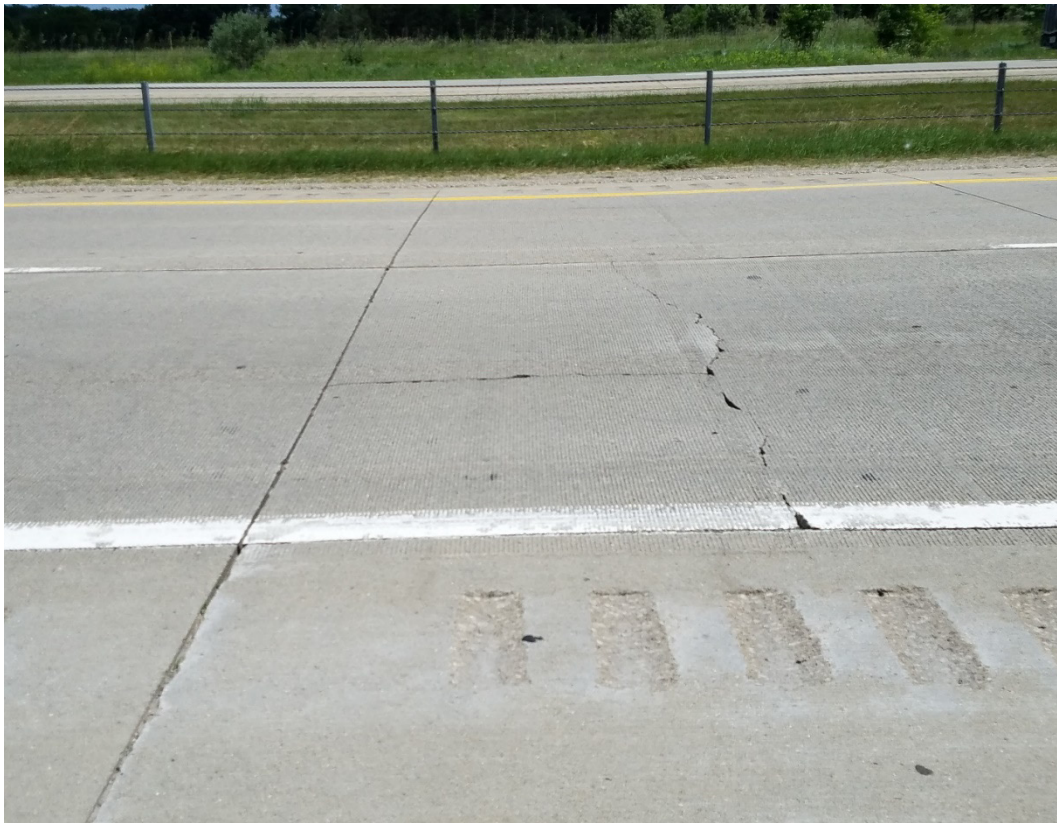
**Figure 3-12. Drainage outlet blocked by vegetation after being exposed with a shovel.**

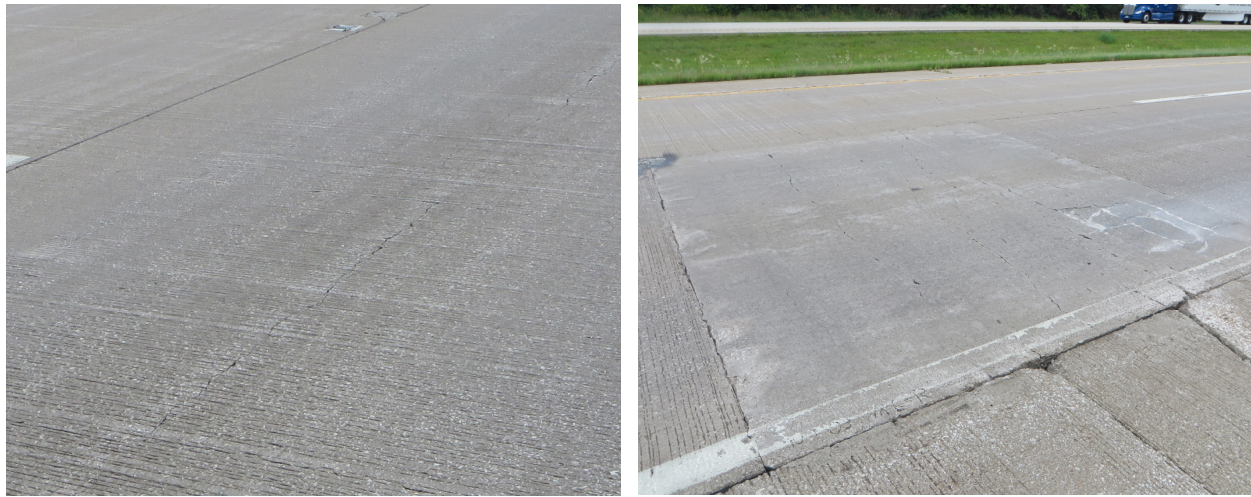
**Figure 4-7. Spalling along transverse crack (left) and punchout (right).**

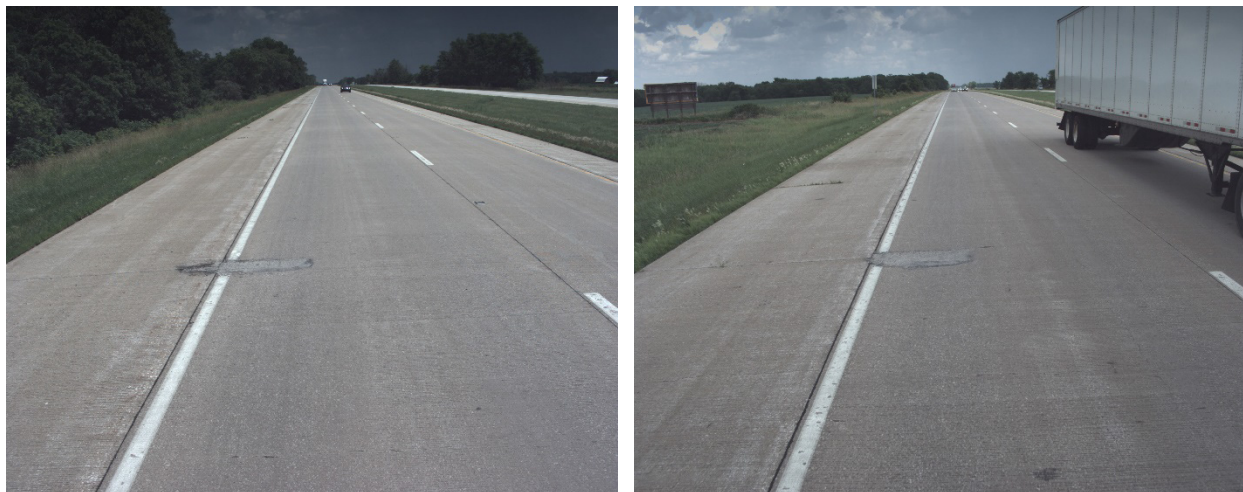
**Figure 4-8. Center of lane longitudinal crack (left) and deteriorated full-depth repair (right).**

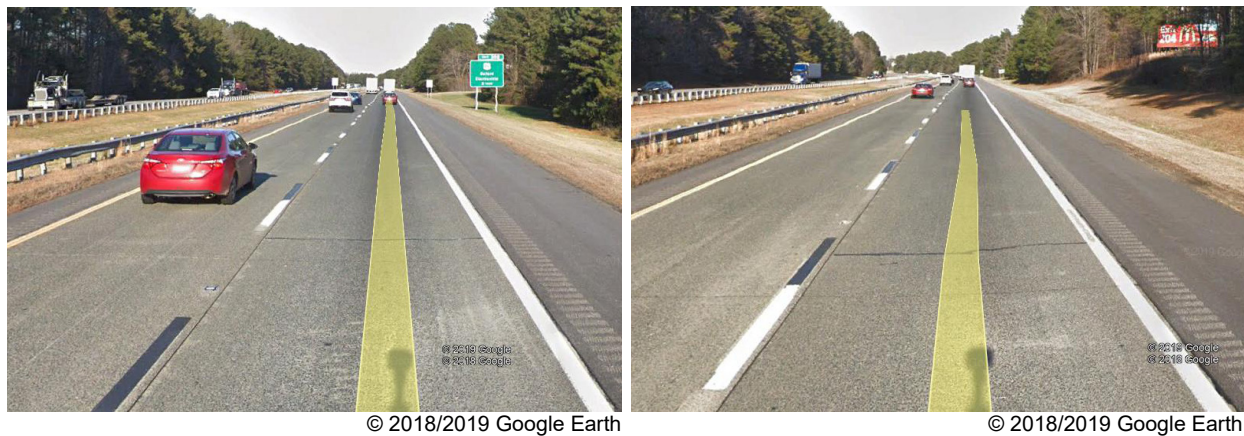
Occasional mid-panel cracking was observed, generally in the outer (driving) lane. In some cases, these cracks were only sealed with a liquid crack sealing material (see Figure 5-7) while in other cases partial-depth spall repairs had been performed over some or all of the crack length (see Figure 5-8). The repair material appeared to be a proprietary polymerized concrete.

**Figure 5-7. Typical 2018 mid-panel transverse cracking with only joint sealant applied (source: Google Earth, December 2018).**

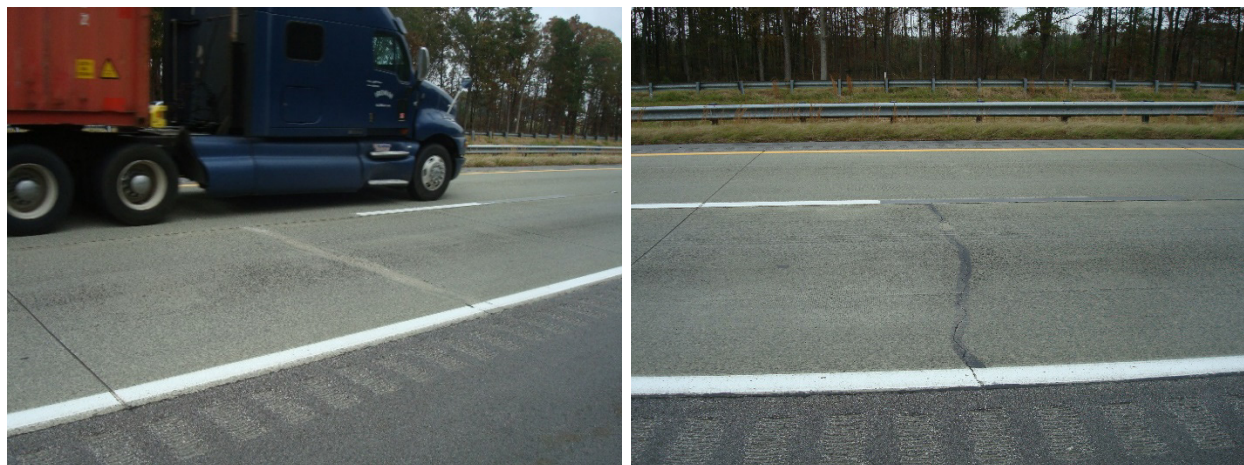
**Figure 5-8. Typical 2018 mid-panel transverse cracking with different amounts of partial-depth spall repair.**

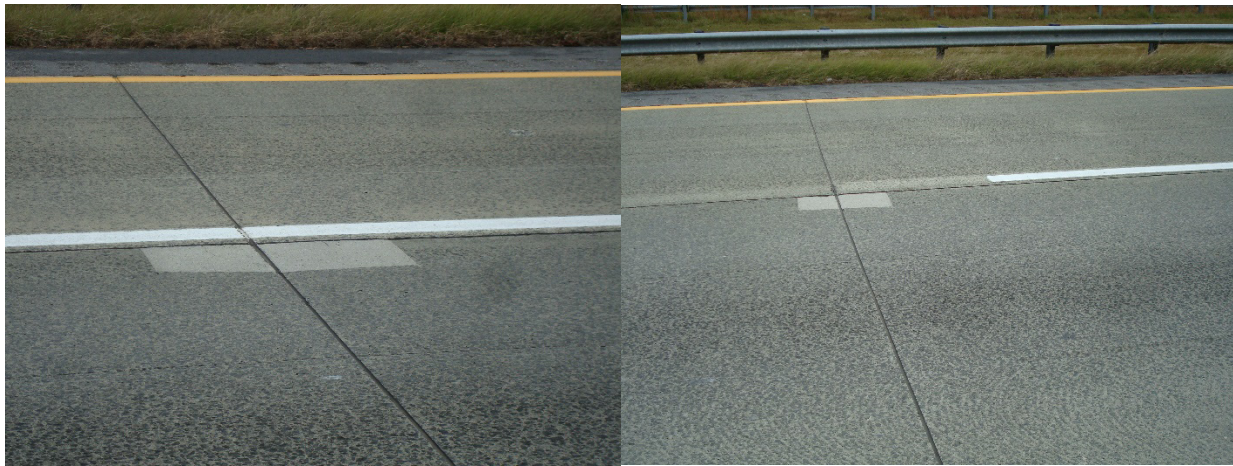
Figure 5-9 shows typical small partial-depth spall repairs that were applied at slab corners and along transverse cracks and joints in 2010. Figure 5-10 shows examples of full depth repairs that were observed in one area near the south end of the project (adjacent to the rest area); these are atypical and not representative of the overall project. As noted previously, these repairs appear to have been placed after the 2010 CPR because they exhibit a different grinding pattern than that of the surrounding concrete (see Figure 5-10).

**Figure 5-9. Typical partial-depth joint spall repairs on NC I-85 overlay project.**

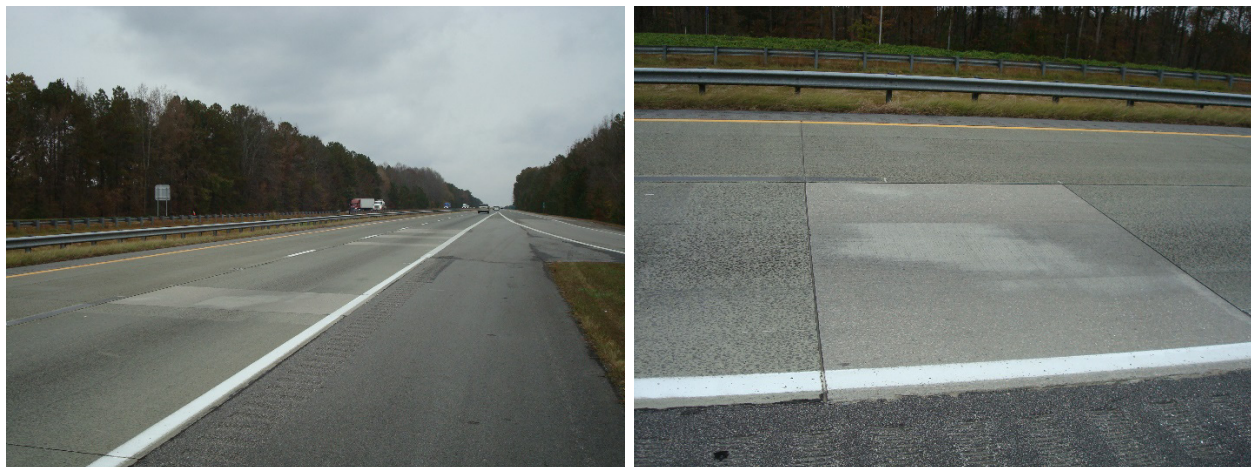
**Figure 5-10. Examples of full-depth repairs near rest area (~MP 198.5) on NC I-85 overlay project.**

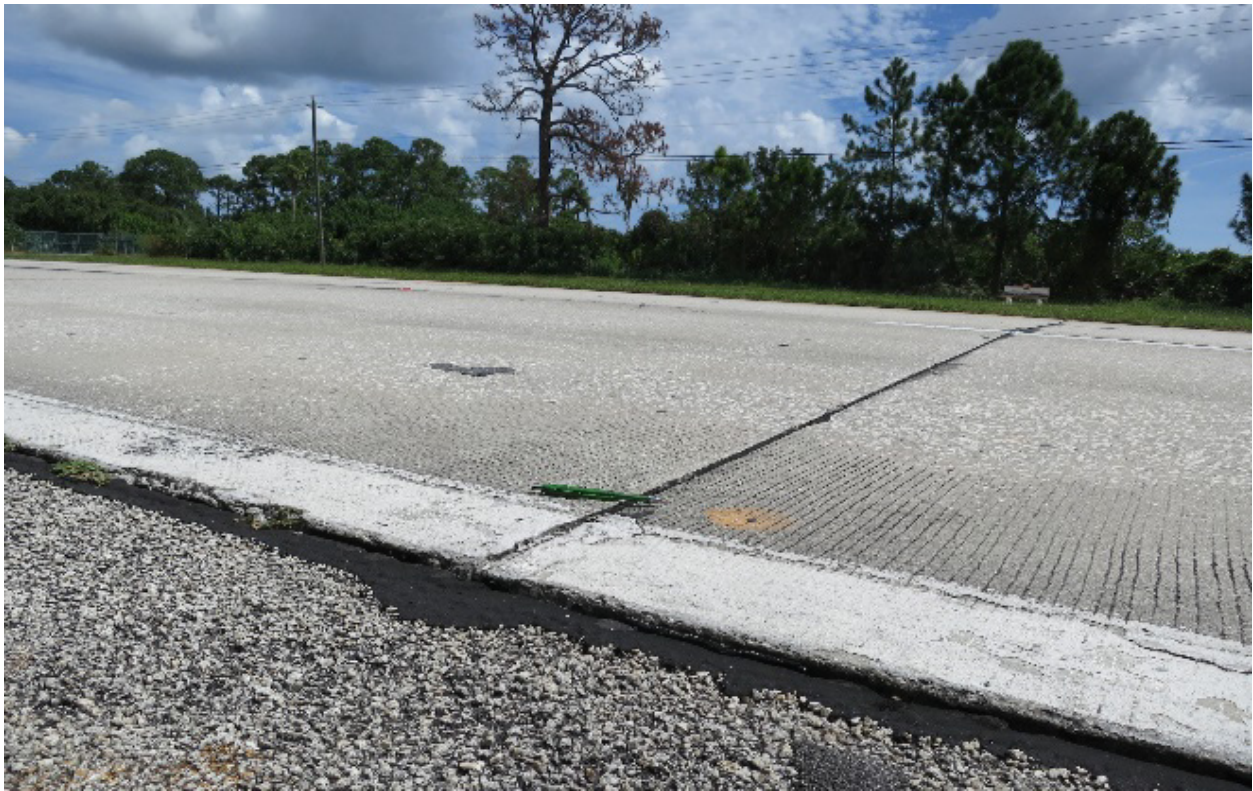
**Figure 6-4. Example transverse cracking on 20-ft panel observed in 2018.**

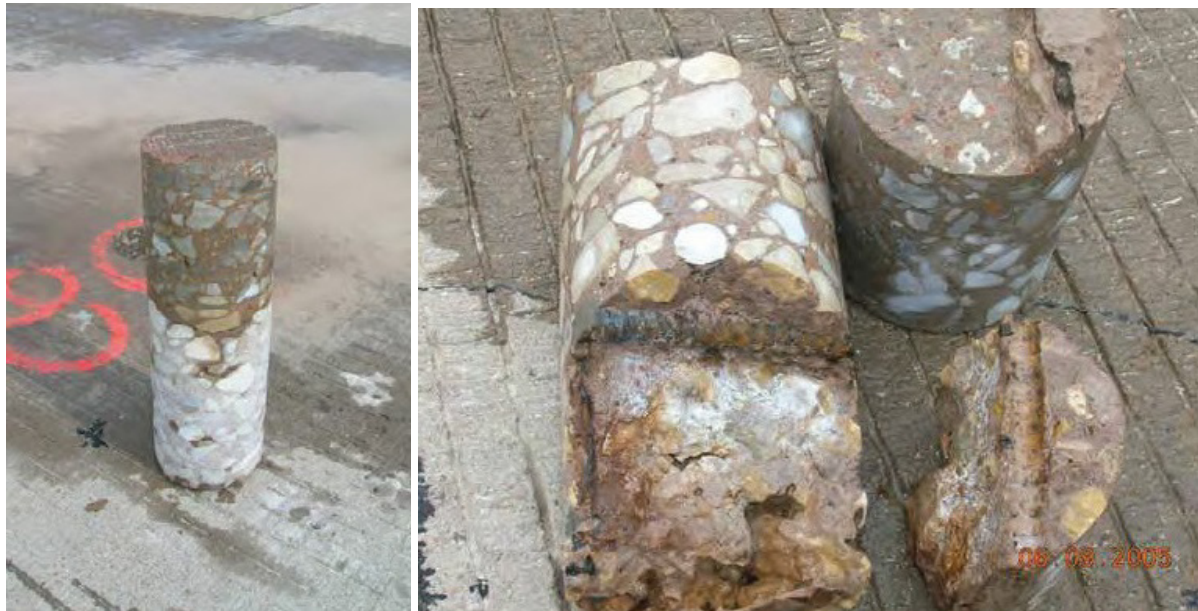
[71  $\mu\text{m}$ ]) except for one test (6.2 mils [160  $\mu\text{m}$ ] performed in an area with more deteriorated cracking). Eight of nine cores retrieved were in good condition (see figure 7-6). One core was taken from a small area near the outside lane-shoulder joint where sounding tests indicated possible delamination; the core revealed voids and deterioration in the original pavement at the level of the reinforcing steel and delamination between the overlay and original pavement, although the overlay concrete was in good condition (see figure 7-6).

**Figure 7-6. Photos of typical U.S.-281 core in good condition (left) and deteriorated and delaminated core (right). (Trevino, Medina-Chavez, and Won 2005)**

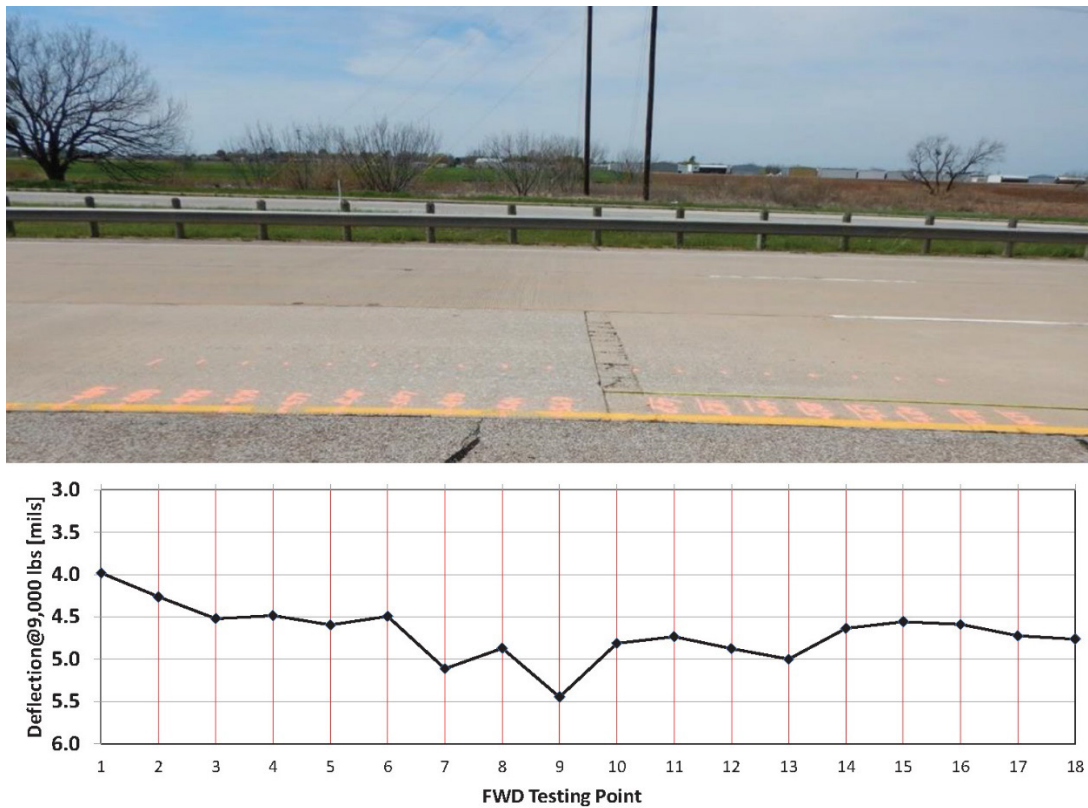
Figure 7-7 shows the FWD deflections at TCJs were much larger than deflections in other areas (Choi et al. 2018). Ultrasonic scanning detected delamination between the overlay and original pavement and also within the existing CRCP (near mid-depth, along the plane of the reinforcing steel – see figure 7-8). The delamination and mid-depth cracking disappeared a short distance away from the TCJ (see figure 7-9).

Figure 7-7. Photo of deterioration near BCO transverse construction joint and associated FWD deflection test results (Choi et al. 2018).

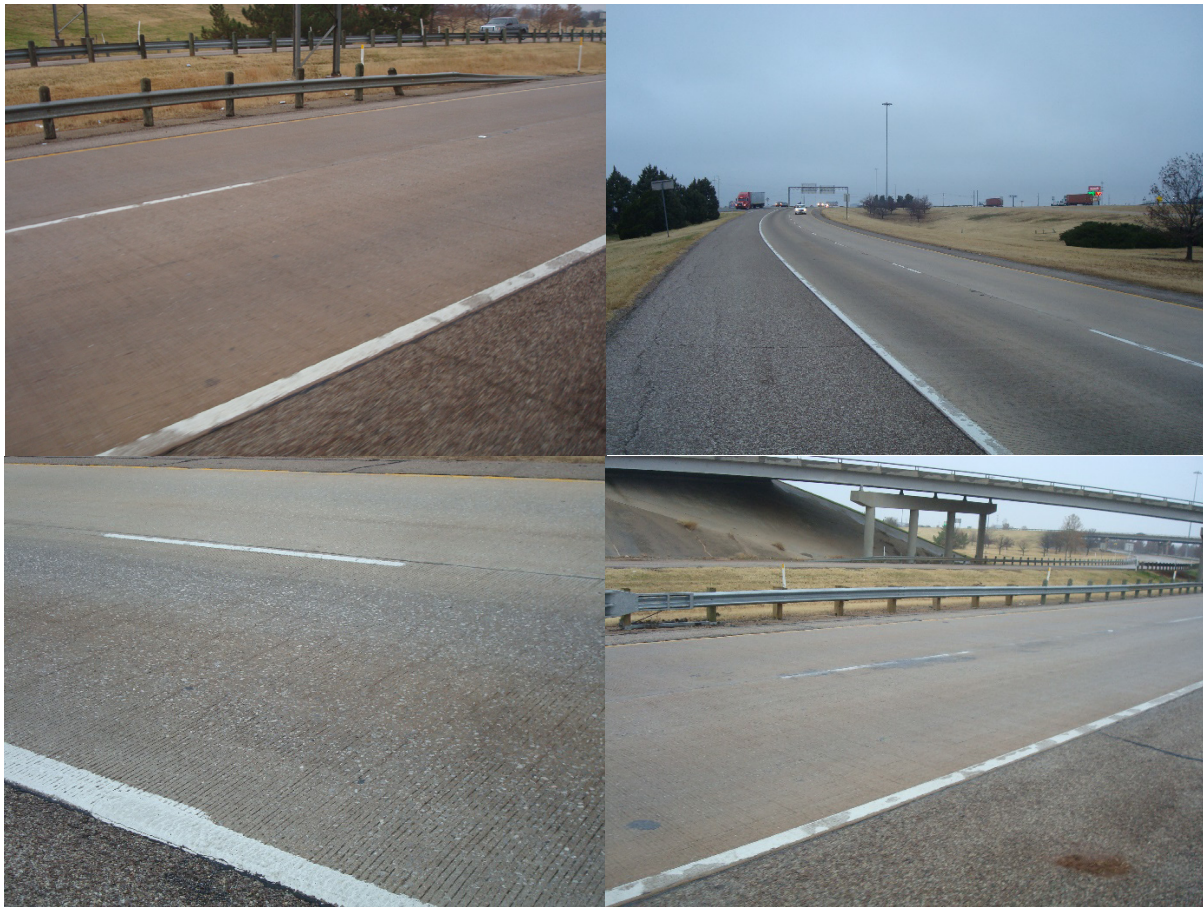
**Figure 7-10. Typical 2018 conditions on U.S. 281 BCO project.**

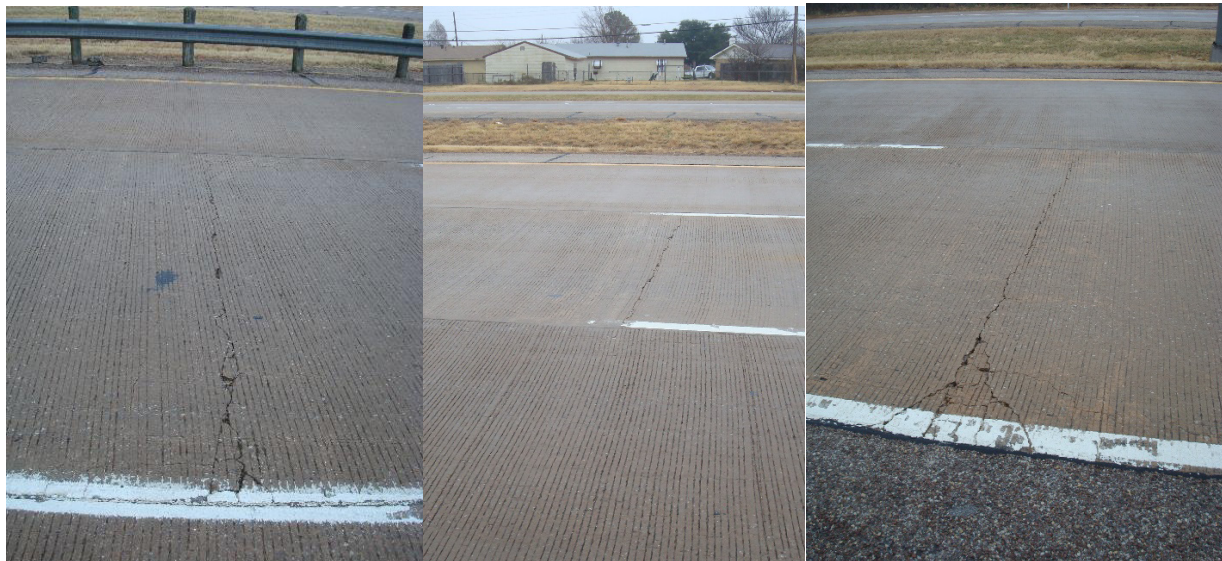
- A few wide transverse cracks (mainly in the outer lane of 2-lane sections and the middle lane of 3-lane sections), as shown in figure 7-11.
- Maintenance (patching) performed in 2016 at some bridge approach transitions (see figure 7-12).
- Two patches placed in 2018 on the southbound ramp to Hatton Road (see figure 7-13).
- Occasional concrete deterioration around transverse construction joints (see figure 7-14).
- A few small areas of concrete deterioration (possible loss of bond and breakup of overlay - see figure 7-15).

**Figure 7-11. Typical wide (deteriorating) transverse cracks.**

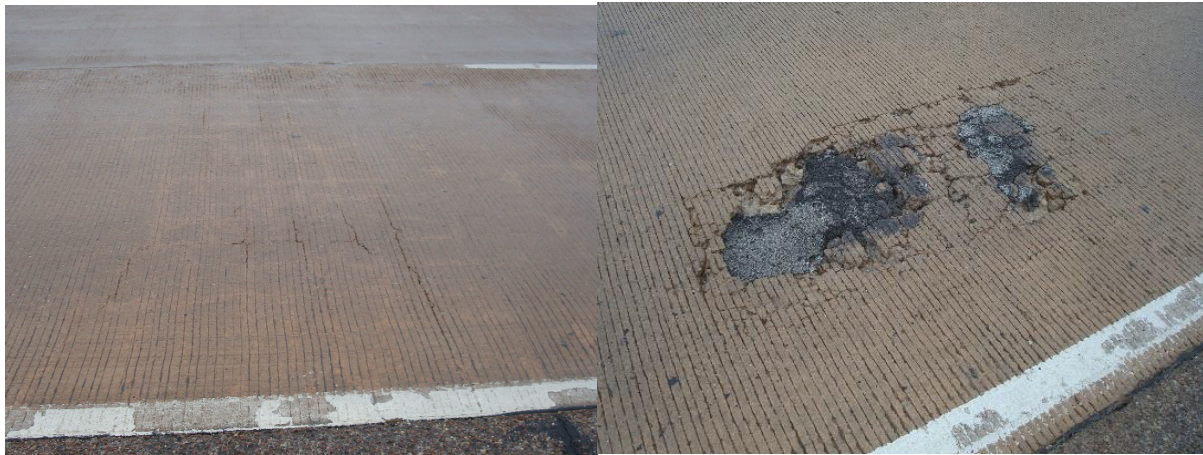
**Figure 7-14. Examples of overlay deterioration around transverse construction joints.**

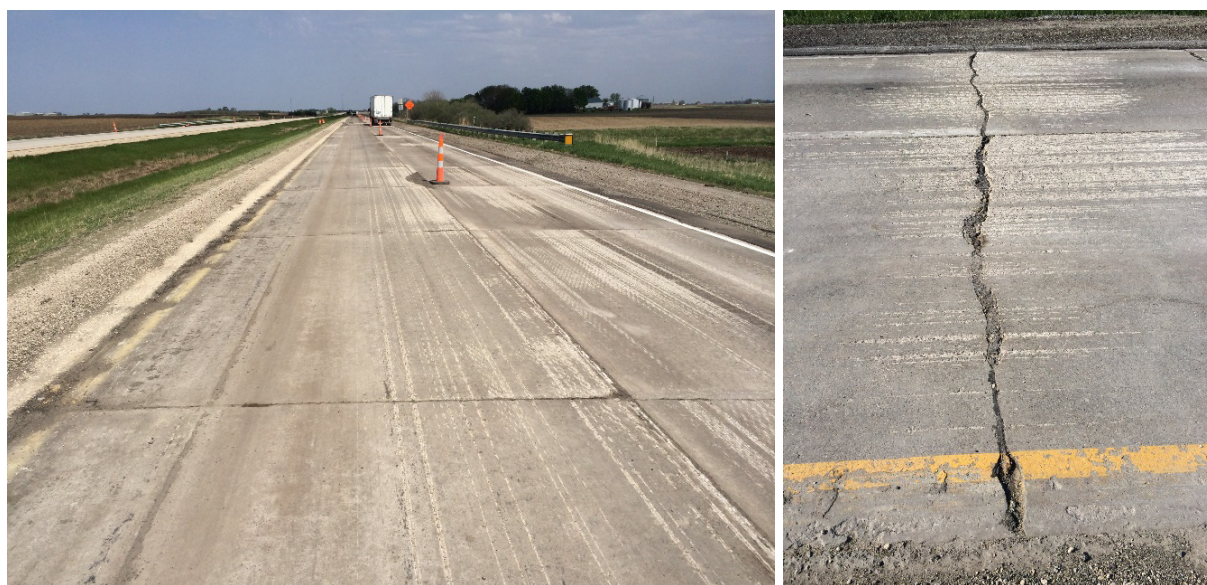
**Figure 8-4. Exposed concrete (left), close-up to pre-existing cracking in eastbound direction of U.S. 20 (right).**

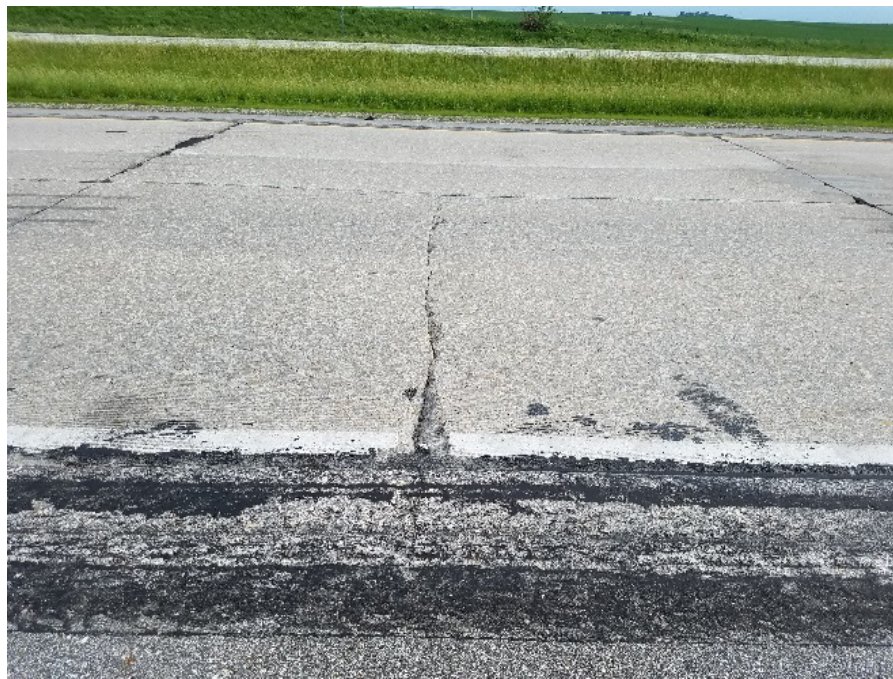
**Figure 8-13. Example of spalling and joint seal damage on U.S. 20 EB in 2018.**

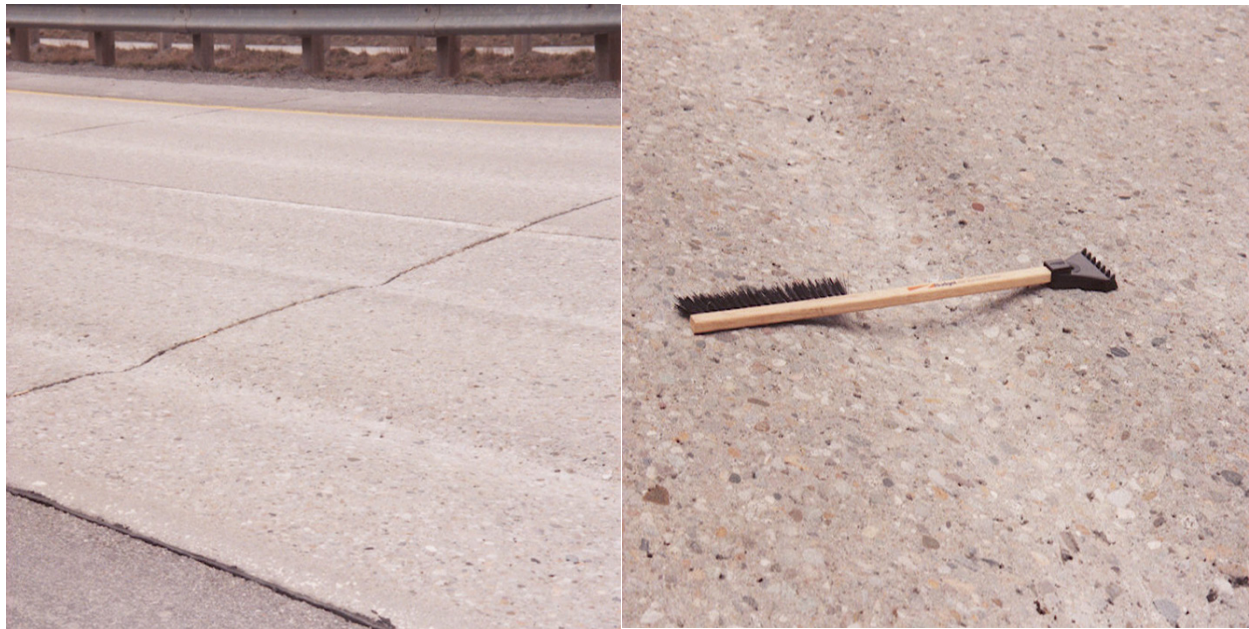
**Figure 10-4. Project wheel path rutting due to tire chains and studded tires (Necessary and Lemasany 2006).**

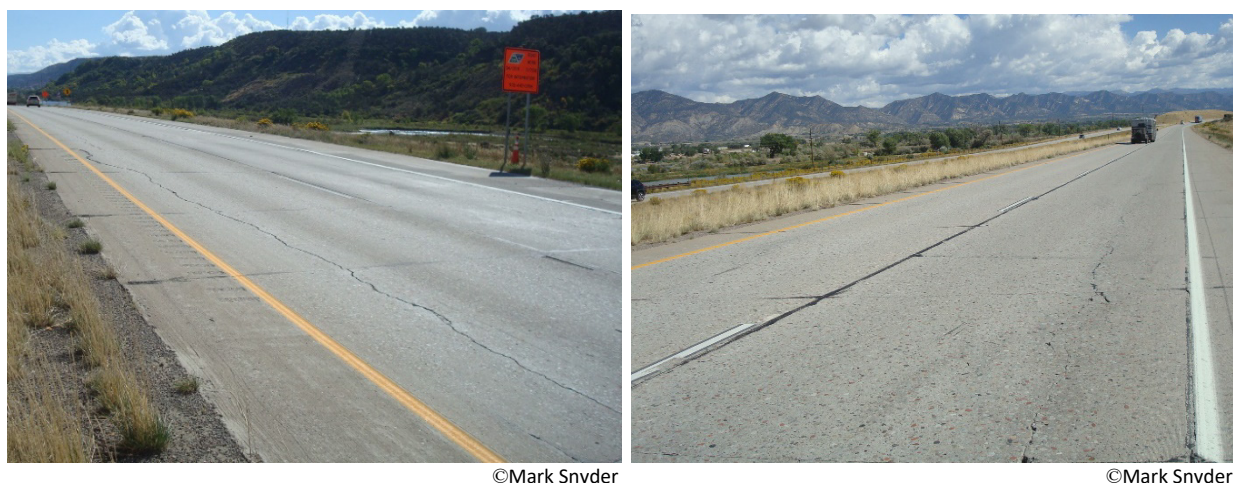
**Figure 10-9. Examples of typical longitudinal cracking in the inside lane (left) and outside lane (right).**

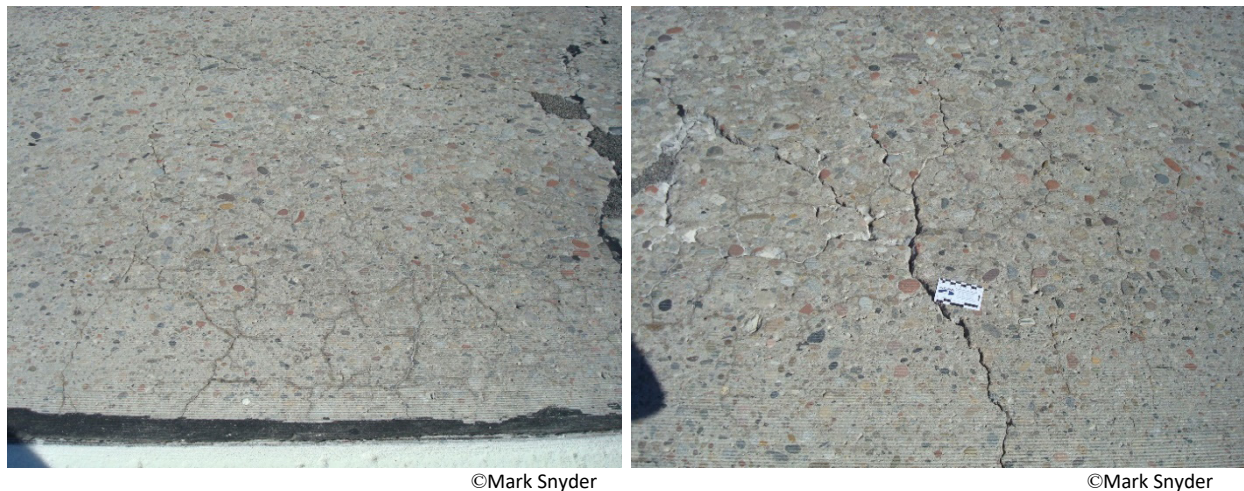
**Figure 10-10. Examples of typical surface cracking (left) and deteriorating surface cracking (right).**

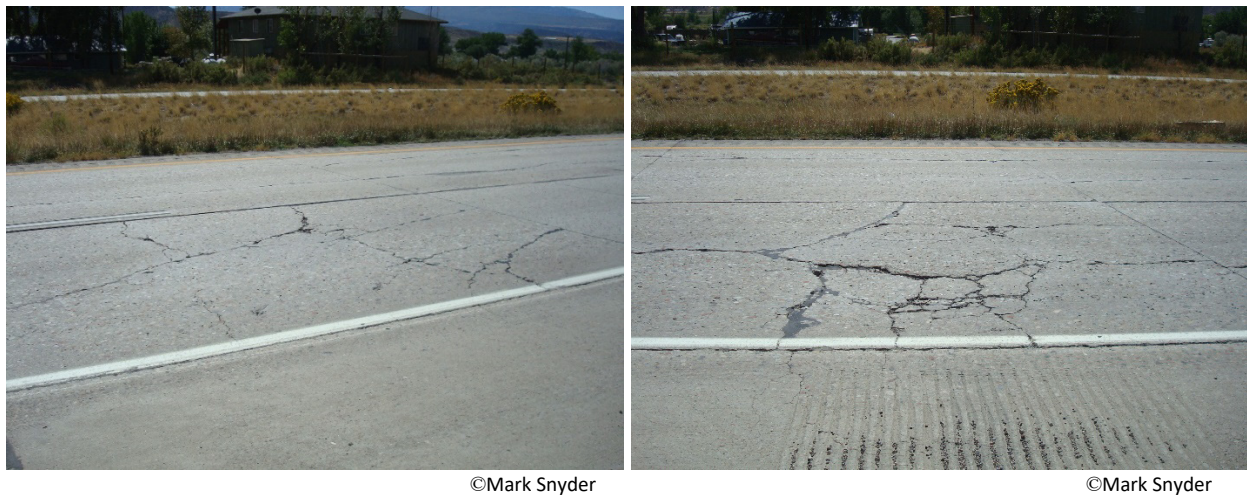
**Figure 10-13. Examples of shattered slabs.**

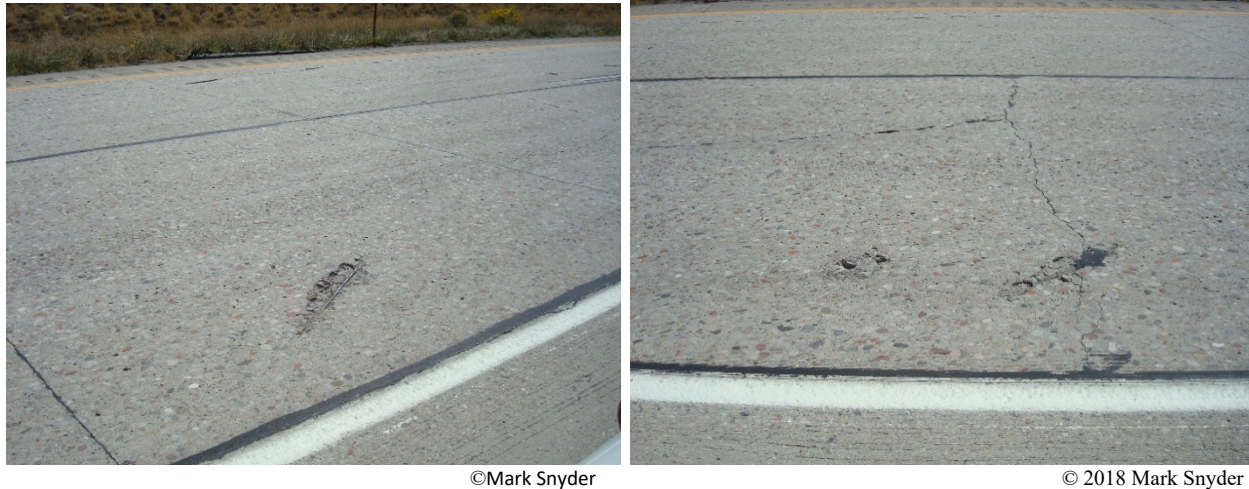
**Figure 10-15. Examples of displaced rebar at pavement surface in outer wheel path of westbound driving lane.**
