EL01-2015 Implementation
Assistance
Program

**Tools to Improve PCC Pavement
Smoothness During Construction
(R06E)**

FIELD REPORT: IDAHO EQUIPMENT LOAN

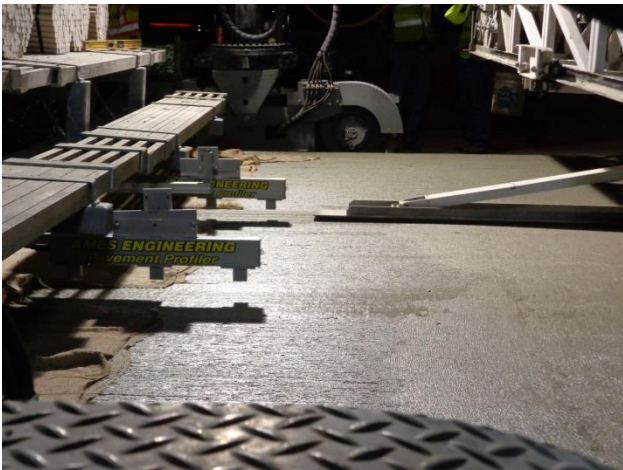
Figure 1. Ames RTP Mounted to G-Z S-850 Paver With a Float Pan

CPC’s paving operation was highly organized and proficient. The concrete mixture was batched at a central plant approximately 8 miles from paving location and delivered in dump trucks. Figures 1 through 6 illustrate the installation of the RTP and different aspects of the paving equipment and processes used by CPC.

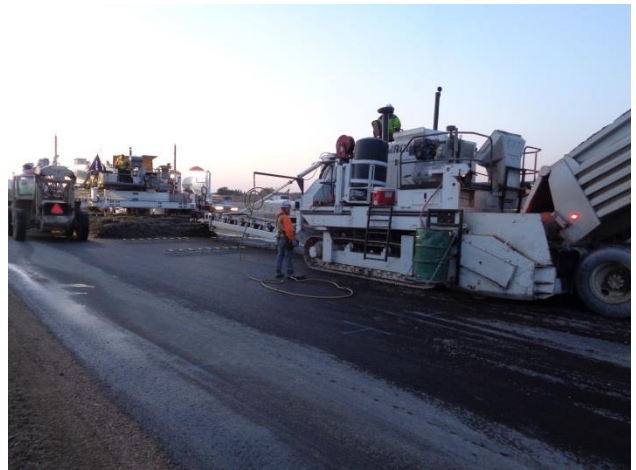
Figure 2. Trucks Dumping Concrete at Gomaco 9500 Placer, Installation of Dowel Baskets and Concrete Deposited Ahead of the Paver

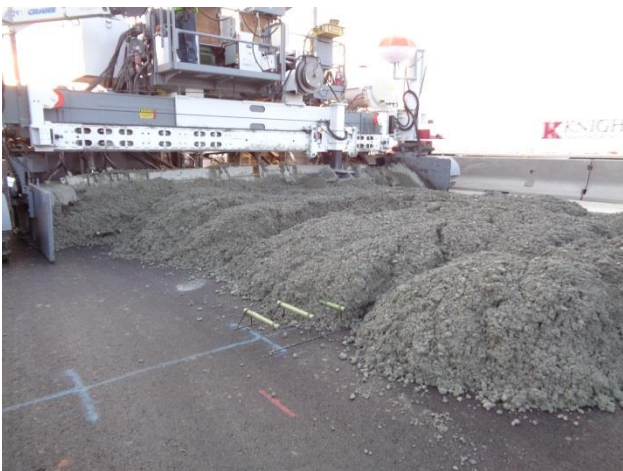
Figure 3. Concrete Deposited on Dowel Baskets Ahead of the Paver

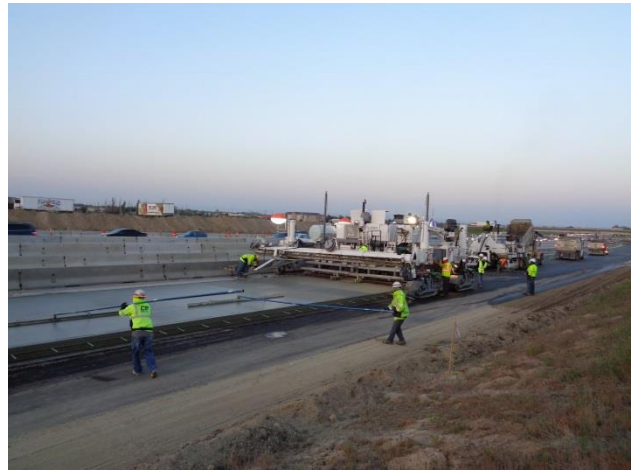
Figure 4. Use of a Final Finisher (auto-float) and Hand Finishing Behind the Paver

- There was not a noticeable difference in smoothness (hardened profile) between the areas where the auto float was and was not used. The RTP was in front of the auto float, so there would not be any effects on the RTP measurements.

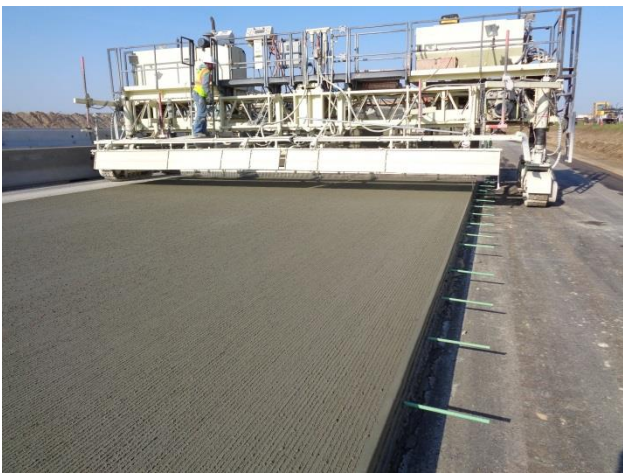
Figure 5. Artificial Turf Drag and Longitudinal Tining

Miscellaneous Details	<p>A vibrator monitor was in use, vibrators were consistently operated in the range of 5,500 to 6,500 vpm.</p> <p>Burlap drag behind the trailing finishing pan.</p> <p>Hand finishing consisted of a 14' straightedge and 12' float advanced with approximately 3' overlaps.</p> <p>An artificial turf drag was used prior to longitudinal tining.</p>

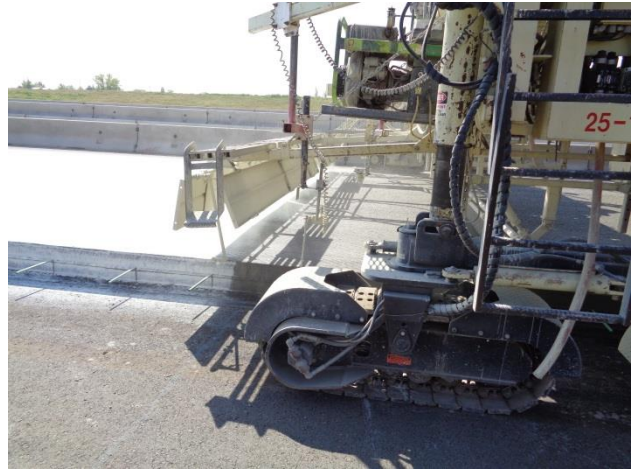
Figure 6. Application of Curing Compound

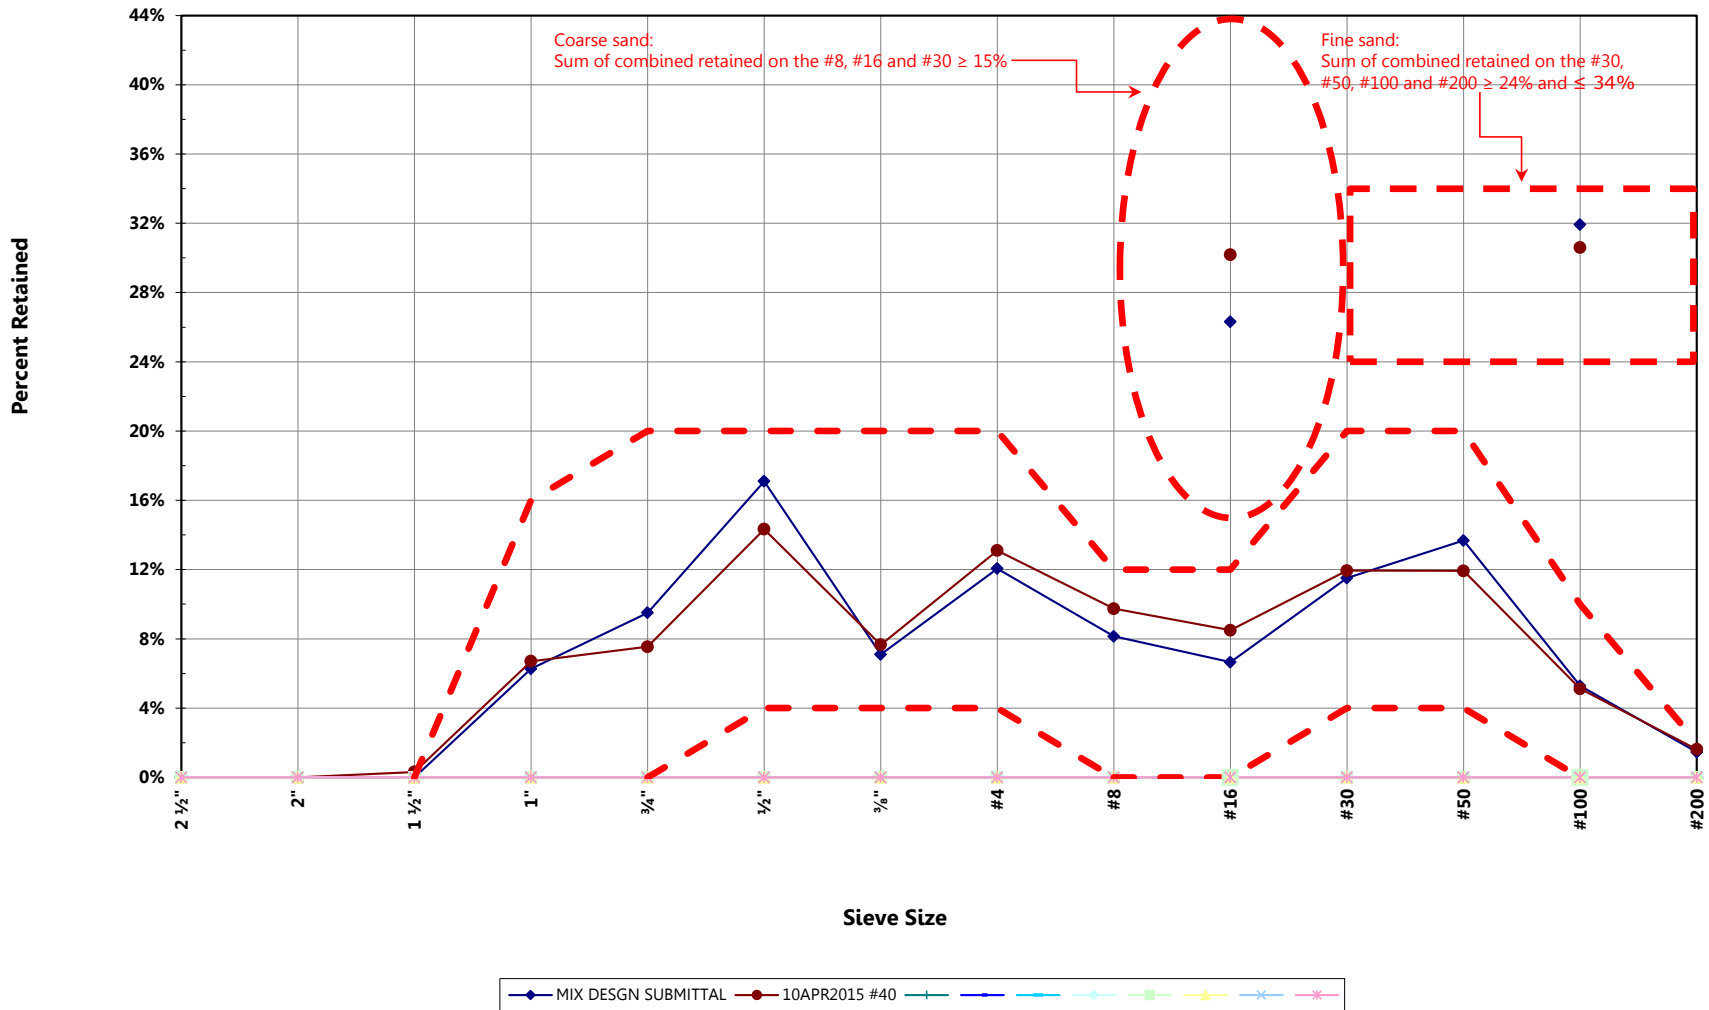
Figure 7. I-84 Combined Percent Retained (Tarantula Curve)

Combined gradation data is provided in Tables 4 and 5 and Figures 7 and 8.

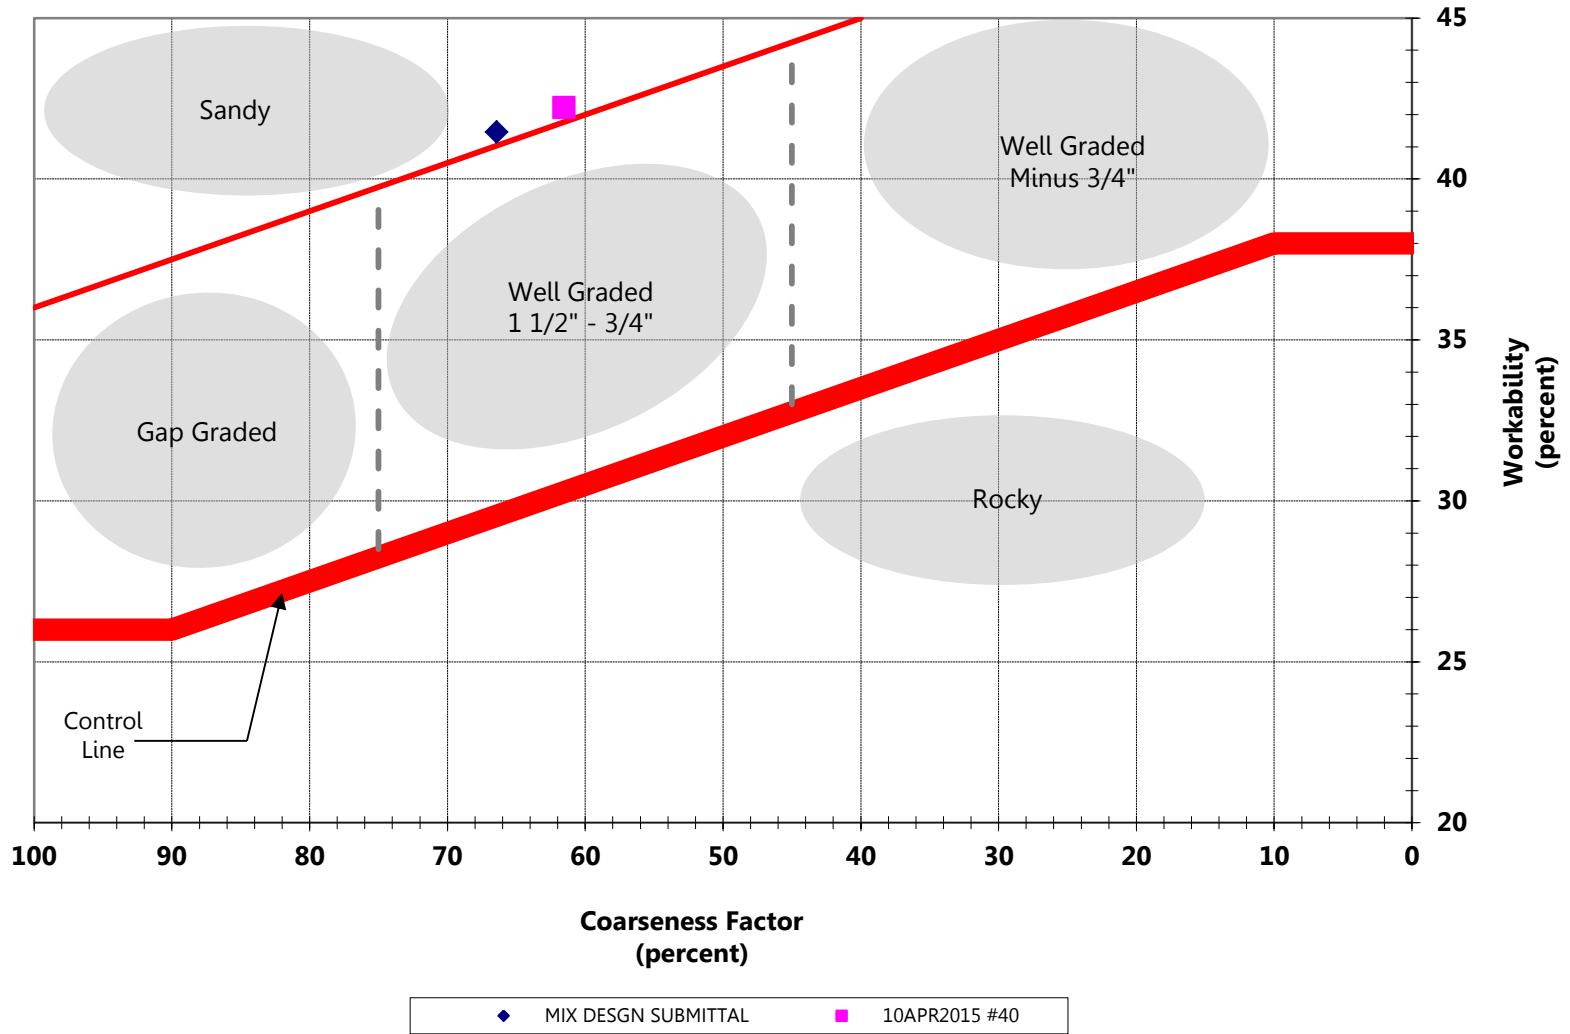
Figure 8. I-84 Combined Gradation Coarseness and Workability Factors

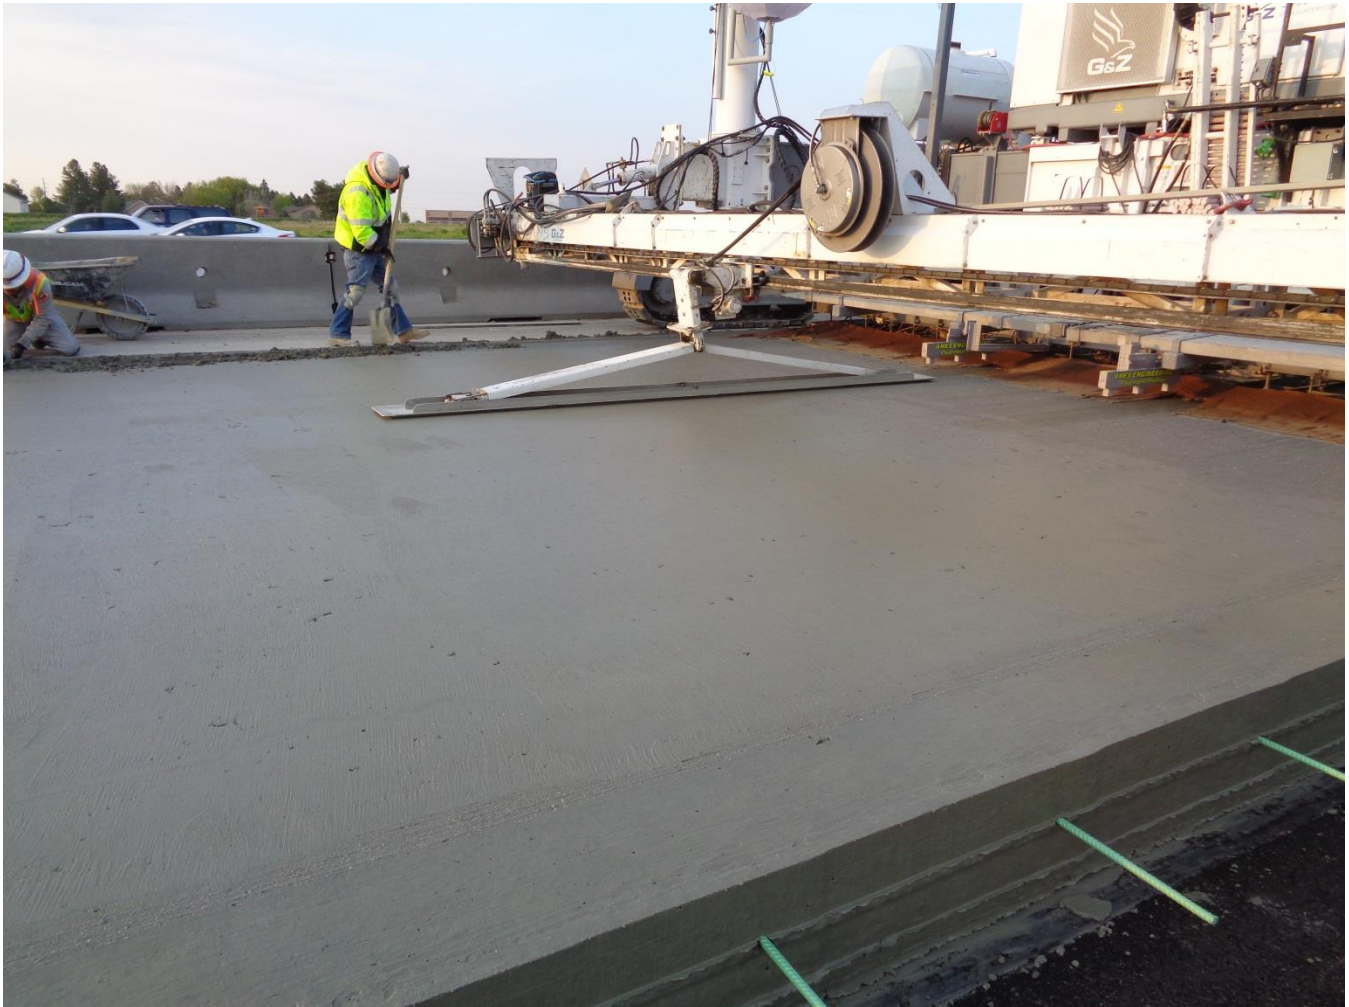
The mixture produced and delivered to the project by CPC was observed to be uniform and workable: consolidation was achieved with relatively low vibrator frequencies (approximately 5,000 vpm) and edges were stable (Figure 9).

Figure 9. Nearly Vertical, Stable Slipformed Edge With Minimal Hand Finishing Required to Seal the Slab Surface

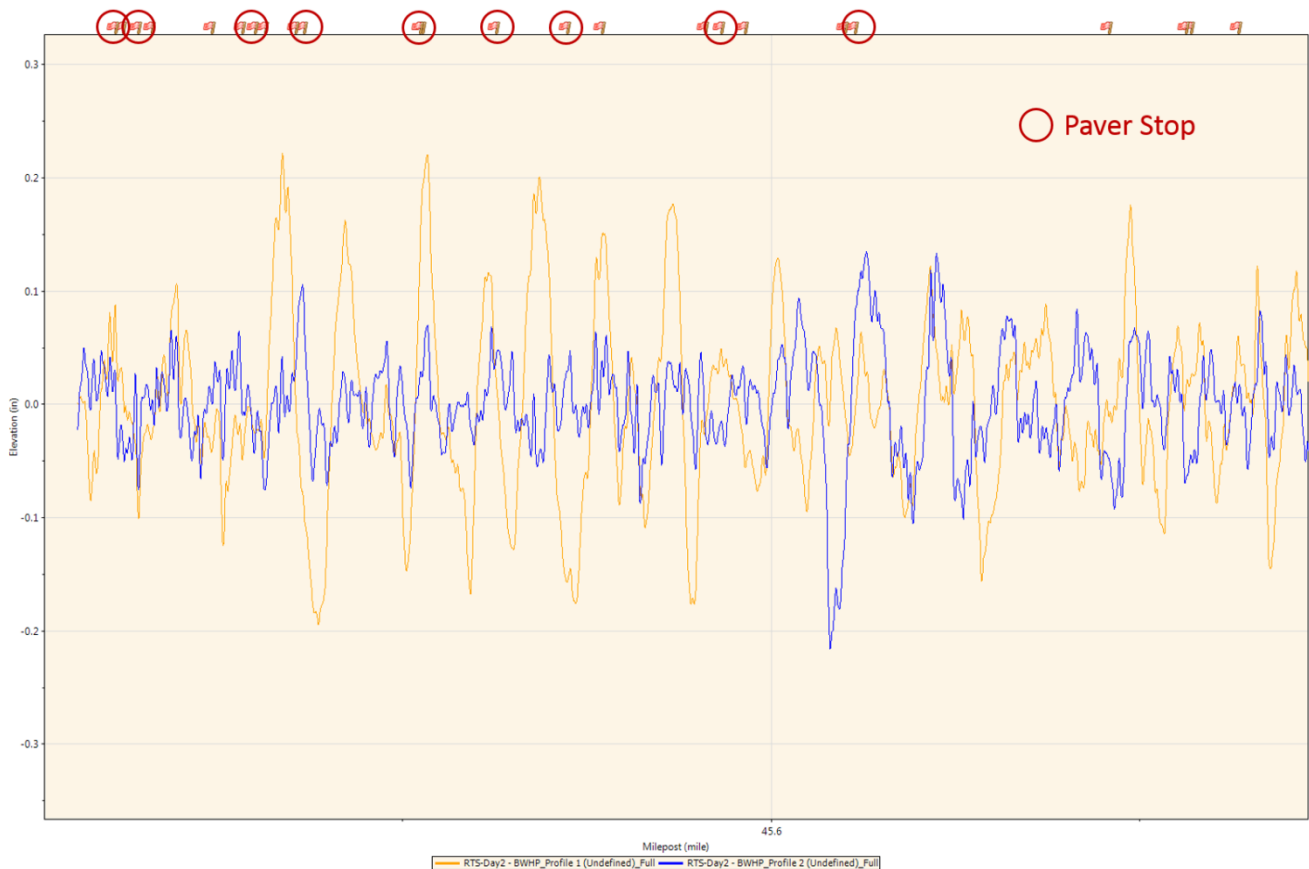
There appeared to be some effect of paver stops on localized roughness (as measured by the RTP), but these localized profile features were not apparent in the hardened QC profiles (Figures 16 [blue and yellow are hardened profile traces, green and pink are RTP traces] and 17). Our preliminary conclusion for this is that hand finishing efforts were effective at mitigating the roughness caused by paver stops.

Figure 17. High-Pass Filtered RTP profiles from April 22, 2015 Showing Paver Stops

- Paver stops and a qualitative assessment of concrete head height within the paving box was tracked for most of April 22nd - there was no clear correlation between material head height and the RTP profiles or localized roughness.
