# Context Sensitive Designs: Testing of Multi-Performance Level Box Beam Standards

Final Report  
June 2017

Iowa Highway Research Board  
(IHRB Project TR-681)  
Iowa Department of Transportation  
(InTrans Project 14-513)  
Federal Highway Administration

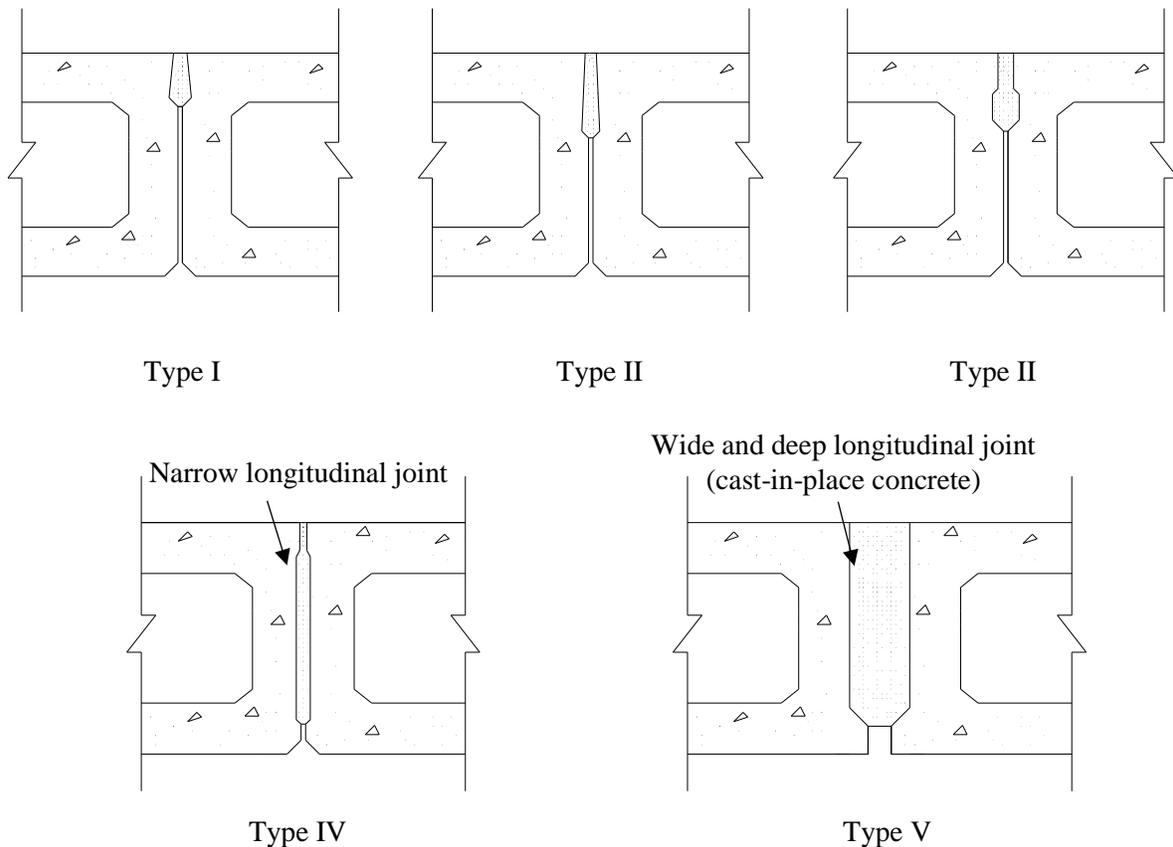
Russell (2009) indicated that keyway configurations consist of partial-depth and full-depth keyways. In the US, there are three typically used generic partial-depth keyway geometries (Types I, II, and III), and one generic full-depth keyway geometry (Type IV), all of which are shown in Figure 1. Conversely, the typical Japanese keyway is the full-depth keyway (Type V, also shown in Figure 1).

**Figure 1. Basic keyway geometries**

Note that in Figure 1, the box beams are shown to be in direct contact. This may or may not always be the case; however, sweep is typically removed with the application of post-tensioning. It is also worth noting that El-Remaily et al. (1996) reported that longitudinal cracking was seldom found in adjacent box beam bridges with Type V full-depth keyways.

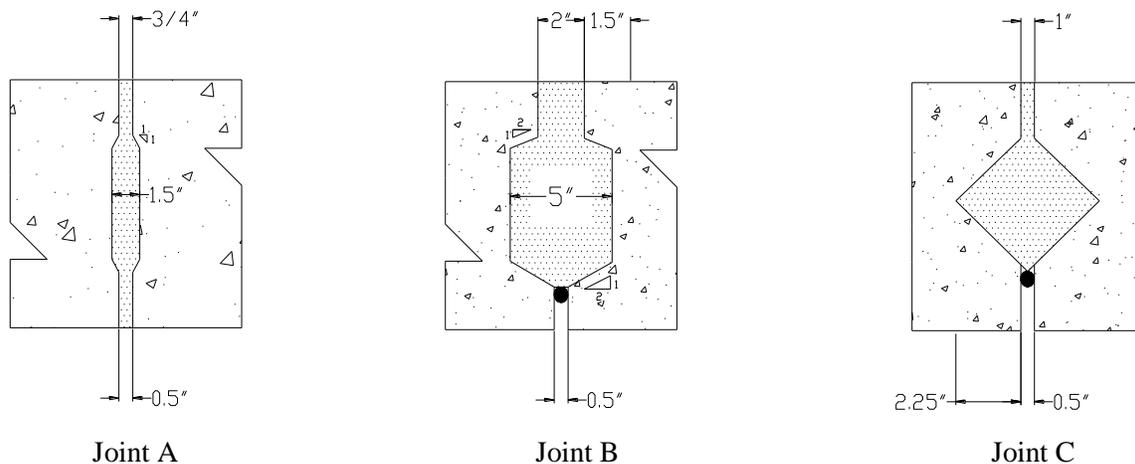
Dong et al. (2007) established 3D finite element models to investigate and compare the behavior of the three types of joints shown in Figure 2.

**Figure 2. Basic shear key shapes**

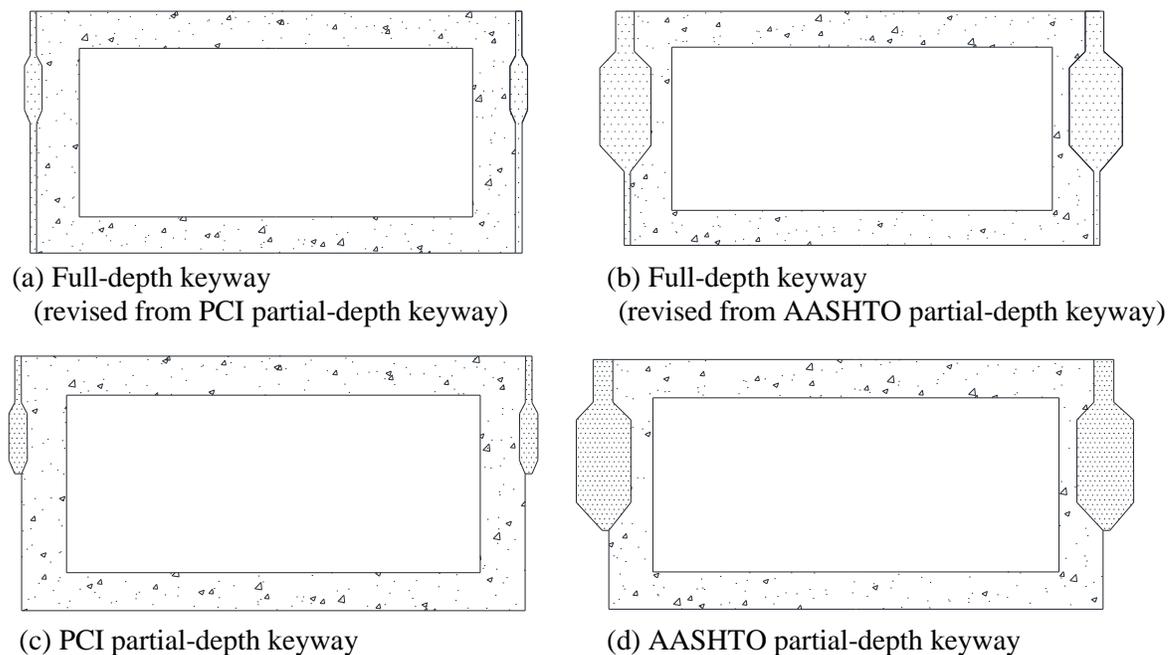
The FE analysis results indicated that reflective cracking was due to high tensile stresses in the shear keys caused by temperature gradients and shrinkage strains instead of live loads. The author also found that these cracks usually developed near the supports instead of at the bridge mid-span. Analytical results showed that composite slabs are most effective at alleviating high tensile stresses in the shear keys although post-tensioning and full-depth keyways also reduce the tensile stresses. Note that the full-depth keyways shown in Figure 3(a) and (b) and examined by Sharpe extend the partial-depth keyways shown in Figure 3(c) and (d) to the beam bottom.

**Figure 3. Keyway geometries for PCI- and TxDOT-style box girder bridges**

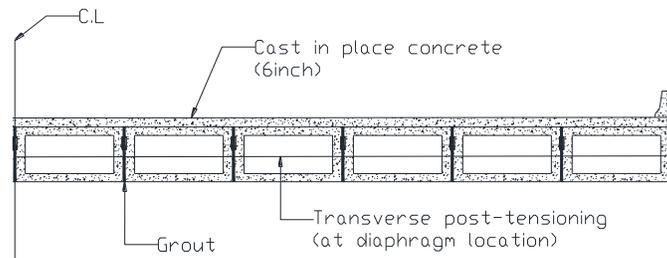
The work done by Attanayake and Aktan (2008) summarized the evolution of the Michigan design procedures for adjacent box beam bridges and their performance since the 1950s. The Michigan Bridge Design Guide had adopted many recommended practices provided in NCHRP Synthesis 393, such as higher transverse post-tensioning forces, full-depth keyways, top shear keys, and using a 6 in. thick cast-in-place concrete deck, as shown in Figure 4.

**Figure 4. Typical Michigan keyway geometry and post-tensioning**

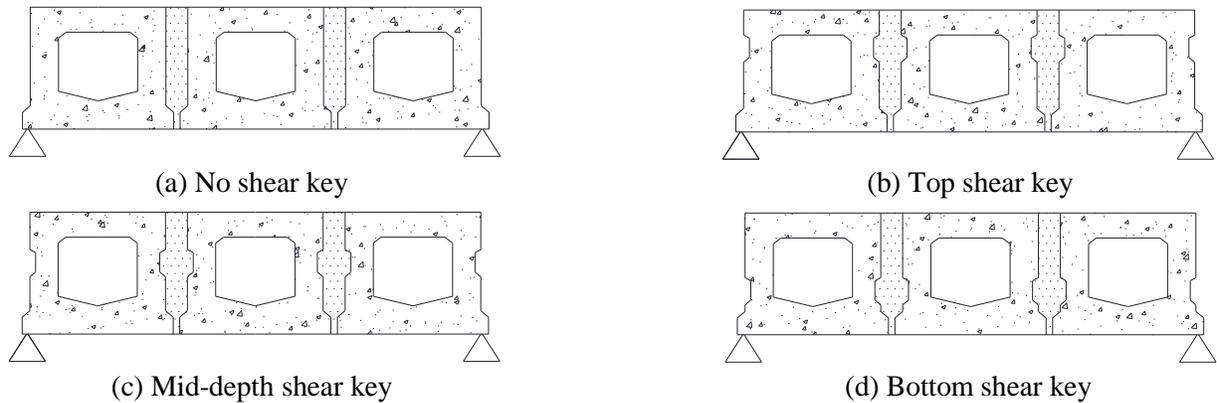
Kim et al. (2008) presented recent applications of precast adjacent box beam bridges with full-depth keyways with mid-depth shear keys grouted with cast-in-place concrete and transverse post-tensioning in South Korea. The authors performed two-dimensional (2D) FE analysis of three box beam sections without transverse post-tensioning to investigate the performance of four placement conditions for the shear key (i.e., no shear key, top shear key, mid-depth shear key, and bottom shear key) as shown in Figure 5(a), Figure 5 (b), Figure 5 (c), and Figure 5 (d).

**Figure 5. Common shear key locations**

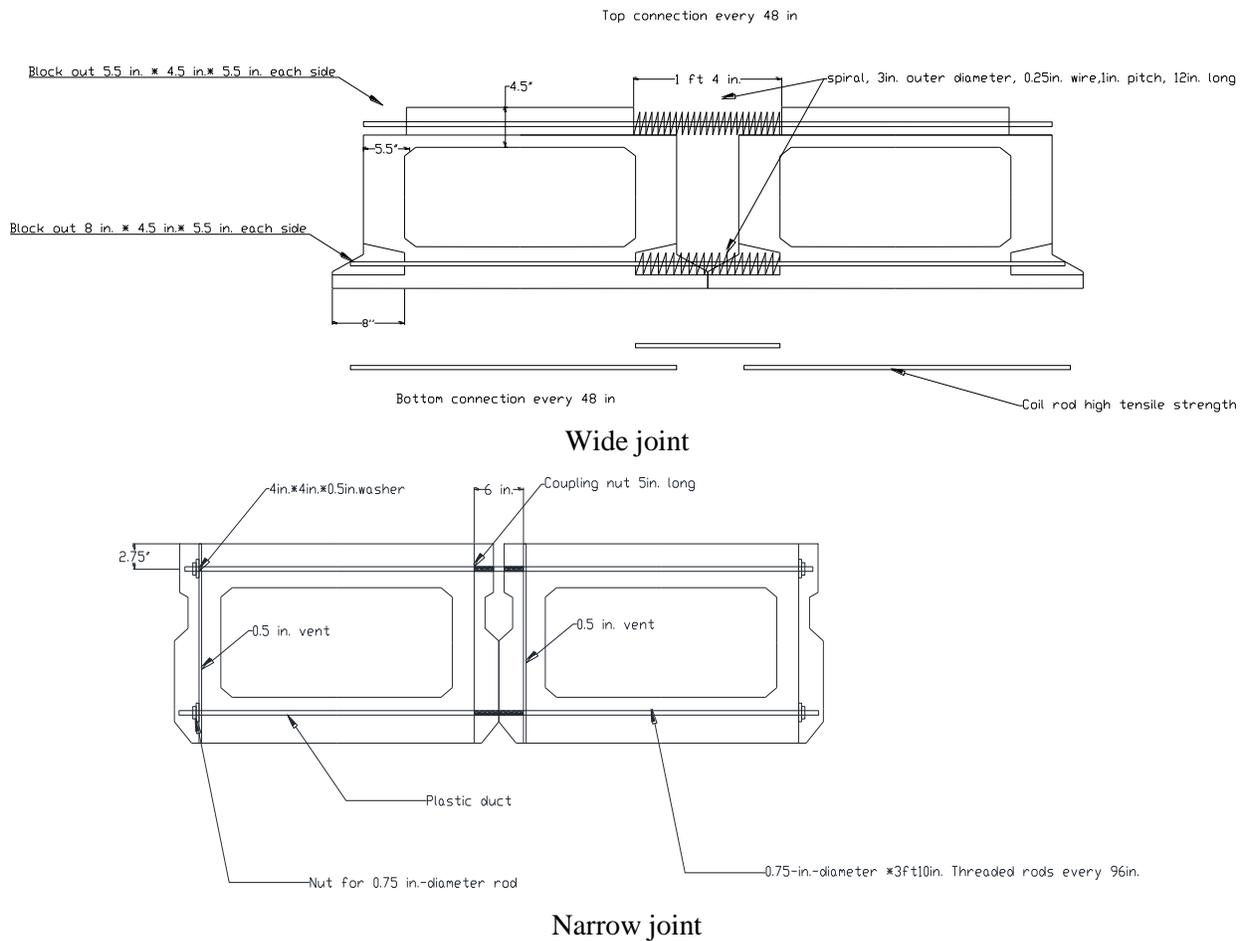
With the goal of achieving simple and economic fabrication and construction of precast adjacent box girder systems, Hanna et al. (2011) developed and evaluated two types of non-post-tensioned transverse connection details that don't use diaphragms or a concrete deck (i.e., the wide joint system and the narrow joint system shown in Figure 7.

**Figure 7. Connection details proposed by Hanna et al. 2011**

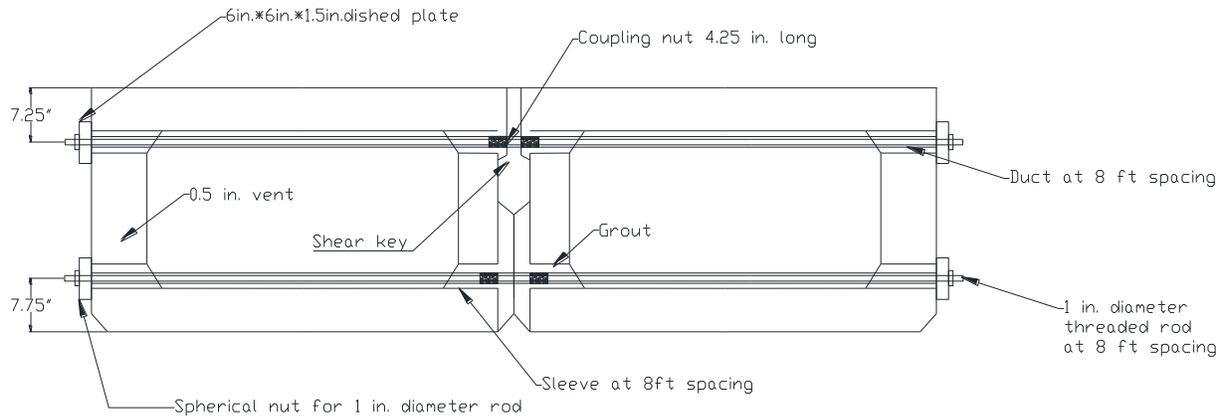
Follow-up work by Hansen et al. (2012) developed another joint system based on the narrow joint system proposed by Hanna et al. (2011). This system was developed without using diaphragms or concrete topping and utilizes post-tensioning to reduce the possibility of cracking or leakage. As shown in Figure 8, the sleeves, located below the beam top flange and above the bottom flange, were used to accommodate the duct, the post-tensioning rods, and couplers.

**Figure 8. Connection details proposed by Hansen et al. 2012**

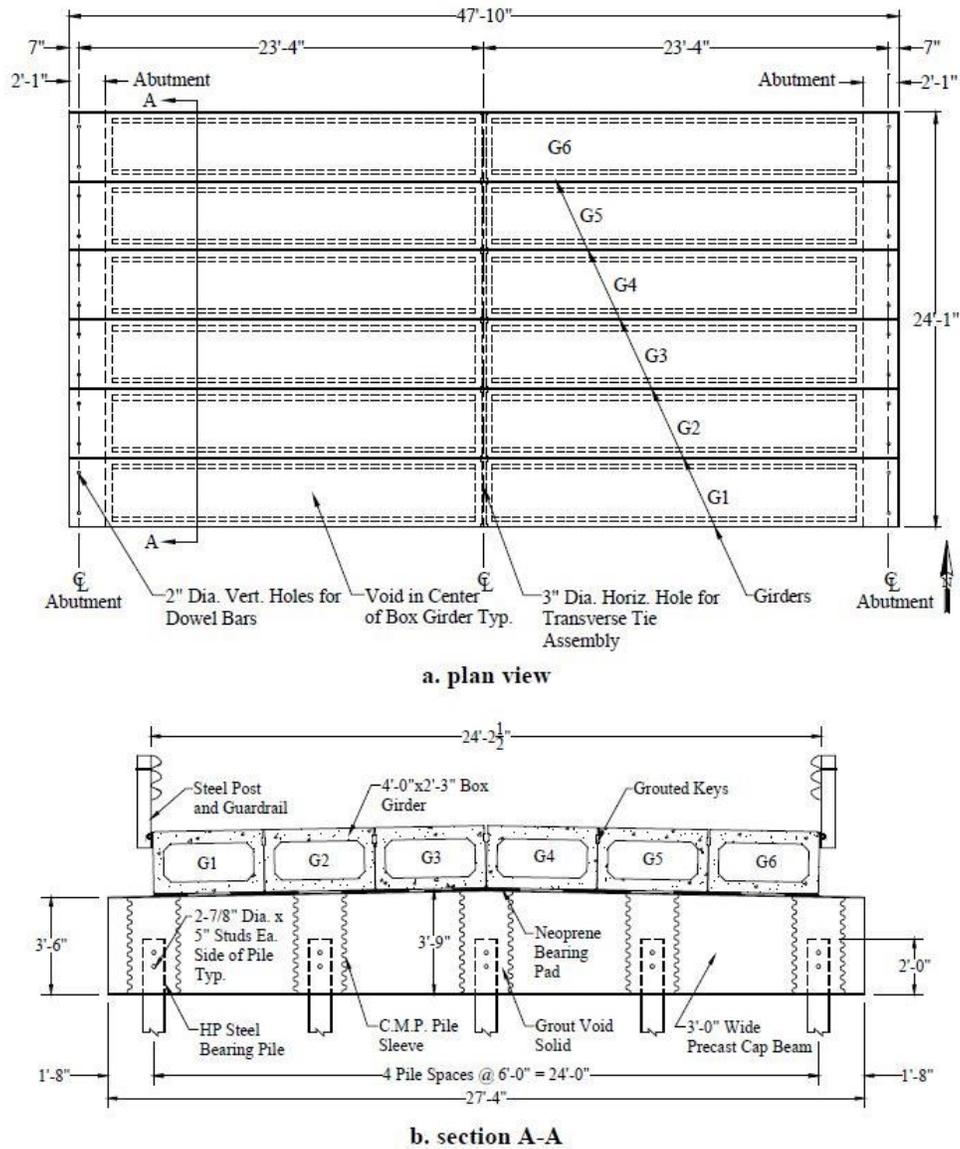
The first bridge inspected is located in the southern part of Madison County, Iowa. Figure 11 shows the plan and cross-section views of the bridge.

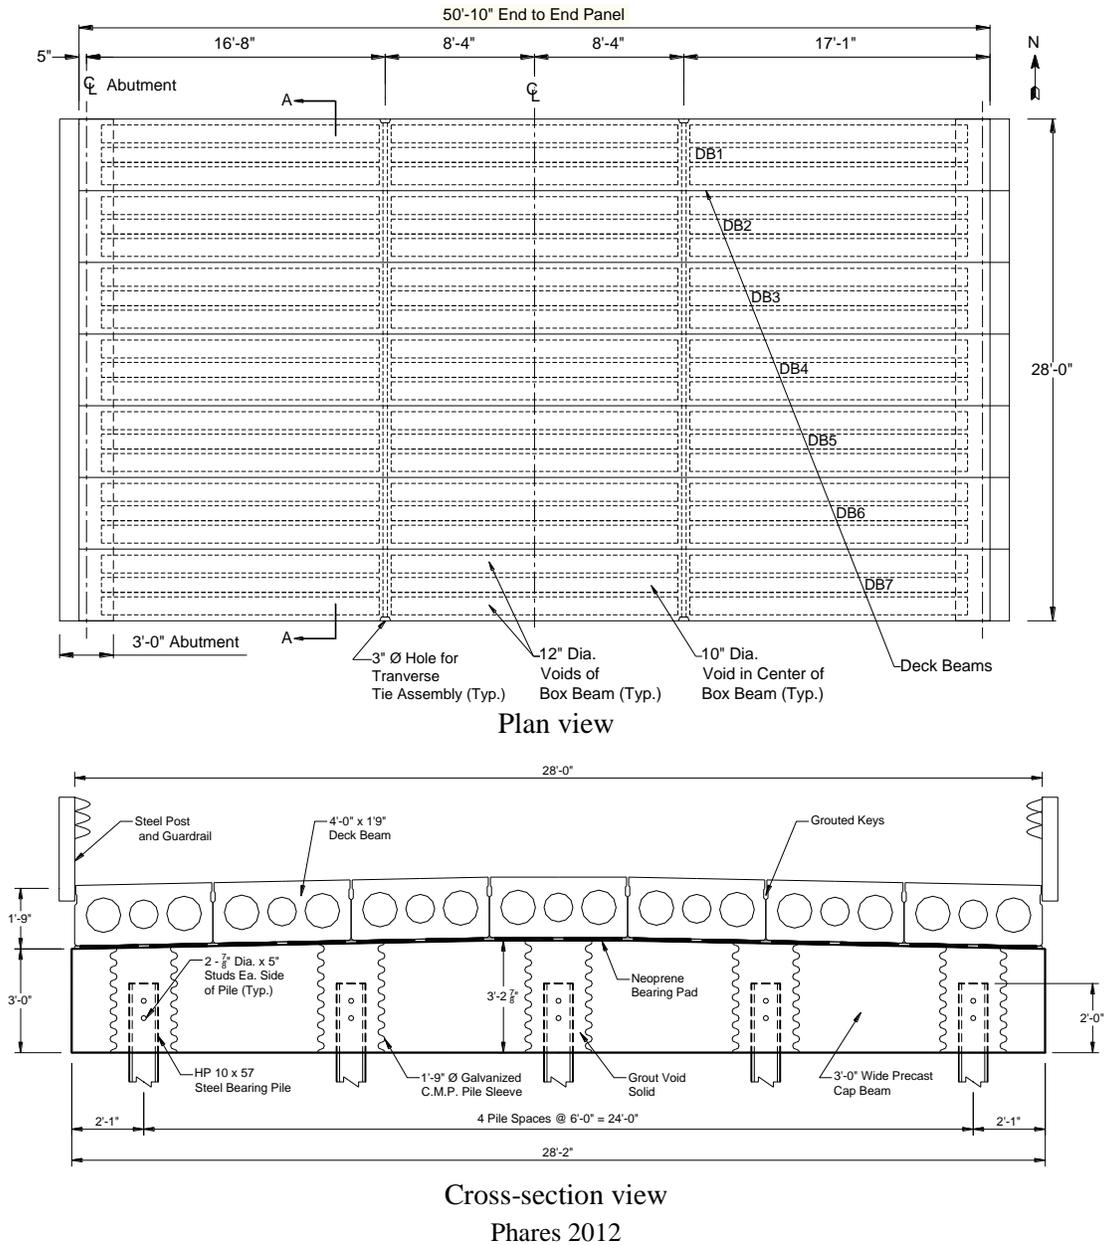
The second bridge is located in Buena Vista County, close to Storm Lake, Iowa. Figure 12 shows the bridge plan and cross-section views.

**Figure 12. Buena Vista County, Iowa bridge**

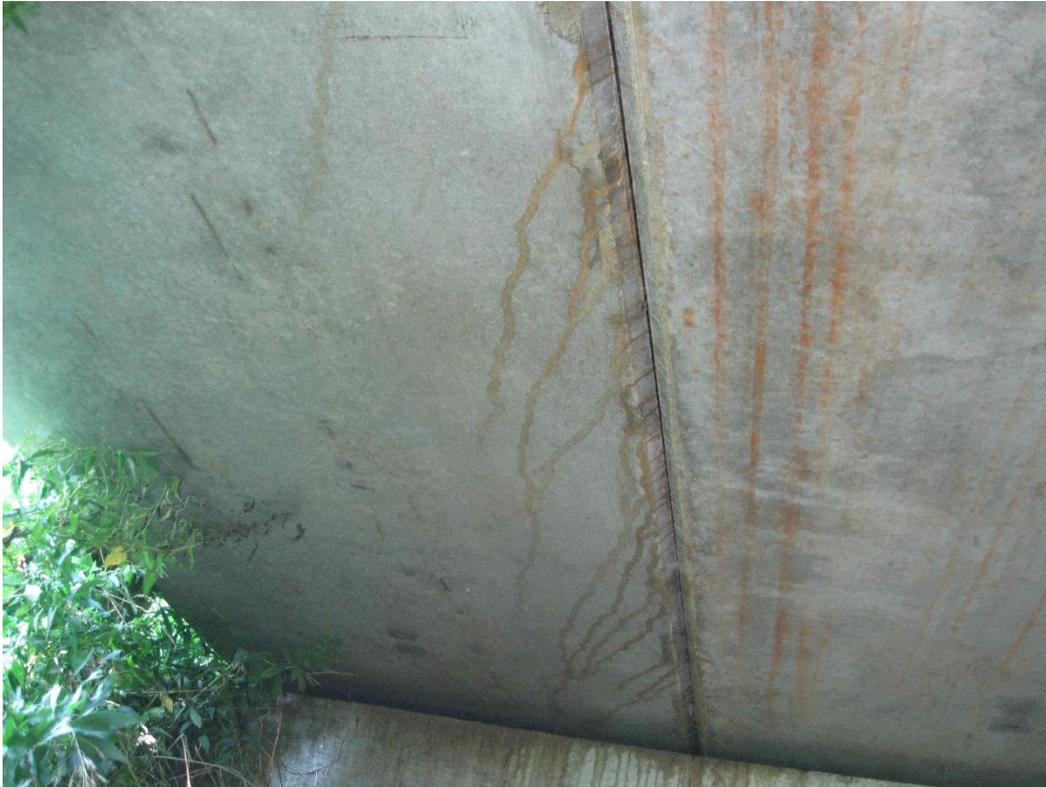
A bridge inspection was conducted on this bridge in April 2014. Significant water leakage issues were found between the box beams. Figure 13 shows the water staining at the bottom of the bridge girders near the abutment.

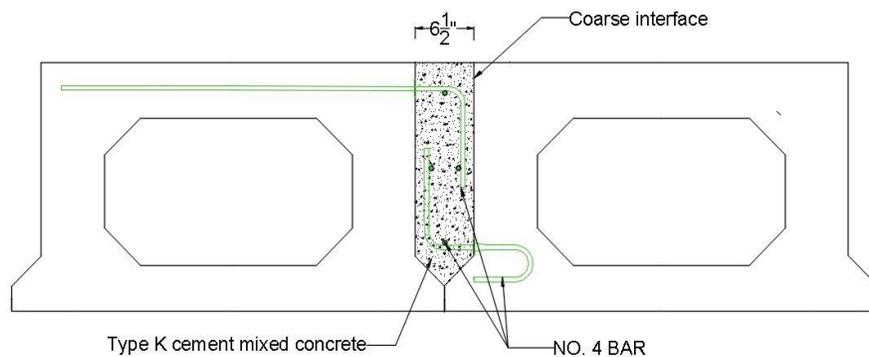
Incorporating these potential and other concepts, an innovative joint (shown in Figure 14) was designed with the following features: wide joint (6-1/2 in.) without shear key, shrinkage-compensating concrete mixed with Type K cement, form retarder to create a rough surface on the sides of the box girder to increase the shear capacity, and reinforcing steel that crosses the interface between the joint and box girder.

**Figure 14. Innovative joint design**

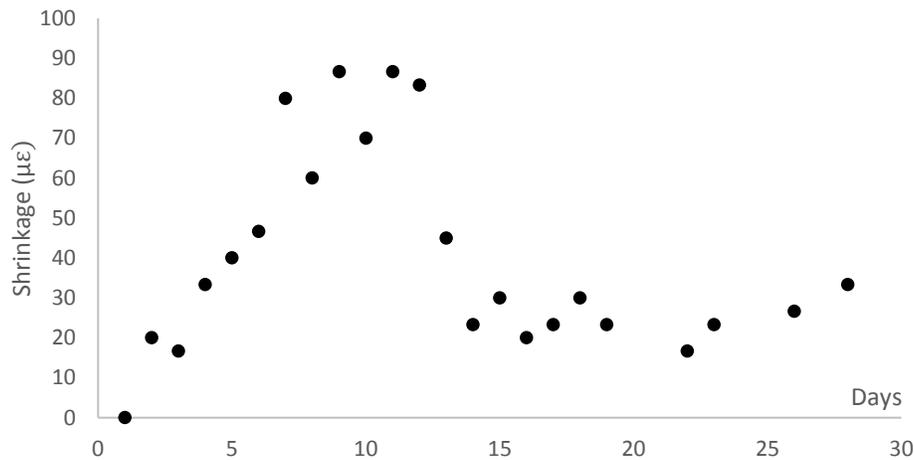
In this developmental work, the research designed the basic joint material to be standard Iowa DOT C4 concrete, because it is widely available across the state. However, to minimize/eliminate the shrinkage typically associated with normal concrete, 15% of the traditional portland cement was replaced by Type K shrinkage-compensating cement. Shrinkage testing conducted on the shrinkage-compensating concrete in the Iowa State University Structural Materials Testing Laboratory was conducted following ASTM C157, and the results (shown in Figure 15) indicated that the material will experience a self-volume expansion during the first 14 days and achieve the peak value (about 90 microstrain) at the 7th day.

**Figure 15. Shrinkage of Type K cement**

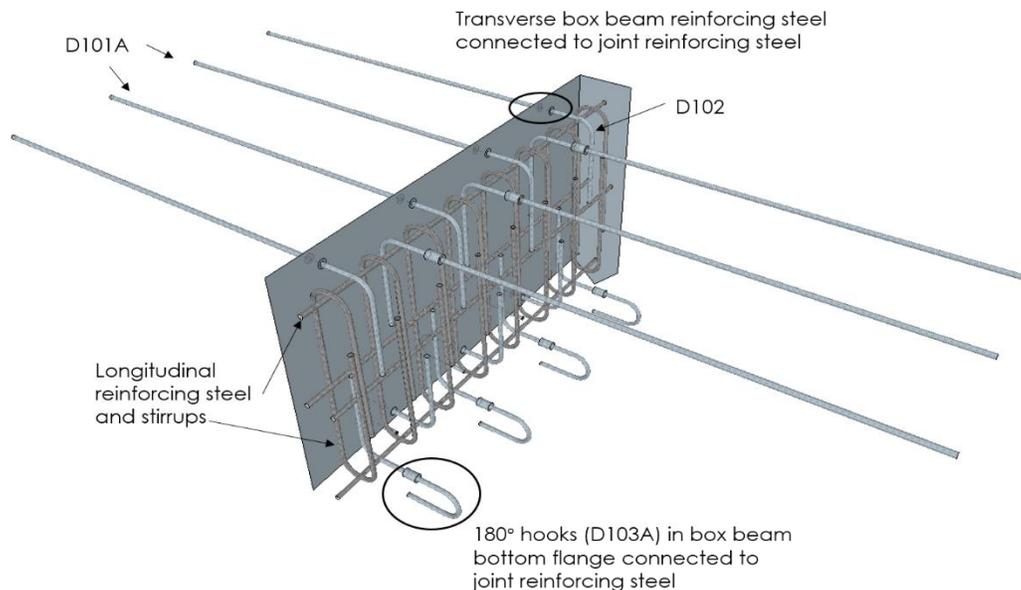
To further enhance the load transfer capabilities of the innovative joint as well as to provide early-age resistance to shrinkage-induced cracking, reinforcing steel was detailed and included. The details of the steel reinforcement in the innovative joint are shown in Figure 16.

**Figure 16. 3D view of joint reinforcement design**

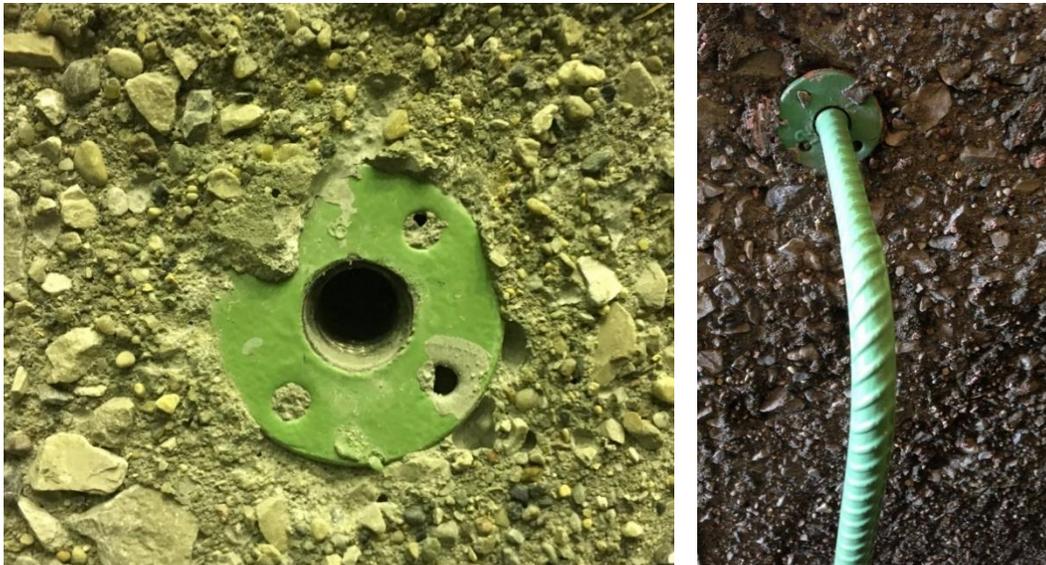
A long straight bar (D101A) was placed in the top of the girder and a 180° hook bar (D103A) was placed at the bottom. Both straight bars and hook bars were connected to 90° hook bars (D102) in the joint using a commercially available coupler (shown in Figure 18).

**Figure 18. Coupler embedded in the box girder concrete (left) and hook bar installed (right)**

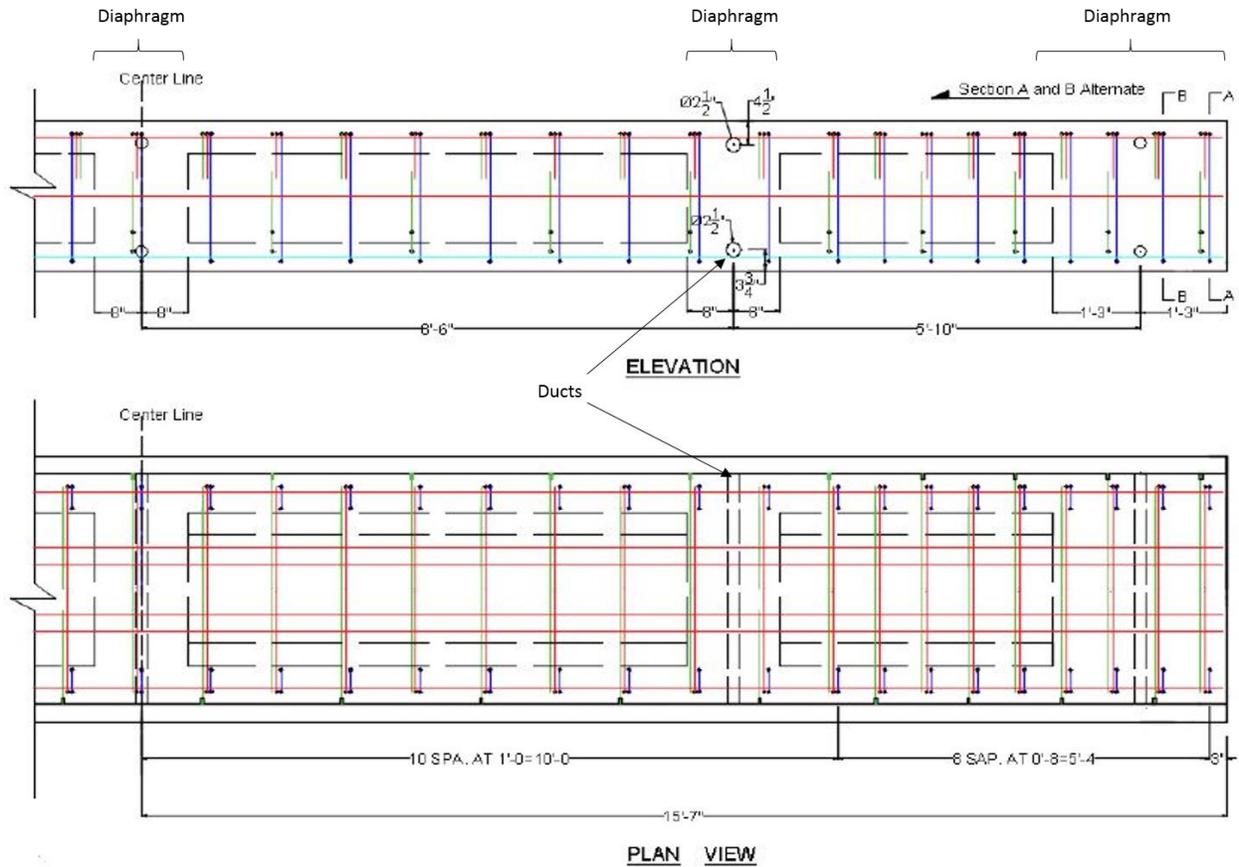
For the laboratory testing phase of this project, two 31 ft long box girders were constructed based on the design drawings shown in Figure 19 and Figure 20.

**Figure 19. Elevation and plan view of the box girder**

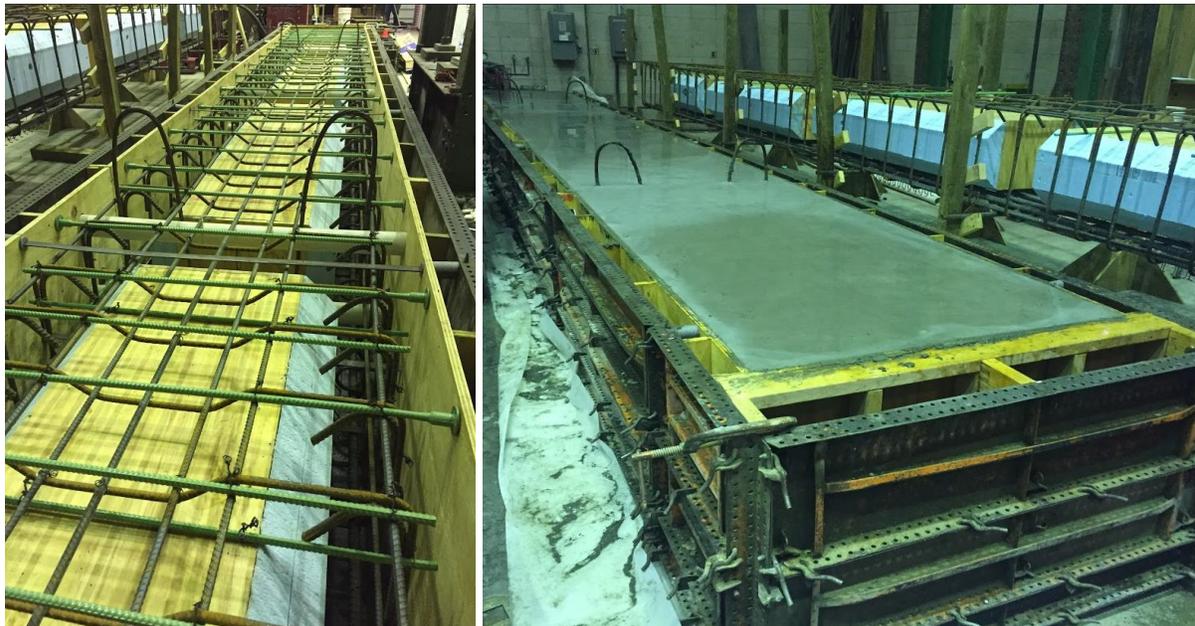
Figure 21 shows the box girder before and after placing the concrete.

Box girder reinforcement

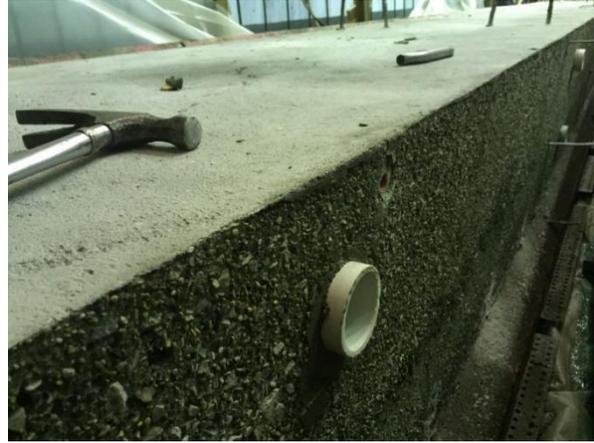
**Figure 22. Water blasting on the side of box girder painted with form retarder**

Before placement of the concrete, the wood formwork was “painted” with form retarder. Seven days after placing the box girder concrete, the wood formwork was removed and the side of the concrete girder was water blasted to create the roughened surface, as shown in Figure 22.

Coarse surface after water blasting

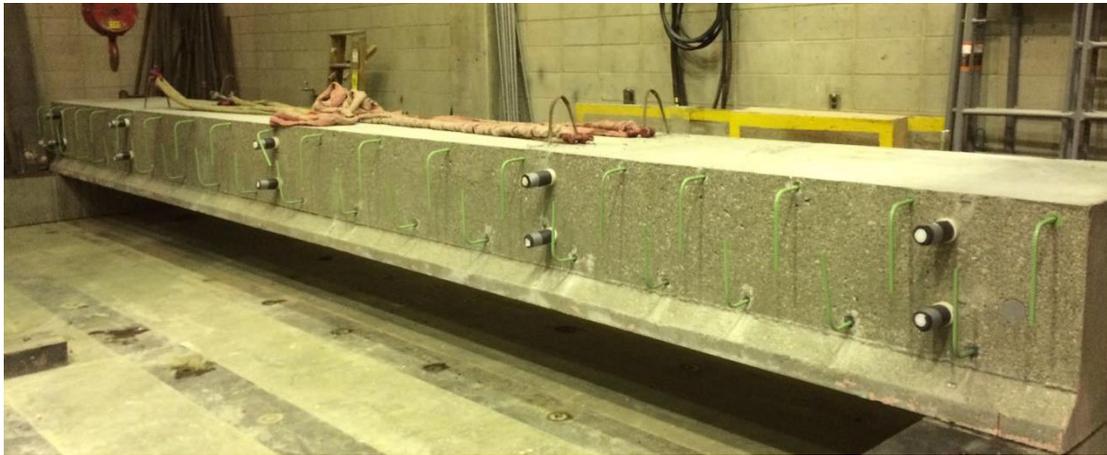
**Figure 23. Side of the box girder with hook bars installed**

After water blasting, the 90° hook reinforcing steel bars (D102) were installed on the box girder (Figure 23).

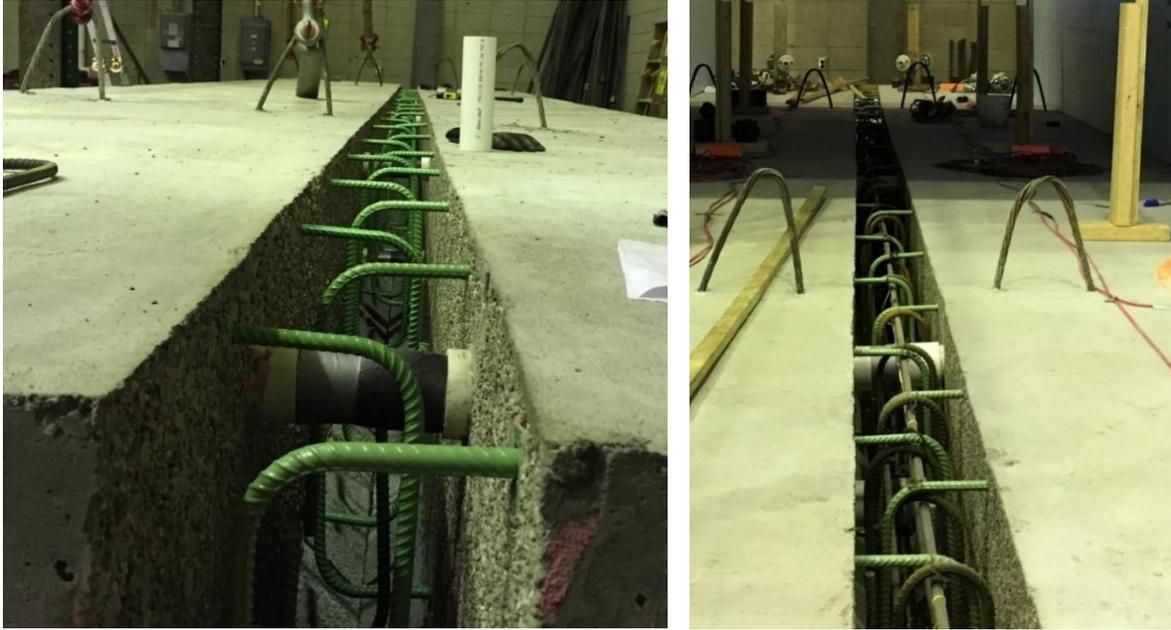
Figure 24 and Figure 25 show the joint before placement of the joint material.

Two box beams placed side-by-side (left); Joint reinforcement with longitudinal bars and stirrups (right)

**Figure 24. Placement of joint reinforcement**

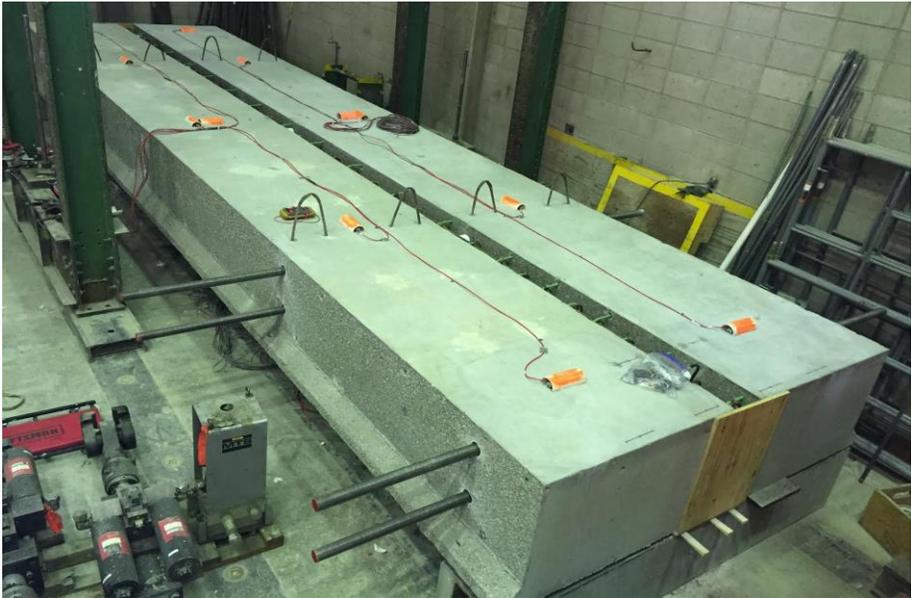
**Figure 25. Specimen before pouring of the joint material**

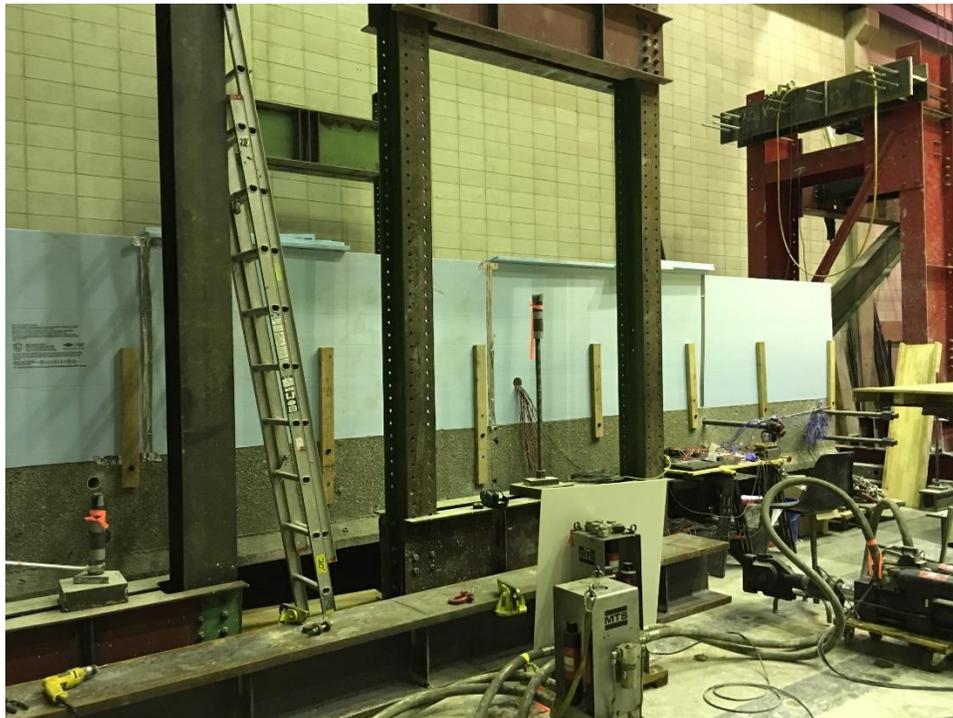
The joint was placed in the Iowa State University Structural Engineering Research Laboratory on August 23, 2016 starting at approximately 1:30 p.m. Before placing the joint material, a temporary temperature isolation room made of blue foam panels was fabricated on top of the specimen as shown in Figure 26.

**Figure 26. Temporary temperature isolation room**

This temperature isolation room allowed for the application of heat that would simulate normal thermal radiation consisting of heating of the top surface. To create the heat source, 20 heat lamps and 2 electric heaters were placed in the temperature isolation room, as shown in Figure 27 and Figure 28.

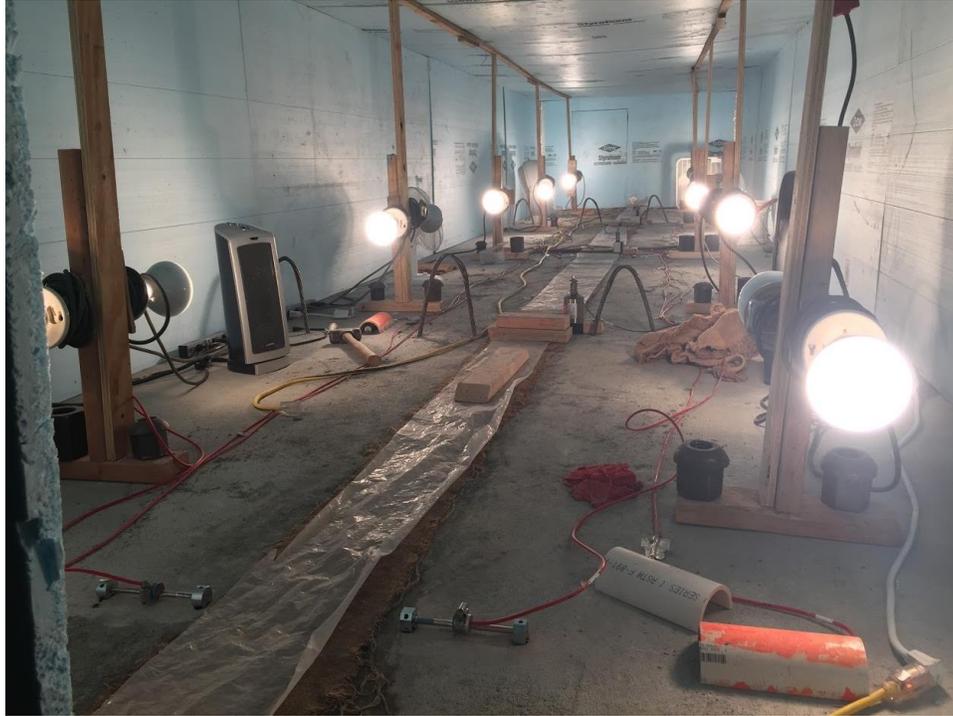
**Figure 27. Heating devices in the temperature isolation room**

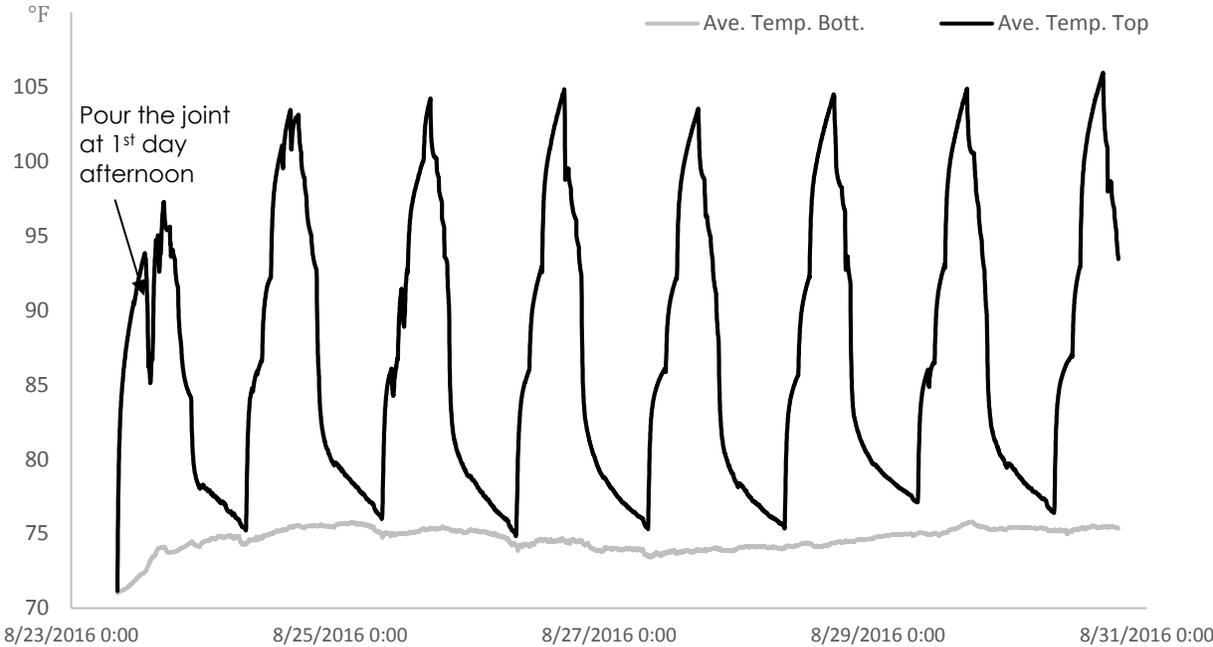
temperature change with time. The average temperature distribution on the top and bottom surface before and for several days after placement of the joint material is shown in Figure 29.

**Figure 29. Average temperature on the top and bottom surface of specimen**

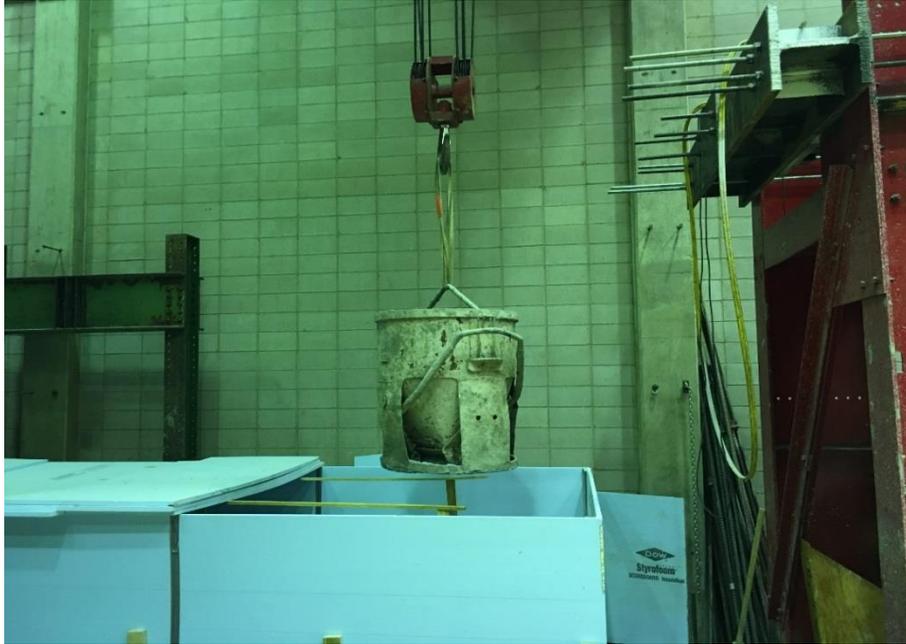
The joint material was placed in the afternoon when the temperature on the top of the specimen was relatively high. To achieve that, the heaters and lamps were turned on in the morning. The joint concrete material was placed using a large bucket, which required temporary removal of the top (shown in Figure 30) of the temperature control room.

**Figure 30. Pouring joint concrete**

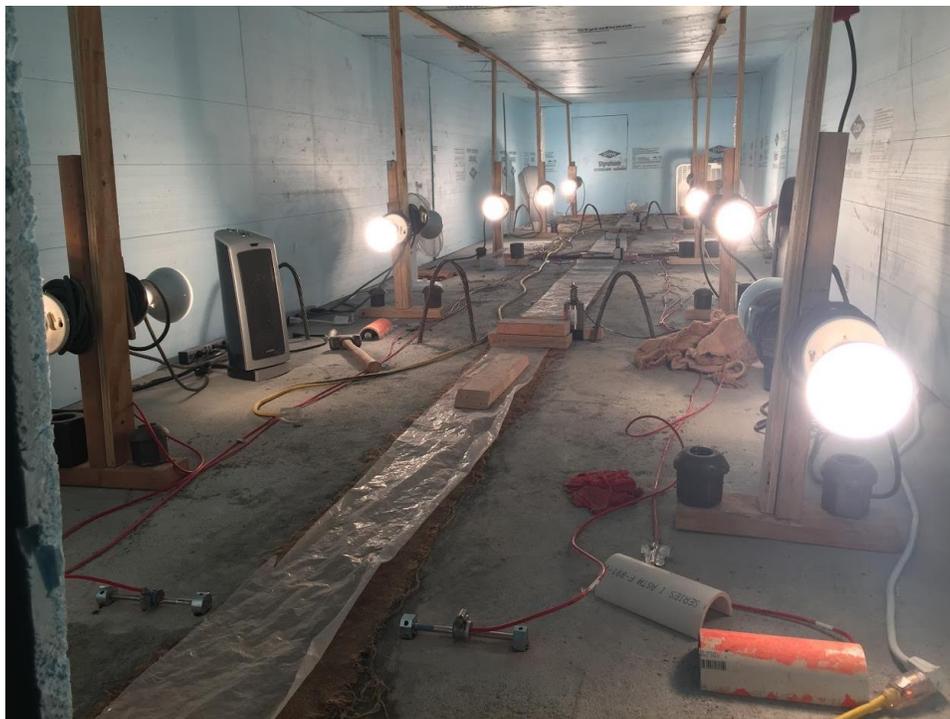
This caused a slight temperature drop during the first day while the joint material was being placed. The placement of the joint material took about 1.5 hr to complete. After placement, the joint concrete was covered with burlap and plastic as shown in Figure 31.

**Figure 31. Curing joint**

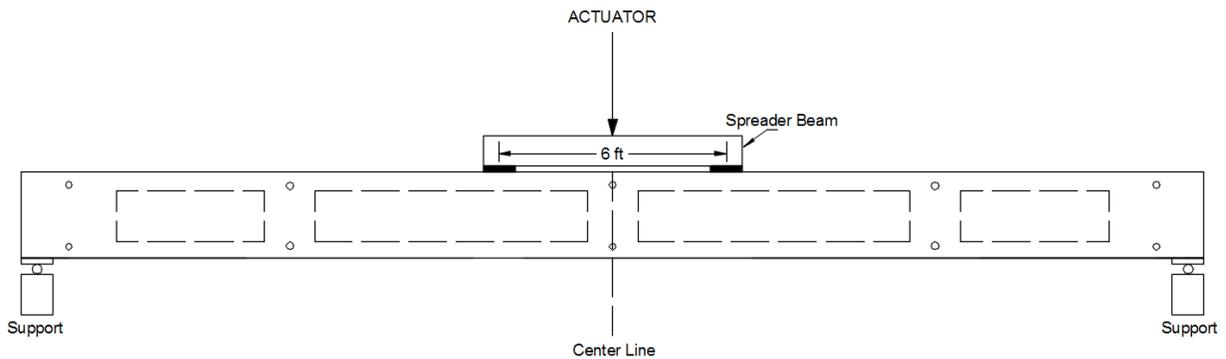
The specimen was first tested with simply supported conditions, as shown in Figure 32.

**Figure 32. Simply supported detail for cyclic live loading**

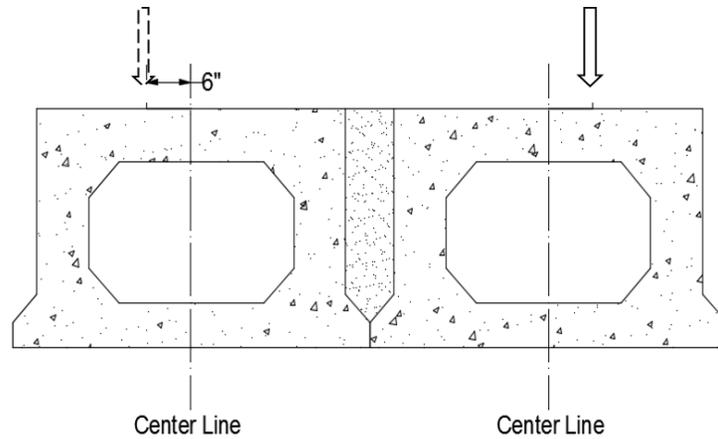
Figure 33 shows the transverse location where the load was applied. On each beam, the load was applied 6 in. off center.

**Figure 33. Cross-section view of load application**

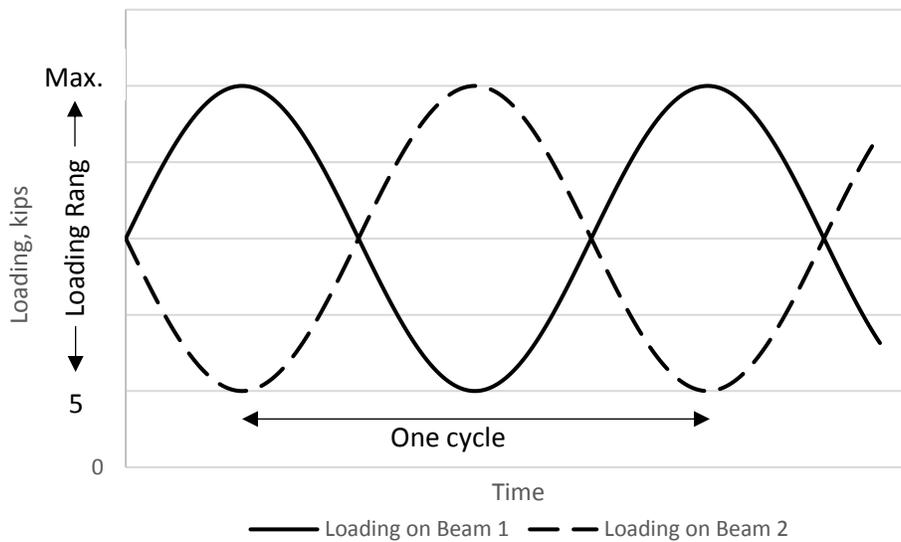
Figure 34 shows a graphical representation of the cyclic loading applied to the specimen, subjected to the simply supported condition.

**Figure 34. Cyclic loading under the simply supported condition**

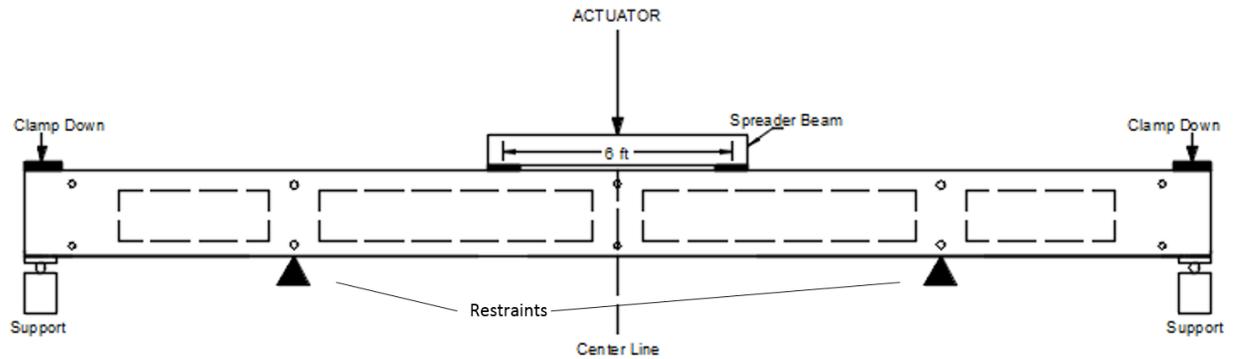
After the simply supported condition was tested, the specimen was further tested with one beam restrained to generate higher stresses in the joint, as shown in Figure 35.

**Figure 35. Cyclic live loading detail for one beam restrained**

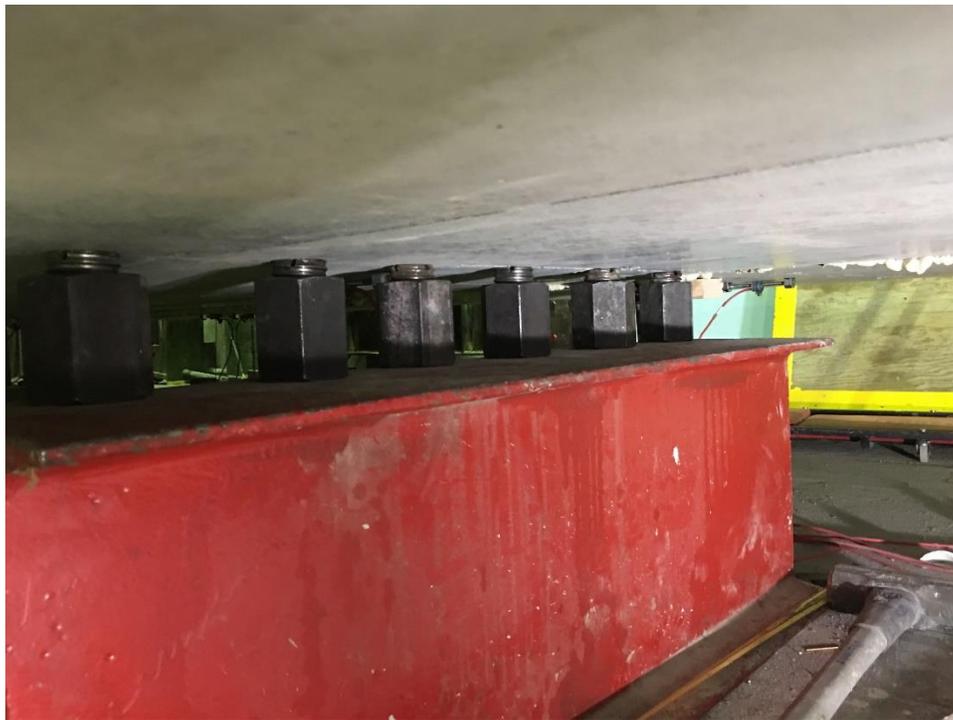
Figure 36 shows the restraints used to restrict deflection of the beam.

**Figure 36. Restraints under one beam**
