# Context Sensitive Designs: Testing of Multi-Performance Level Box Beam Standards

Final Report  
June 2017

Iowa Highway Research Board  
(IHRB Project TR-681)  
Iowa Department of Transportation  
(InTrans Project 14-513)  
Federal Highway Administration

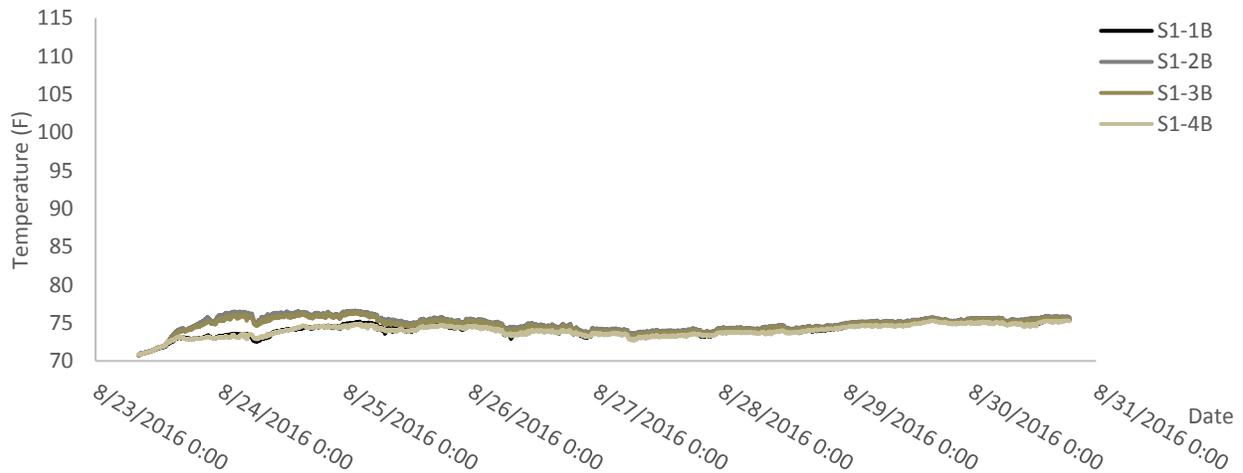
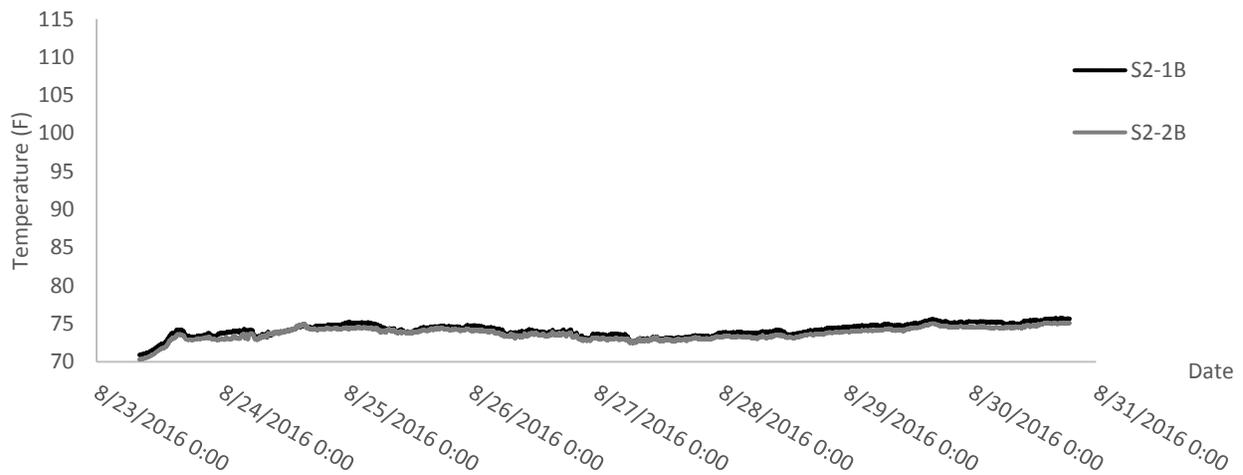
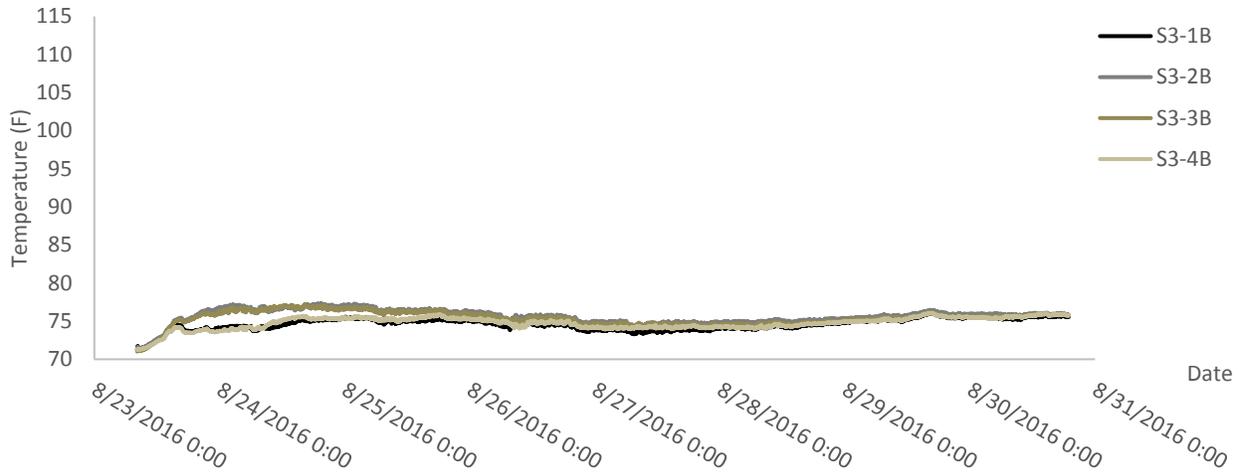
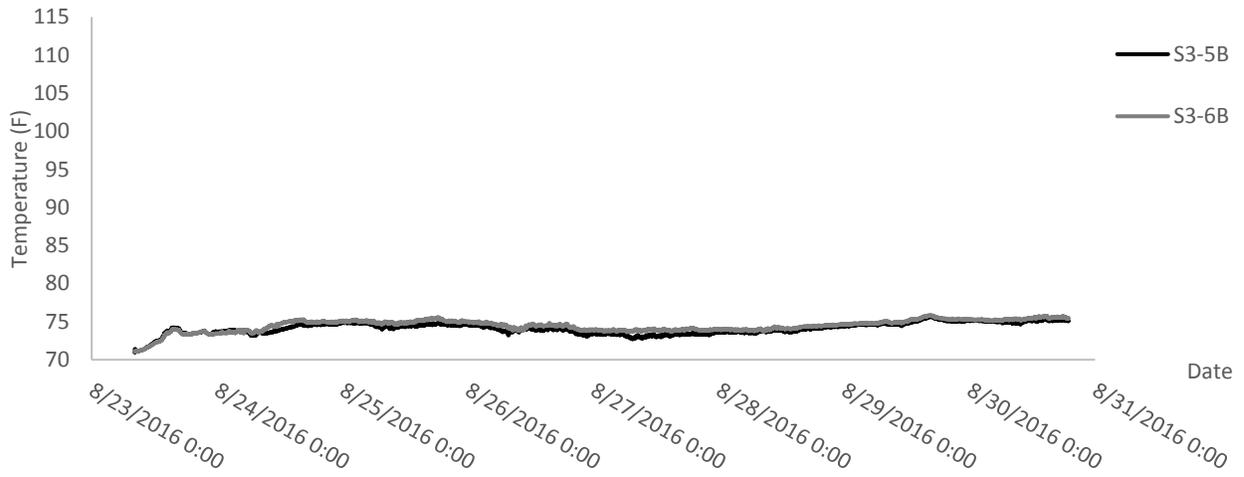
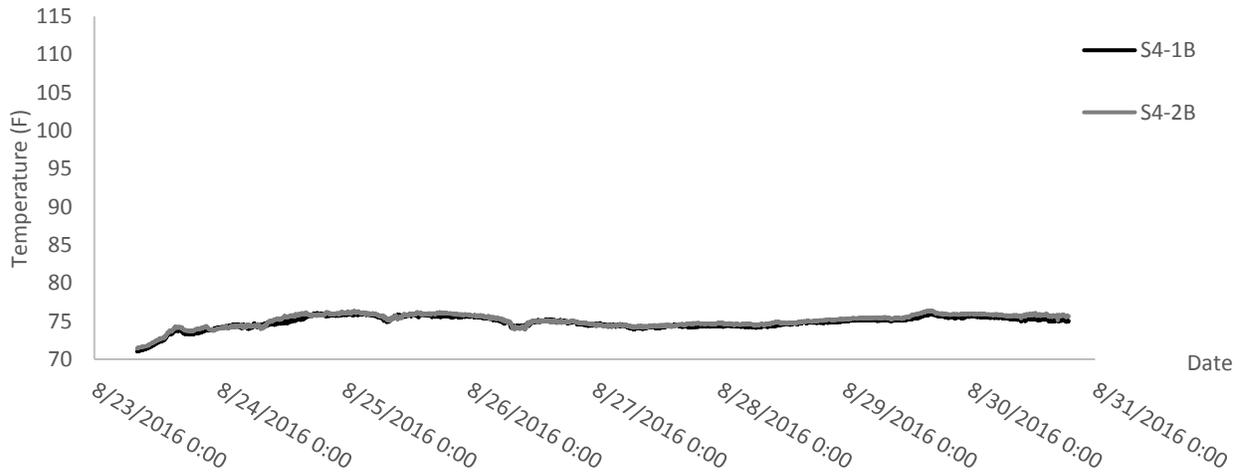
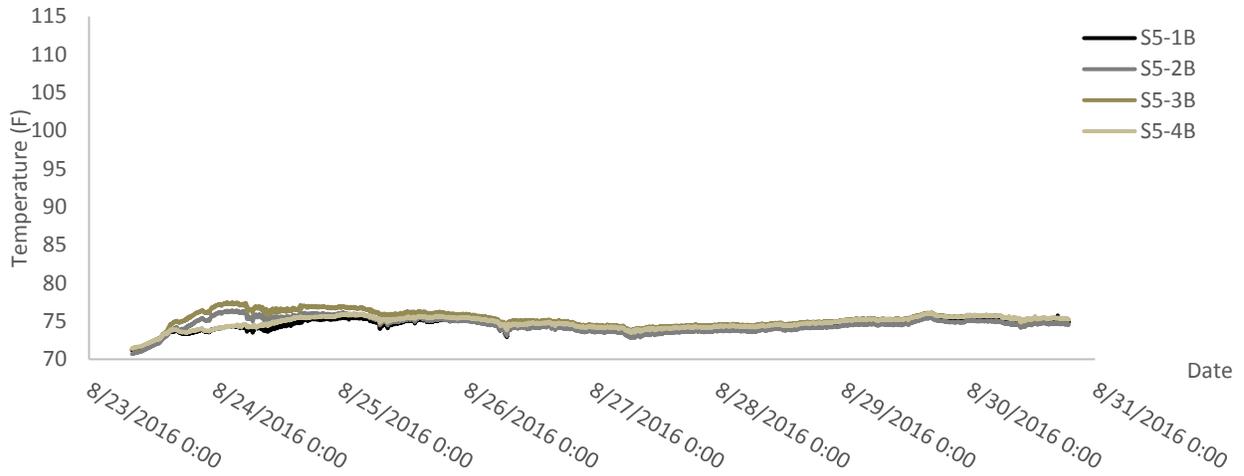
Figure 47 through Figure 58 show the temperature data collected from the VWSGs attached on the top and bottom surfaces. The location of each VWSG can be found previously in Figure 37.

The temperature distribution was very uniform on both the top and bottom surfaces. On the bottom surface, the temperature difference was less than 5 °F. On the top surface, when the temperature reached its peak each day, the temperature difference was about 10 °F. Figure 59 compares the average temperature from the top and bottom surfaces to the maximum and minimum temperatures.

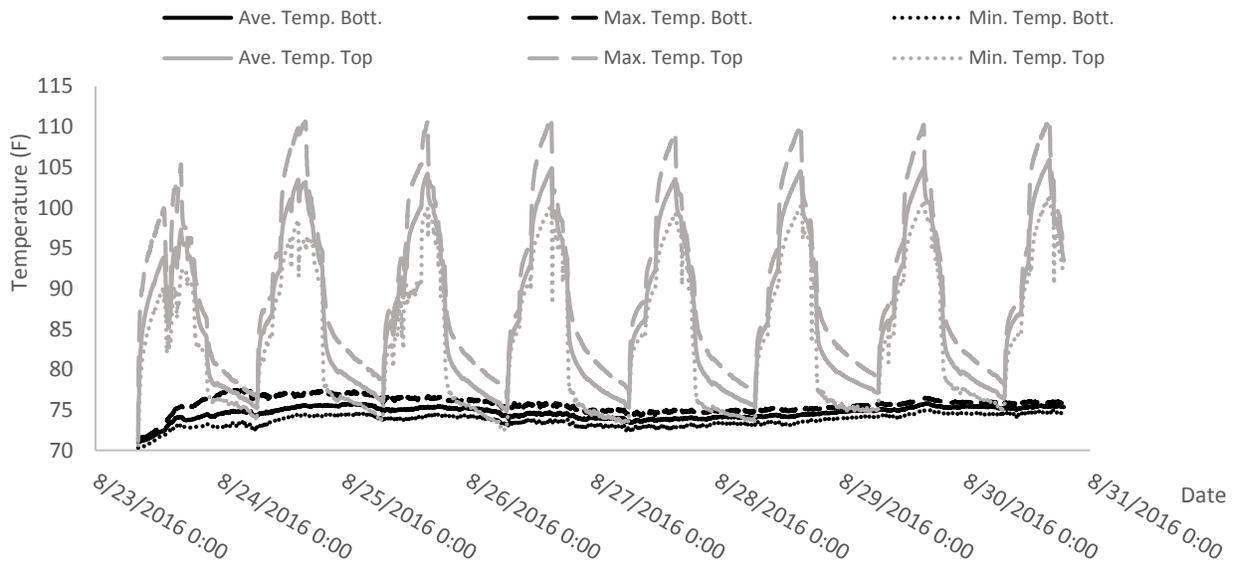
**Figure 59. Average temperatures on top and bottom surfaces**

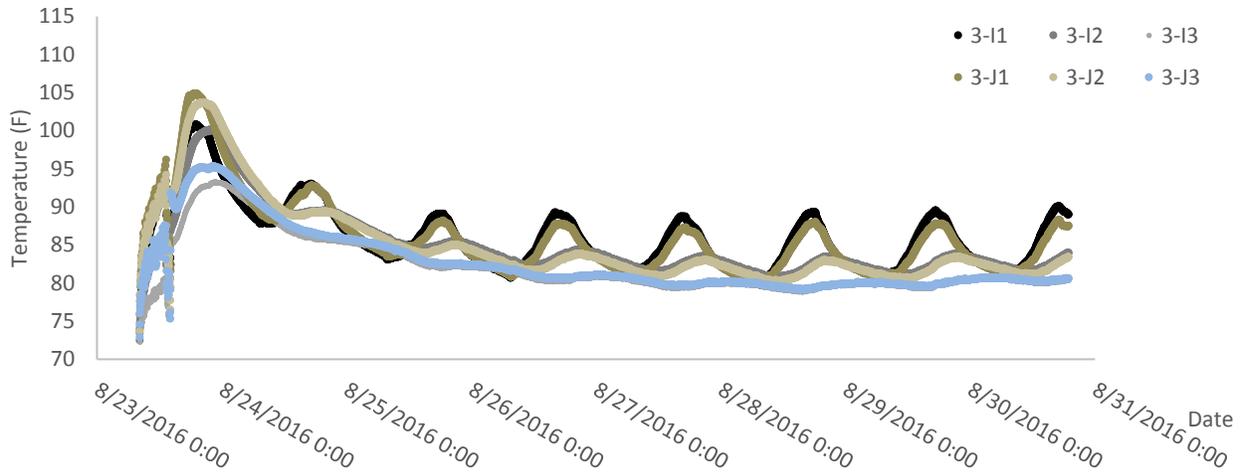
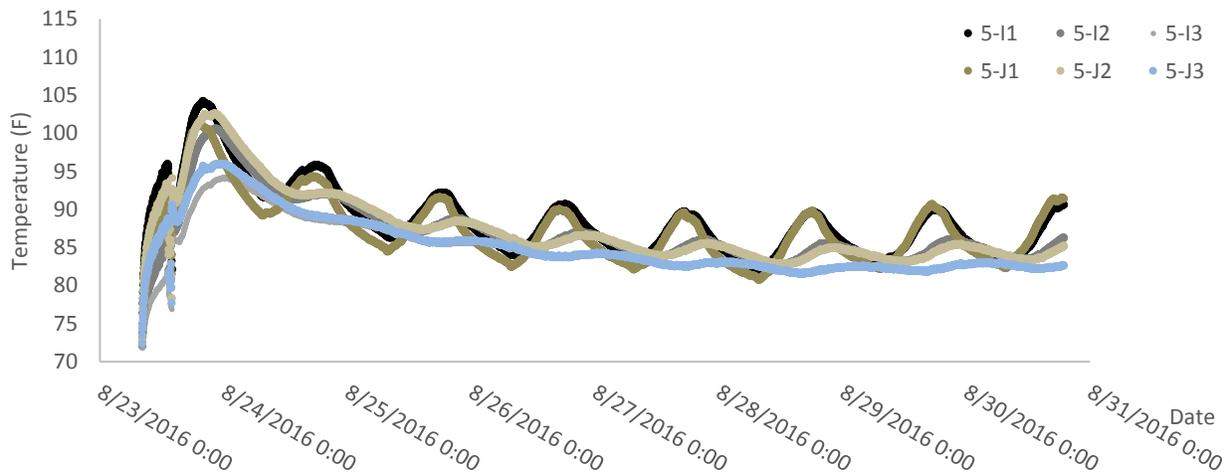
Figure 60 and Figure 61 show the temperature distribution in the joint at Sections 3 and 5. The gauge locations were shown previously in Figure 38.

**Figure 60. Temperatures in the joint at Section 3**

**Figure 61. Temperatures in the joint at Section 5**

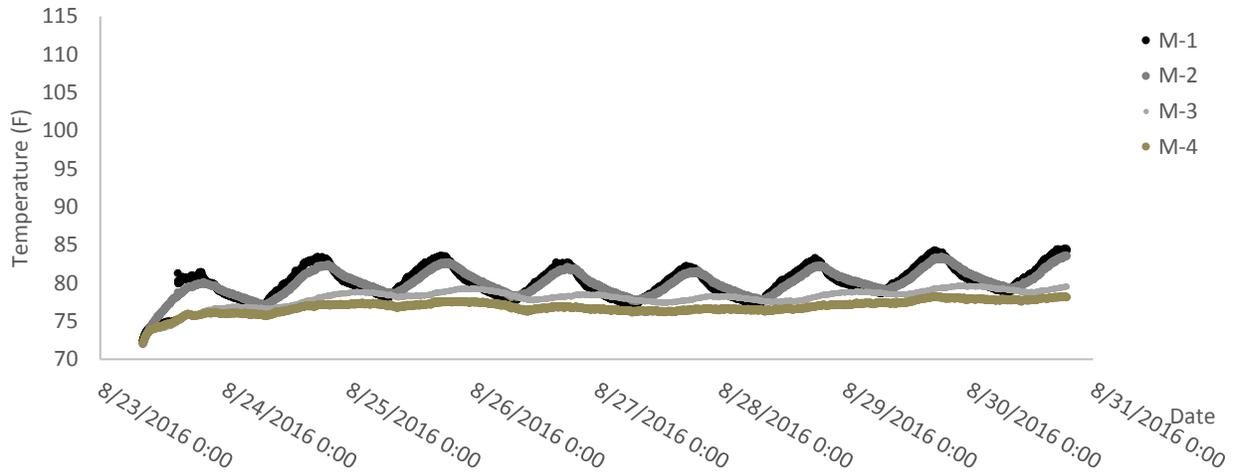
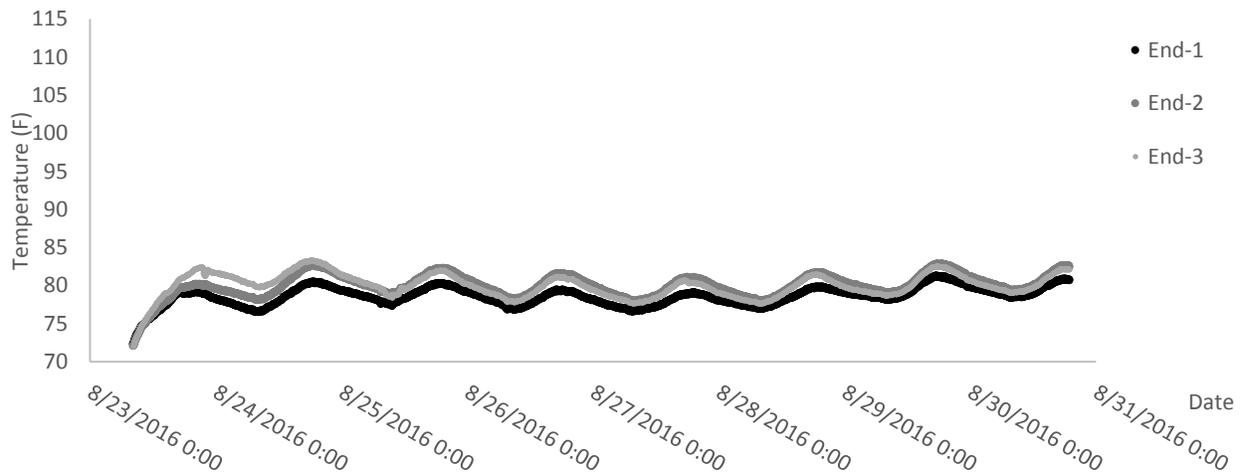
Figure 62 and Figure 63 show the temperature distribution at the exterior of the specimen. The gauge locations were shown previously in Figure 39 and Figure 40.

**Figure 62. Temperatures at the side of specimen**

**Figure 63. Temperatures at the end of the specimen**

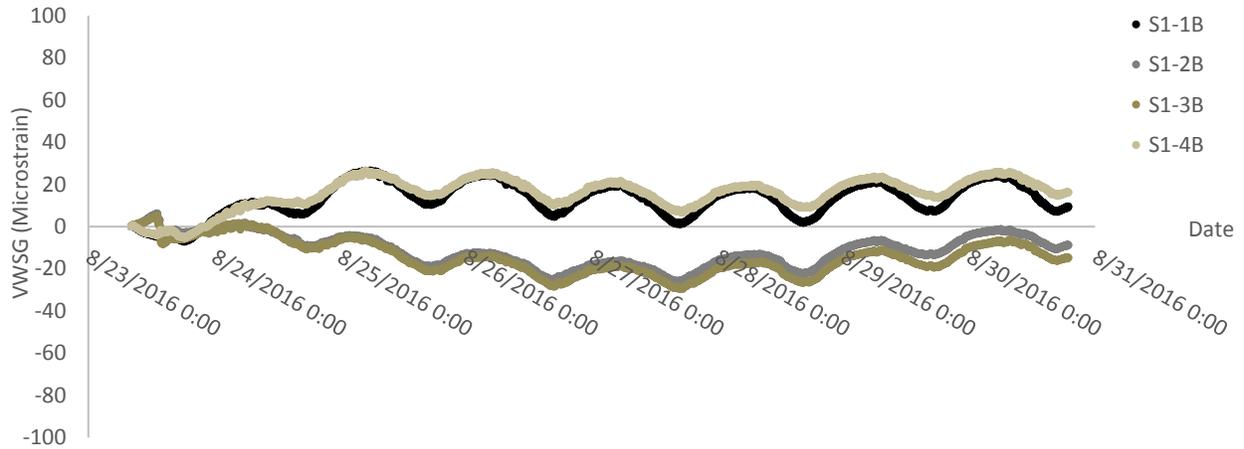
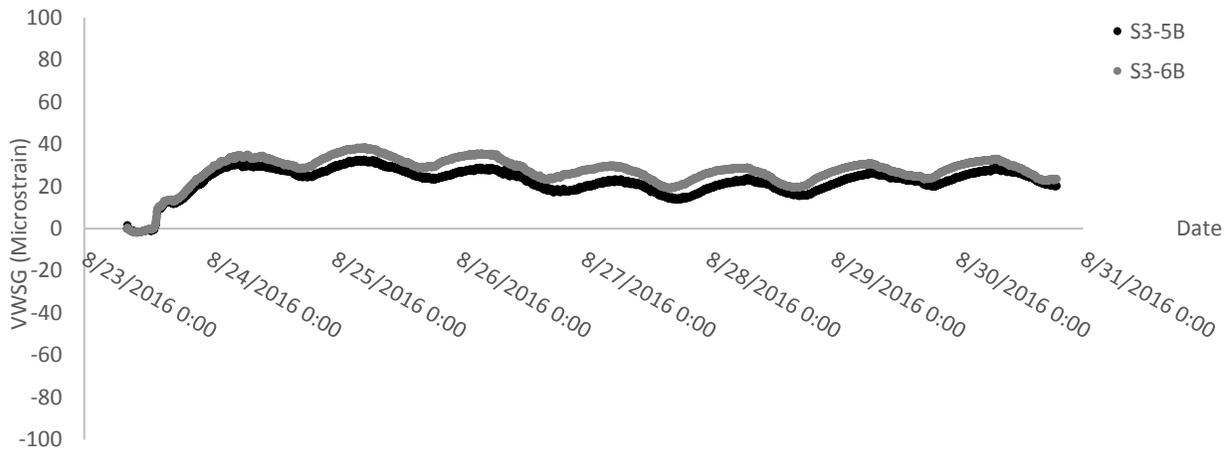
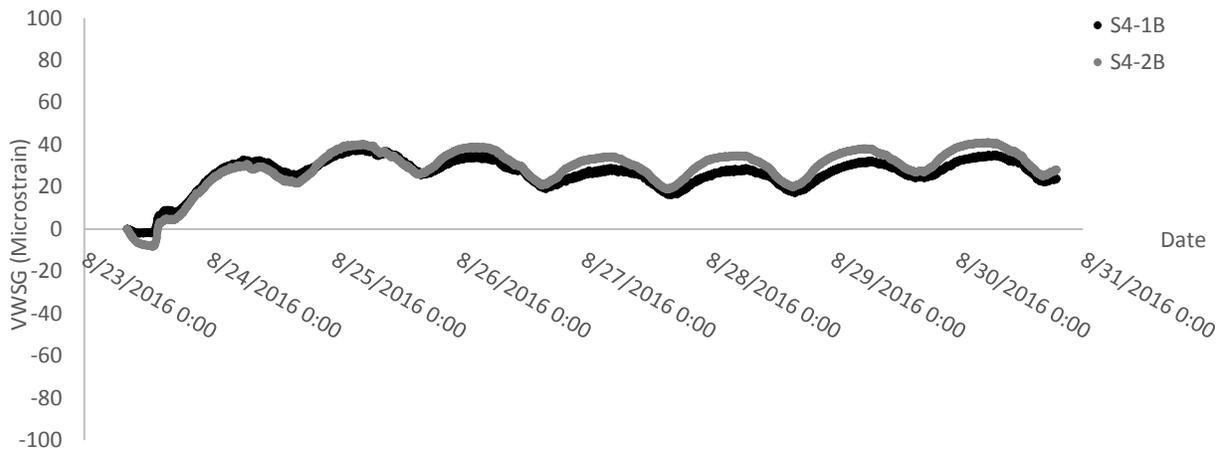
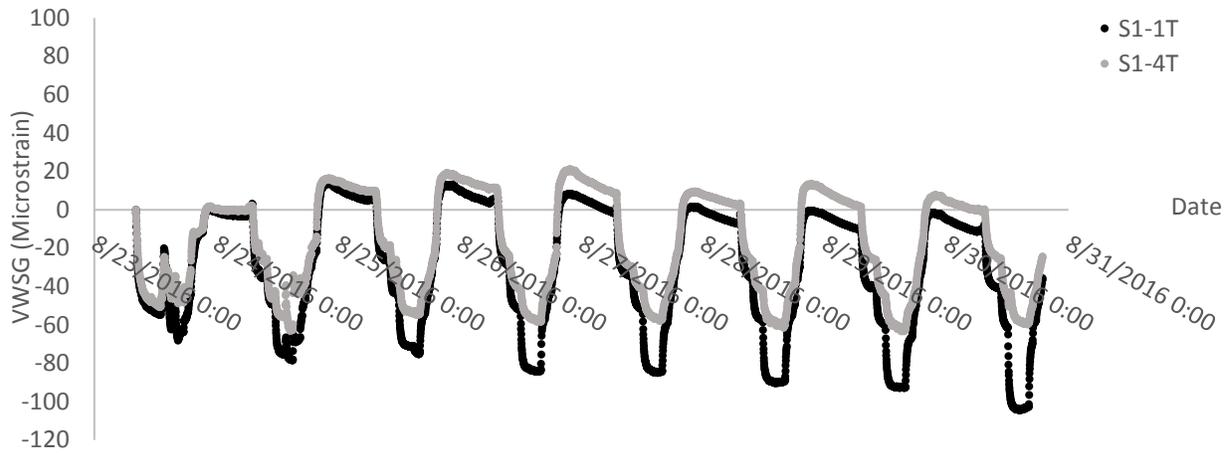
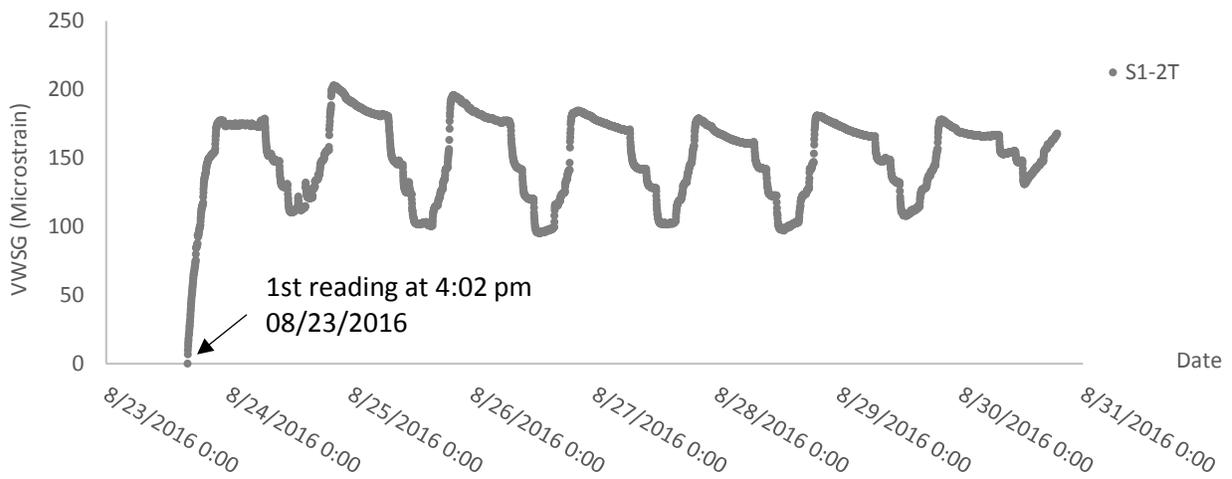
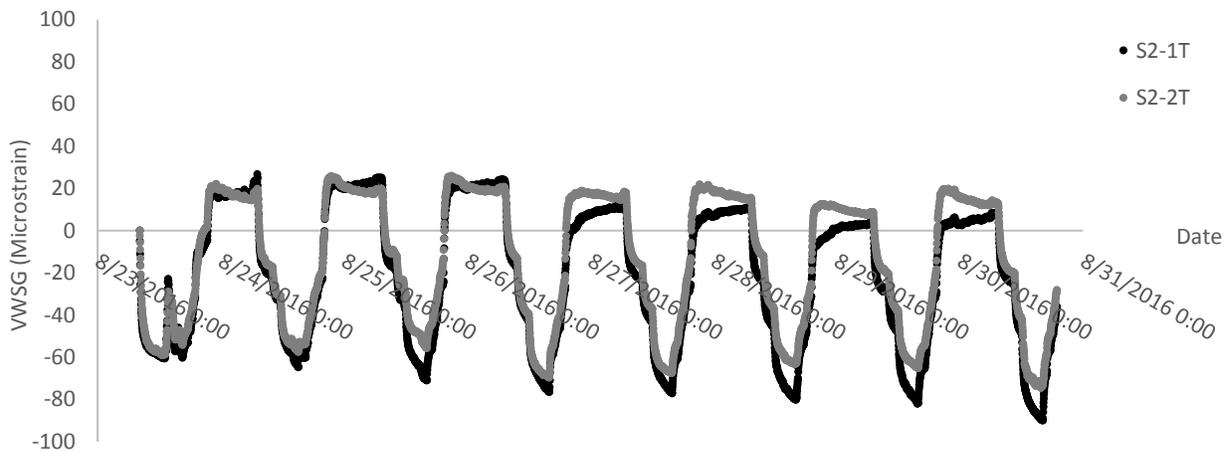
Figure 64 through Figure 78 show the strain data collected from the VWSGs on the top and bottom surfaces.

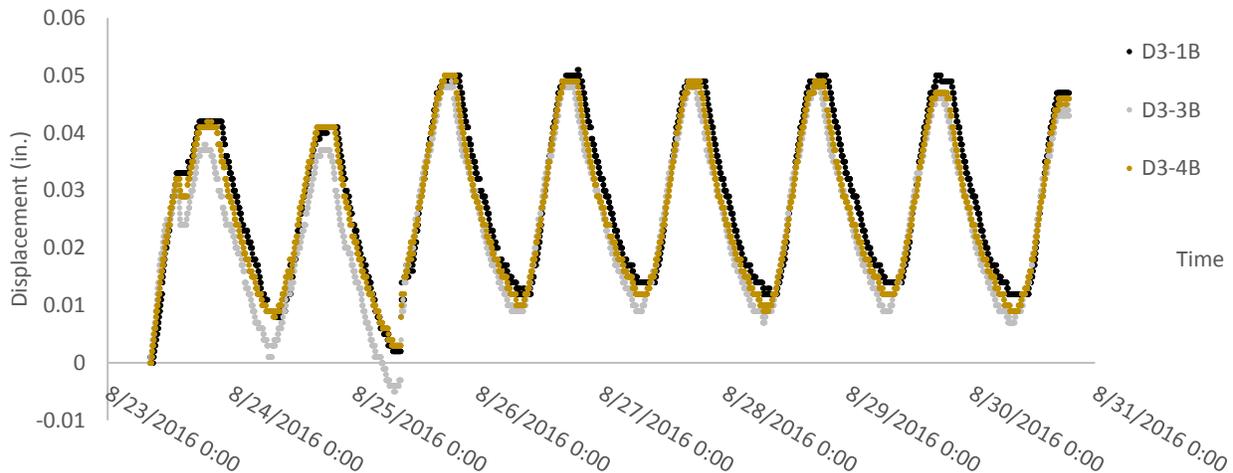
Figure 79 shows the vertical displacement at the middle span of the beam from four displacement transducers along the transverse direction (see previous Figure 43 for the transducer locations).

**Figure 79 Vertical displacement at the middle span at early-age**

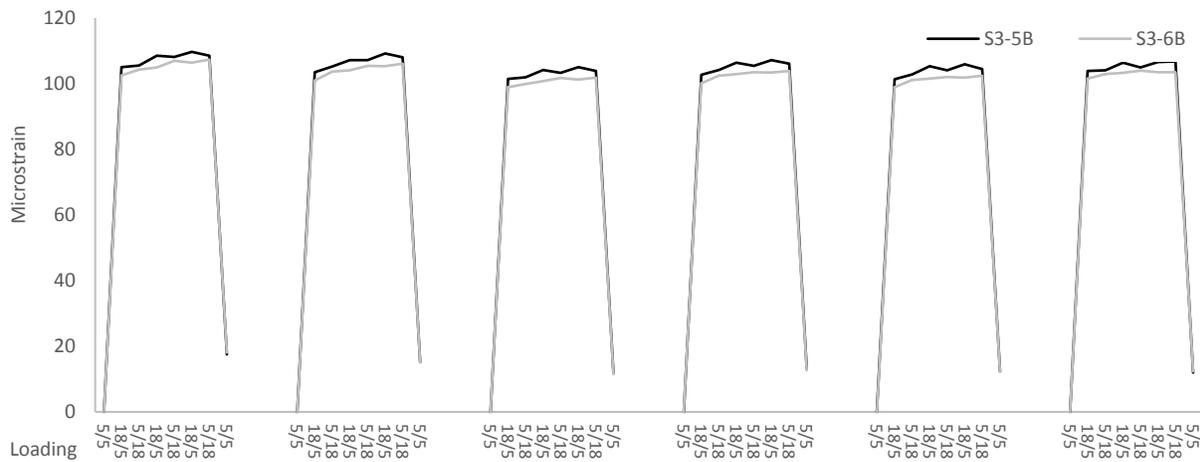
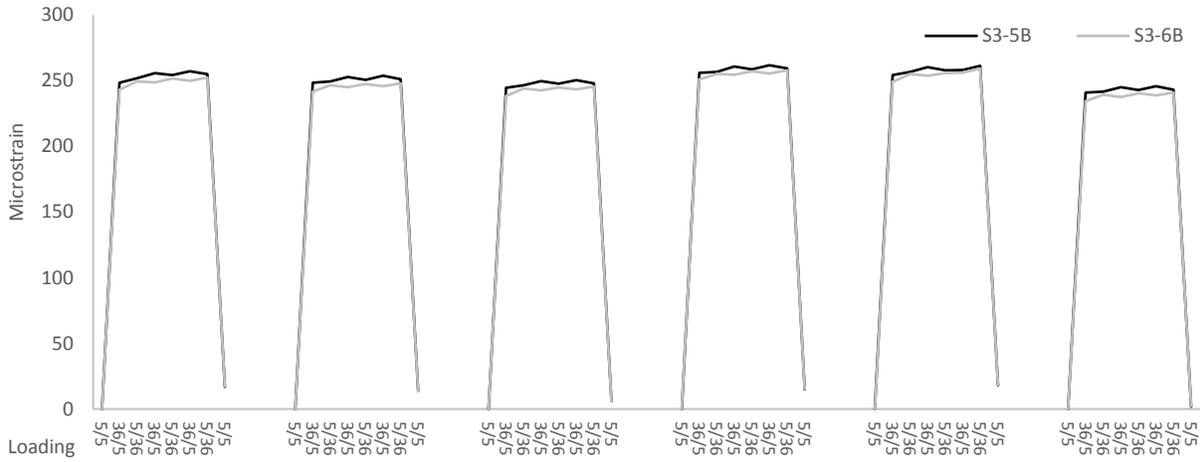
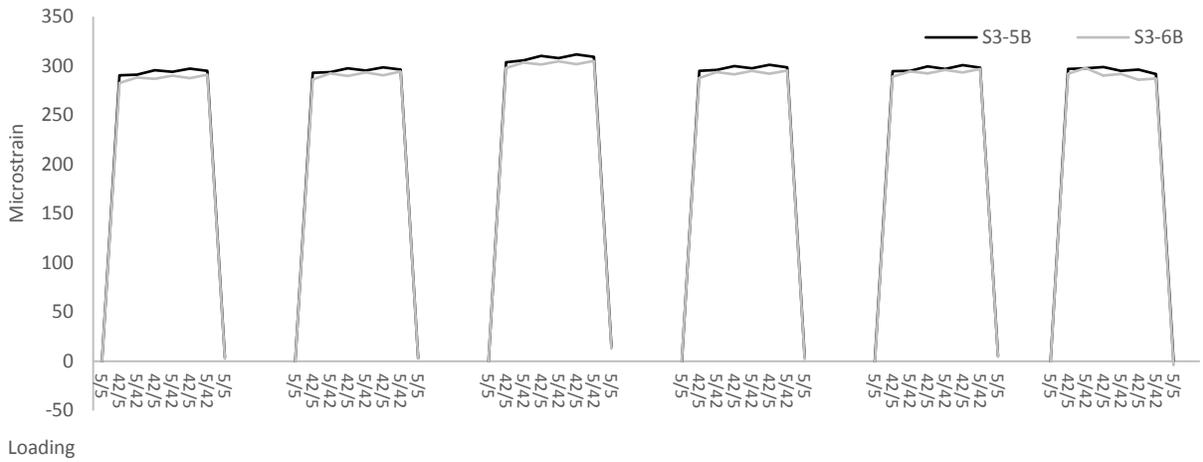
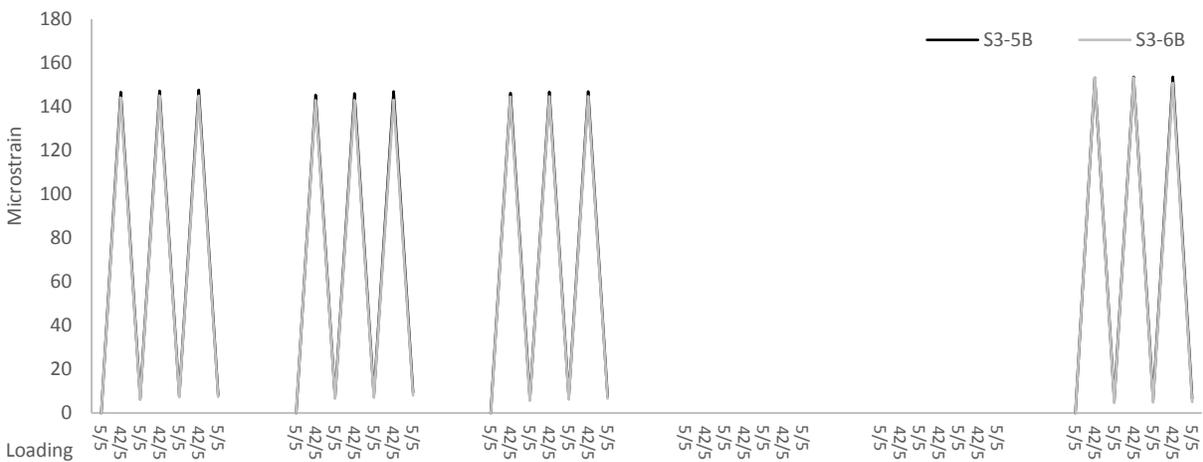
Figure 85 through Figure 88 show the longitudinal strain at the bottom surface of the middle span for each static test (see previous Figure 37 for gauge locations). Both gauges crossed a crack (see the following Section for crack information), so the strain readings are artificially large.

**Figure 85. Bottom longitudinal strains from 18 kips static tests**

**Figure 86. Bottom longitudinal strains from 36 kips static tests**

**Figure 87. Bottom longitudinal strains from 42 kips static tests**

**Figure 88. Bottom longitudinal strains from 42 kips static tests (one beam restrained)**

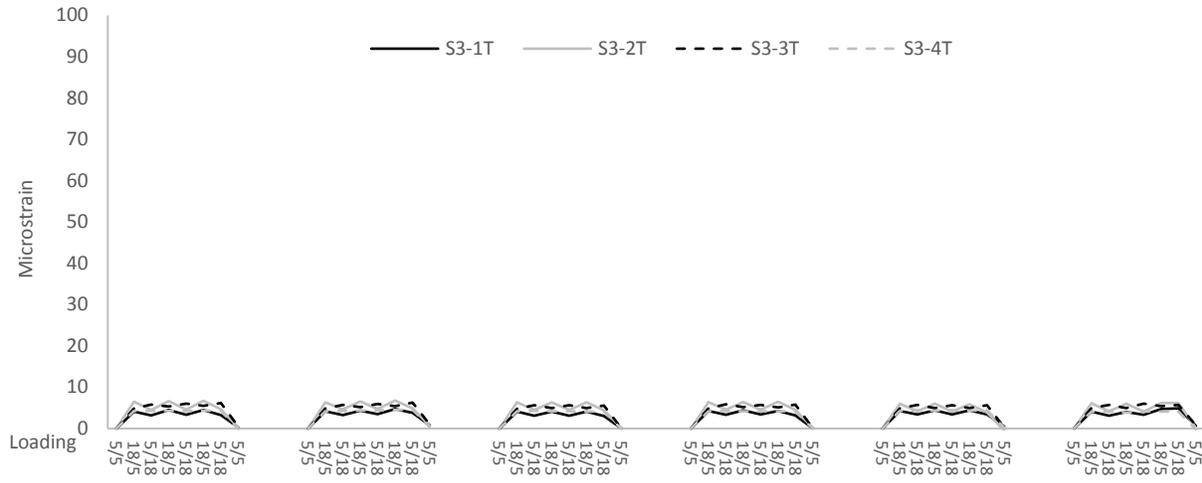
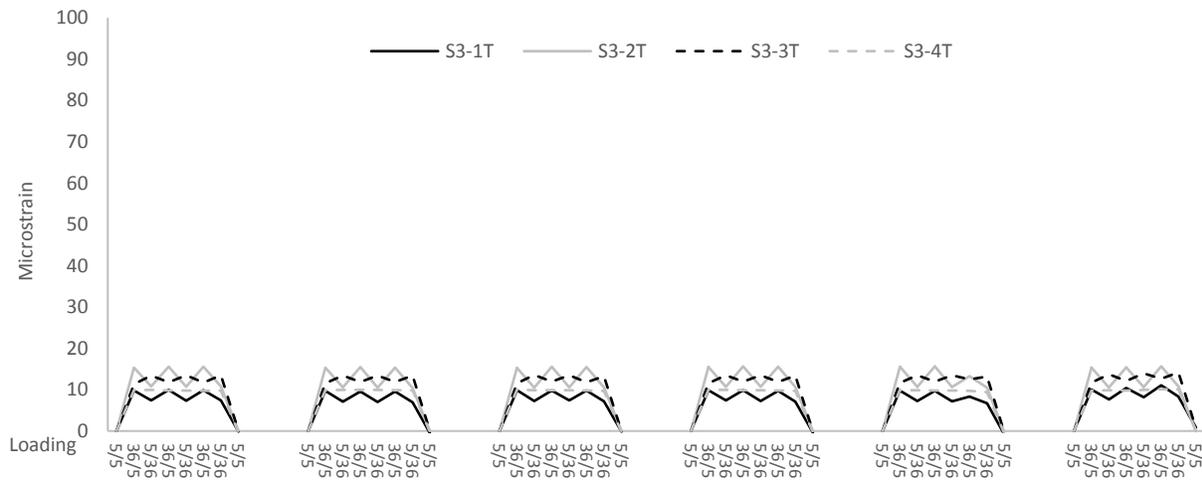
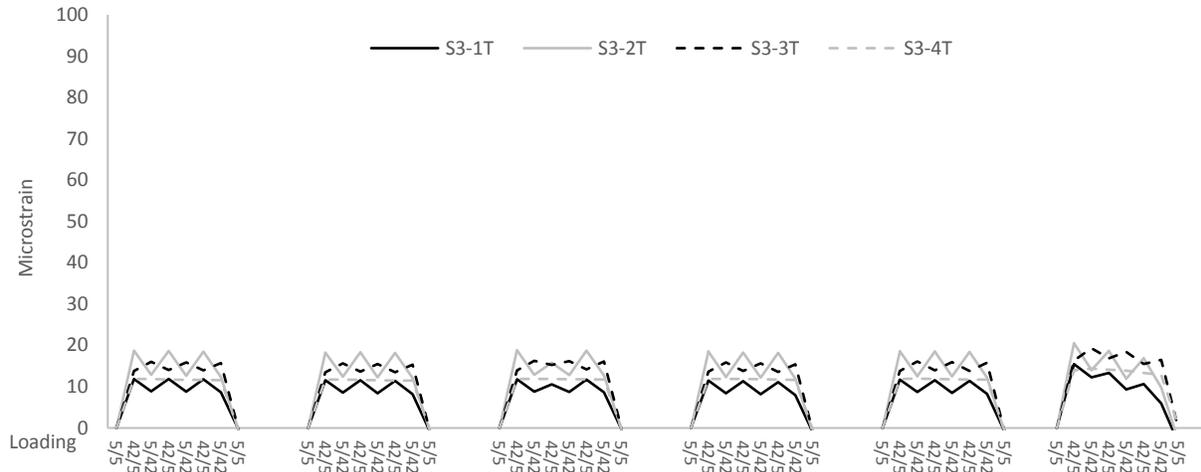
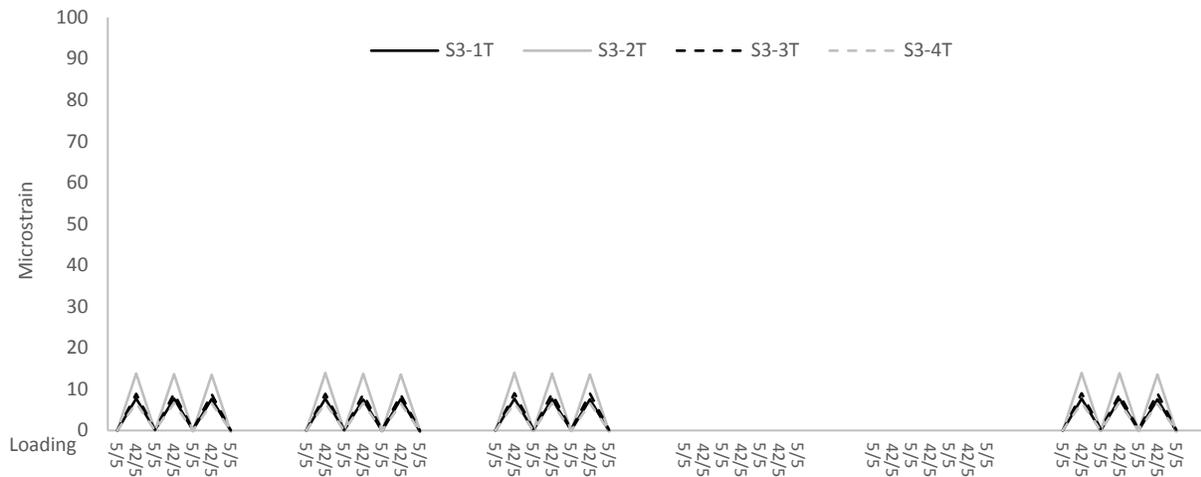
Figure 89 through Figure 92 show the transverse strain at the top surface. The strain values from these four gauges were very small (maximum of ~25 microstrain) and well below the cracking strain.

**Figure 89. Top transverse strains from 18 kips static tests**

**Figure 90. Top transverse strains from 36 kips static tests**

**Figure 91. Top transverse strains from 42 kips static tests**

**Figure 92. Top transverse strains from 42 kips static tests (one beam restrained)**

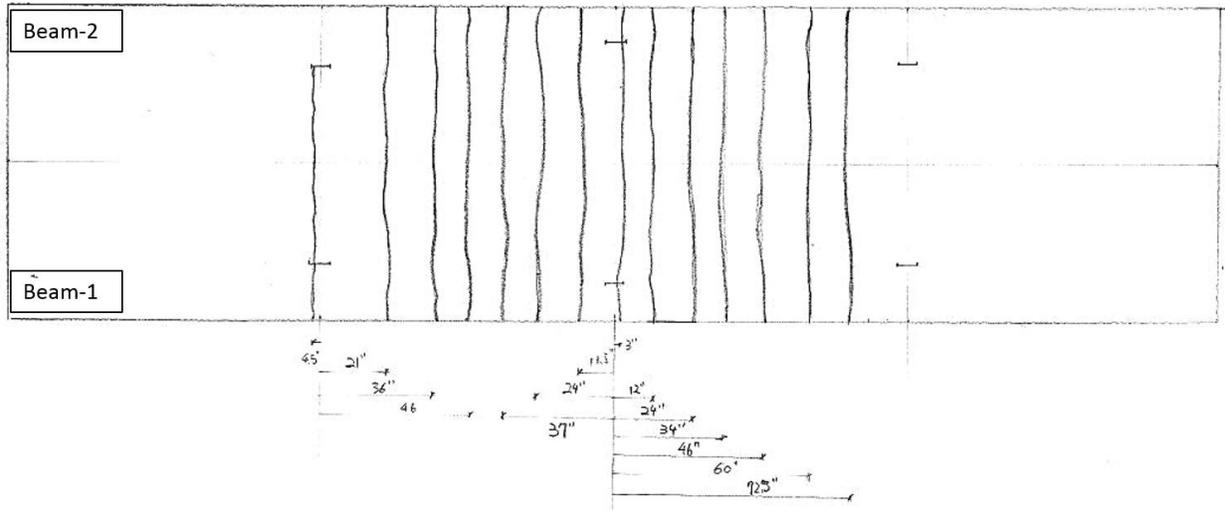
**Figure 93. Transverse cracks on bottom of box girder after first cycle loading of 18 kips**

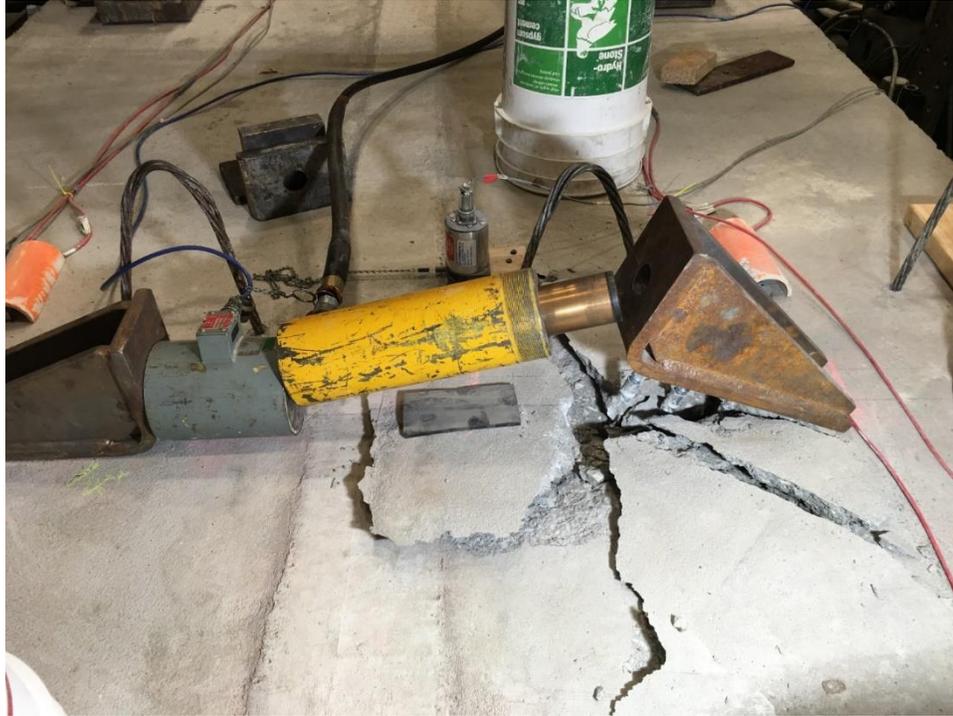
**Figure 94. Crushed box girder due to horizontal load**

Based on the results of the literature review, an innovative wide joint was designed with a roughened interface surface, shrinkage-compensating concrete, and reinforcement steel. The researchers built and tested a specimen that consisted of two box beams and one innovative intermediate joint under early-age thermal loading and cyclic live loading in the laboratory. During these tests, no crack was found in the joint and no trend of increasing differential displacement was found between the two beams. The specimen was eventually cracked by the direct horizontal load.
