# Impact of Curling, Warping, and Other Early-Age Behavior on Concrete Pavement Smoothness: Early, Frequent, and Detailed (EFD) Study

**Phase I Final Report**  
**December 2005**

**Sponsored by**  
the Federal Highway Administration (Project 16)

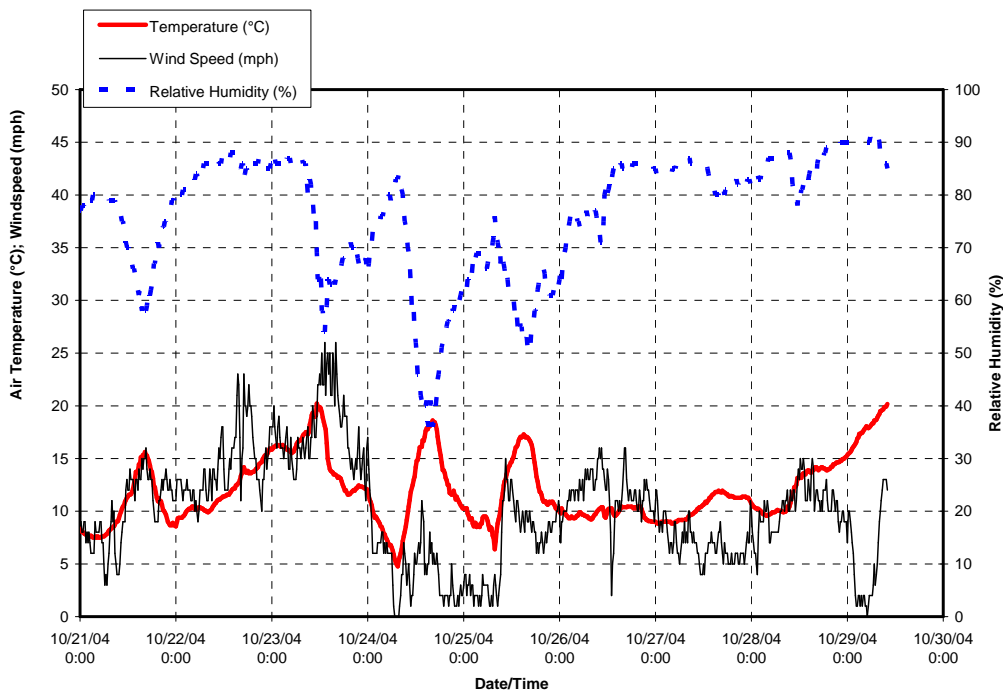
**Figure 5. Recorded environmental conditions**

warmer at the bottom than at the top. The maximum upward curling condition generally occurs during early morning hours, just before sunrise. In a similar manner, downward slab curling occurs when the top of the slab is warmer than the bottom. The maximum downward curling condition generally occurs around noon or in the very early afternoon, when the surface of the slab is heated by the sun. These maximum conditions are highly dependent on climatic conditions, such as cloud cover, but in general these are the timeframes for the maximum slab temperature gradient. The project team documented the diurnal cycles by continuously recording the environmental conditions before, during, and after construction, as shown in Figure 5.

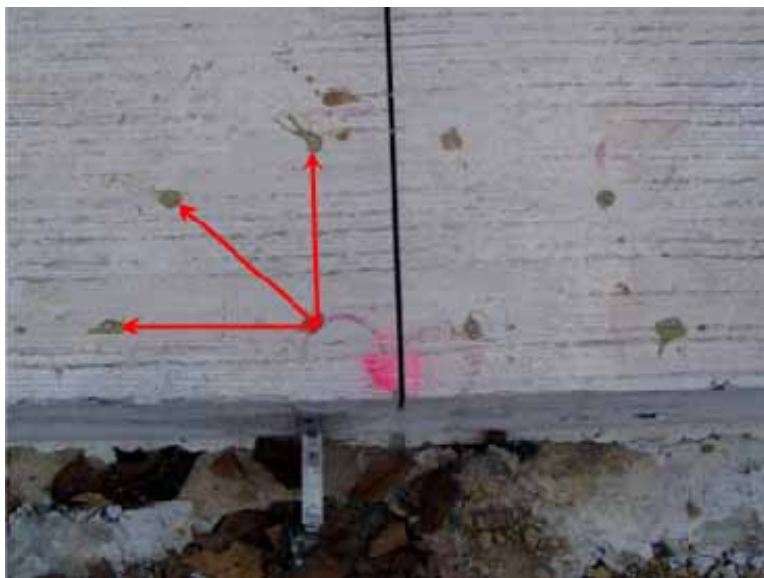
**Figure 9. DEMEC points in the “peacock” pattern**

To aid in the characterization of slab curling and warping, it was necessary to characterize the movement of transverse and longitudinal joints immediately following construction, as well as during diurnal cycles. Beginning shortly after construction, the project team attached stainless steel discs to the pavement surface to be used with DEMEC caliper measurements. Figures 9 and 10 show the discs on the concrete surface for joint movement and surface strain measurements, respectively.

- nine successive transverse joints, to measure joint movement
- eight successive longitudinal joint locations, to measure joint movement
- two “peacock” patterns at slab corners, to measure surface strain (CTE)

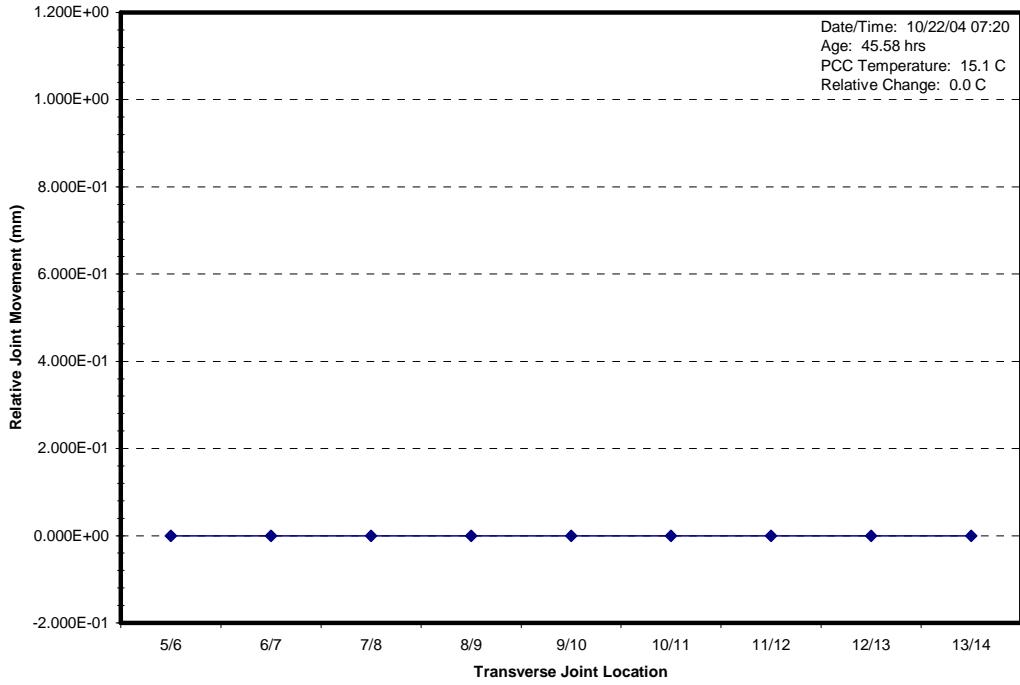
**Figure B5. Transverse joint relative opening**

Since this instrumentation involved a new concrete pavement with joints that had not fully begun to open and close in direct response to temperature changes, the project team referenced all relative joint movements to the initial reading taken at each location. To further aide in the analysis, the date, time, concrete age, and average concrete temperature was provided with each recording. Figure 1 and Table 5 provide the cumulative results for surface strains observed in the “peacock” pattern. It should be noted that this construction took place late in the paving season and resulted in a relatively small range of concrete temperatures. Cumulative results for relative joint movements are provided in Appendices B and C for the morning and afternoon paving test sections, respectively.
