# Laboratory Investigation of Grouted Coupler Connection Details for ABC Bridge Projects

**Final Report  
August 2015**

**Sponsored by**  
Federal Highway Administration  
Iowa Department of Transportation  
(InTrans Project 12-441)

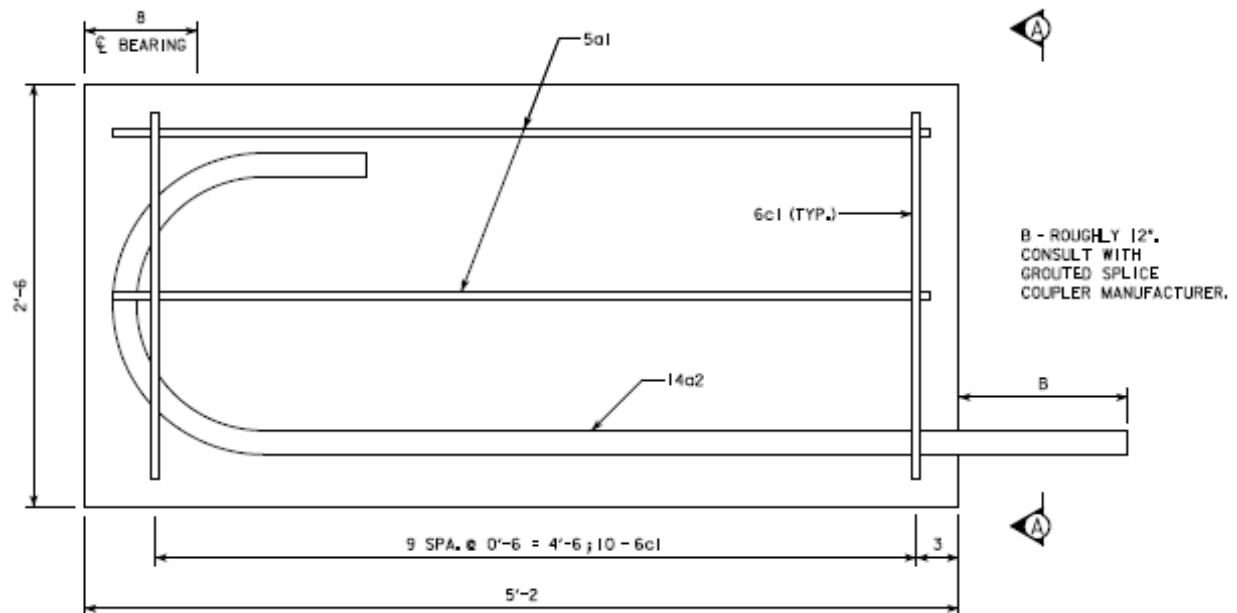
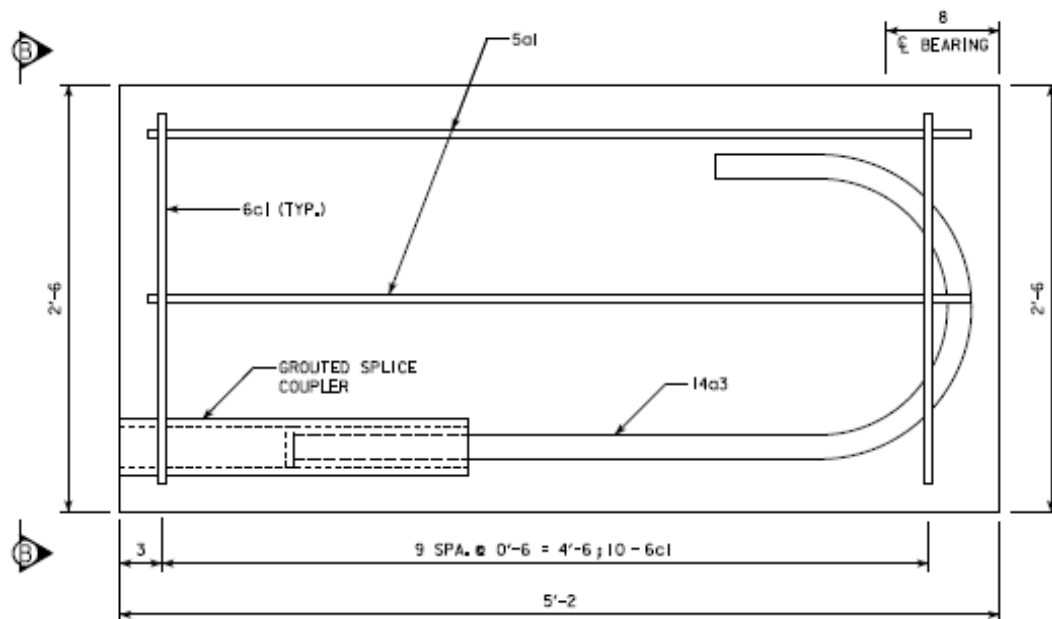
Figure 1. Grouted coupler specimen plan view

At Keg Creek, the pier columns were square cross-sectionally, and since the specimen would be tested in four-point-bending, the decision was made to make the specimen rectangular cross-sectionally, with the couplers at the bottom of the coupled joint, i.e. in the tension zone. See Figures 1 and 2 for specimen cross-section and plan view schematics.

Side A

Side B

The specimen was ultimately designed based on developing the two #14 bars used as tension reinforcing in the bottom of the specimen. The two #14 bars, as tension reinforcement, do not meet American Association of State Highway and Transportation Officials (AASHTO) (2010) Load and Resistance Factor Design (LRFD) Specification 5.7.3.4. Control of Cracking by Distribution Reinforcement. However, since there is no additional crack control reinforcing steel in the connections utilizing the grouted couplers at Keg Creek, this was not considered to be critical to this study. Using a four-point bending loading setup, the calculated point load,  $P$ , on the specimen based on development of the two #14 bars was found to be  $P=444$  k.

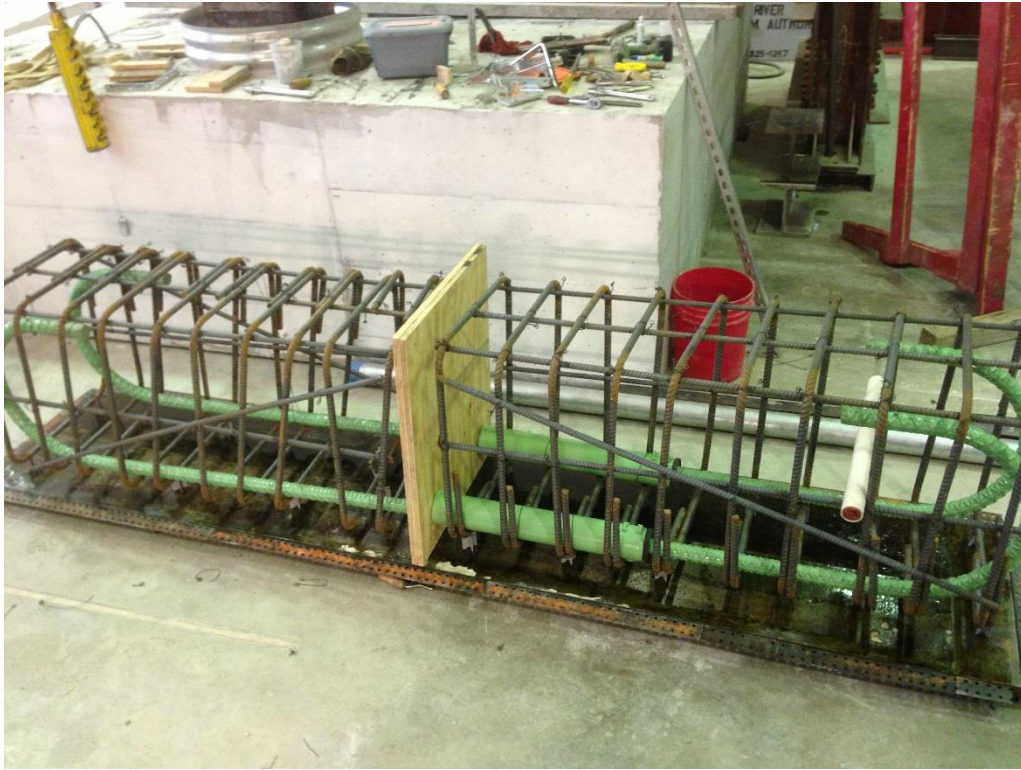
**Figure 3. Laboratory specimen reinforcement cage, couplers, and bars**

Figure 3 shows the formwork, reinforcing cage, and #14 bars and couplers for the laboratory specimens during construction.

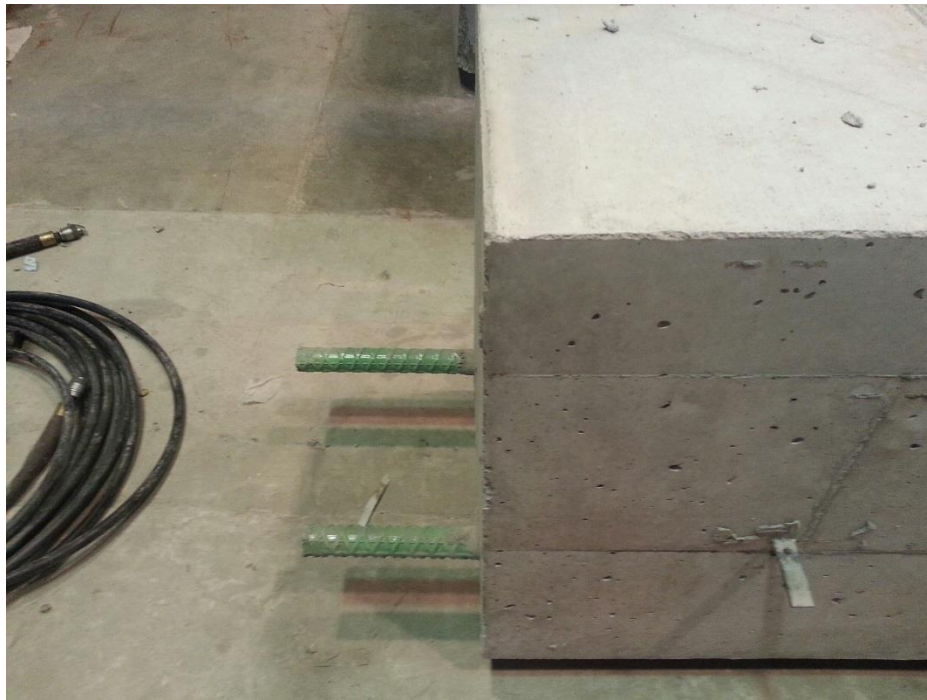
**Figure 4. Protruding #14 bars from Side A of the specimen**

Figure 4 shows the bottom portion of one specimen after removal of the forms and the protruding #14 bars.

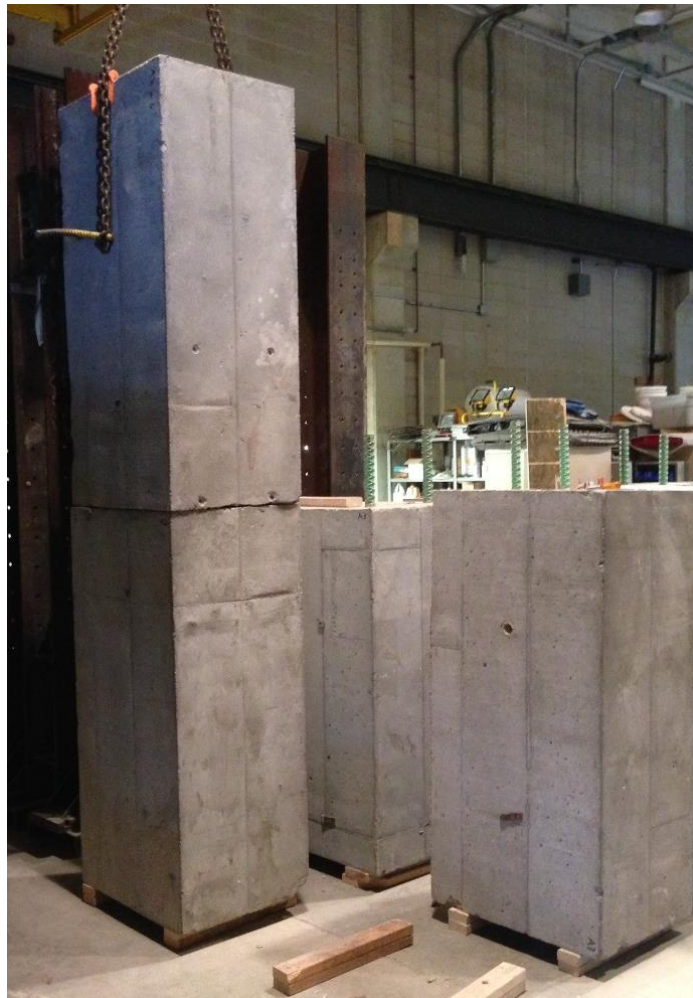
**Figure 5. Dry fit of Side B on top of Side A in laboratory**

Figure 5 shows both portions of the specimen reoriented vertically, in a dry fit configuration, with the coupler grout ports visible.

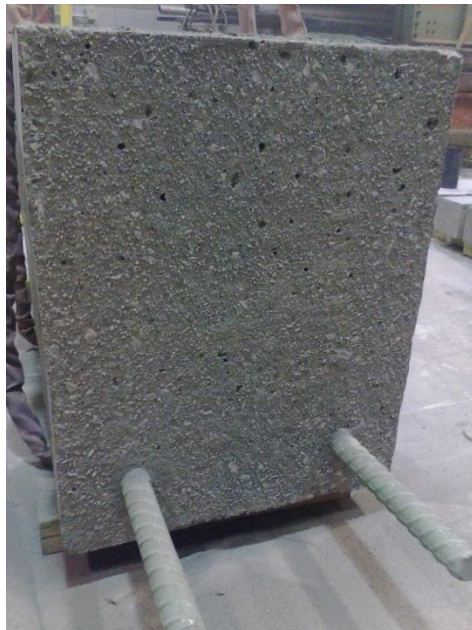
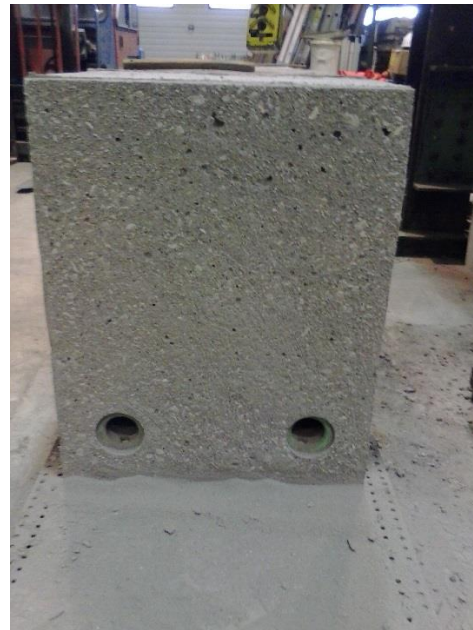
**Figure 6. Specimen grout bed interface using form retarder**

Specimens 1 through 3 utilized sandblasting on the grout bed surface and W. R. Meadows 588-10k grout, which was the grout used at Keg Creek, for the bedding grout with no axial load. Specimens 4 and 5 were then cast and erected using the same procedure and materials but with an applied axial load during static testing. Specimens 6 and 7 were cast last in the same manner, but used a form retarder, specifically Altus In-Form Retarder (pink) from Architectural Concrete Chemicals, on the interface to be grouted, and ultra-high performance concrete (UHPC) for the bedding grout. The objective of using the form retarder was to create a roughened exposed aggregate surface at the interface. Figure 6 shows the concrete interface after removing the forms with the form retarder.

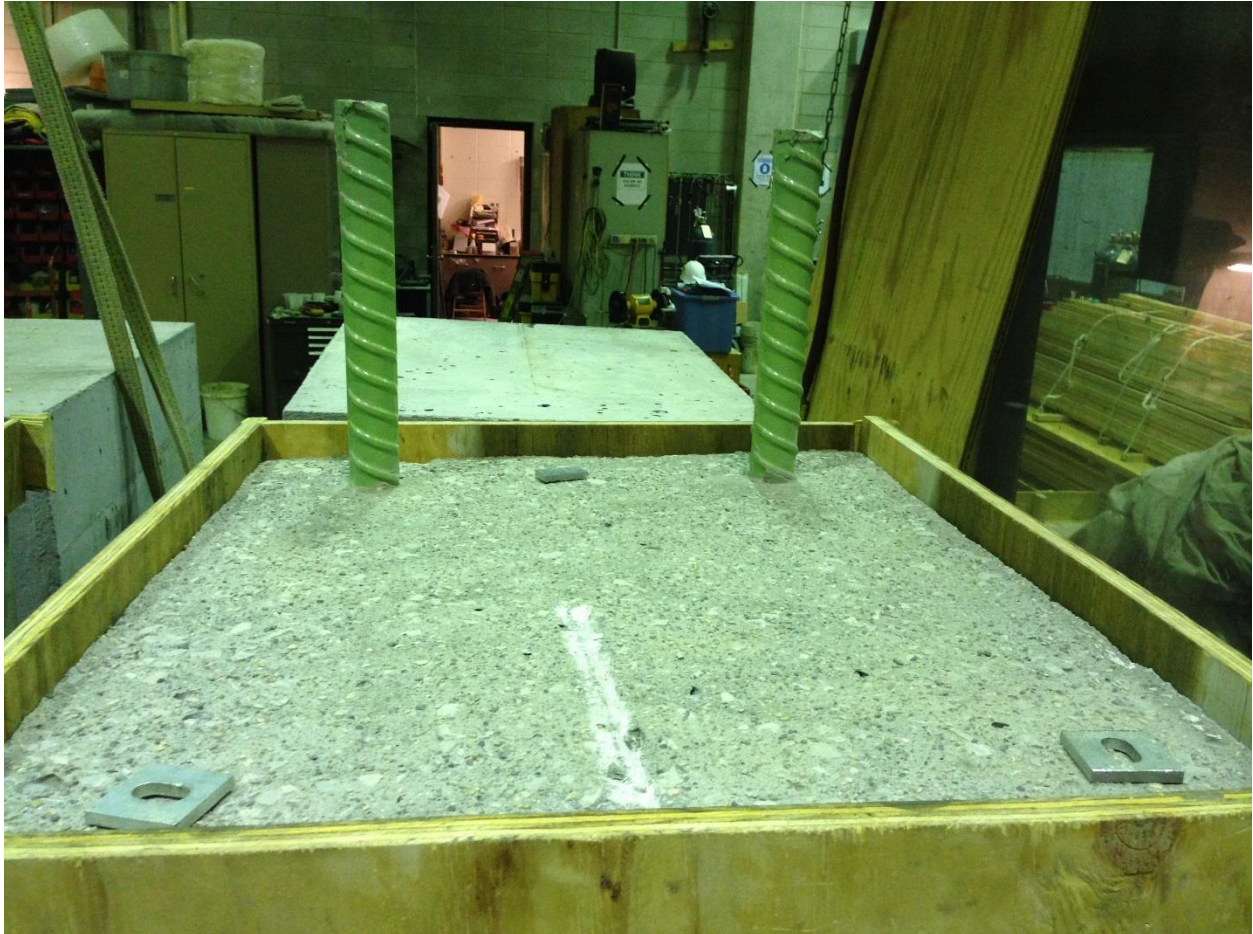
**Figure 7. Dam around the top of the bottom specimen to contain the grout for the grout bed**

Erection of the specimens began with installation of a dam around the top of the bottom specimen to contain the grout for the grout bed. Shims were installed to ensure a specific grout bed depth and to ensure that all of the grout was not pressed out of the joint (see Figure 7).

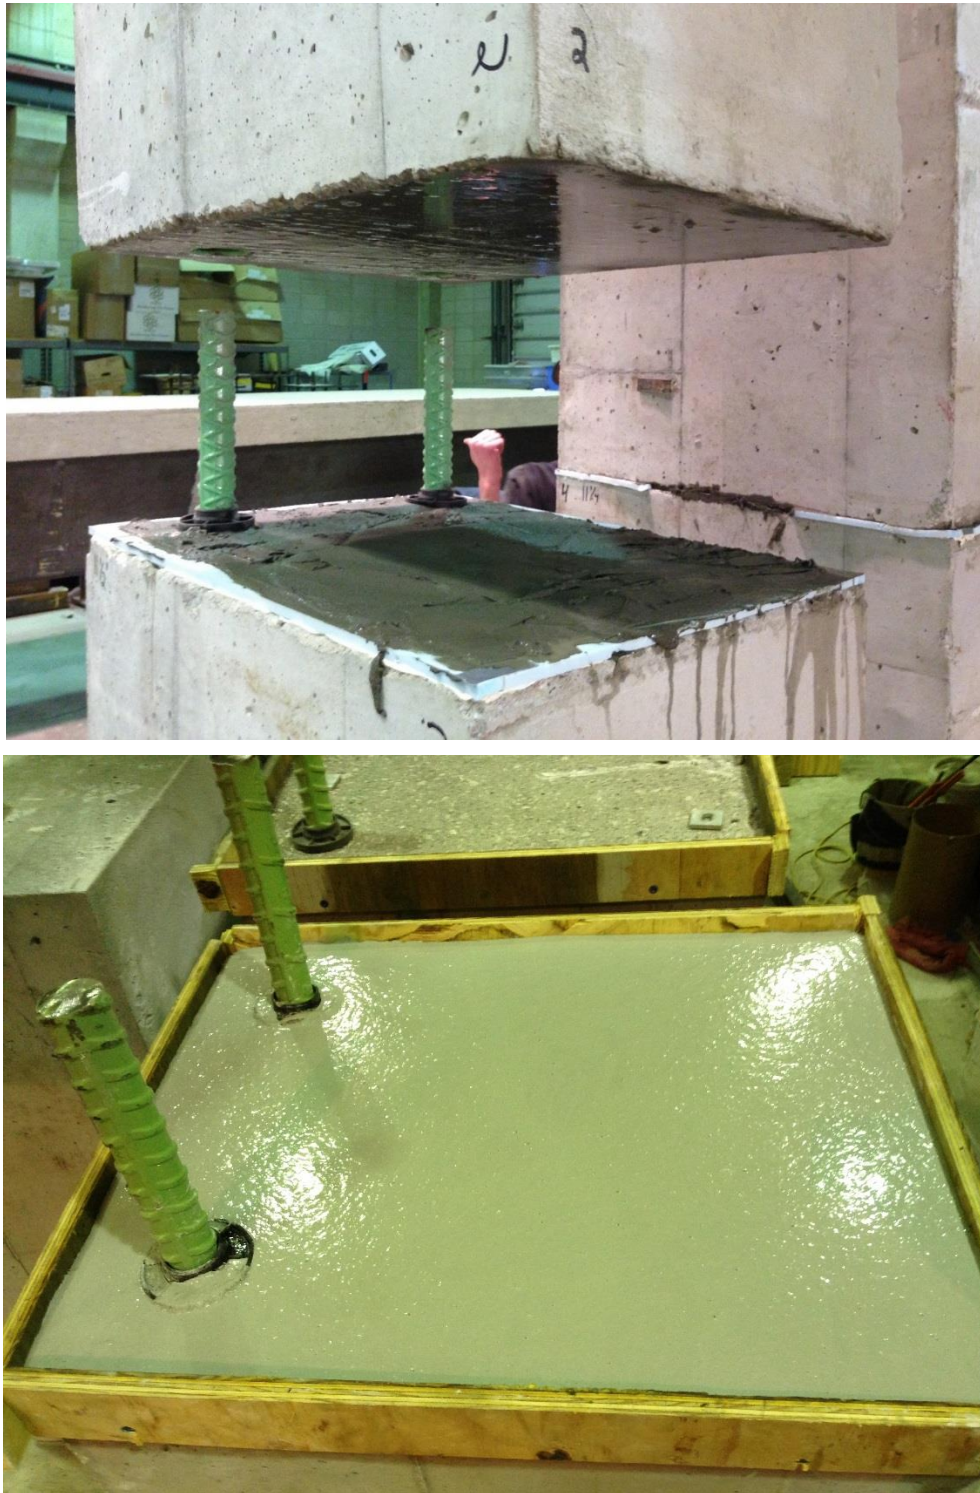
**Figure 8. W. R. Meadows grout bed (top) and UHPC grout bed (bottom)**

Sleeve-lock seal plugs were used on the protruding reinforcing steel to prohibit bedding grout from entering the couplers. Once all three were properly in place, the grout was placed on the top of the bottom specimen and the top specimen was carefully lowered on top (see Figure 8).

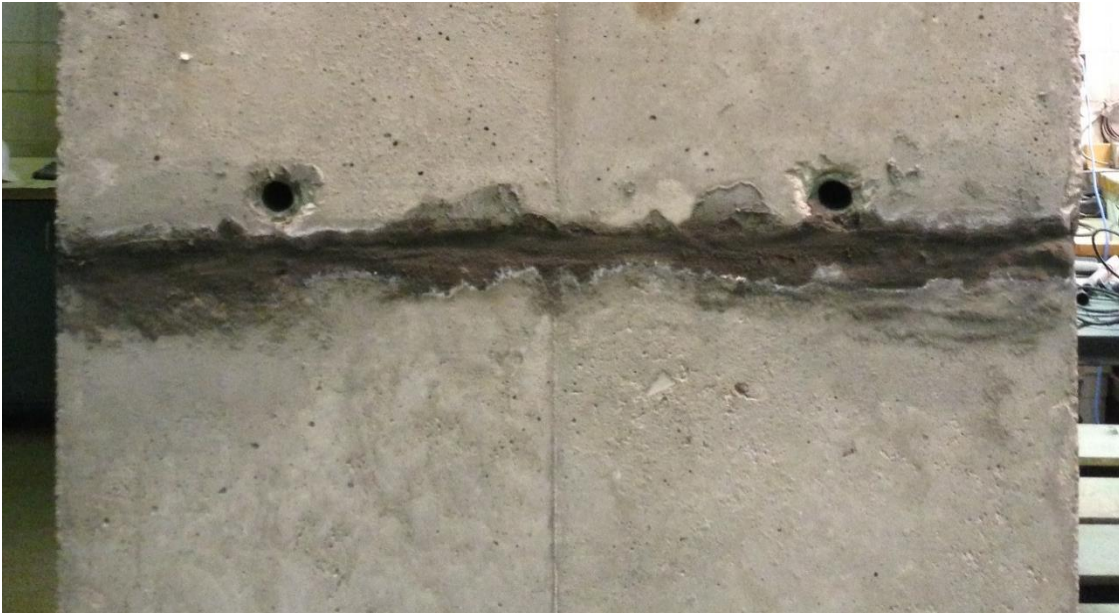
**Figure 9. Specimen grout bed using W. R. Meadows 588-10k**

Figures 9 and 10 show the completed grout beds for one specimen using W. R. Meadows 588-10k grout and another using UHPC as the grout bed, respectively.

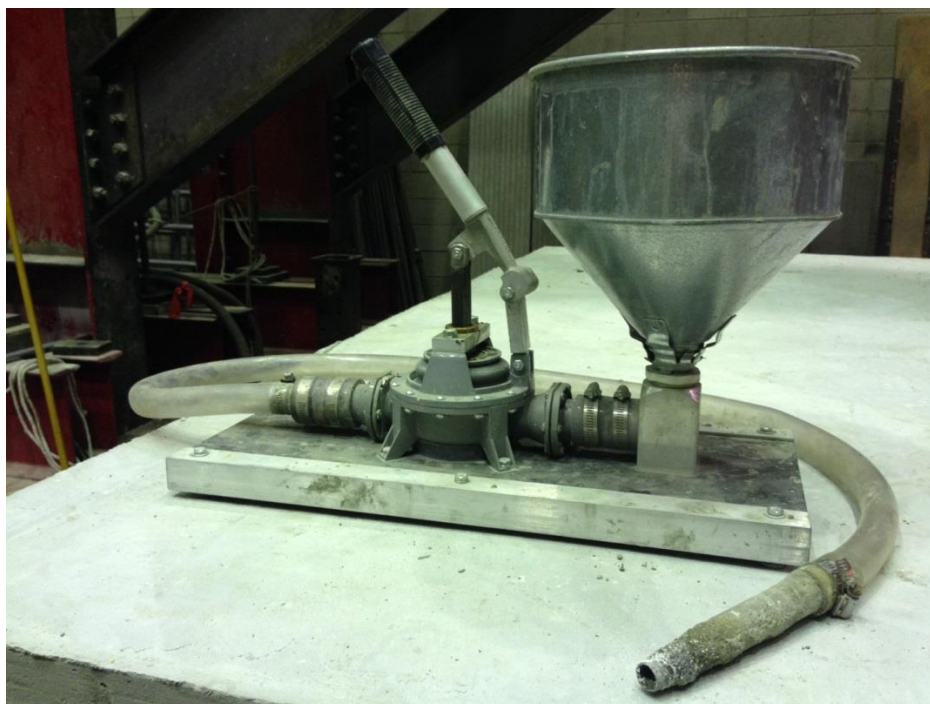
Figure 12. Grout pump used for grouting the reinforcing steel couplers

After installation of the bedding grout, the reinforcing steel couplers were grouted. The couplers were grouted using Dayton Superior Sleeve-Lock Grout and a hand pump (Figures 11 and 12).

Each batch of grout was mixed per manufacturer recommendations and pumping of the grout was completed as follows: 1) mix grout, 2) fill pump hopper with grout, 3) insert nozzle of pump into lower port of the grouted coupler, 4) slowly pump the grout into the coupler until it begins to come out of the top port of the coupler, 5) with a steady stream of grout exiting the top port, plug the top port using a port plug, 6) quickly remove the pump nozzle and plug the bottom port with a port plug. Figure 13 illustrates the ports before grouting and Figure 14 illustrates the ports after grouting with port plugs installed.

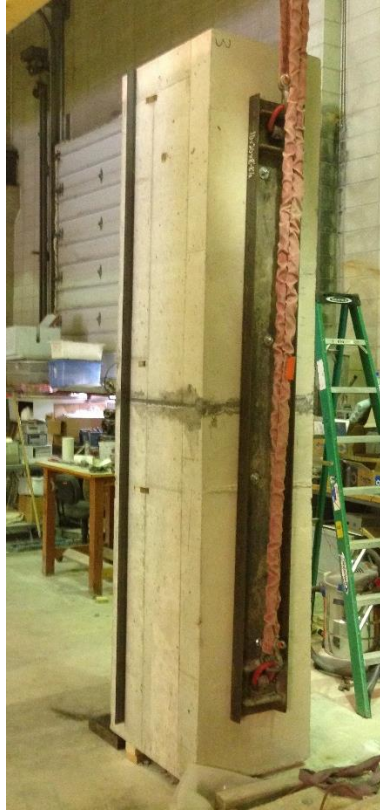
**Figure 15. Vertical braced specimen before lowering to horizontal position for testing**

Following curing of the bedding and coupler grout and validation of their 28-day compressive strengths, the specimens were braced in their vertical orientation by anchoring steel angles and channels to the sides and tops of the specimens. The bracing reinforced the grouted joints as the specimens were carefully lowered to their horizontal positions for testing. Figure 15 shows one specimen in its vertical braced condition prior to lowering it.

A cursory inspection of the grout joint was completed subsequent to the lowering of each specimen to ensure no cracking of the joints had occurred, and none was observed.

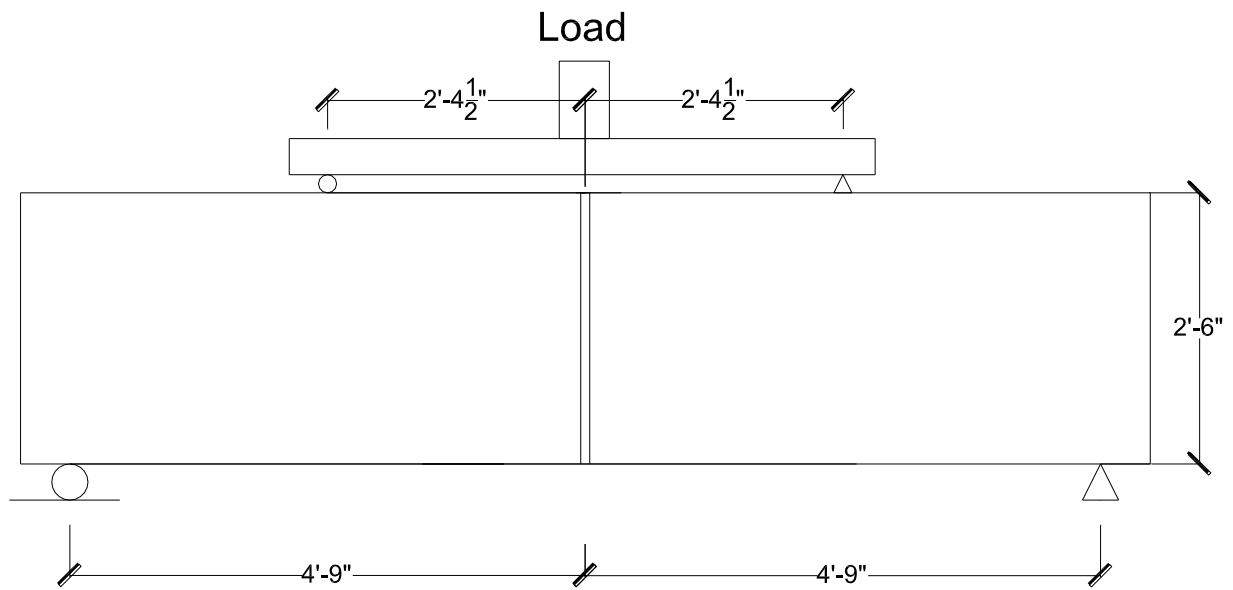
**Figure 16. Four-point bending (L/2) setup for grouted coupler specimens**

Figure 16 and 17 are schematics of the load setup with span dimensions and load placement.

Specimen 1 was loaded using span length divided by 2 ( $L/2$ ) for the four-point bending setup. The load setup was adjusted to  $L/3$  for the remainder of the testing to allow for a greater moment at the grout joint. Specimens 1 through 3 were loaded and tested as shown in Figure 18.

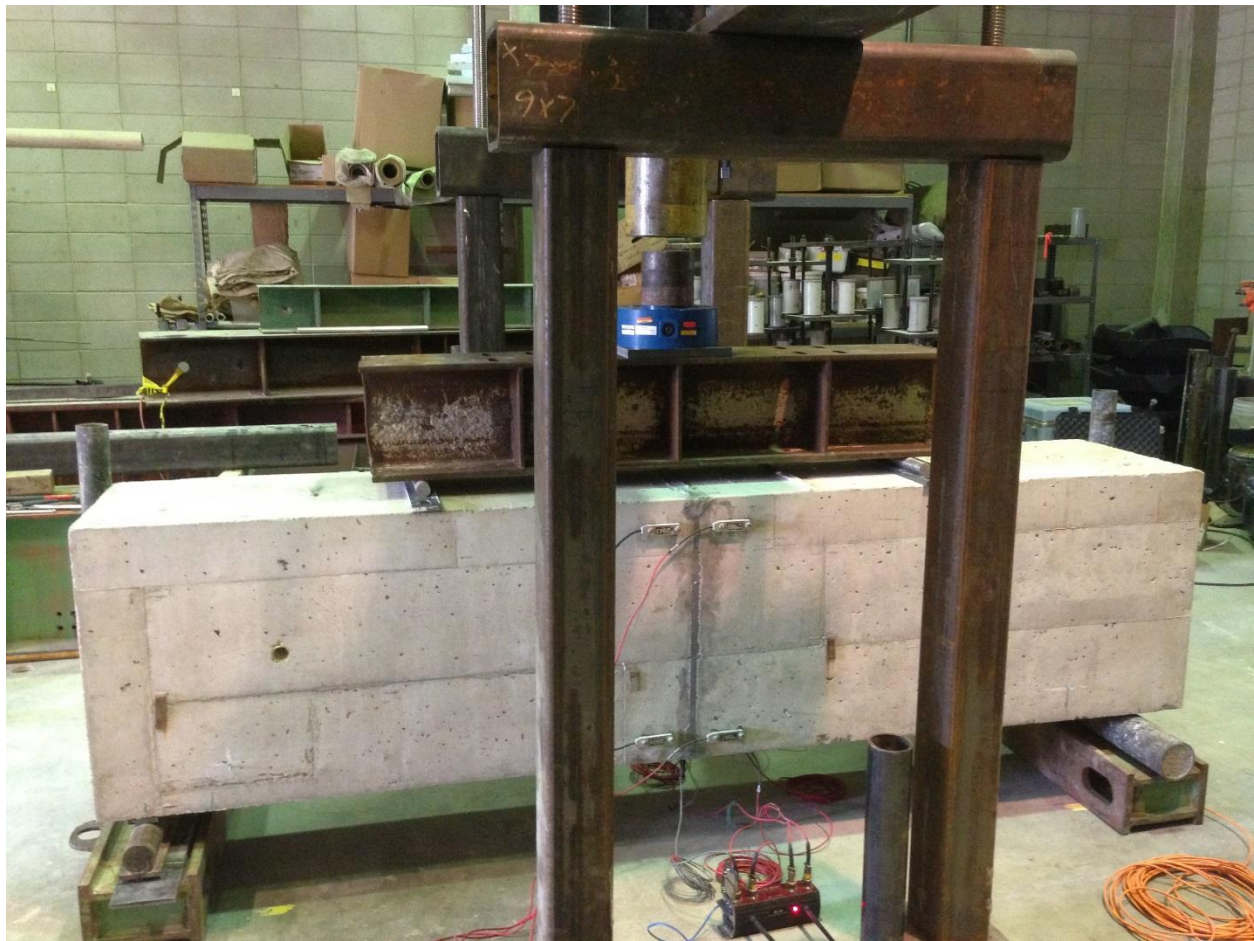
**Figure 18. Specimen setup for static four-point bending test**

Figure 18 shows one specimen in the test frame ready for loading.

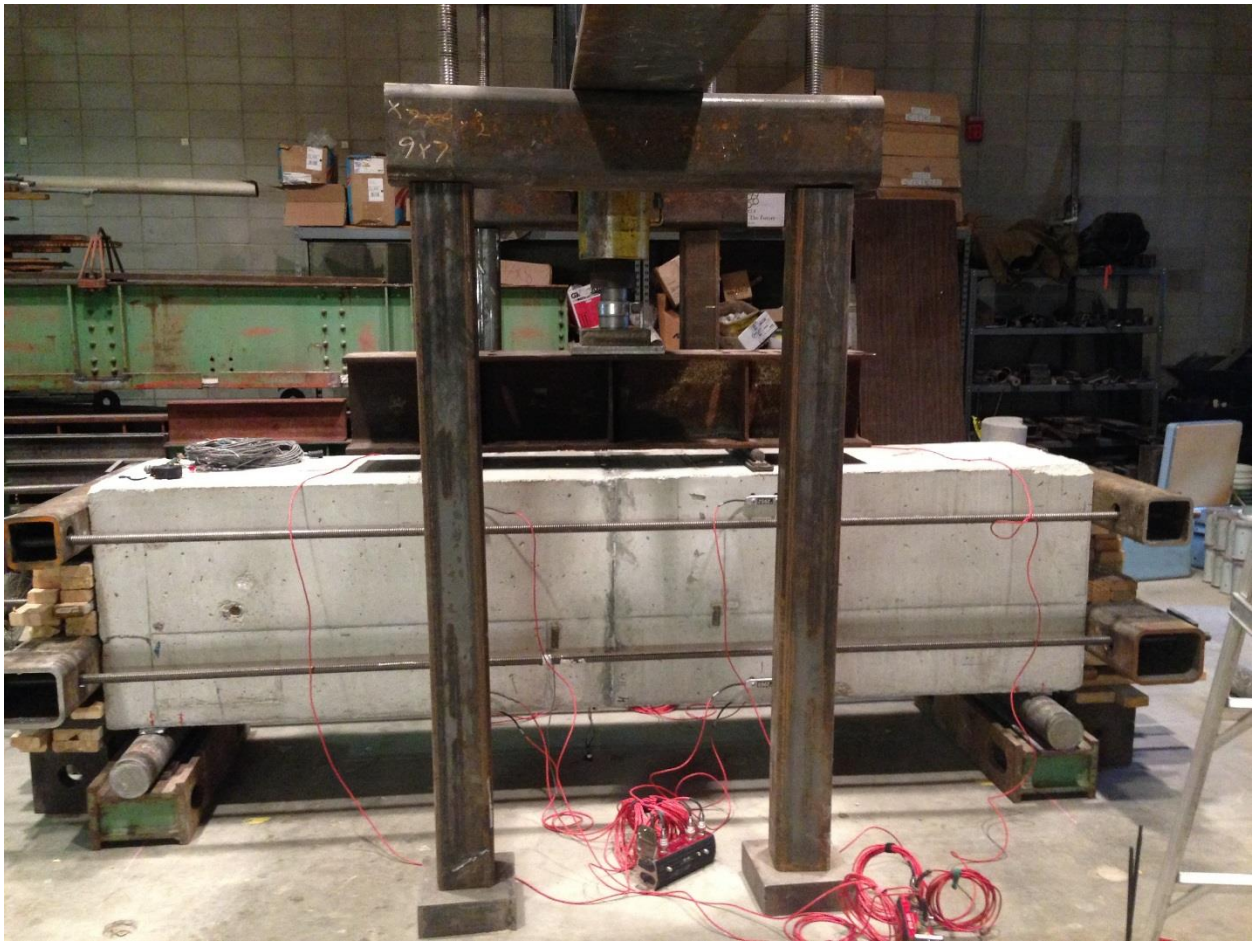
**Figure 19. Specimen setup for static four-point bending test with applied axial load**

Figure 19 shows a specimen in the test frame setup with an axial load applied with post-tension rods.

Following testing of the first three specimens, a discussion with the technical advisory committee (TAC) led to questions regarding whether an imposed axial load, such as would be found in the columns of the Keg Creek Bridge due to dead load, would affect the static behavior of the specimens and ultimately the cracking of the joint under bending load.

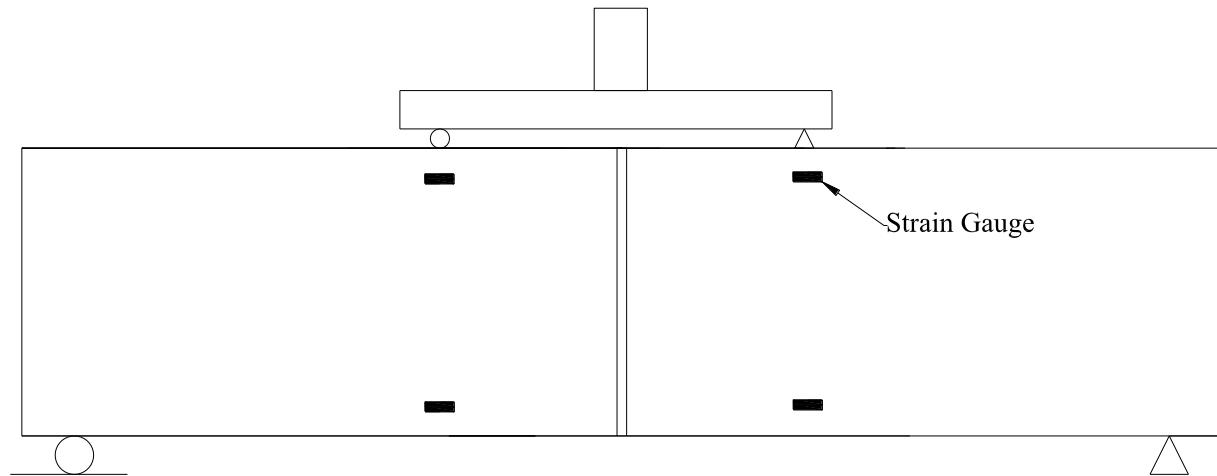
**Figure 20. Instrumentation layout on the sides of each specimen**

Instrumentation of the specimens consisted of crackmeters placed across the grouted joint on the bottom of the specimen in line with each of the grouted couplers. In addition, a global deflection transducer was placed at midspan of each specimen to obtain load versus deflection information. Lastly, strain transducers from Bridge Diagnostics, Inc. (BDI) were installed on the sides of the specimens directly below the load points near the top and bottom edges, and on the underside of the specimen in line with the grouted couplers.

Figures 20 and 21 show the instrumentation placement for all of the specimens tested.

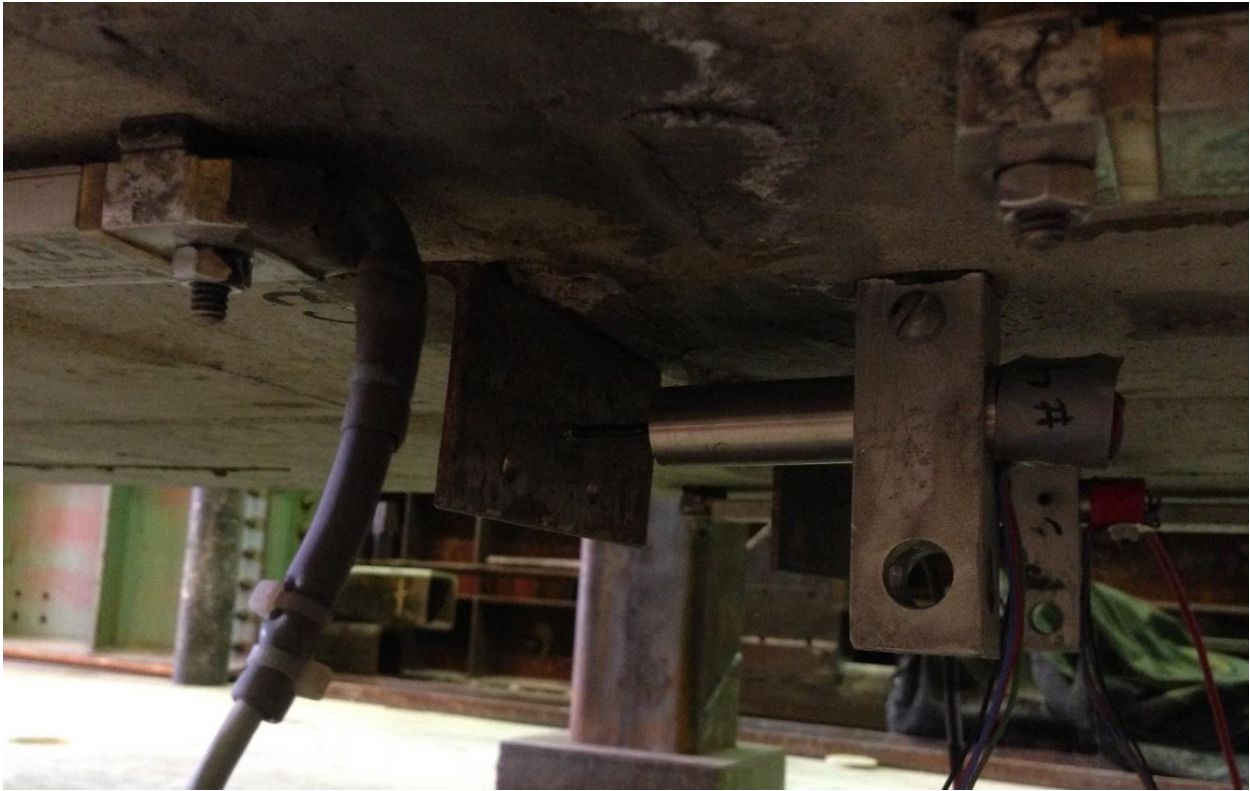
**Figure 22. Crackmeters and strain transducers near the joint on the underside of a specimen**

Figure 22 shows the crackmeters and gauges near the joint on the underside of a specimen.

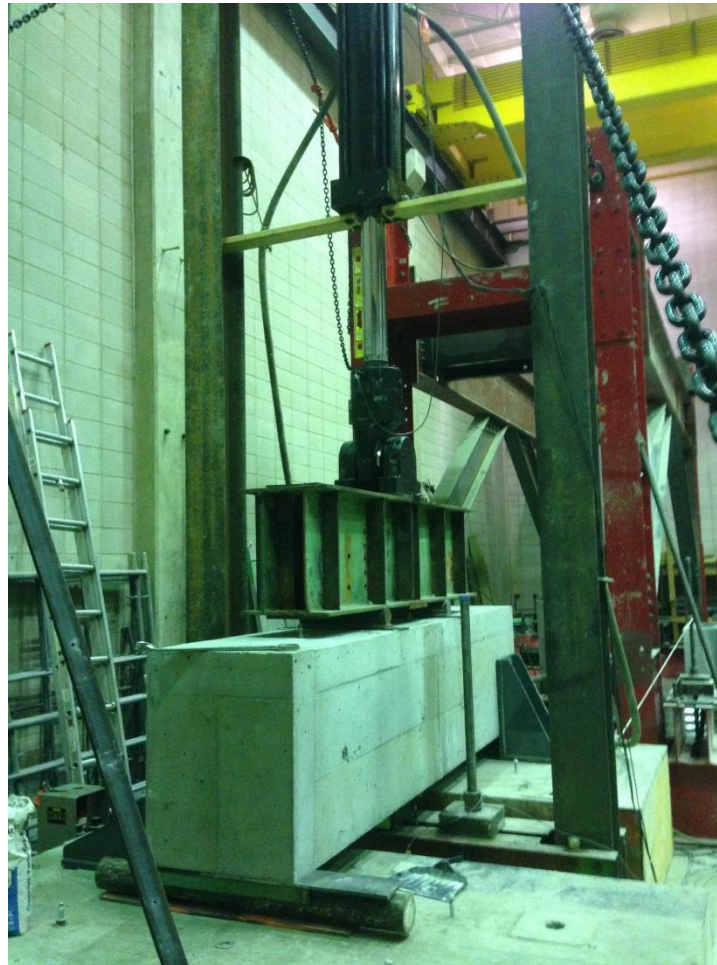
**Figure 23. Coupler specimen setup for fatigue testing**

For fatigue testing, a 225k actuator was used in the four-point bending setup ( $L/3$ ), as shown in Figure 23, along with a computer-driven hydraulic pump cycling the actuator at approximately 1 hz for 1 million cycles.

The applied load for the fatigue test was calculated assuming the recommended 18ksi reinforcing steel stress from Table 5.5.3.4-1 from the AASHTO LRFD Design Specification (AASHTO 2010) for fatigue greater than or equal to 1 million cycles. Therefore, assuming the stress in the two coupled #14 reinforcing steels to be 18ksi, the applied load was calculated to be 106.3 kip, and 106 kip was used for testing.

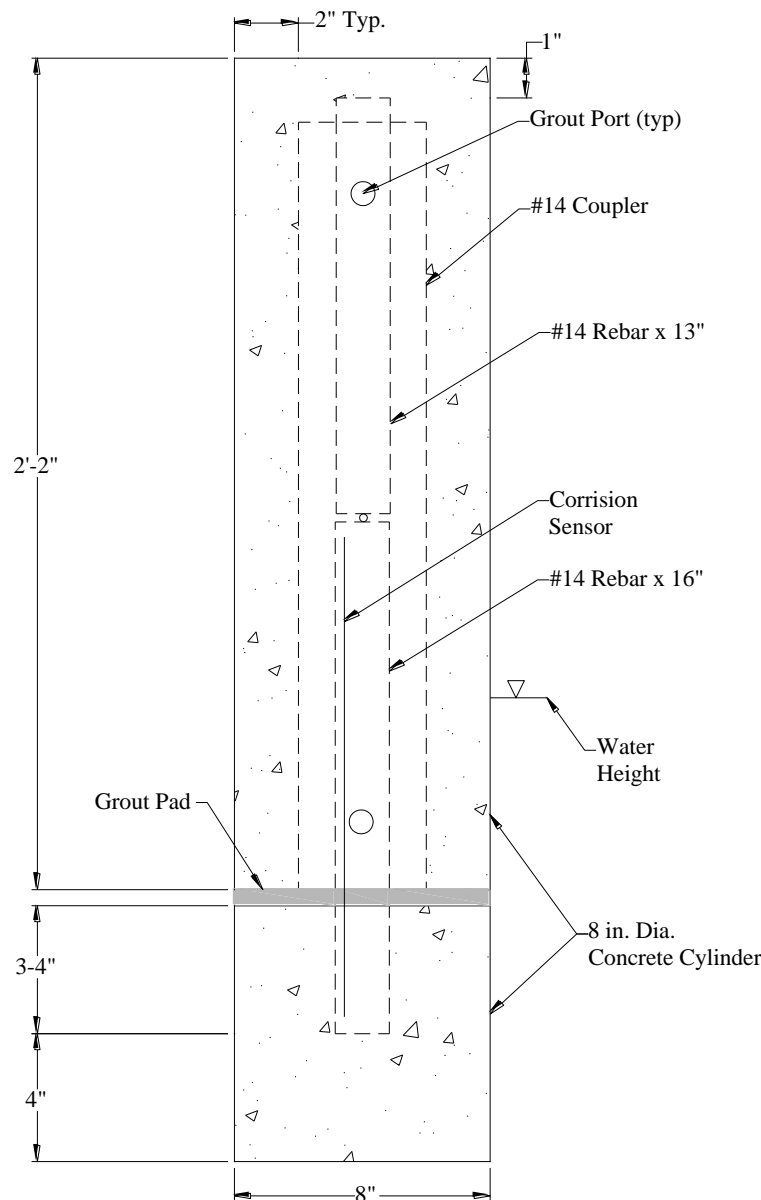
**Figure 24. Cross-section view of coupler specimens for chloride penetration tests**

In addition to the structural testing of the grouted joint, several small specimens were cast to evaluate the chloride penetration resistance of an un-cracked coupled joint. Figure 24 provides a cross-section view of the coupled specimens used for chloride penetration testing.

All three specimens included a full-sized #14 grouted reinforcing steel coupler, just as were used in the large specimen, and the grout bed and grouting of the couplers was the same as that used on the first three large specimens and the Keg Creek Bridge. The grouted couplers were cast into an 8 in. diameter sonotube to provide a minimum of 2 in. of clear cover around the circumference of the coupler. Another 8 in. diameter cylinder with a protruding #14 bar was then grouted to the section with the coupler.

Three additional small specimens were cast, each with one #14 grouted coupler cast into an 8 in. diameter sonotube to provide a minimum of 2 in. of clear cover around the circumference of the coupler. Another 8 in. diameter cylinder with a protruding #14 bar was then grouted to the section with the coupler. The reinforcing steel in these three specimens were outfitted with corrosion wire and submerged in a 3 percent chlorine bath to just above the grouted joint. The specimens were allowed to soak for approximately 6 months with periodic readings taken on the corrosion wire. Because the grouted joints were uncracked, and the reinforcing steel was epoxy coated, no evidence of corrosion was seen during the testing of these specimens.

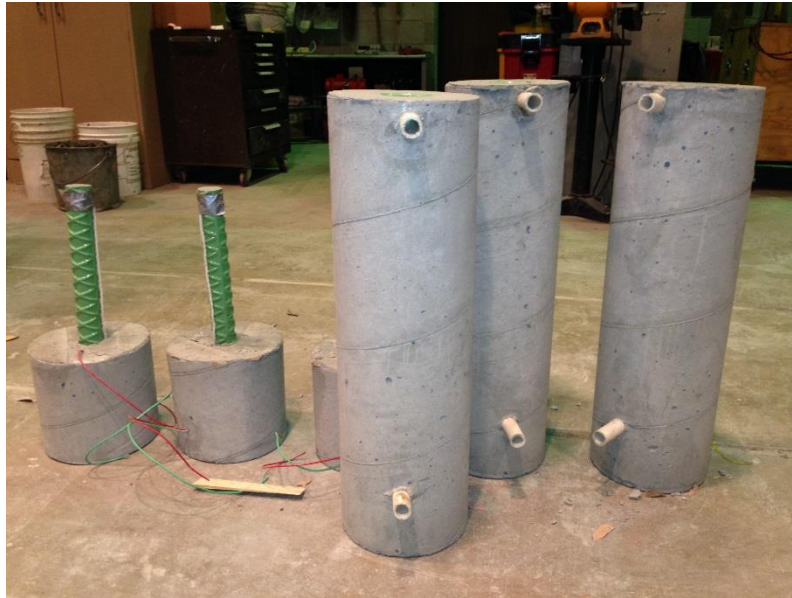
**Figure 25. Small grouted coupler specimens prior to grouting**

Figures 25 and 26 show specimens before and after grouting, respectively.

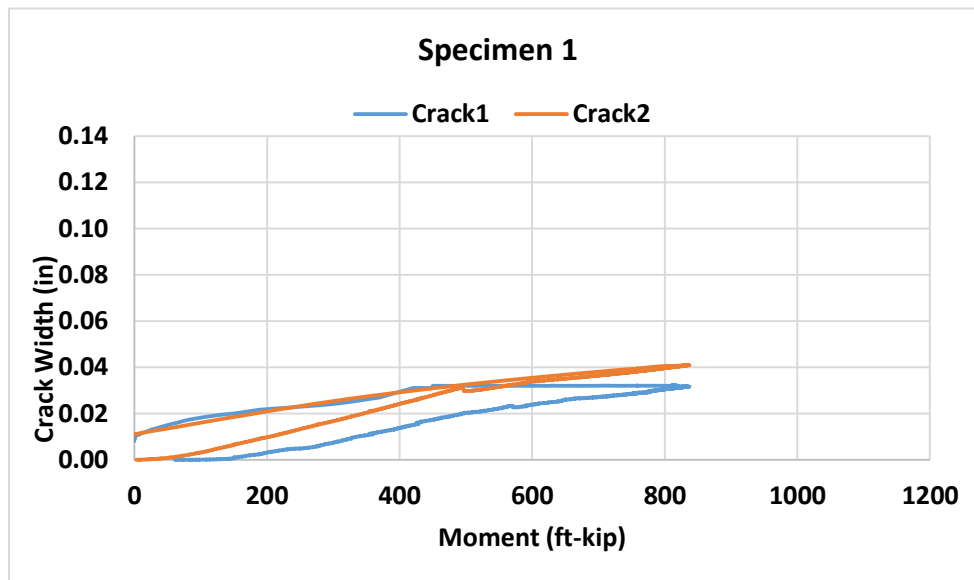
Figure 27. Moment versus crack width for Specimen 1

Initial static testing of the grouted coupler specimens was completed on Specimens 1 through 3, with each loaded in four-point bending to approximately 360 kips. As previously mentioned, the load configuration for the first specimen was span length (L) divided by 2 ( $L/2$ ), as shown in Figure 16. Figure 27 illustrates the moment versus crack width for Specimen 1, with the moment being the calculated moment at the joint.

The crack width was measured by the two crackmeters, labeled Crack1 and Crack2, on the underside of the specimen.

Specimen 1 and 3 both exhibited good closure of the crack after removal of the load. The Specimen 2 crack width did not close as much after unloading, although this is believed to be the result of the sustained peak load on this specimen. Peak load was temporarily maintained on

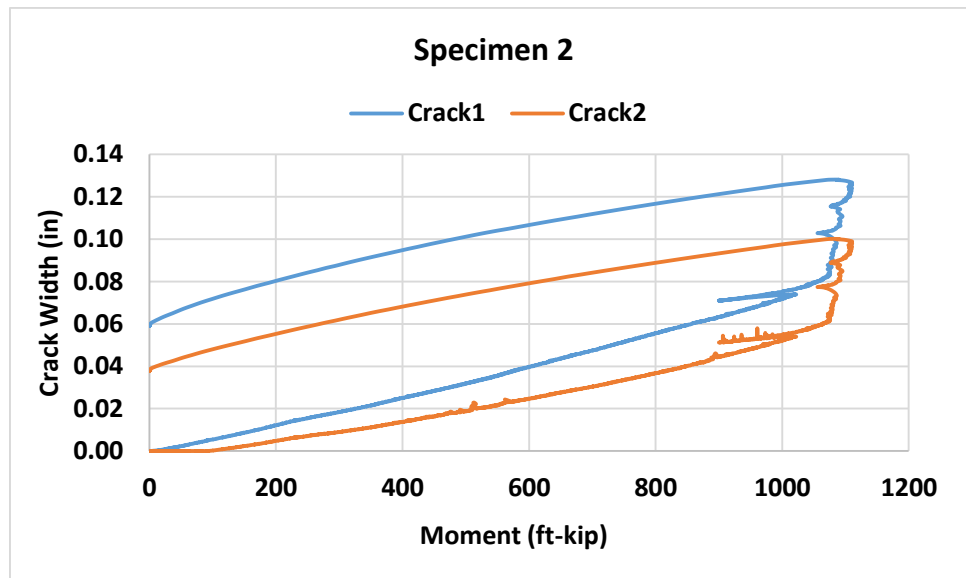
**Figure 28. Moment versus crack width for Specimen 2**

After testing the first specimen, the research team decided to shift the four-point loading from  $L/2$  to  $L/3$  to increase the moment on the joint. This decision was made in attempt to widen the crack at the joint and evaluate if it closes after removal of the load. Subsequently, Specimens 2 and 3 were tested in this configuration and the results are shown in Figures 28 and 29, respectively.

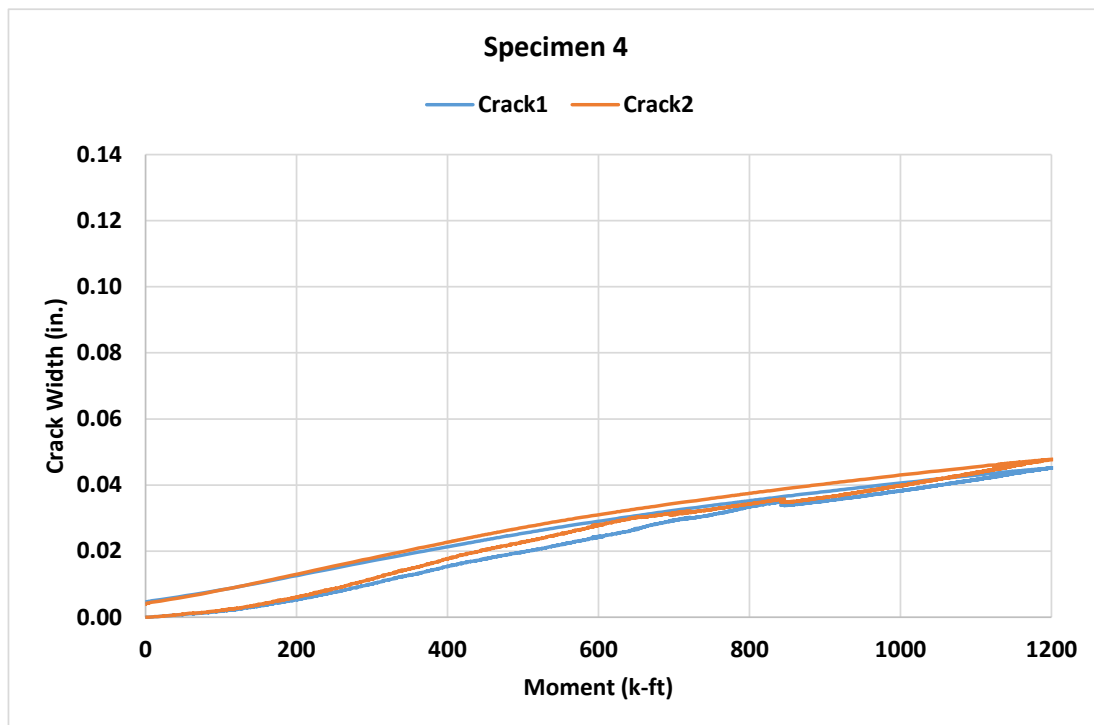
**Figure 30. Moment versus crack width for Specimen 4**

Following the testing of Specimens 1 through 3, Specimens 4 and 5 were instrumented and tested with an applied axial load to better represent the in-service connection detail at Keg Creek (Figure 19). Both of these specimen were loaded using the L/3 test configuration. Figures 30 and 31 show the moment versus crack width data for Specimen 4 (54k axial load) and Specimen 5 (115k axial load), respectively.

From Figures 30 and 31, it is evident that the axial loads applied to Specimen 4 and 5 only slightly decreased the crack width at the peak load when compared to Specimens 1 through 3, although there is an improvement of approximately 50 percent in the residual crack width once the load was removed.

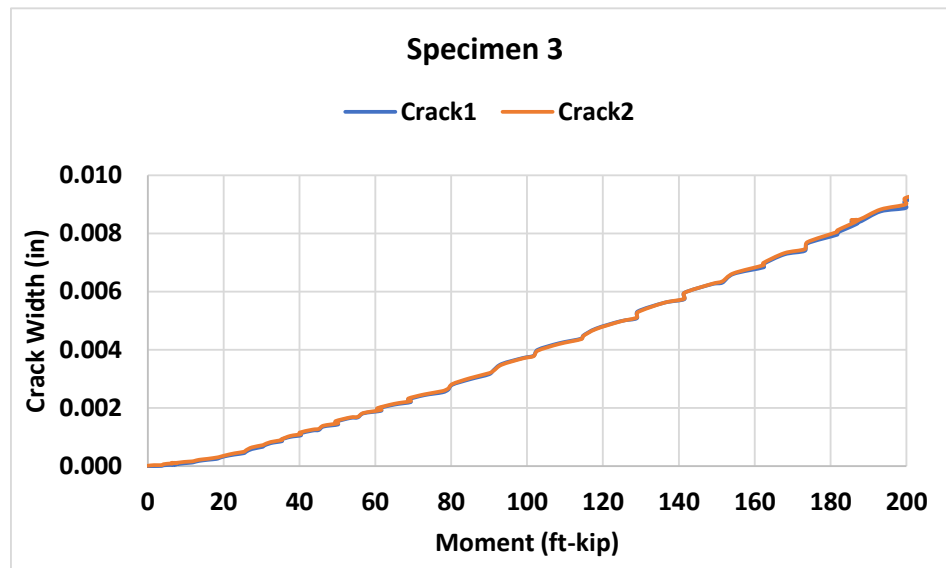
**Figure 32. Typical initial crack width for specimen with no axial load, Specimen 3**

For Specimens 1 through 5, cracking of the joint typically occurred on one of the interfaces between the existing concrete and the grout and started almost immediately after loading, as seen in Figures 32 and 33.

Essentially, the crack formed due to debonding of the grout.

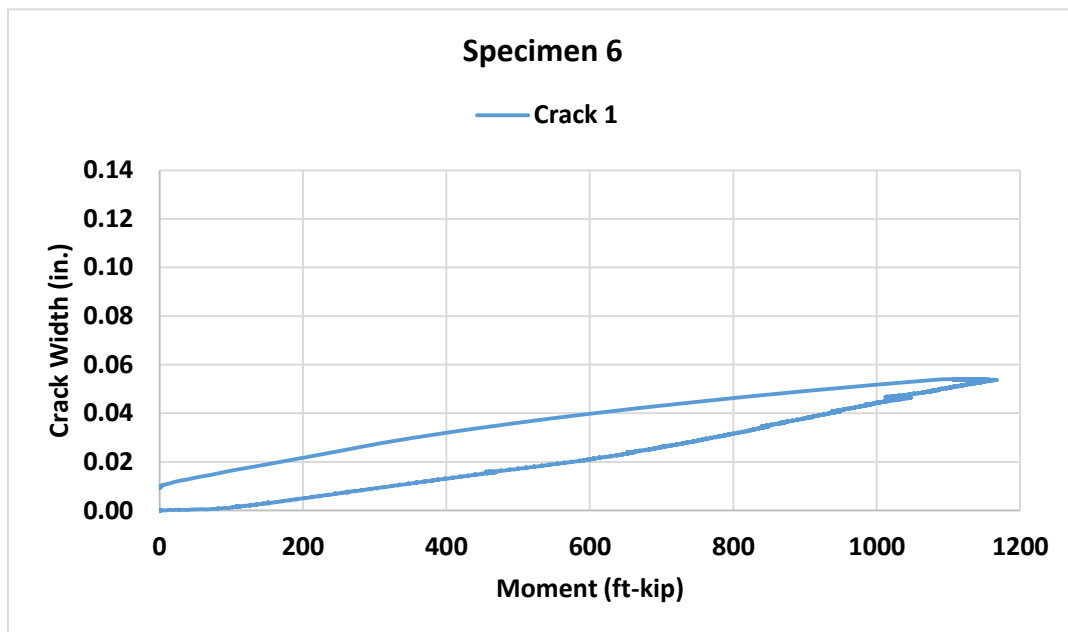
**Figure 34. Moment versus crack width for Specimen 6**

This setup of Specimen 6 allowed for a comparison of the data from Specimen 6 with data from Specimen 4 to evaluate the effect of the UHPC on the performance of the joint under loading. Note that one of the crackmeters malfunctioned during testing of Specimen 6; therefore, only data from one crackmeter, Crack 1, are presented. Figure 34 shows the moment versus crack width plot for Specimen 6.

Based on test data, initiation of the crack at the grout interface for Specimen 6 using the UHPC occurred at an applied moment of approximately 13 ft-k. This suggests that use of UHPC for the bedding grout in this application would slightly delay the initiation of cracking of the joint. However, there was no improvement in the degree to which the crack closed upon unloading or the magnitude of the crack width during loading when compared to Specimens 1 through 5.

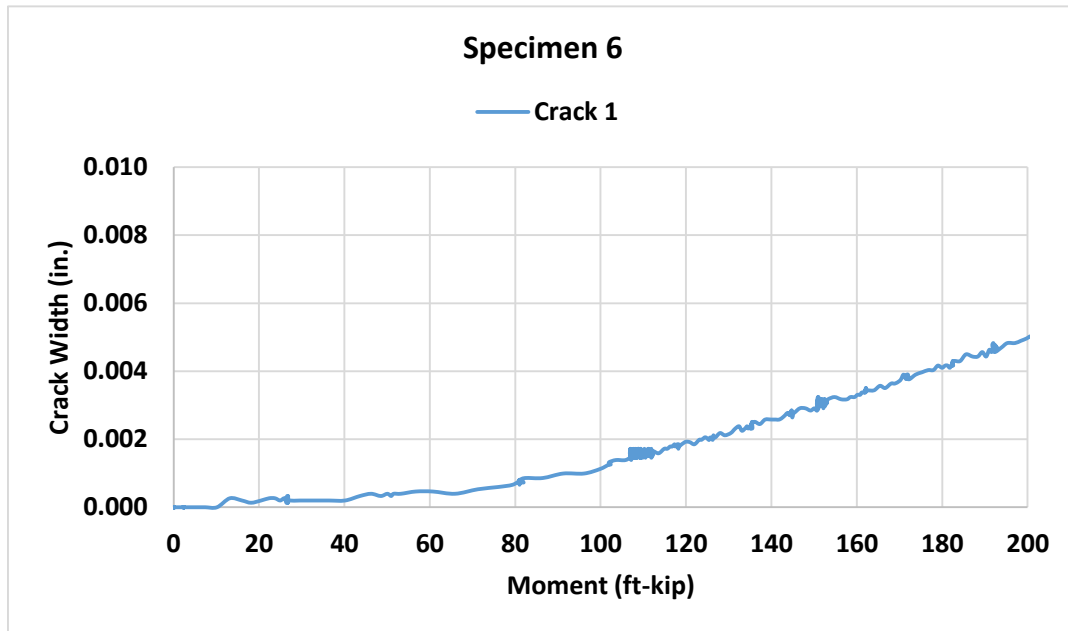
**Figure 35. Initial crack width for Specimen 6**

As shown in Figure 35, cracking of the joint on Specimen 6 appears to start with an applied moment of approximately 13 ft-k; whereas, cracking started almost immediately for the previous specimen.
