# Laboratory Investigation of Grouted Coupler Connection Details for ABC Bridge Projects

**Final Report  
August 2015**

**Sponsored by**  
Federal Highway Administration  
Iowa Department of Transportation  
(InTrans Project 12-441)

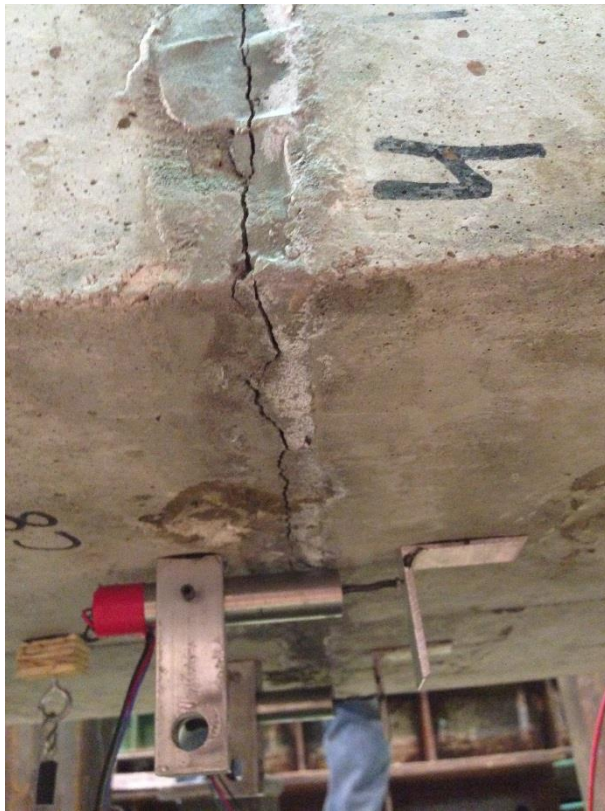
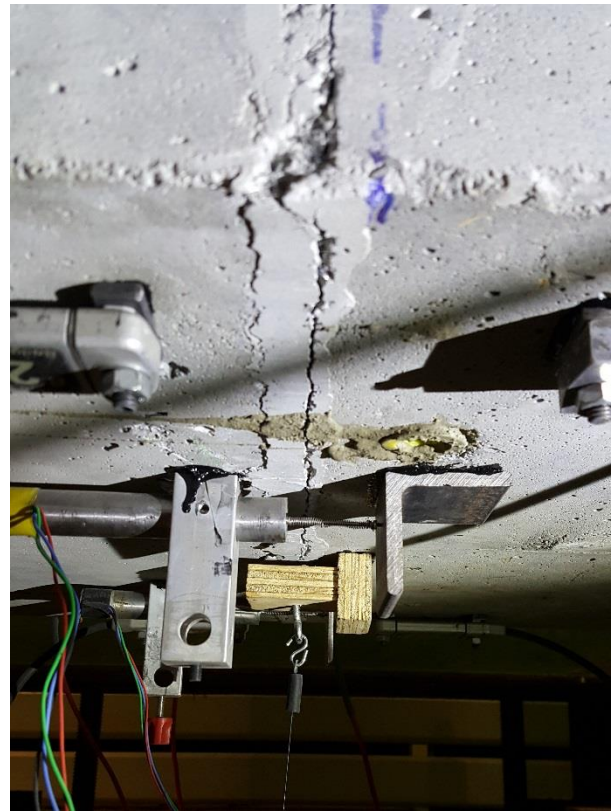
**Figure 36. Crack width comparison during loading**

Figure 36 shows a typical crack during loading of one specimen (Specimen 3) with standard grout (left) and Specimen 6 using UHPC (right).

**Specimen 3 (standard bedding grout)**

**Specimen 6 (UHPC bedding grout)**

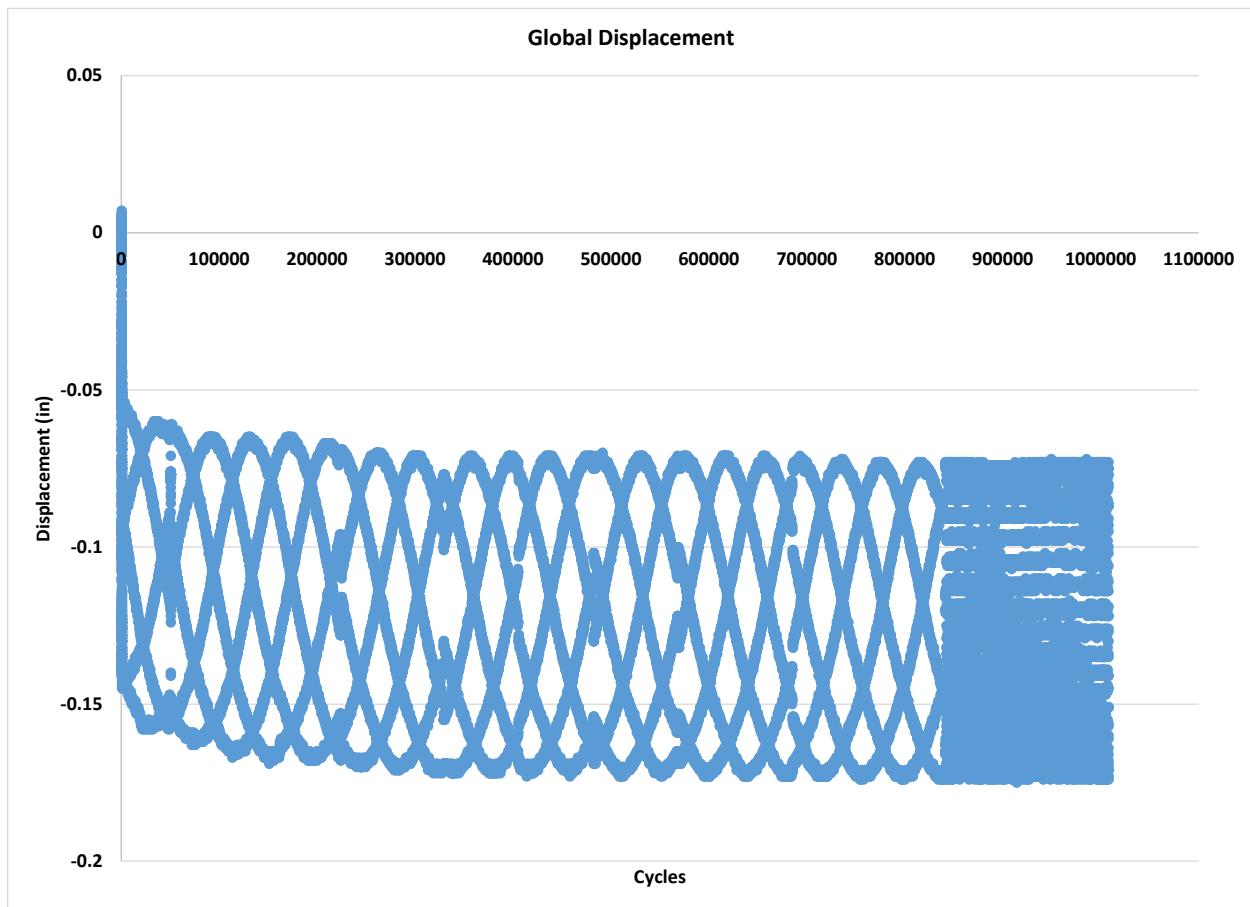
**Figure 37. Specimen 7 fatigue test – global displacement**

Specimen 7 was tested for fatigue up to approximately 1 million cycles. The fatigue test data indicated a well performing system with little to no creep in global deflection and/or crack width growth at the grouted interface throughout the duration of the 1 million plus cycles. In addition, upon conclusion of the testing, the global displacement and one working crackmeter returned to almost zero after unloading the system. Visibly, the cracks at the grouted joint were difficult to discern after removal of the load.

Figure 37 shows the global displacement versus cycles for the test.

The last specimen, Specimen 7, was tested in fatigue to approximately 1 million cycles using a point load of 106 kips. This was the point load calculated to produce the 18 ksi stress in the coupled #14 bars specified by the AASHTO LRFD Specification (AASHTO 2010). The fatigue test data indicated a maximum global displacement of approximately 0.18 in., which was consistent throughout the duration of the testing. Likewise, the crack width at the grouted interface remained relatively constant during the 1 million cycles and never exceeded 0.02 in.

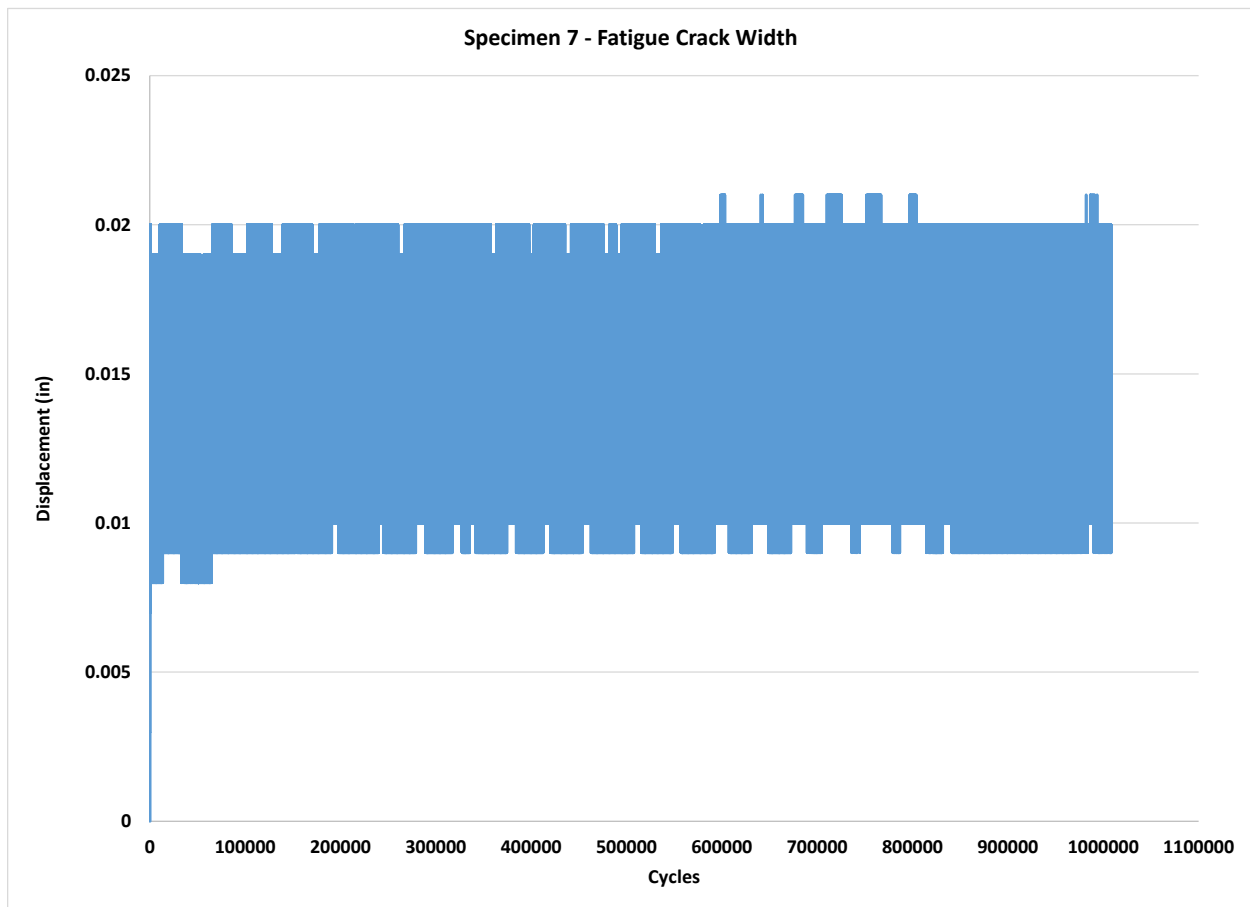
**Figure 38. Specimen 7 fatigue test – crack width**

Figure 38 shows a typical crack width versus cycles plot.

Note that maximum crack width measured during the fatigue testing, approximately 0.02 in., was more than half of that measured during static testing, which would be expected given the reduced loading.
