Crack Development in Ternary Mix Concrete Utilizing Various Saw Depths

Final Report
February 2009

Sponsored by
the Iowa Highway Research Board
(IHRB Project TR-587)
and
the Iowa Department of Transportation
(CTRE Project 08-317)

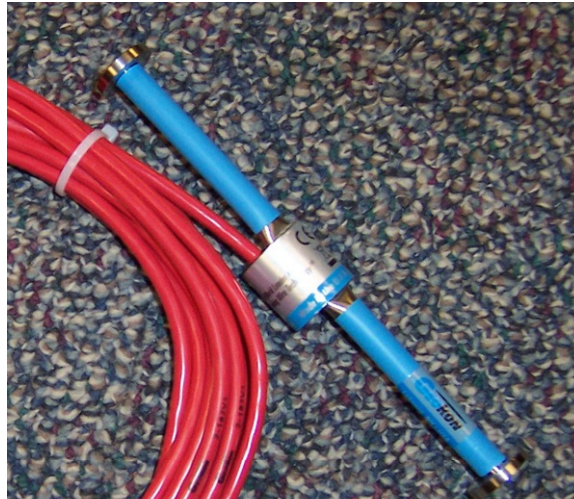
Figure 2. Geokon 4200 vibrating wire strain gage

The 4200 VW strain gage has a 152 mm gage length and a 1 micro-strain ($\mu\epsilon$) sensitivity and is commonly used for strain measurements in foundations, piles, bridges, dams, tunnel linings, etc. Detailed specifications, according to the product manual from the manufacturer (Geokon 2008a), can be found in Table 1.

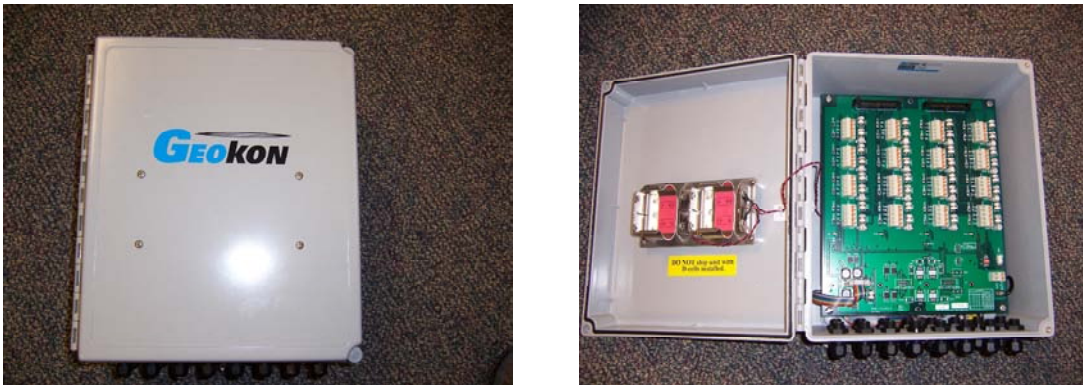
(a) LC-2X4

(b) LC-2X16

Figure 4. LC-2 4-channel and 16-channel data logger

Upon deciding the type and number of strain gages, a data logger was chosen accordingly in order to store the strain reading from strain gages. A Geokon model LC-2X16 16-channel data logger and a model LC-2X4 4-channel data logger were chosen based on the strain gages' layout, number of channels, price, and size of memory. The data loggers are shown in Figure 4.

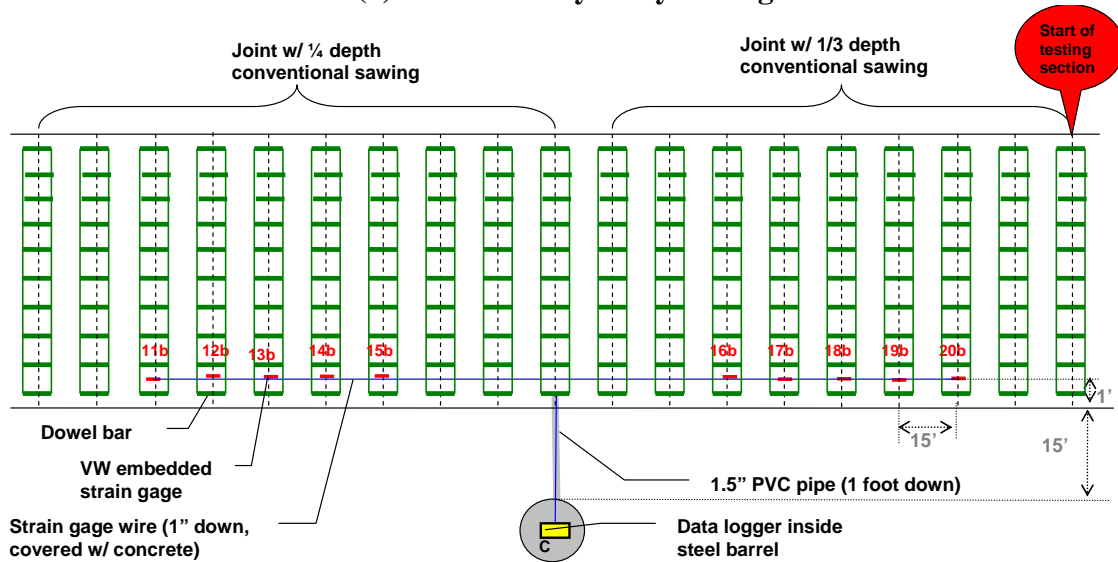
(a) Part I – Early entry sawing

(b) Part II - Conventional sawing

Figure 7. Floor plan of strain gage setup

In order to avoid disturbance/damage from possible external forces during concrete paving and to ensure the correct orientation, the concrete embedment strain gages were installed prior to the concrete placement. As shown in Figure 8, two short pieces of steel rebar were tied to the existing dowel bars using nylon tie-wraps. The strain gages were then tied to the short pieces of rebar, again using nylon tie-wraps. The gages were located approximately at the middle height of pavement thickness (4 $\frac{3}{8}$ in.). Special care was paid to ensure that the strain gages are located across the joints and lined up perpendicular to the joints.

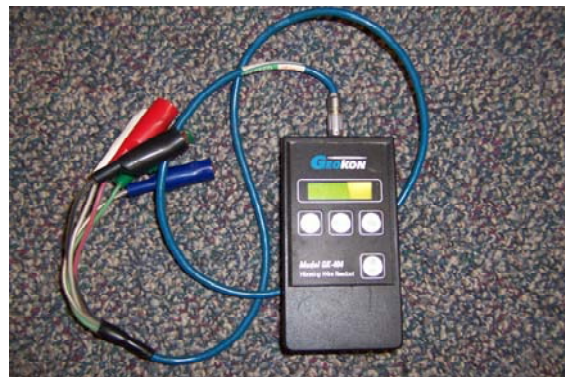
Figure 9. CK-404 vibrating wire readout

Prior to connecting the strain gages to the data loggers, an initial strain reading, a “zero reading,” was taken using the CK-404 vibrating wire readout on each of the gages in order to ensure the proper functioning of the gages (Figure 9). The readings provide necessary voltage pulses to pluck the wire and convert the measured frequencies so as to display the reading directly in micro-strain units ($\mu\epsilon$). The results indicated that all gages but one were working properly after installation.

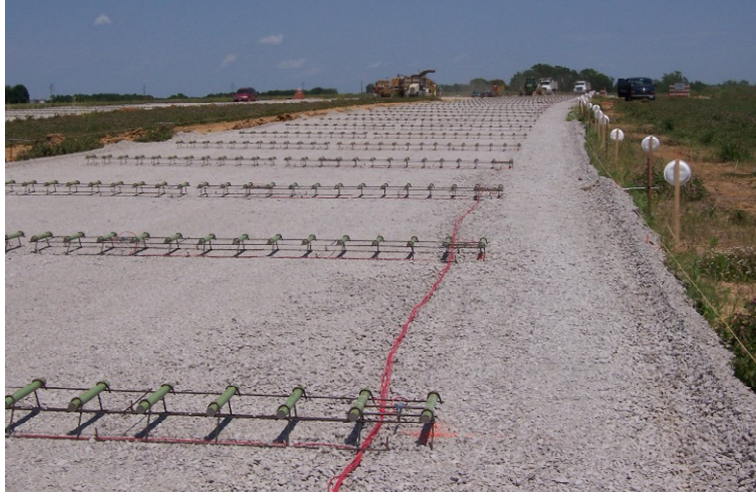
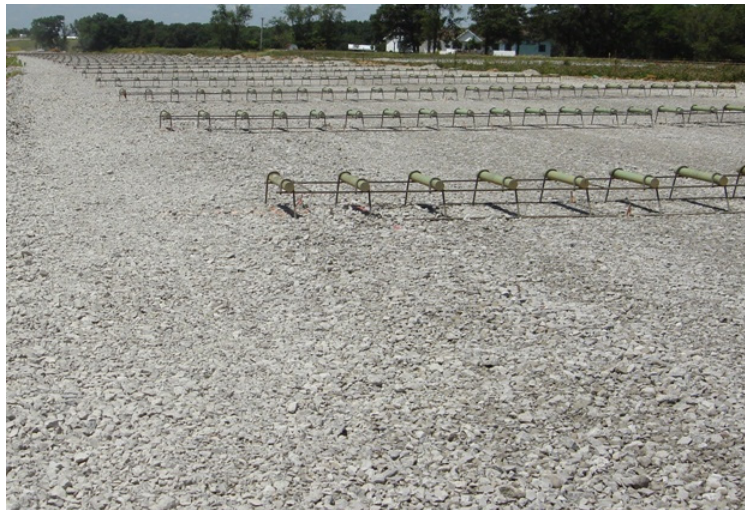
(a) Arrangement of strain gages and cables

(b) Cables after installation

Figure 10. Setup of cables for strain gage

Depending on the location of the strain gages, the length of the cable for wiring the gages to the logger ranges from 35 to 175 ft. The information about lengths of cable for individual strain gages can be found in Table A.3 in Appendix A. In order to protect the cable from damage during concrete paving, all cables running underneath the pavement, as shown in Figure 7, were buried inside small trenches approximately one inch deep. The cable from the strain gages located 11 ft away from the pavement edge were run inside the dowel baskets and met with the cable over the edge of the pavement. The trenches were then backfilled so that the cables were completely buried. Pictures of the cable setup can be found in Figure 10. It appeared that there was no obvious disturbance on the base surface caused by the installation of the strain gages and cables.

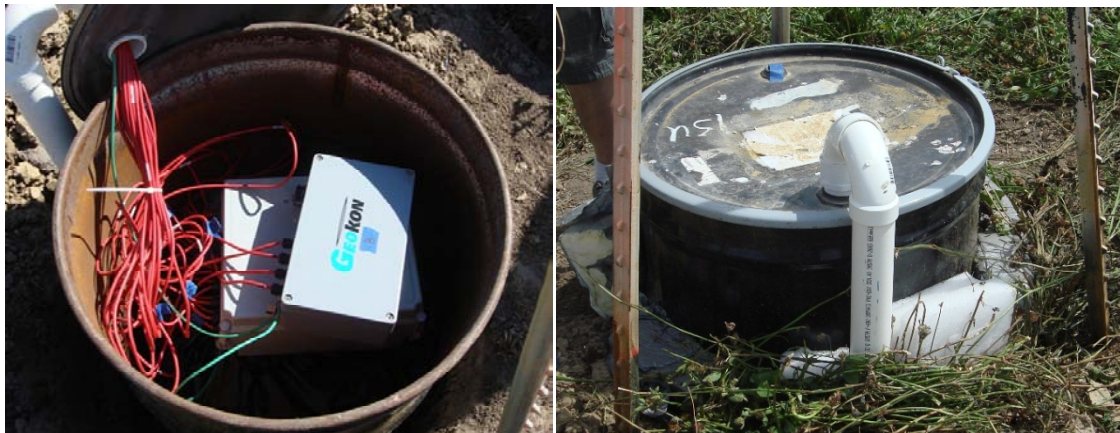
Figure 11. Setup of data loggers

“U shape” tube to protect them from damage and prevent water getting inside the barrels. Both steel barrels were half-buried and locked for security reasons (Figure 11).

All strain gages were lightning protected through a ground connection made possible by the earth grounding of the data loggers (as shown in the green cables in Figure 11). Grounding cable was used to divert the energy from a lightning strike safely to ground. The grounding rod was driven as close to the data logger as possible and to a depth of approximately three feet. A copper grounding lug was supplied on the exterior of the LC-2X16 and LC-2X4 enclosure to provide connection to this wire from the grounding cable.

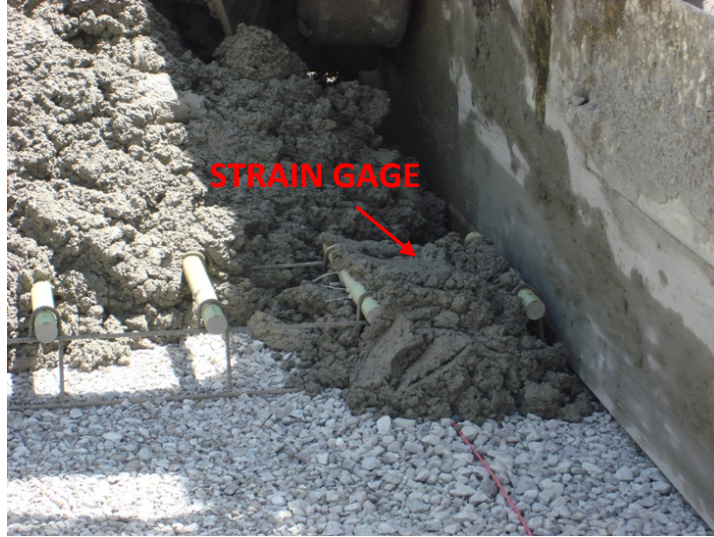
Figure 12. Strain gages during paving

The test section was paved on June 23, 2008 in the afternoon. The paving time through each joint was recorded and is shown in Table A.4 in Appendix A. The strain gages and cables during paving are shown in Figure 12. It appeared that both strain gages and cables were well protected against the paving process. The air content was also measured on site during paving: air contents of 9.6% and 6.9% were recorded before and after paving, respectively.

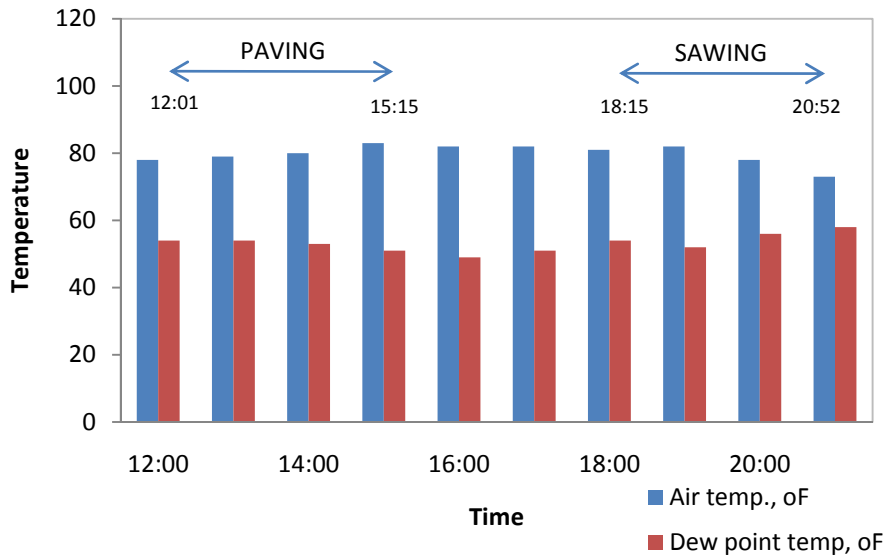
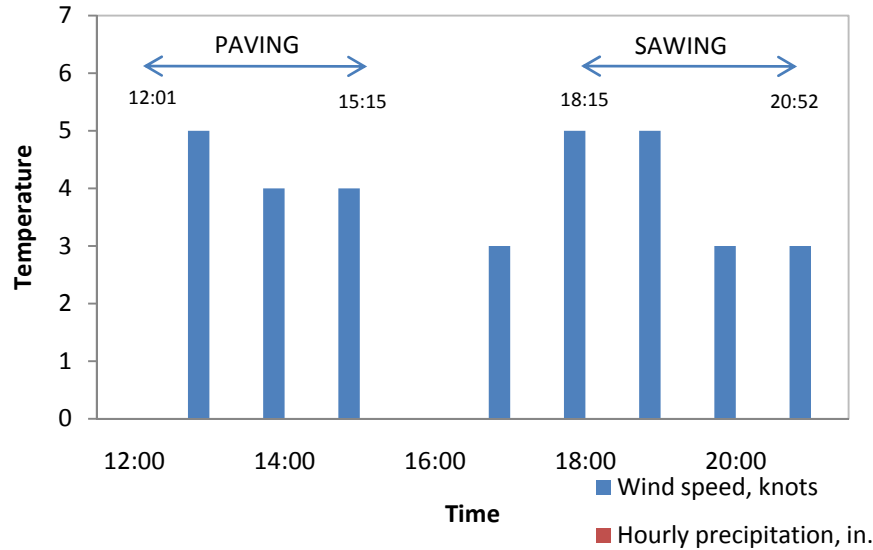
Figure 13. Weather condition during paving and sawing

Figure 13. Weather condition during paving and sawing (continued)

The weather profile of the paving site was obtained from Iowa Environmental Mesonet (IEM) of the Iowa State University Department of Agronomy. The data was accessed by Automated Weather Observing System (AWOS) sensors managed by the Iowa DOT. Weather data from a weather station at latitude 41.05 and longitude -91.98 located in Fairfield, Iowa, was used in the present study. The weather information during paving and sawing is shown in Figure 13. It appeared that, due to the summer construction, the air temperature remained relatively high, while wind speed was negligible and no precipitation was observed during the paving and sawing period.

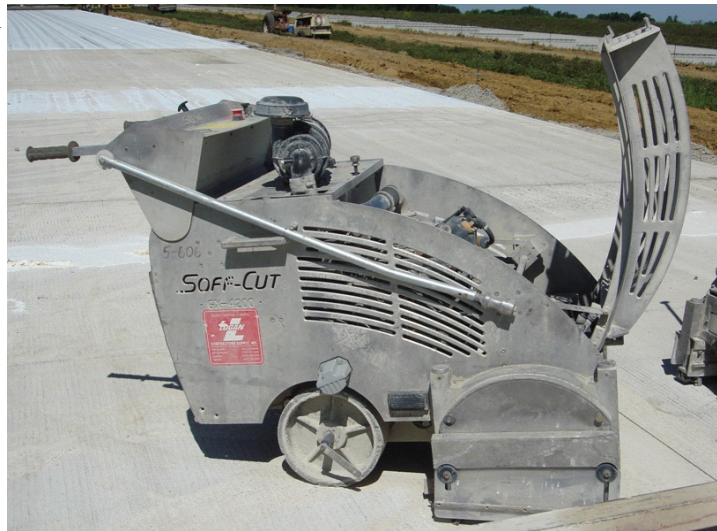
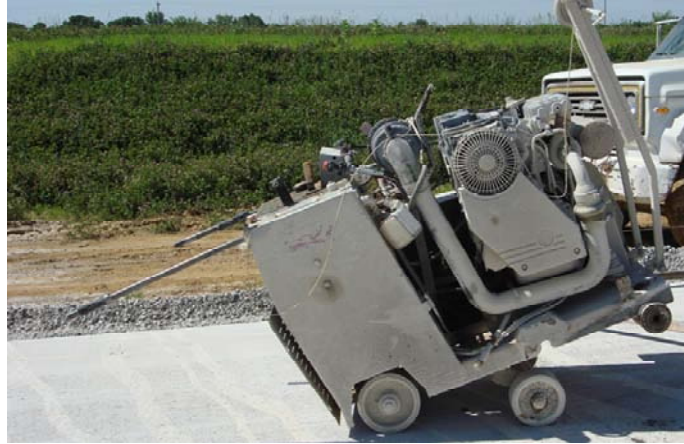
(a) Early entry sawing

Figure 14. Sawing equipment

(b) Conventional sawing

Figure 15. Sawing equipment (continued)

In order to compare the effect of different sawing types and depths, two different types of sawing equipment were used in this study. A GX-4200 Soff-Cut was used for early entry sawing (see Figure 14[a]) and conventional sawing with the depth of one-quarter of pavement thickness (T/4). A Diesel conventional sawing machine (Figure 14[b]) was used for conventional sawing with the depth of one-third of the pavement thickness (T/3). The sawing information regarding blade types and joint depths were provided by the contractor and are summarized in Table 3. The pavement joints with

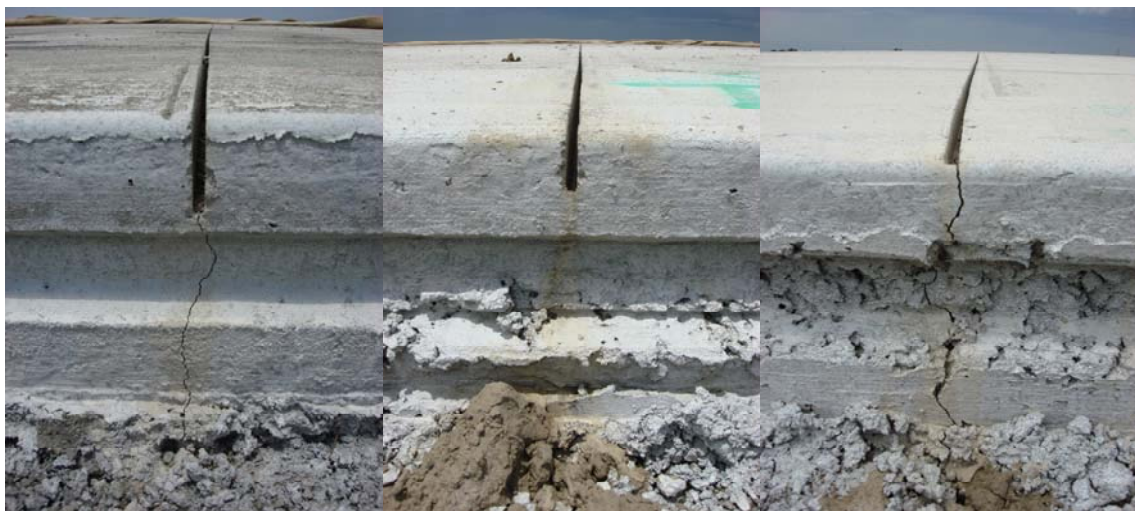
(a) T/3

(b) T/4

Due to the differences in joints and sawing machines, joints were sawed at different periods after paving. The early entry sawing was performed at approximately 5.1 hours after paving, and the conventional sawing was performed a little later, at approximately 6.6 hours after paving. More detailed sawing information can be found in Table A.4 in Appendix A.

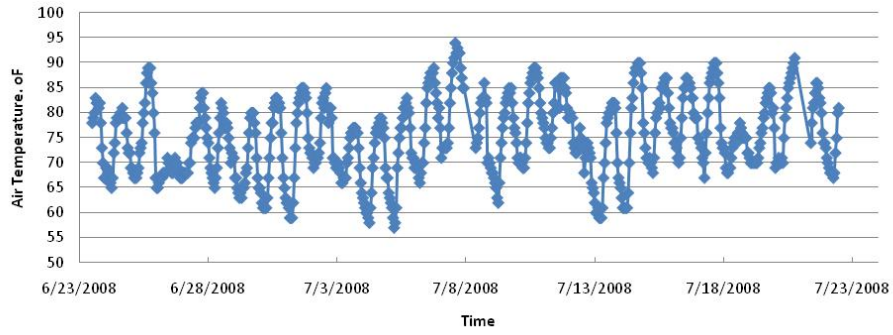
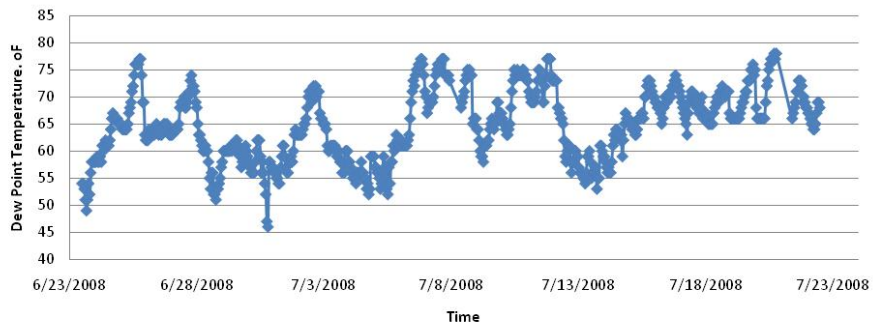
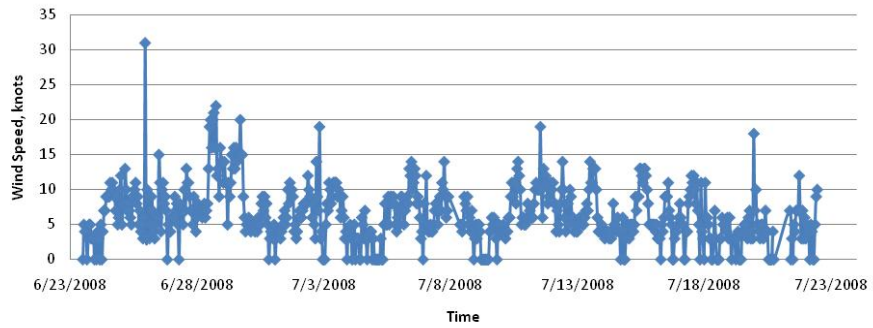
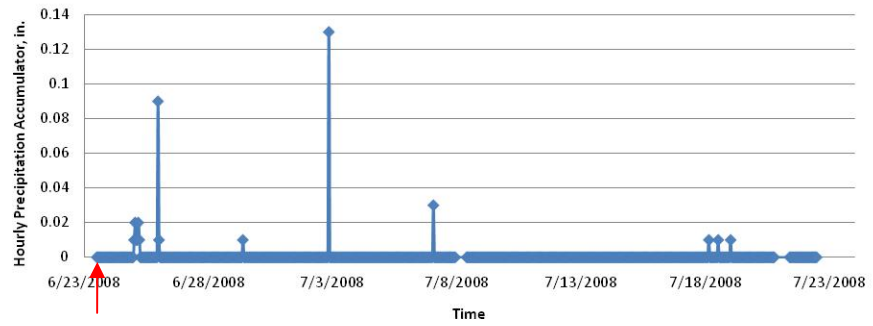
TEST SECTION PAVED

Figure 17. Weather profile of paving site

As mentioned above, the weather profile of the paving site was obtained from IEM of the Iowa State University Department of Agronomy. The weather profiles of the first 30 days after paving are shown in Figure 17. The daily high and low temperature profiles for the first 30 days after paving show that the temperatures were in a band of 55 °F to 95 °F and were cycling between daytime and nighttime relatively constantly. The difference between the low and high peaks of a cycle can be up to 30°F, which might have significantly affected the joint cracking development and pavement deformation, while a relatively low wind speed and precipitation accumulation should not have had a major effect.

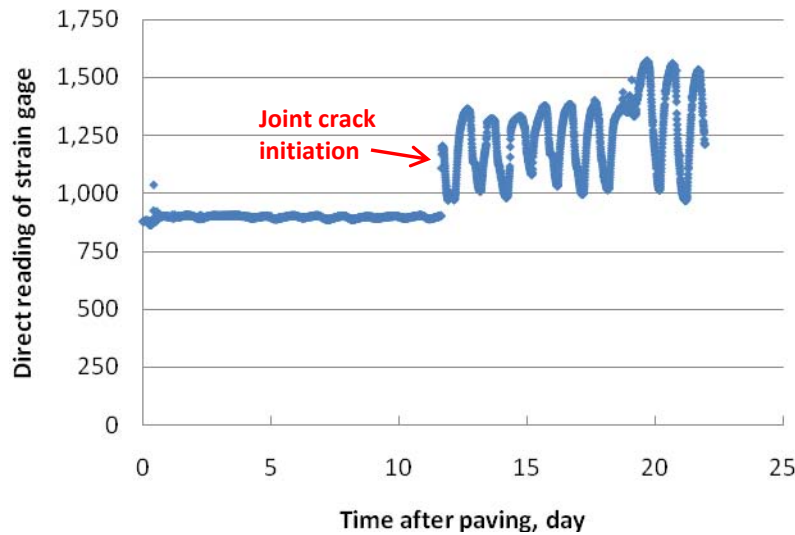
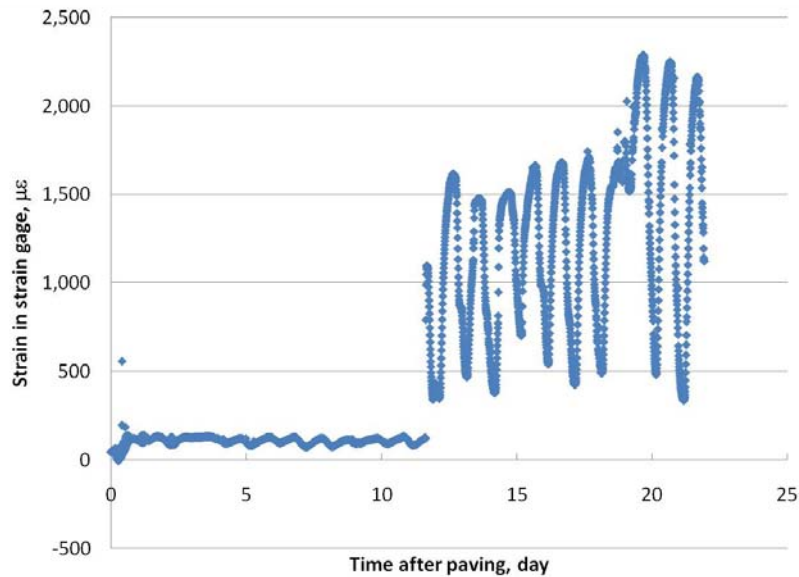
(a) Direct reading from strain gage

Figure 18. Example of strain calculation (Joint 7)

(b) Calculated strain in strain gage

Figure 19. Example of strain calculation (Joint 7)

By using Equation 6, the true strain of the strain gages can be calculated. An example of the difference between the direct strain gage reading and the calculated strain in the gage (Joint 7, logger number B1) for 30 days after paving is shown in Figure 19(a) and (b). A zero reading of 862.0 and a temperature of 17.2°C at zero reading was used in Equation 6 for the calculation of true strain in this strain gage.

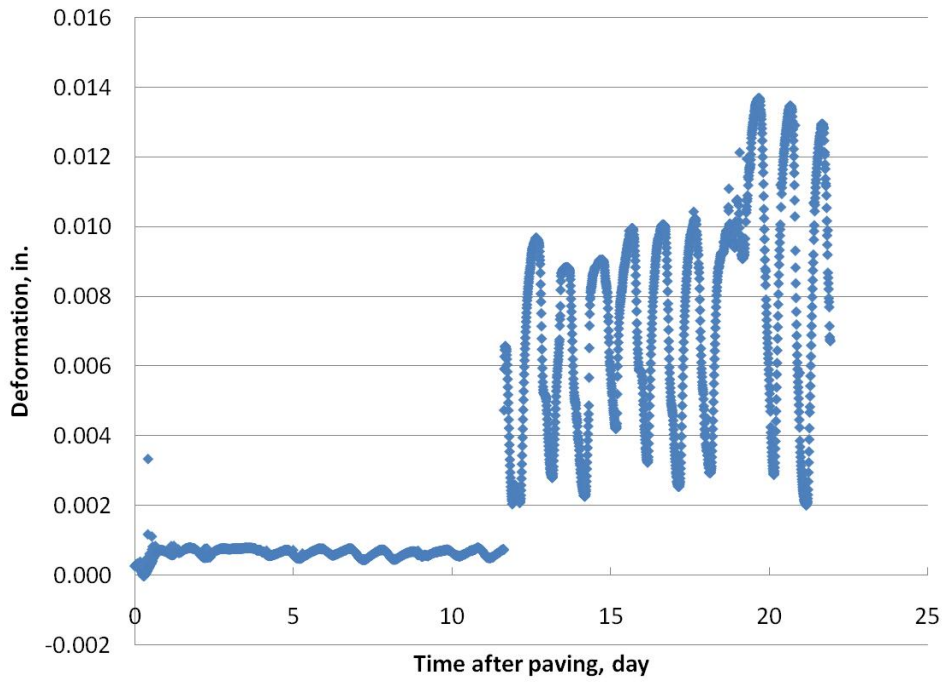
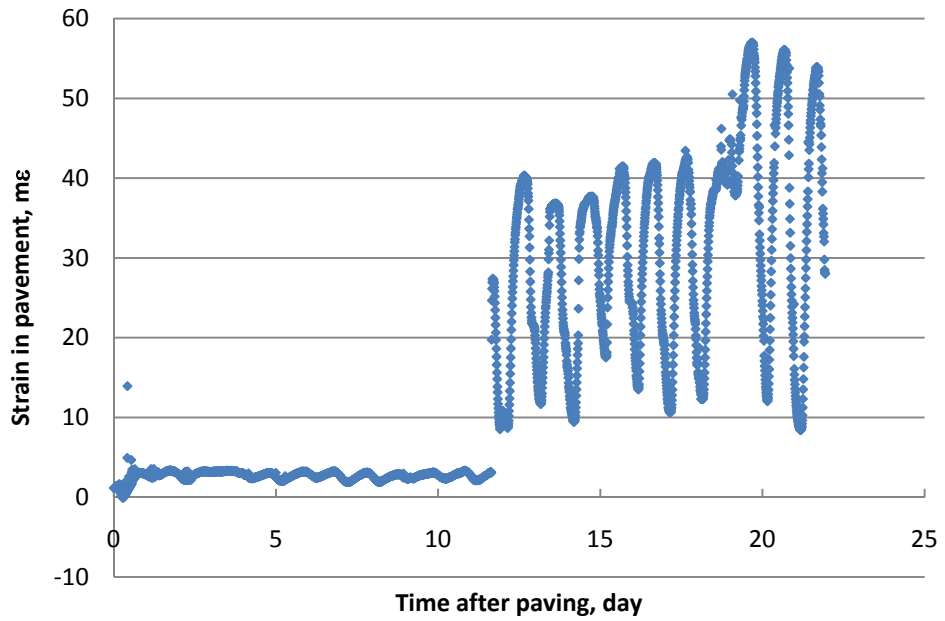
(a) Calculated deformation

(b) Calculated strain in pavement

Figure 20. Example of pavement strain and deformation calculation

The dramatic increase of the strain and deformation indicated that the strain level increases significantly during a very short period of time after paving, usually within hours. This first dramatic increase of strain and deformation inside the pavement was considered to be the initiation of joint cracking. The periodic decrease and increase of the deformation after cracking, however, is considered to be caused by the thermal deformation of the concrete slab due to daily temperature variation, which includes approximately one cycle per day. The maximum daily length change of a 20 ft long concrete slab due to thermal effect is calculated based on the temperature data, as shown in Figure 21. Based on the available temperature data, the theoretical free expansion due to the daily temperature differences can range between 0.011 and 0.033 in. The values calculated from the strain gage measurements fall in this range, as shown in Figure 20.

Based on the same procedure presented in Figure 20, the strain and deformation levels for all 30 strain gages and the corresponding pavement deformation and strain level were calculated. Examples of the deformation of a 20 ft PCC pavement slab with early entry sawing (Joint 7, logger number B1, and Joint 6, logger number A6) and conventional sawing (T/4 – Joint 13, logger number C3, and T/3 – Joint 20, logger number C10) under different periods are presented in Figure 22 and Figure 23. Results show that the strain (deformation) development generally showed two different styles: a few of the strain gages stopped taking readings after a drastic increase in strain, and most of the gages showed a cycling strain development with periodic increases and decreases. The former situation probably indicates that the crack width falls out of the strain gage measurement range, and the latter shows that the crack width fluctuation due to temperature cycling occurs in the measurement range.

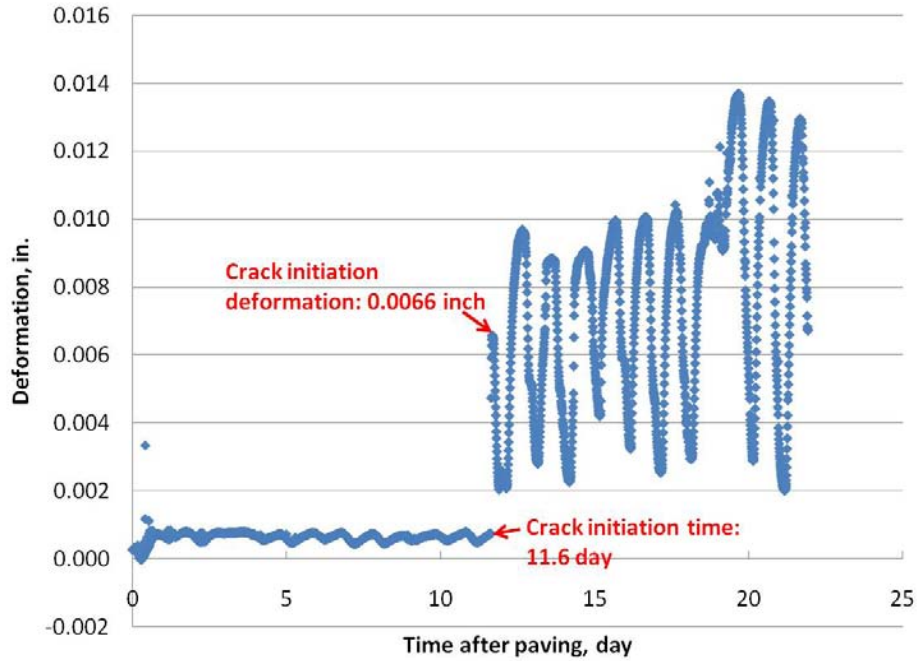
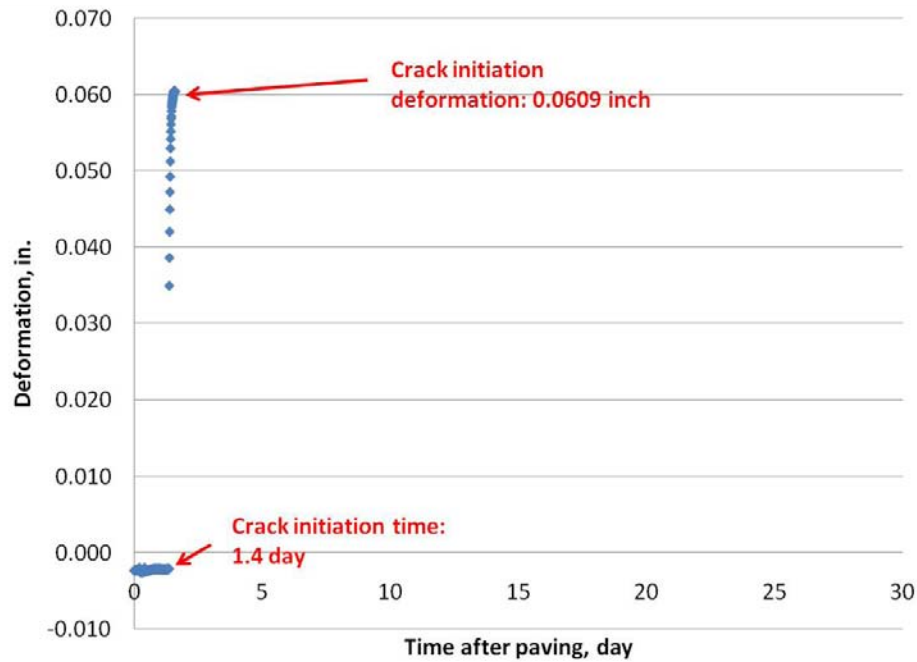
(a) Joint 7, logger number B1

(b) Joint 6, logger number A6

Figure 22. Examples of stress development of early entry sawing

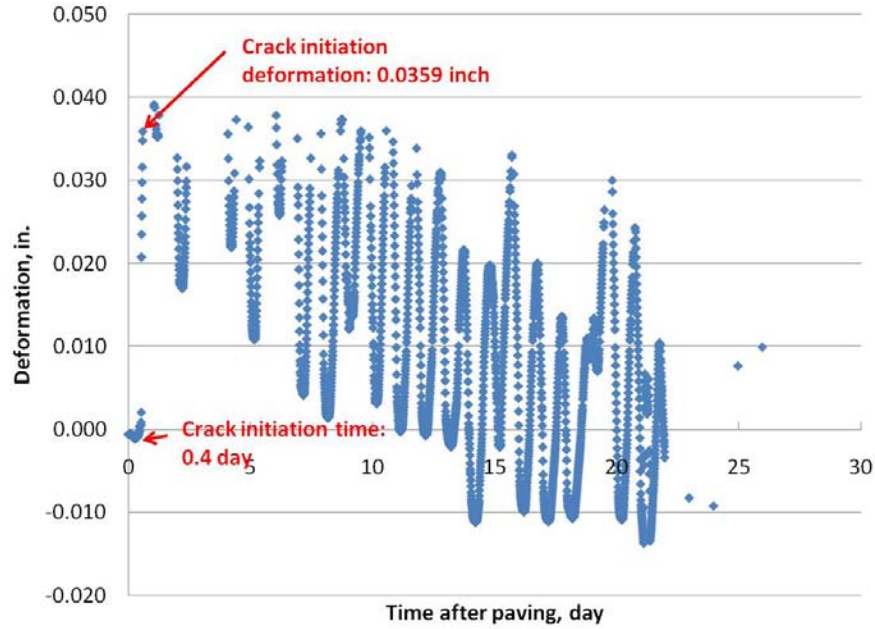
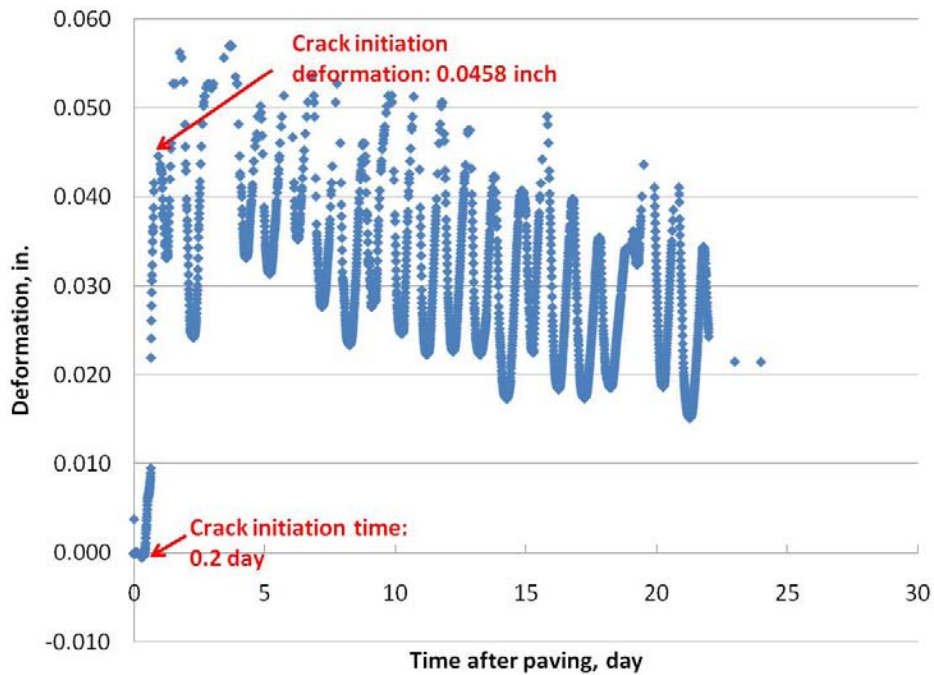
(a) Joint 13, logger number C3

(b) Joint 20, logger number C10

Figure 23. Example of stress development of early entry sawing

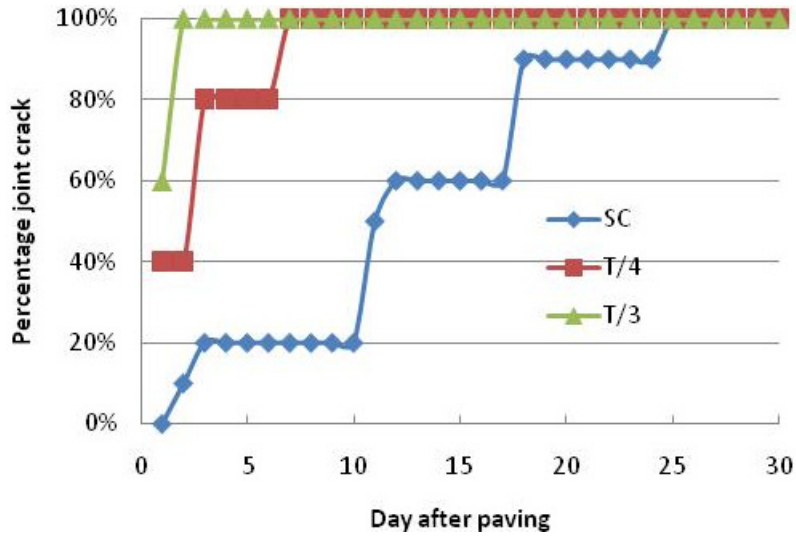
Figure 24. Percentage of joint cracking at different ages

Based on the estimation of cracking data, as shown in Table 6 and Table 7, the percentage of cracked joints at different ages was calculated by dividing the number of cracked joints by the total number of joints with certain types of sawing (5 joints with conventional sawing or 10 joints with early entry sawing). For example, two out of five joints (40%) with T/4 conventional sawing cracked within one day and two more joints cracked between one to two days, which means four out of five joints (80%) cracked within two days, and all five (100%) cracked with seven days. The results are summarized in Figure 24, which shows that most of the joints formed with conventional sawing cracked within 5 days and that the percentage reaches to 100% at less than 10 days. The figure also shows that only approximately 20% of the joints formed with early entry sawing cracked at the age of 10 days and that the percentage reaches 100% by approximately 25 days.

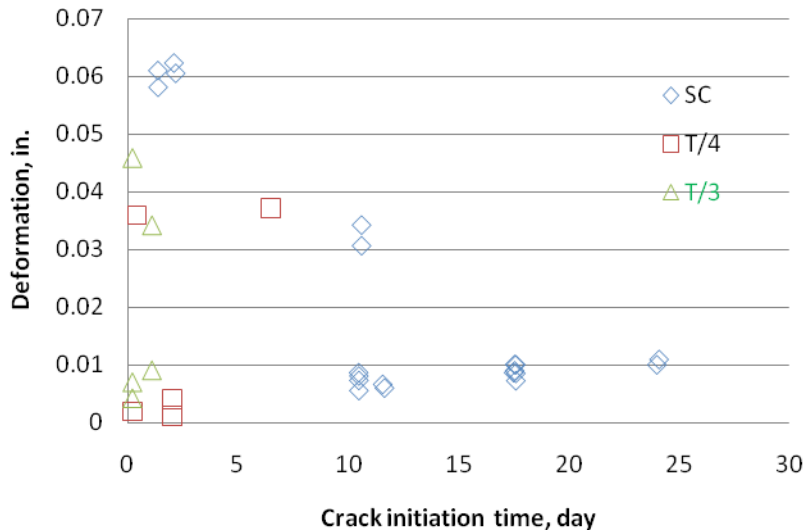
Figure 25. Relation between crack time, initiation time, and deformation at the joints

The relationship between the time of crack initiation and the deformation at that point was also studied. The results, as shown in Figure 25, indicate that, in early entry sawing, early cracking is usually associated with a higher deformation level, which is reasonable because a higher concentration of stress should likely result in an earlier crack initiation. However, no obvious relation between deformation and time of crack initiation was found in the joints formed with conventional sawing.
