Laboratory Investigation of Bridge Strip Seal Joint Termination Details

Final Report
February 2016

IOWA STATE UNIVERSITY
Institute for Transportation

Sponsored by
Federal Highway Administration
Iowa Department of Transportation
(InTrans Project 14-502)

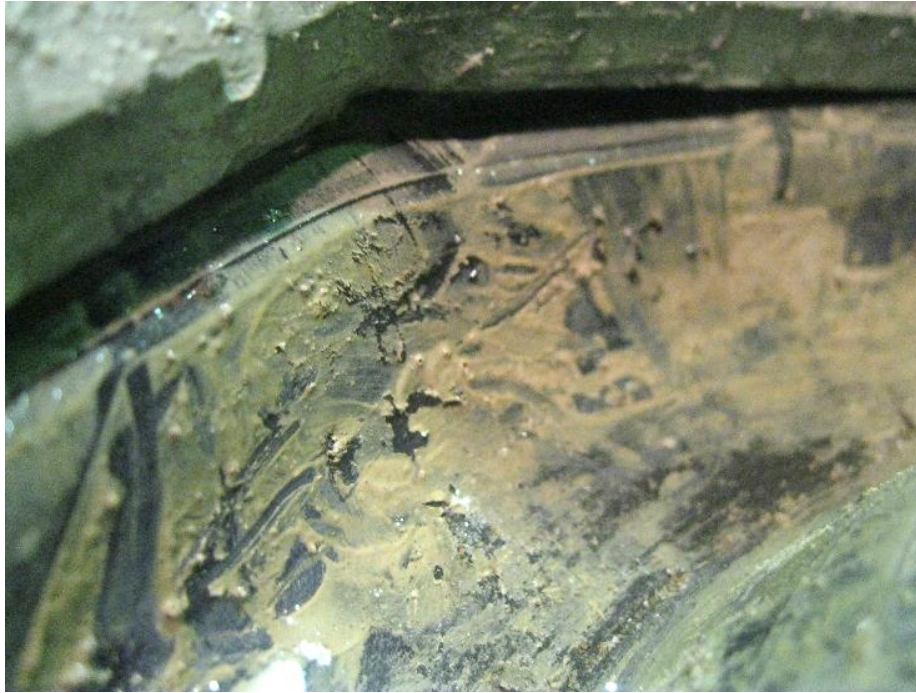
Figure 55. Improper gland installation causing leak in Watson Bowman Acme dogleg specimen

In the laboratory, the Watson Bowman strip seal straight-through detail passed the ponding test, while the Watson Bowman dogleg detail did not. The dogleg detail did not pass any of the ponding tests performed after multiple attempts to install the gland properly. The dogleg bend in the metal extrusion was too sharp for the gland to be properly installed into the extrusion, which caused water to leak through the gland/extrusion/joint.

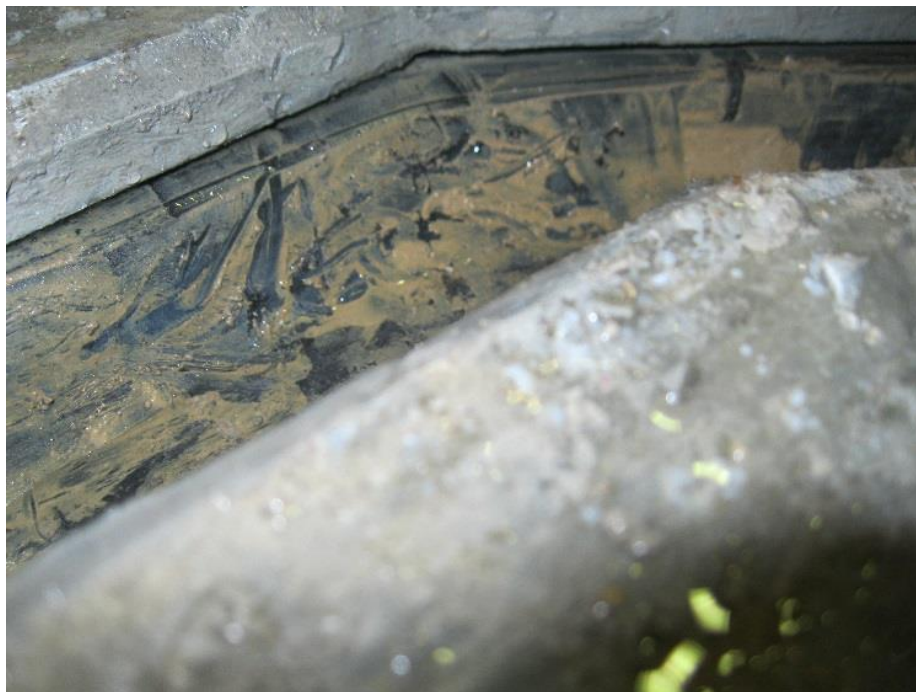
Figure 56. Second attempt to properly install gland in Watson Bowman Acme dogleg specimen
