Prevention of Longitudinal Cracking in Iowa Widened Concrete Pavement

tech transfer summary

June 2018

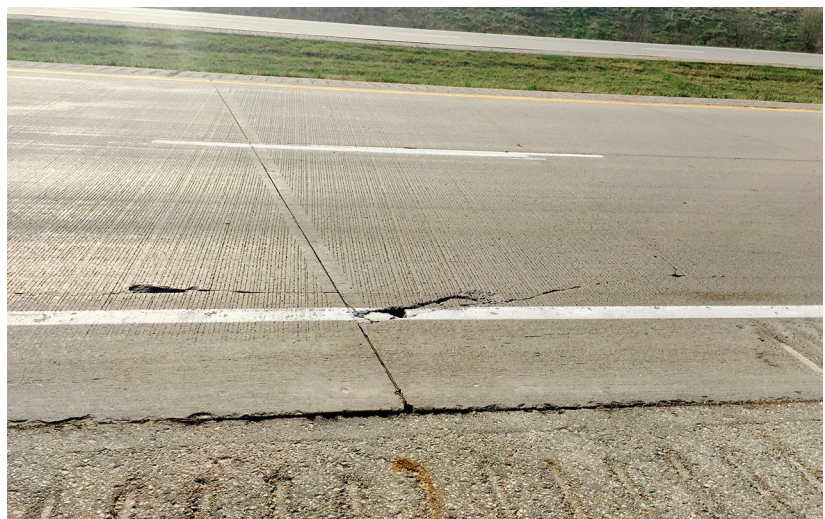
Longitudinal cracking observed in widened concrete pavement with a skewed transverse joint on US-65 in Polk County, Iowa

- Use of rectangular joint design instead of a skewed joint design is recommended.
- A tied PCC shoulder can perform better than other shoulder alternatives.

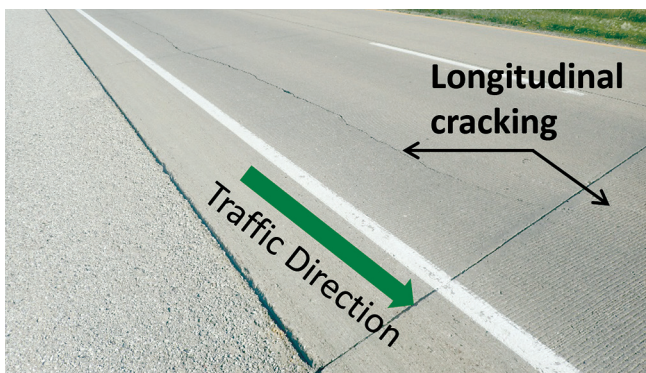
Longitudinal cracking observed on IA-163 with widened slabs in Mahaska County, Iowa

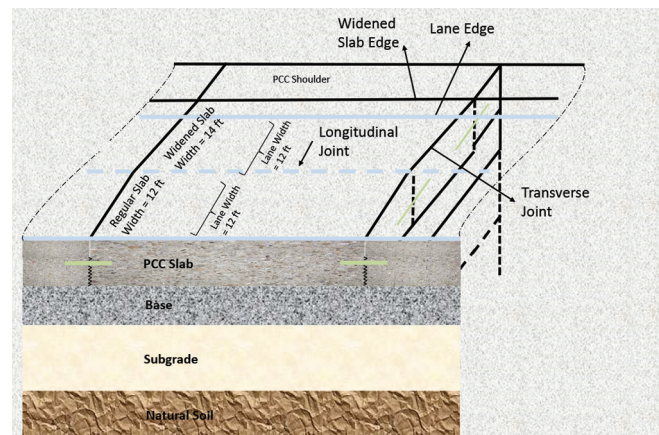
Numerical analysis using ISLAB2005 and EverFE 2.25 FEA software was conducted to understand the underlying mechanisms of longitudinal cracking failures in JPCP. A typical Iowa widened JPCP slab was modeled using a six-slab setup (three widened slabs in the traffic direction and three regular slabs adjacent to the widened slabs).

Finite element model definitions
