Evaluation, Laboratory Testing, Construction Documentation, and Field Testing/Monitoring of the US 52 Overflow Bridge over the Mississippi River

**Final Report
July 2020**

Sponsored by
Iowa Department of Transportation
(InTrans Project 16-596)
Federal Highway Administration

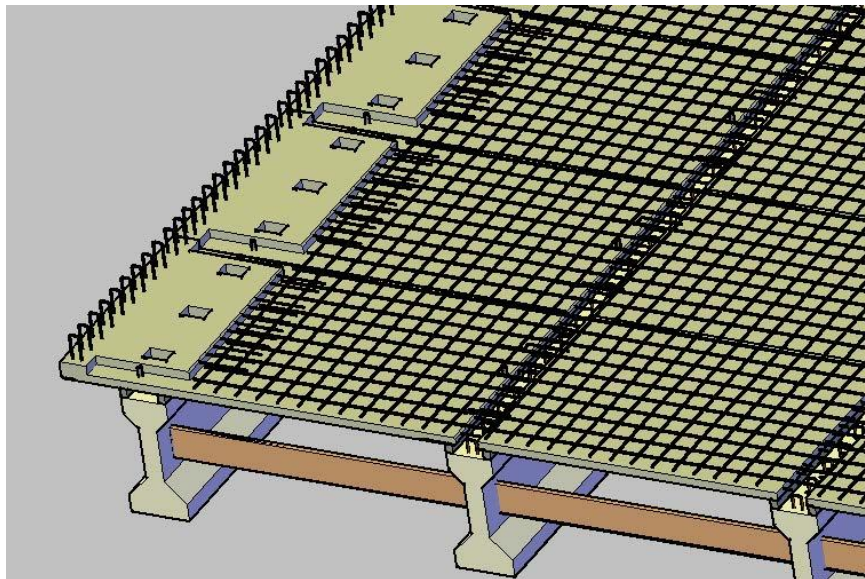
The first use of partial-depth precast concrete dates back to the 1950s in Illinois. Traditional partial-depth precast concrete deck panels are thin (typically 3.5 in. thick) prestressed concrete panels that span between girders (see Figure 1).

Figure 1. Precast partial-depth deck and precast deck overhang

For example, Mander et al. (2010) introduced a precast deck overhang system (as shown previously in Figure 1) and conducted a series of laboratory tests to investigate the deformation behavior up to factored design load limits. Two small-scale specimens, each consisting of three supporting girders, two overhang panels, and two precast, prestressed interior deck panels were fabricated and tested. The specimens were loaded near the edge to examine the collapse capacity and the associated failure modes—and particularly the influence of panel-to-panel connections that exist, transverse to the bridge deck axis.

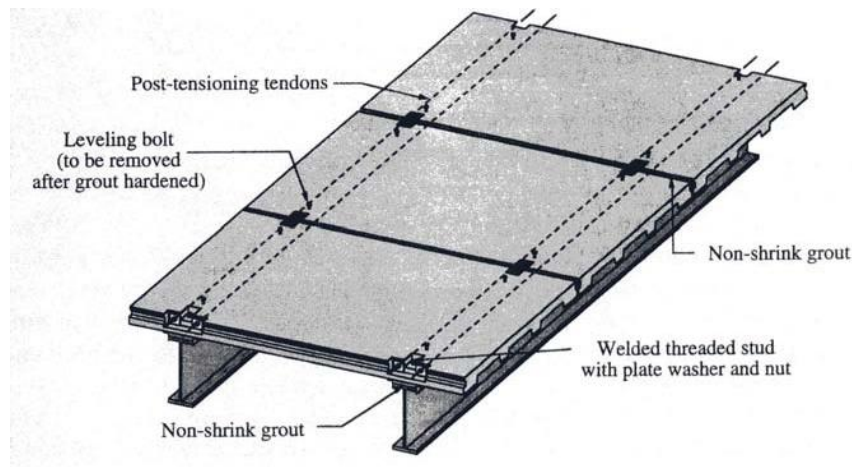
Traditional full-depth precast deck systems are one of the most widely used ABC techniques due to their shorter construction times, high-quality components, and relatively simple construction procedures. These systems typically consist of precast concrete panels, approximately 8 in. thick and 10 ft long, placed adjacent to one another on bridge girders (as shown in Figure 2).

Figure 2. Precast full-depth deck

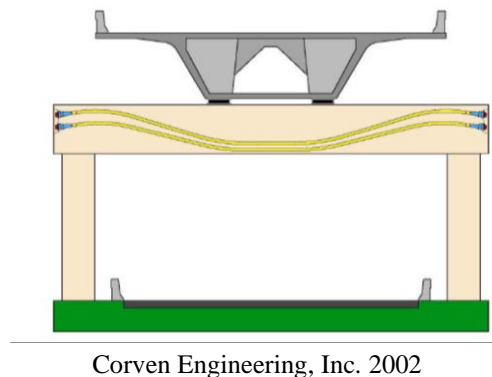
The use of precast/post-tensioned pier caps appears to be novel. A preliminary literature search did not find any previous applications of this construction approach. However, the Florida DOT (FDOT) introduced the use of post-tensioning on straddle bents (Corven Engineering, Inc. 2002), as shown in Figure 3.

Figure 3. Post-tensioned straddle bents

In a typical straddle bent, tendons drape to a prescribed profile that may be similar to the drape in a beam on simple supports, or it may rise over the columns where a monolithic connection is made to transfer moments into the columns and provide frame action. The columns may be reinforced or post-tensioned, depending upon the magnitude of the forces and moments induced in the frame. Tendons in straddle bents are internal and grouted during construction. However, it is possible to apply external tendons of a similar type to repair or rehabilitate a damaged structure.

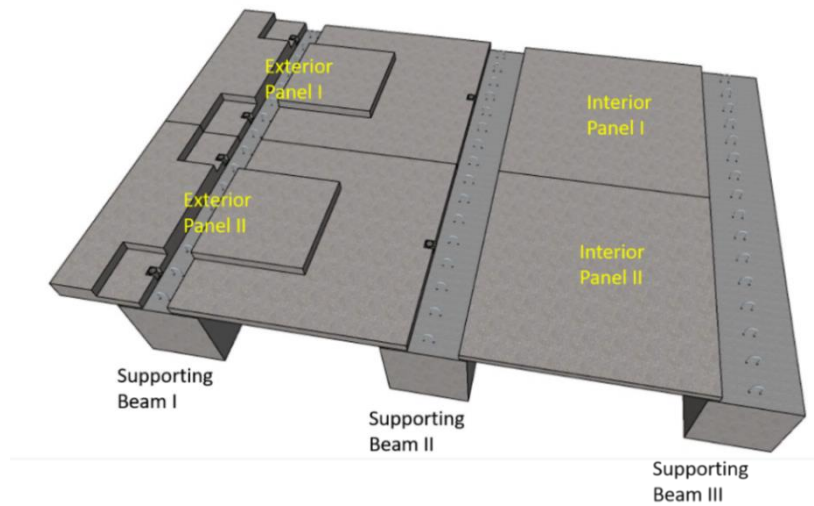
Figure 6 shows the three-dimensional (3D) view of the specimen without a barrier or the CIP concrete deck.

**Figure 6. 3D view of test specimen without CIP deck**

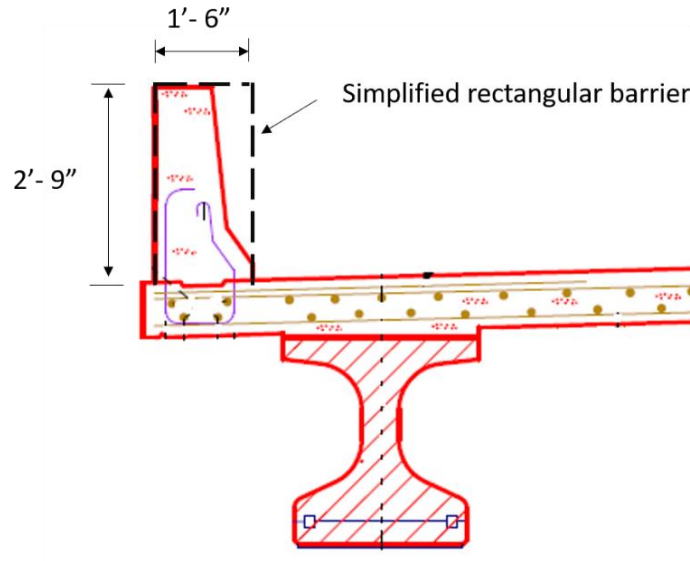
A barrier was constructed on one specimen with horizontal loading to transfer the load to the deck panel. The trapezoid barrier on this specimen was simplified as a rectangular shape as shown in Figure 7 to create a flat vertical surface for the application of the horizontal loading.

Figure 7. Simplification of barrier

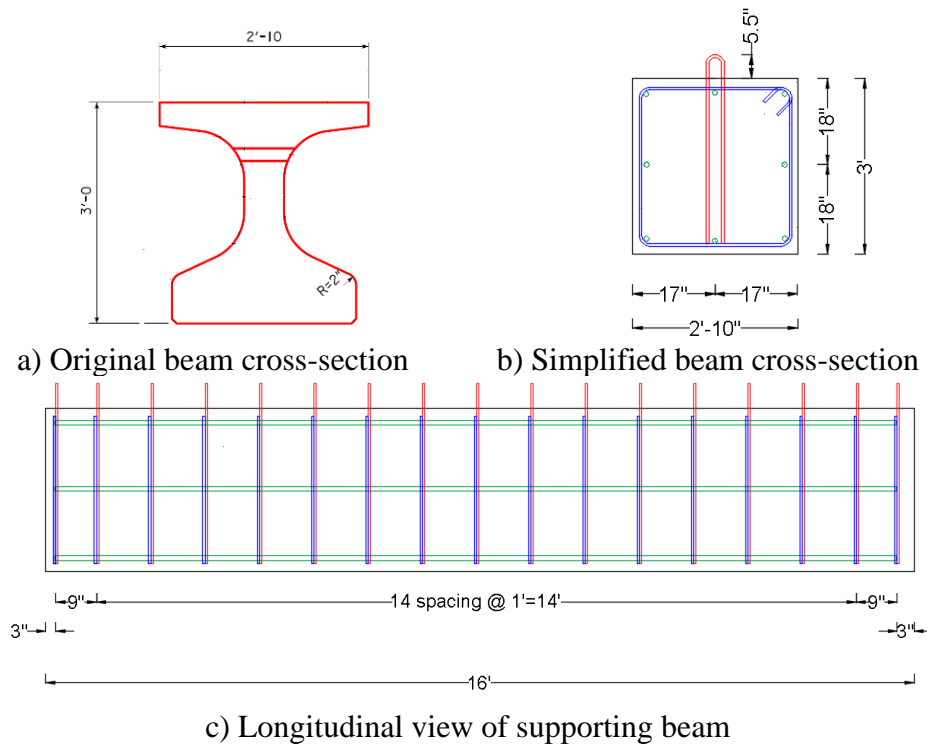
Given the beams were only used as support for the deck panels, and the I shape would not contribute to the structural behavior of the deck system, the beams were simplified to a rectangular shape and designed without longitudinal prestressing force. Figure 8 shows the simplification of the supporting beam.

Figure 8. Design of supporting beam

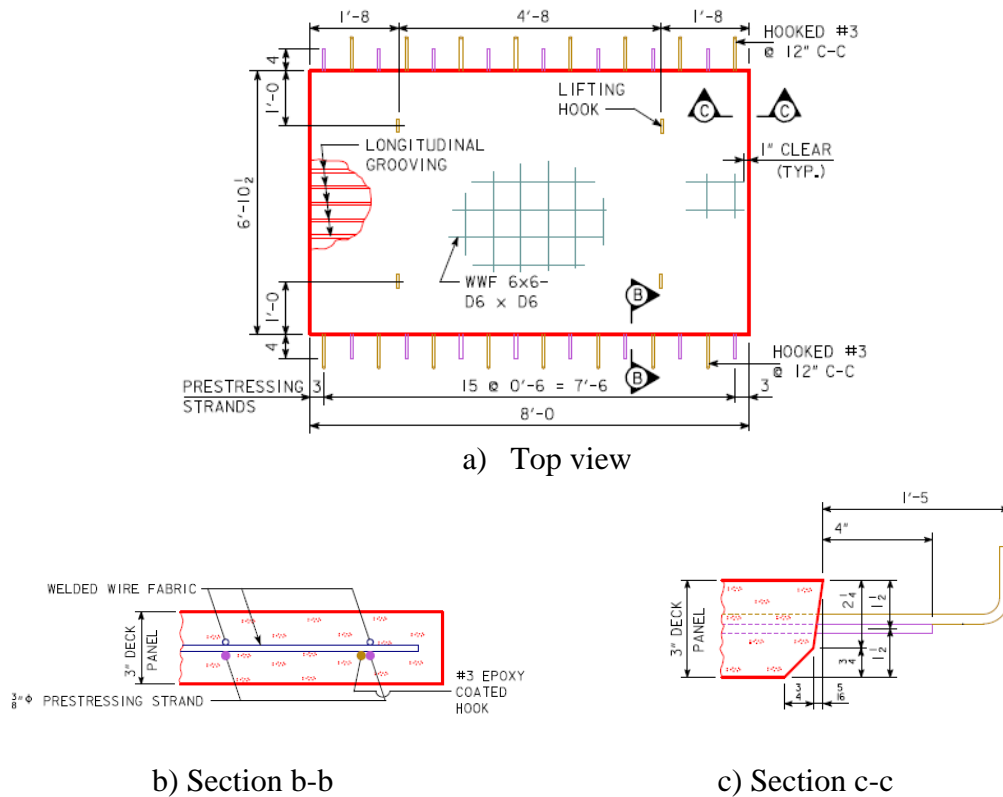
The interior and exterior panels were designed according to the design drawings shown in Figure 9 and Figure 10.

Figure 9. Design of precast prestressed interior deck panel

According to the design drawings, these precast deck panels are designed to support the dead load of the panel, reinforcement steel, CIP concrete, and 50 lb/ft² of construction load. The panel and CIP slab, acting as a composite section, is designed for HL-93 loading plus 20 lb/ft² of roadway for a future wearing surface. The top surface of the precast deck panels shall be given a suitable texture with a wire broom or comb having a single row of tines, with the desired grooving in the longitudinal direction (parallel to the centerline of bridge roadway).

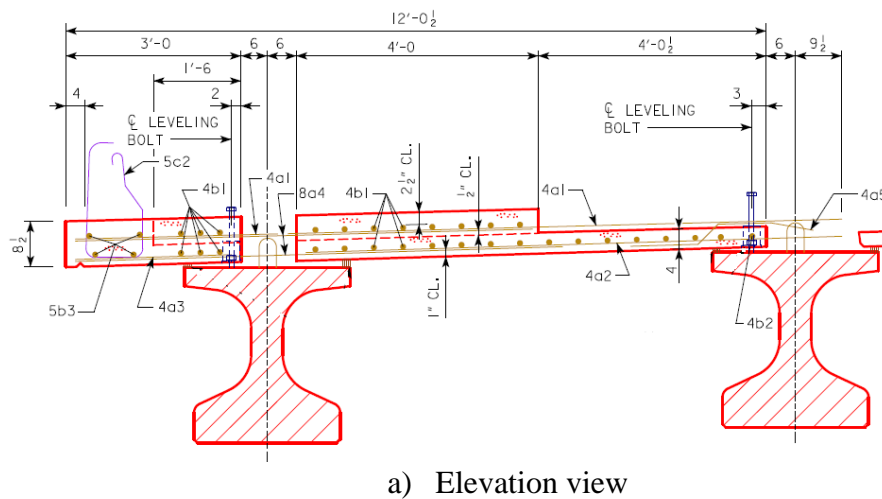
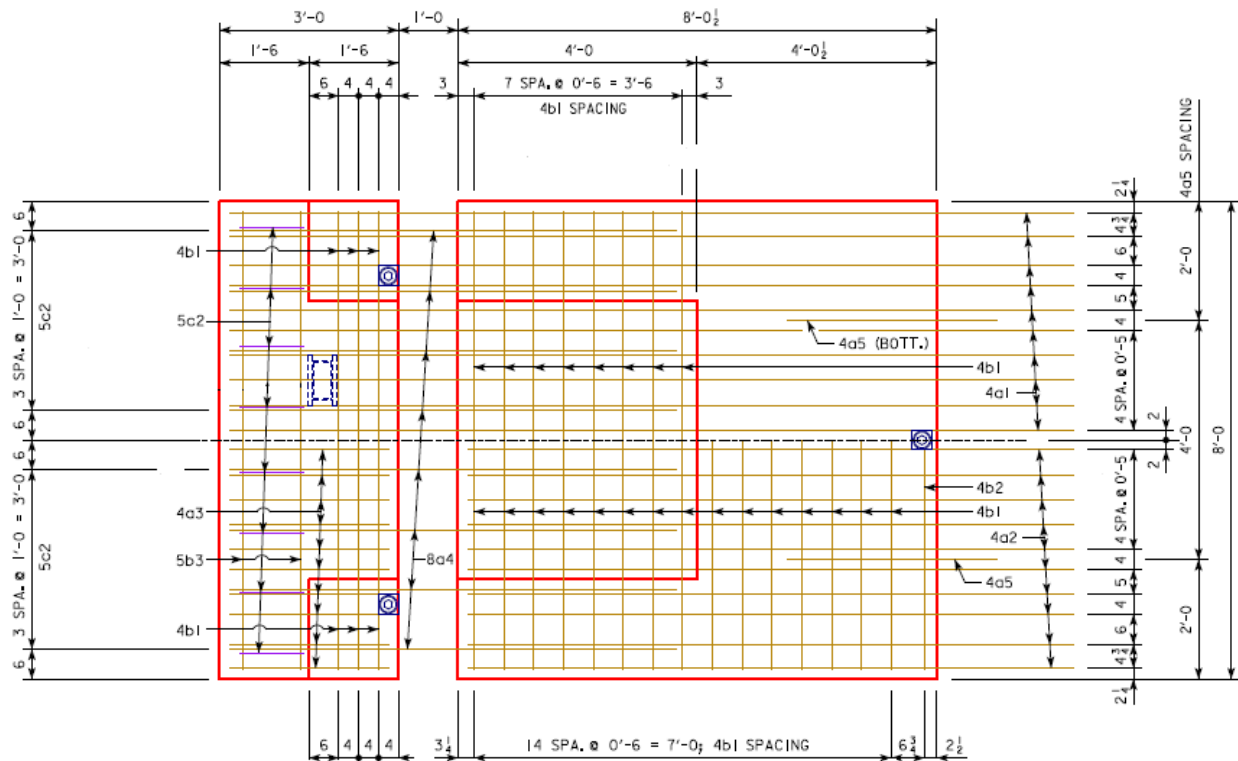
b) Top view

Figure 10. Design of precast double-panel overhang (exterior panel)

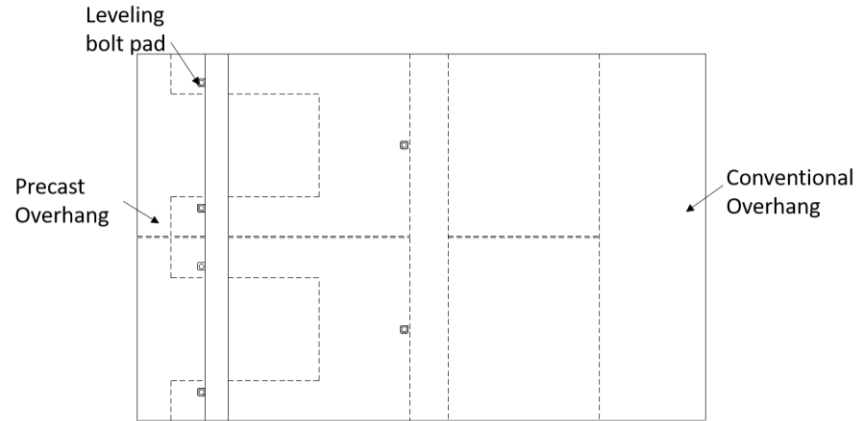
Figure 11 shows the plan view of the tested specimen without the barrier, and Figure 12 shows the reinforcing details of the tested specimen with the barrier.

Figure 11. Plan view of the tested specimens (without barrier)

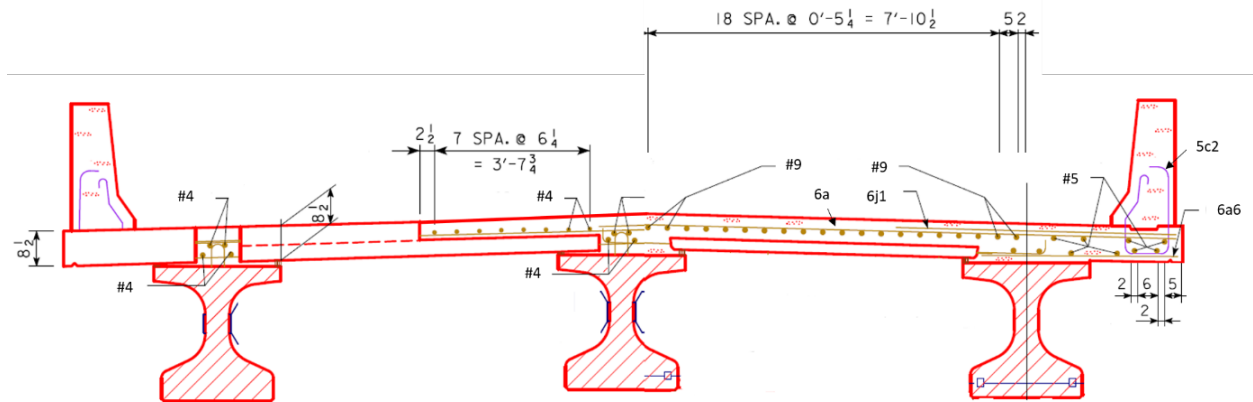
Figure 12. Reinforcing details of the tested specimens (with barrier)

The tested specimen was designed to include both a precast double-panel overhang and the CIP deck overhang. This design allows for a comparison of structural performance of the overhangs.

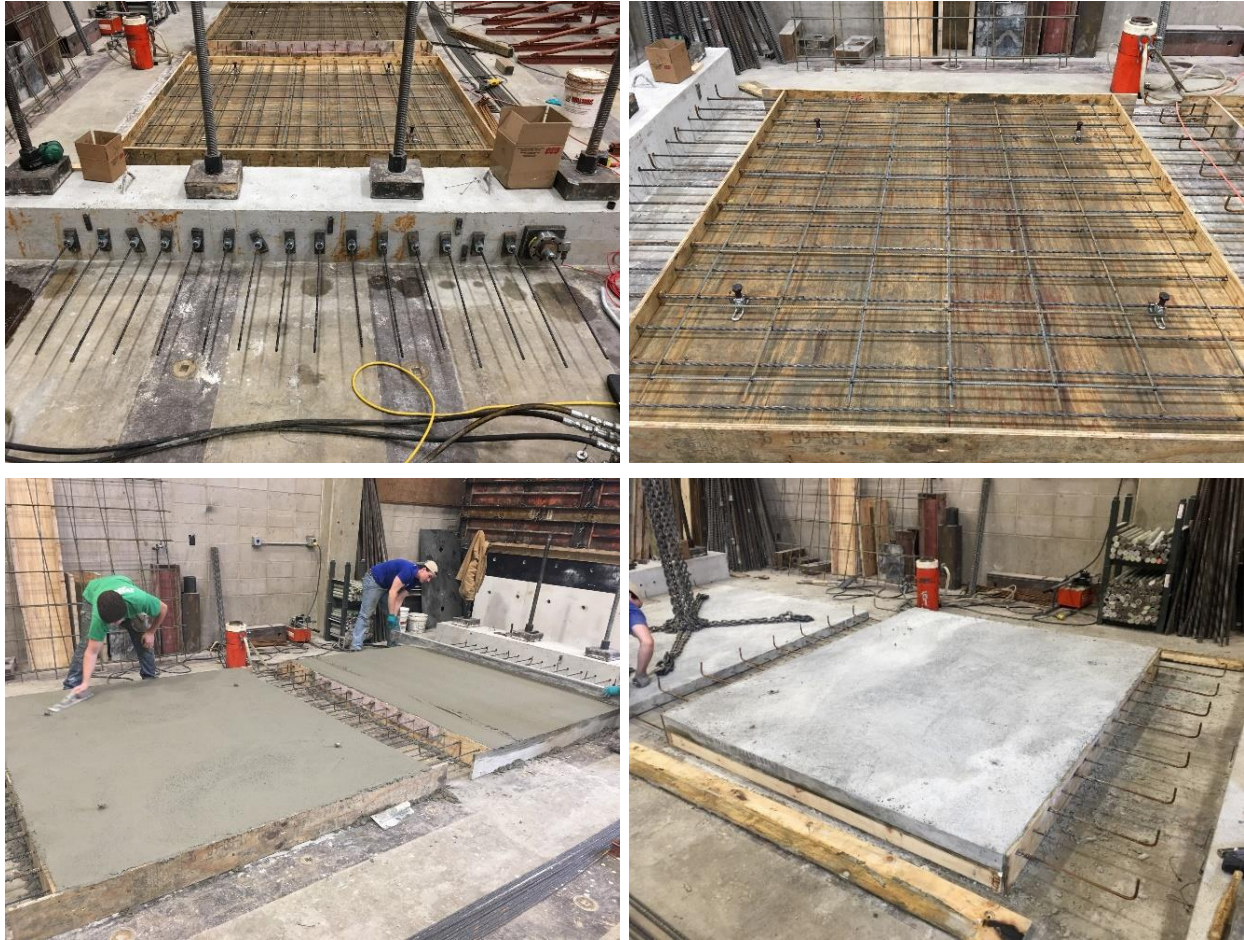
Figure 13 shows the construction of the precast prestressed interior deck panel.

Figure 13. Construction of precast prestressed interior deck panel

Before construction of the interior panel, two dead walls were cast and tied down on the floor in the laboratory to provide the reaction force for the application of the pre-tensioning load. According to the bridge design drawings, each strand was pretensioned to 16,100 lb/strand, which is 70% of its ultimate tensile strength.

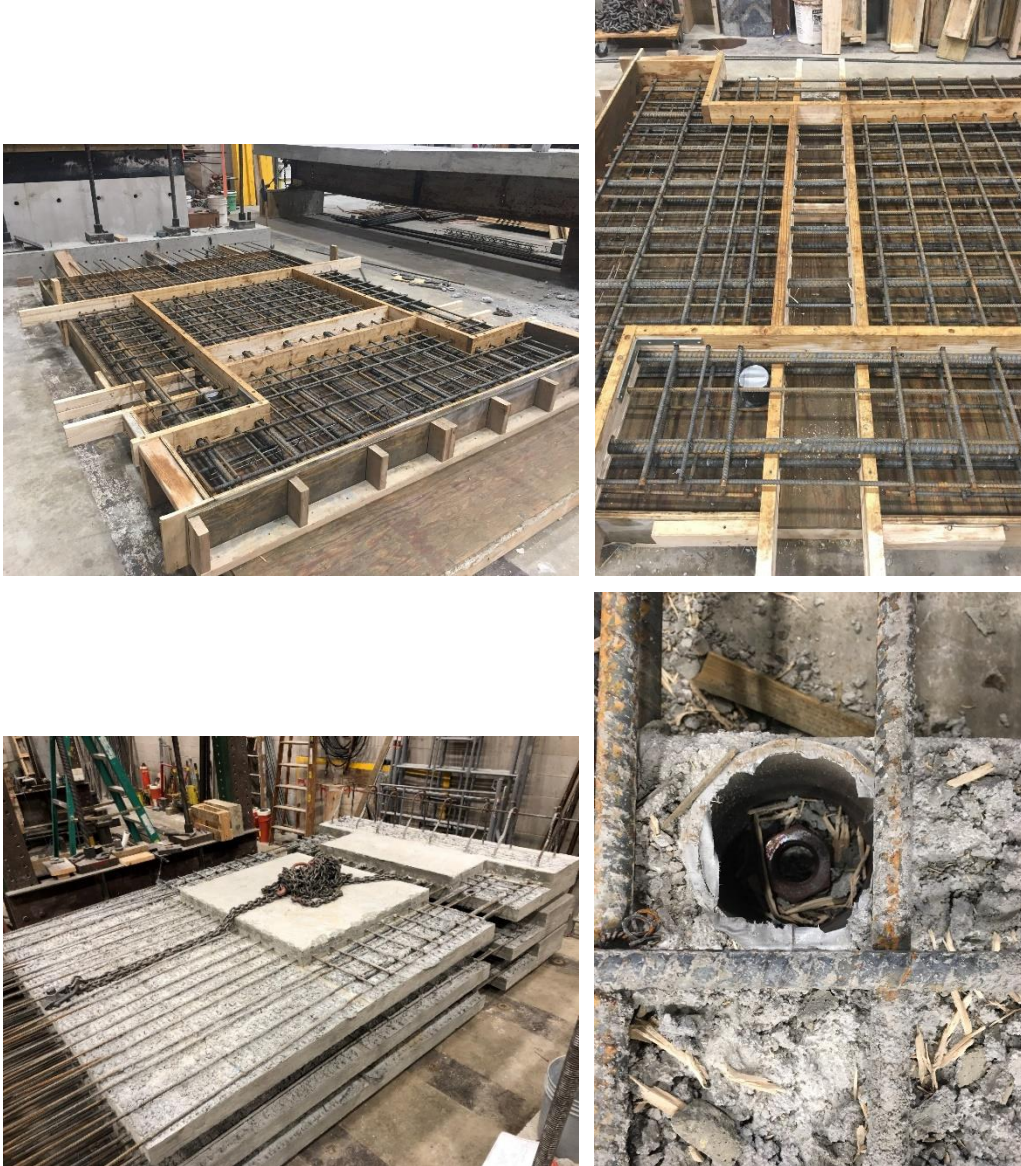
Figure 14 shows the construction of the precast double-panel overhang (exterior panel).

Figure 14. Construction of precast double-panel overhang (exterior panel)

Complex formwork was designed and built for the specific geometry of the double-panel deck overhang. The steel pieces for the level bolt were embedded into the precast concrete. According to the specifications, the top surface of the bottom precast deck layer on both interior and exterior panels was roughened with a wire broom to strengthen the bond between the CIP and precast deck concrete.

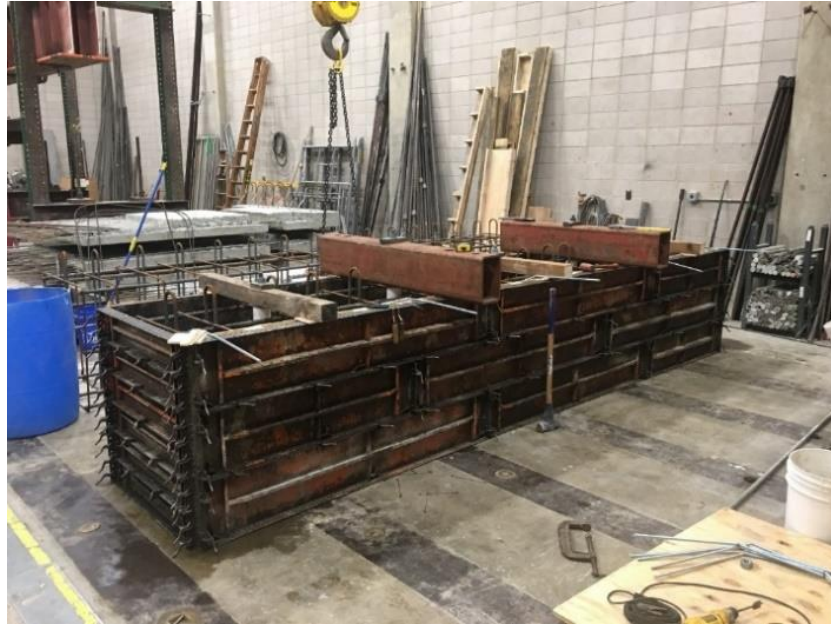
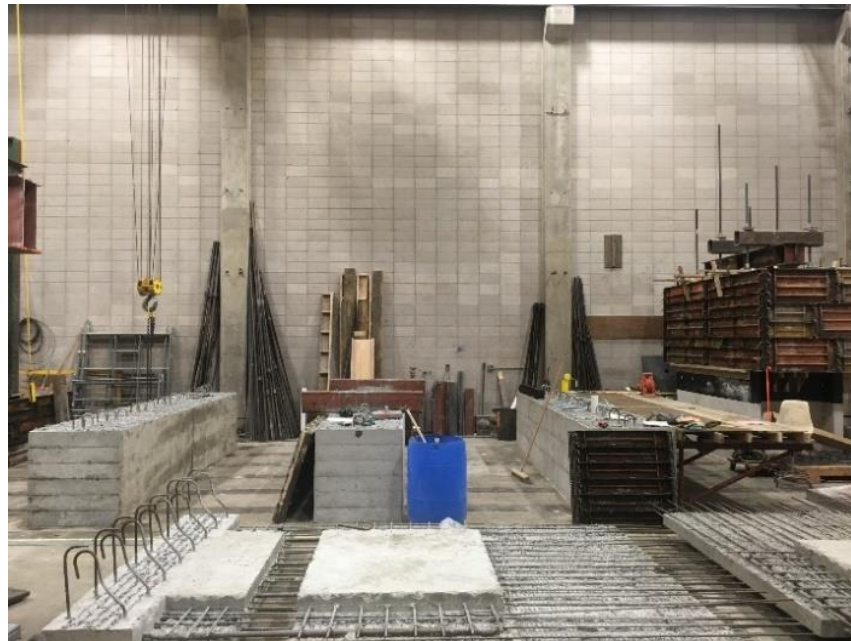
Figure 15 shows the construction of the rectangular supporting beam.

Figure 15. Construction of supporting beam

Three vertical polyvinyl chloride (PVC) ducts were embedded into each beam with a spacing of 4 ft to allow for tightening of the beams to the floor during testing.

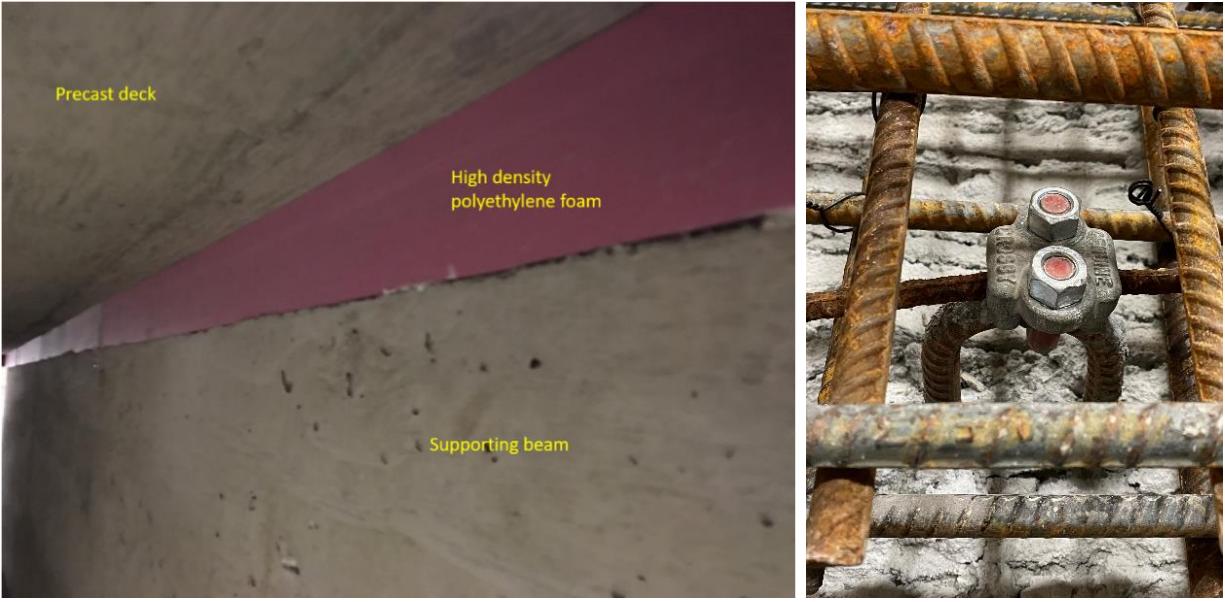
The high-density polyethylene foam was installed over the right edge of Beam 1 and 2 and the left edge of Beam 3. The high-density polyethylene foam used here served two functions: 1) provide enough strength to support the precast deck panel, CIP deck, and construction weight and 2) provide enough stiffness to keep the desired haunch height without experiencing large deformation when subjected to the deck and construction loads. Figure 17-a shows the polyethylene foam after it was installed on the specimen.

a) High density polyethylene foam

b) Coupler used to anchor the precast deck

After placement of the precast exterior and the interior decks, couplers were used to anchor the extension reinforcement of the precast deck to the shear studs of the supporting beam, as shown in Figure 17-b. While one coupler was used for each precast deck panel to prevent potential deck slippage during the placement of the CIP concrete, it was found that the precast deck panels are very stable and no slippage occurred.

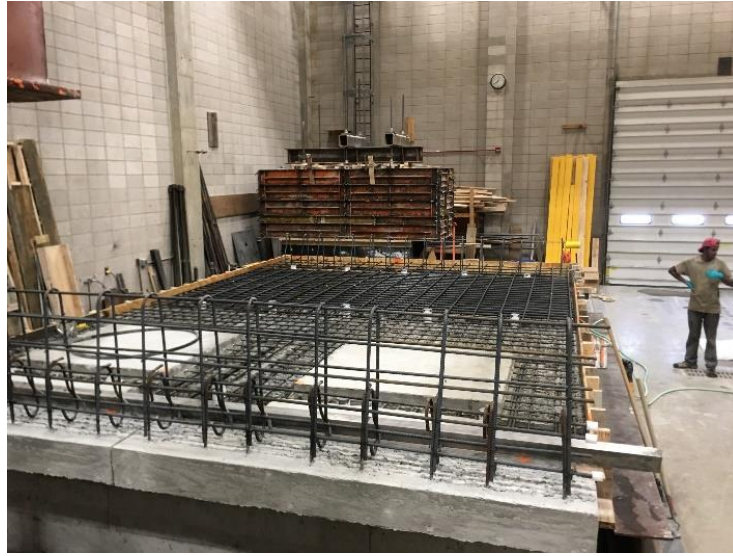
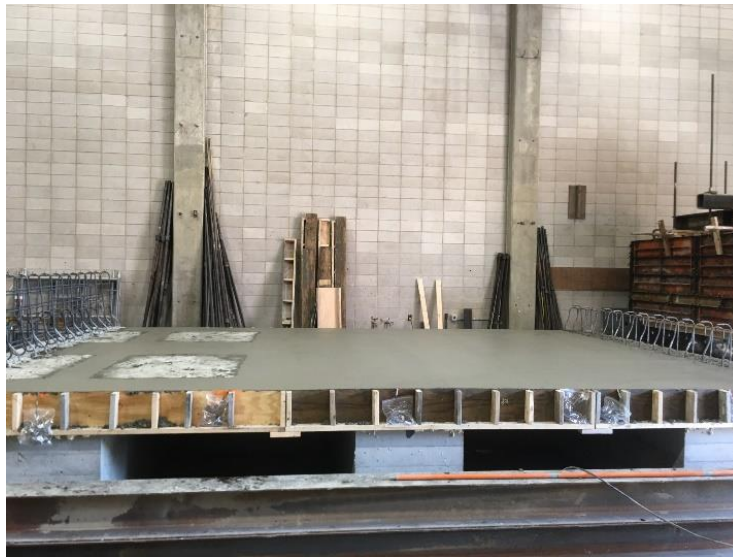
Prior to concrete placement, the exposed surfaces were blown via an oil-free air blast to remove all dust and debris. Figure 18 shows the construction of the CIP concrete and barrier.

Figure 18. Construction of CIP concrete and barrier

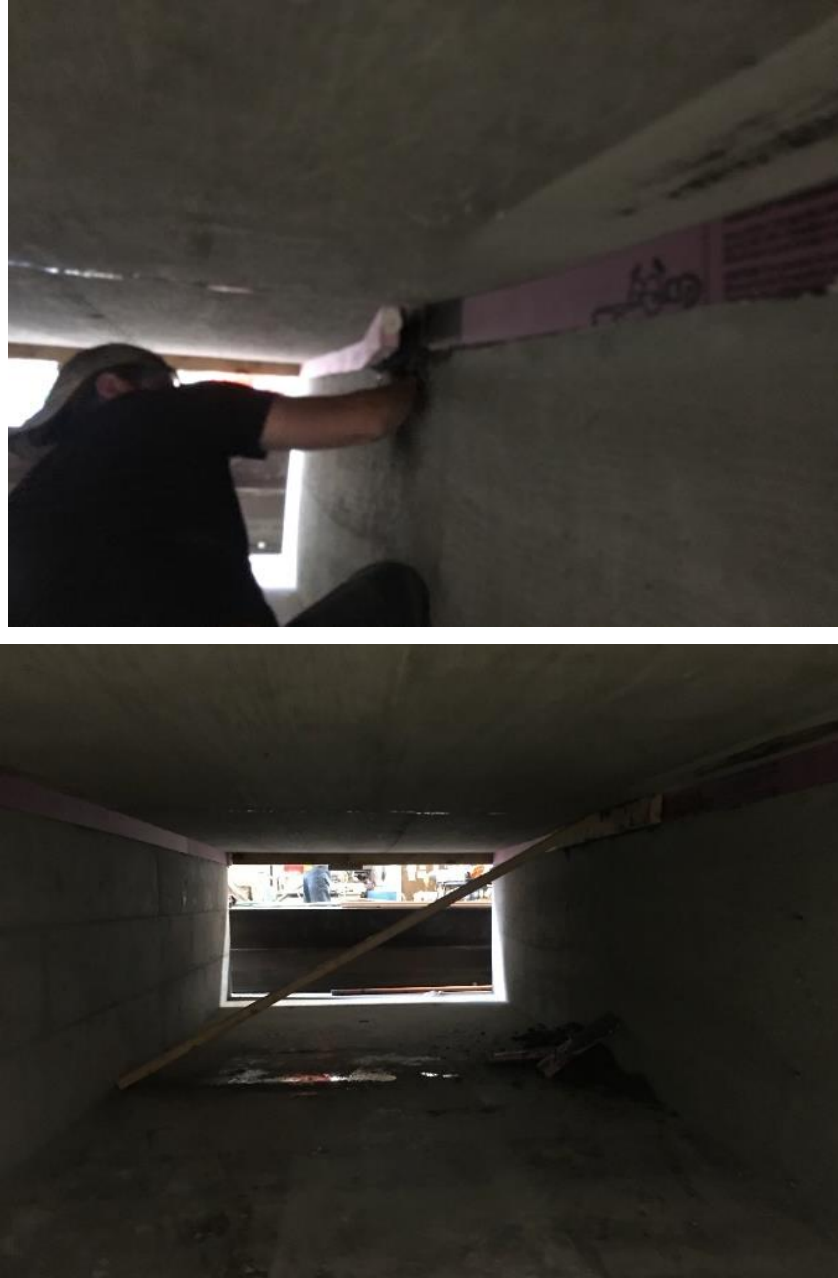
Both high-density polyethylene foam and normal polyethylene foam were glued to the top of the supporting beams. However, during placement of the CIP concrete on Specimen I (with the barrier), the high lateral pressure of the fresh concrete broke the high-density polyethylene foam over Beam 2, as shown in Figure 19.

Figure 19. High-density polyethylene foam punch-out

A timber board was used to temporarily provide additional bracing. The glue-work on the second specimen was conducted with additional attention. In addition to that, before the gluing work, the top surface near the edge was ground to create a flat surface for the application of the glue material.

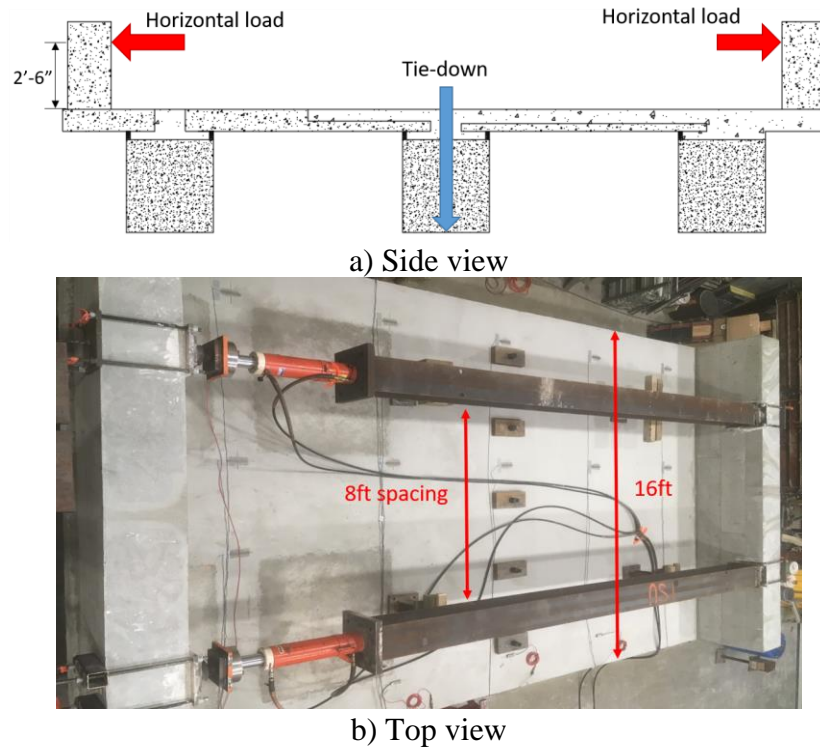
The two specimens were subjected to different types of loading. Specimen I – with barrier was horizontally loaded. The objective of this test was to investigate the structural behavior of the exterior double-panel deck when a vehicle collides with the barrier. The load was applied on the vertical surface of the barrier, as shown in Figure 20.

Figure 20. Application of horizontal load on Specimen I – with barrier

The specimen was loaded until failure to measure the ultimate capacity. During the test, the middle supporting beam was tied to the floor to prevent rigid motion of the specimen. The load was applied at two points on each side of the barrier, as shown in Figure 20. The total length of the specimen in the traffic direction was 16 ft and the spacing of the two load application locations was about 8 ft.

The horizontal load was gradually applied to each barrier through two actuators, as shown in the previous Figure 20-b. The loading was paused when each actuator reached 15 kips and 50 kips to document crack propagation of the specimen. At each pause, the cracks on the top and bottom surfaces of the deck were marked and photographed.

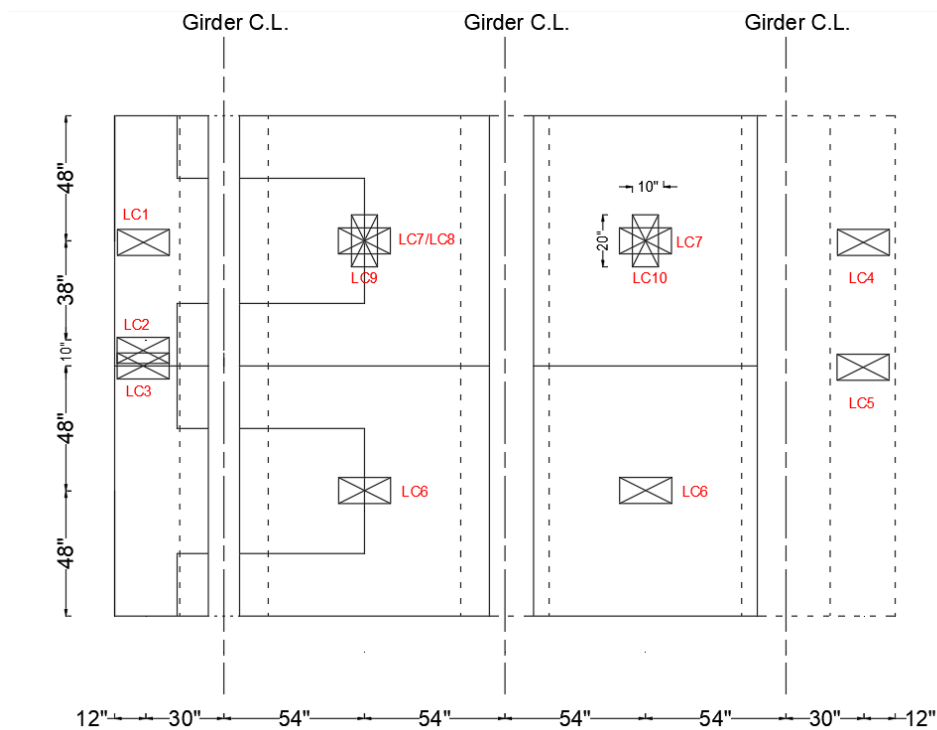
LC No.	Magnitude	Load until Failure
1	16	---
2	16	---
3	16	---
4	16	---
5	16	---
6	32	---
7	180	---
8	200	---
9	250	Yes
10	240	Yes

**Figure 21. Load cases on the specimen subject to vertical loading**

In total, 10 load cases were performed. LC1 to LC5 were applied on the deck overhang to simulate the construction load. LC6 and LC7 were applied to the deck between the girders to simulate truck loading during the bridge service life. From LC1 to LC6, each load point was loaded to 16 kips, which generates a transverse negative moment equivalent to that induced by a

LC7 was designed to break the specimen; however, the actuator reached its capacity (90 kips) during the test. It was then decided to load each bay separately until failure. LC8 and LC9 were performed over the precast double-panel (see previous Figure 21).

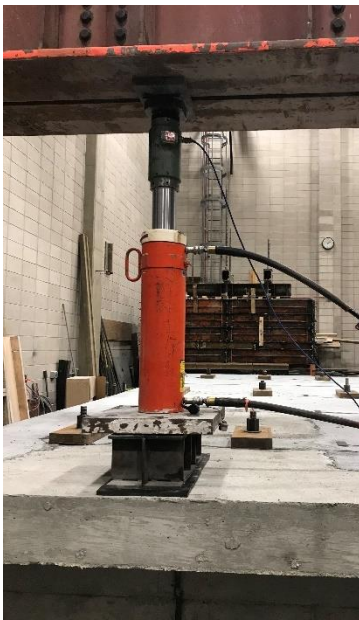
a) LC1

LC8 loaded the specimen to 200 kips, at which the actuator was at capacity, and the specimen was still unbroken. LC9 was then performed with a larger actuator. Note that for LC1 through LC8, the load pad was placed with the short edge parallel to the traffic direction. In LC9 and LC10, the loading pad was turned 90° to generate a greater bending moment to break the specimen. The ultimate loading in LC9 was about 250 kips. LC10 was conducted over the prestress interior panel with an ultimate load of about 240 kips. The results from each LC are presented in Section 4.5. During this test, the specimen was tied to the ground utilizing the post-tensioning rods through the plastic ducts pre-installed into the supporting beams. The whole specimen was restrained at nine locations (three on each beam), as shown in Figure 22.

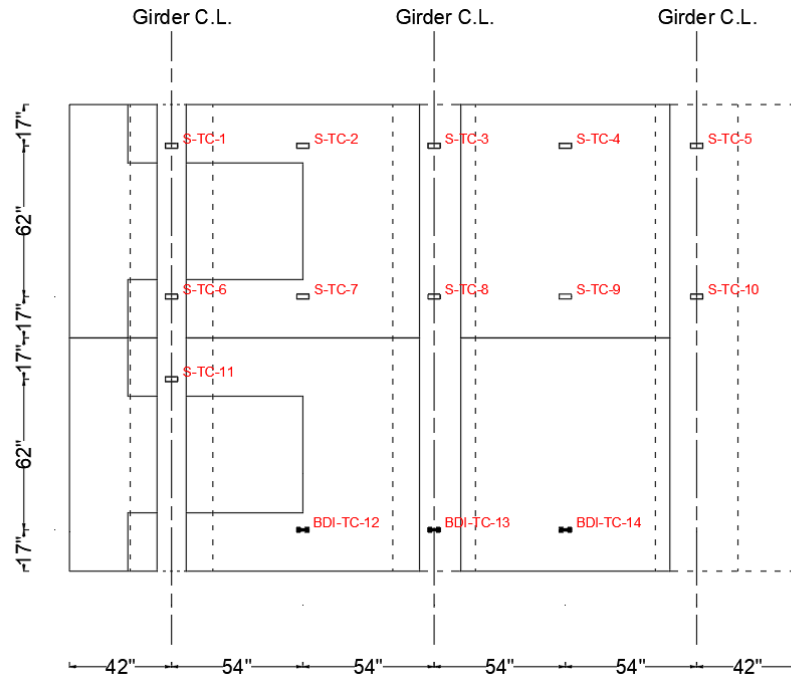
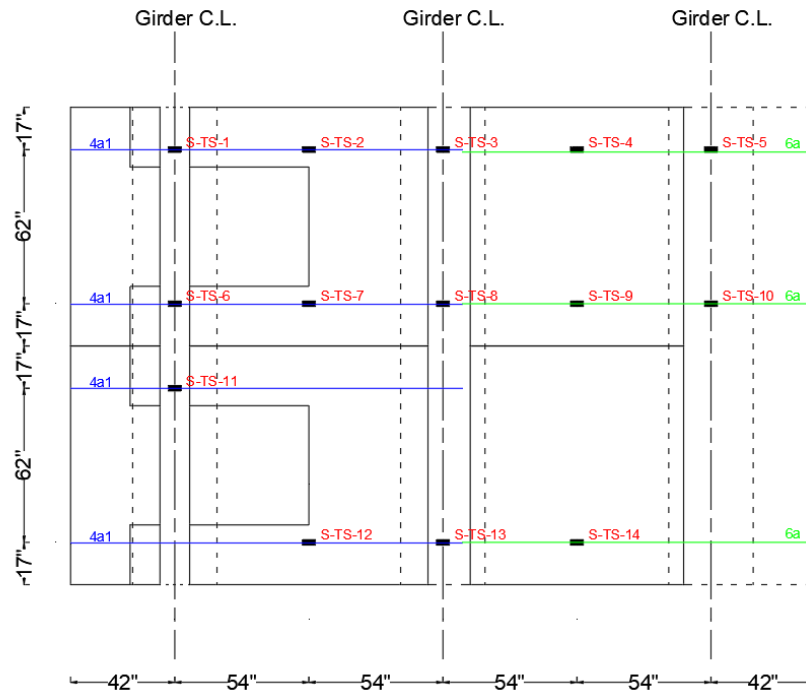
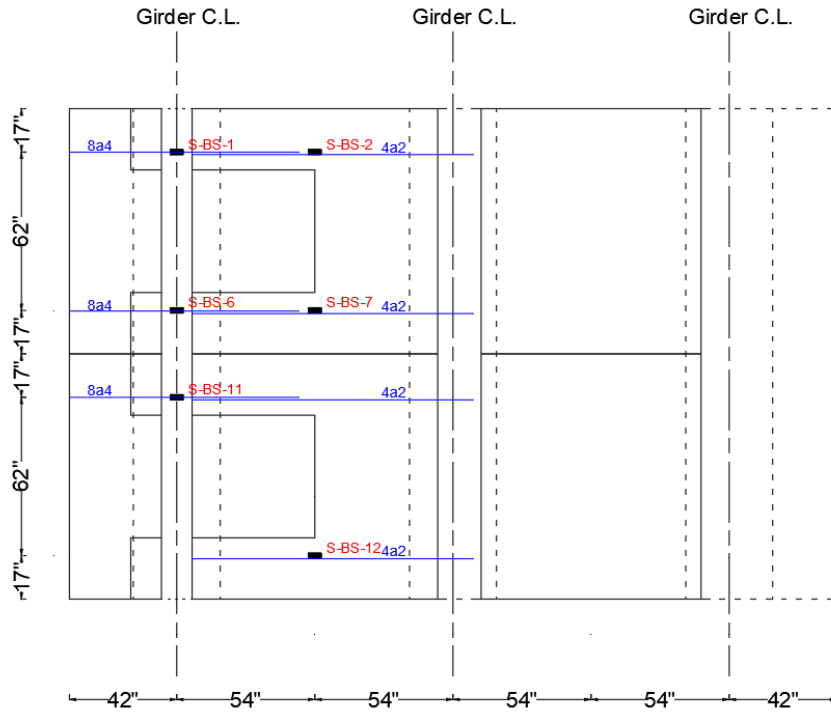
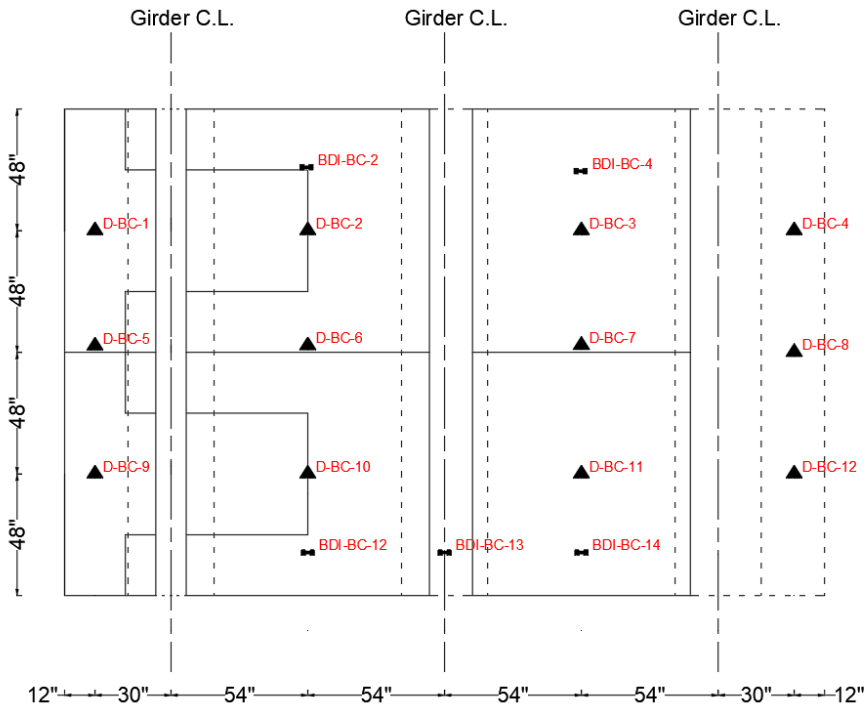
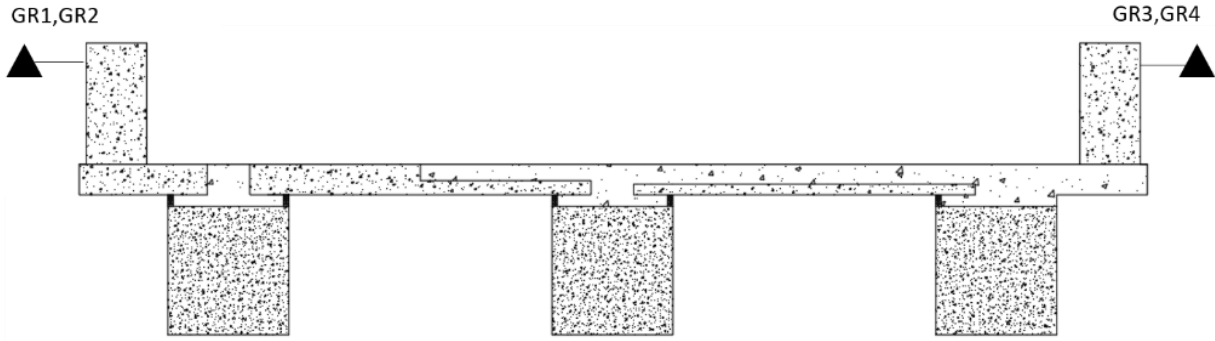
The instrumentation plan was designed to capture the composite action between the precast and CIP deck system when subjected to vertical and horizontal loading. Hence, multiple strain gauges were placed at the same location, but at different levels in or on the exterior surface of the deck to measure the strain variance within the height of the deck. In general, the gauges were installed at four layers: top surface of the concrete deck, top layer of reinforcing steel bar in the deck, bottom layer of reinforcing steel bar in the deck, and the bottom surface of the concrete deck. The instrumentation plan for each layer is shown in Figure 23.

a) Top surface of concrete

b) Top layer steel rebar

c) Bottom layer steel rebar

d) Bottom surface of concrete

e) Lateral displacement measurement (Specimen I only)

Figure 23. Instrumentation plan

In this section, the measured strain and displacement data are plotted with the loading change in each actuator. For example, Figure 27-a shows the load versus horizontal displacement at each loading point (see the previous Figure 23 for the gauge locations).

Figure 28 plots the strain data versus loading at various locations (see the previous Figure 23 for the gauge locations).

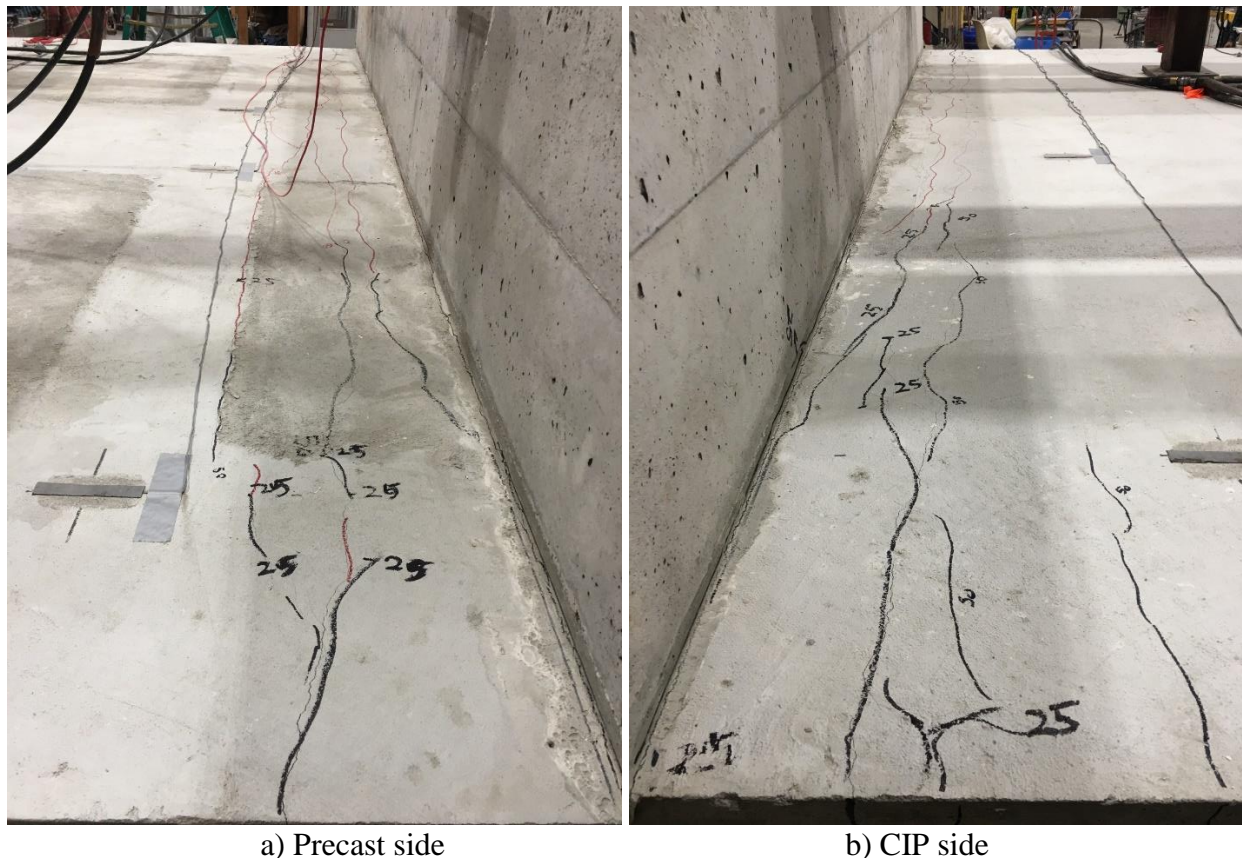
Figure 24 shows the crack propagation near the barrier and on top of the deck.

Figure 24. Cracks on the top surface (Specimen I)

It was found that when the load reached 25 kips, both the CIP and precast sides already experienced some level of cracking. On the precast side, the cracking included debonding between the precast deck panel and the CIP concrete.

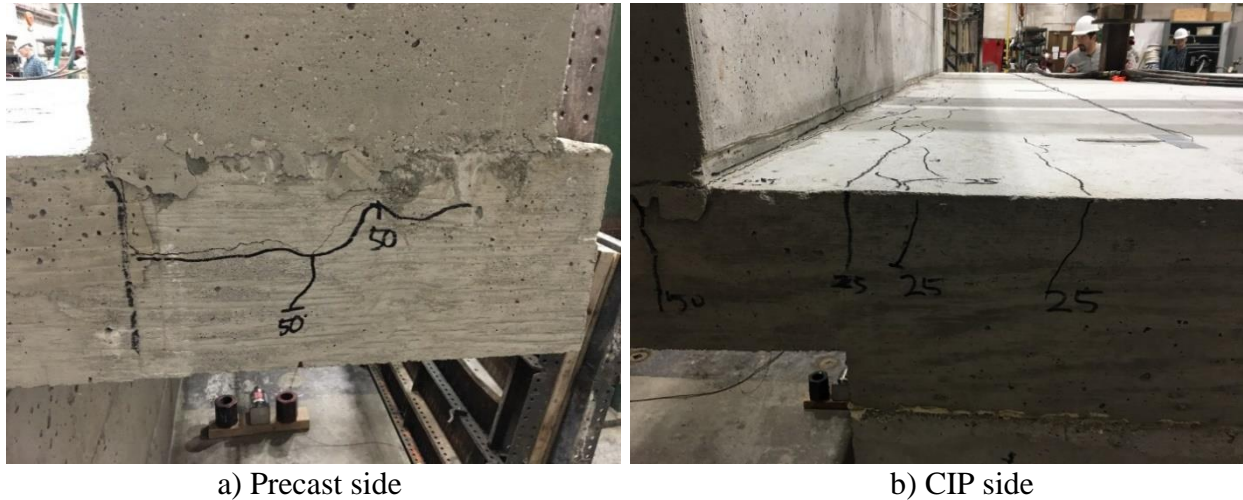
Figure 25 shows the cracking at the side of the deck near/underneath the barrier.

Figure 25. Cracks under the barrier (Specimen I)

It was found that, on the precast side, the debonding occurred at the vertical interface between the precast and CIP deck when the load reached 25 kips. When the load was increased to 50 kips, the cracking continued in the horizontal direction, as shown in Figure 25-a. On the CIP side, three vertical cracks were found in the deck over the exterior beam when the load reached 25 kips, and one vertical crack was found underneath the barrier when the load reached 50 kips.

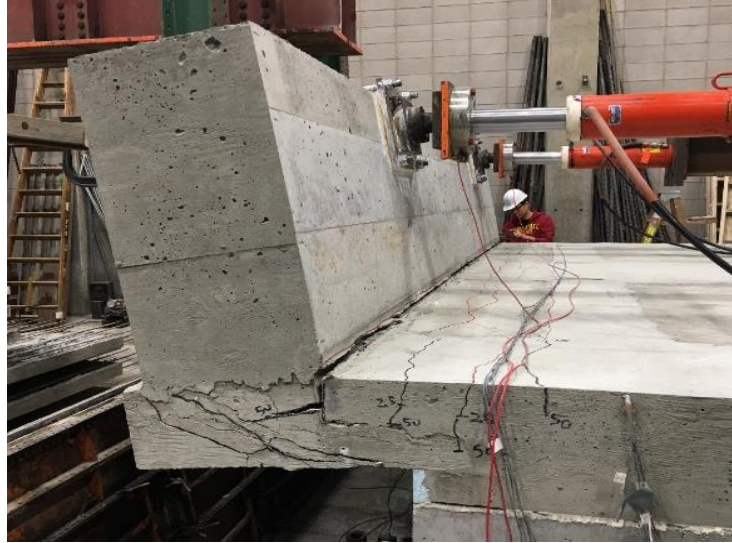
Figure 26 shows the failure on the precast side underneath the barrier after the ultimate load of 55 kips per actuator.

Figure 26. Precast deck concrete crash (Specimen I)

It was found that when the load surpassed 55 kips, most of the new cracks occurred in the deck underneath the barrier.

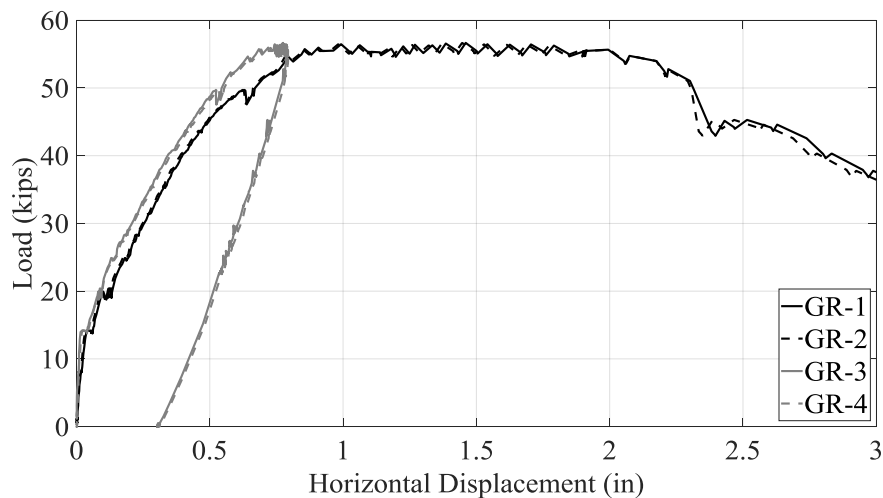
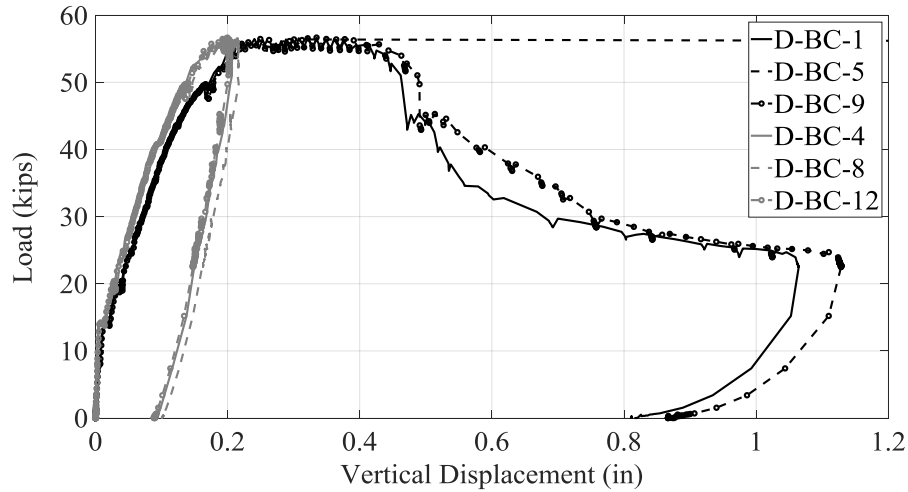
a) Horizontal displacement collected at the load application points

b) Vertical displacement at the bottom surface

Figure 27. Displacement data from Specimen I test

The results indicated that the load versus displacement curves at each loading point on the same barrier are very similar, and no significant twisting behavior was found. Comparing the data from the precast side (black lines) and CIP side (gray lines), it was found that the CIP side has greater stiffness than the precast side throughout the duration of loading. This result was validated by the vertical displacement data shown in Figure 27-b, such that the vertical displacement measured from the precast side (black lines) was higher than that of the CIP side (gray lines).

The setup of the loading frame ensured that both barriers were subjected to the same magnitude of load, and, thus, the ultimate loading occurs when any portion of the barrier fails first. Based on the results from the inspection during the test and the analysis of the test data, it could be concluded that the ultimate load of 55 kips failed on the precast deck side. The ultimate capacity of the CIP deck may be higher than 55 kips, but could not be obtained from this test.
