Evaluation, Laboratory Testing, Construction Documentation, and Field Testing/Monitoring of the US 52 Overflow Bridge over the Mississippi River

**Final Report
July 2020**

Sponsored by
Iowa Department of Transportation
(InTrans Project 16-596)
Federal Highway Administration

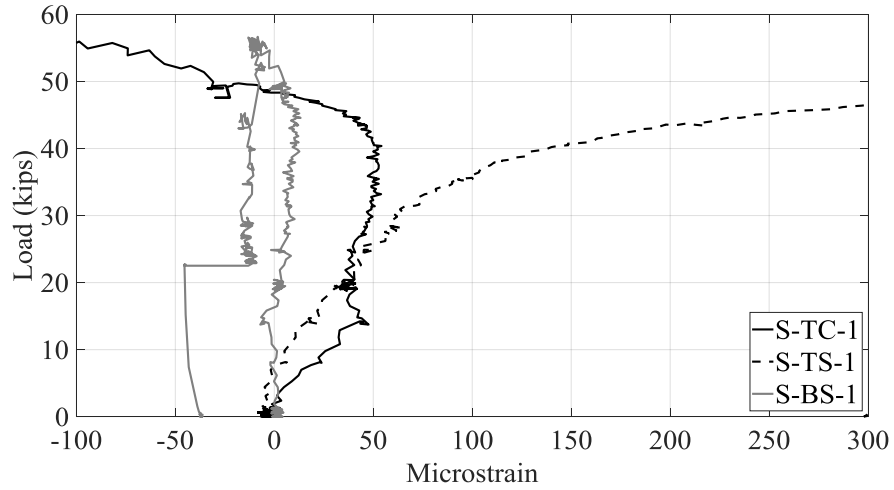
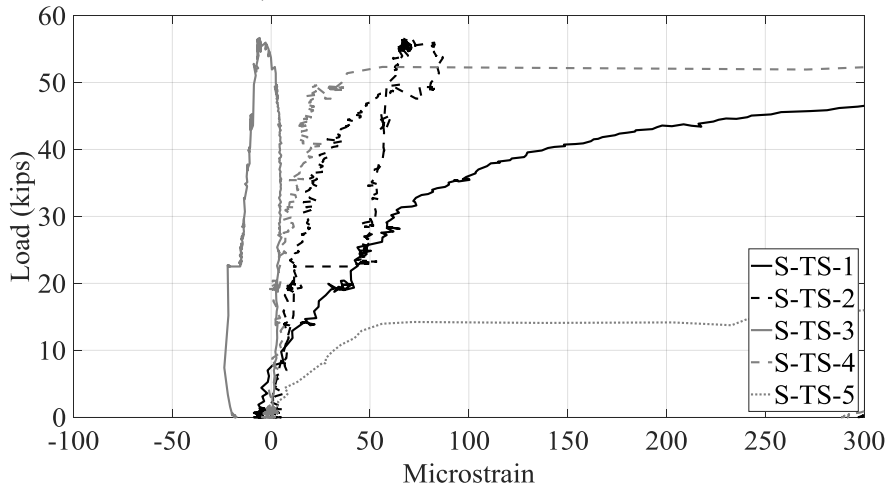
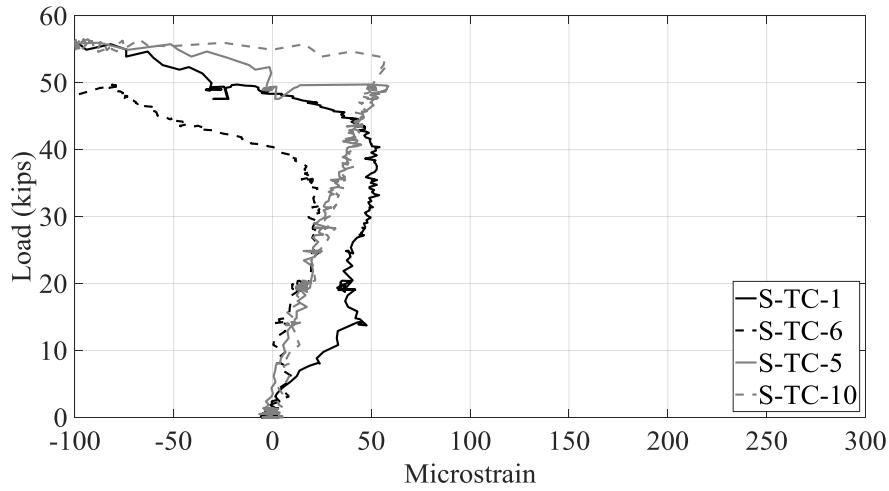
Figure 28 plots the strain data versus loading at various locations (see the previous Figure 23 for the gauge locations).

a) Strain collected at location-1

b) Selected strain data on the top layer reinforcement

c) Selected strain data on the top surface of concrete deck

Figure 28. Strain data from Specimen I test

Figure 28-b plots the strain in the top layer reinforcing steel bar at multiple locations. It was found that S-TS-5 shows a sudden strain increase when the load reached about 15 kips. This indicates that the first crack occurs in the concrete at this load level. This finding could also be validated by the strain data shown in Figure 28-c, which plots the strain on the top surface of the deck at various locations. The strain from S-TC-1, initially, linearly increased; however, a yielding point occurred when the load reached about 5 kips. These results indicate that the first cracks occurred when the load reached 15 kips, and after that the reinforcing steel bar starts to carry more load.

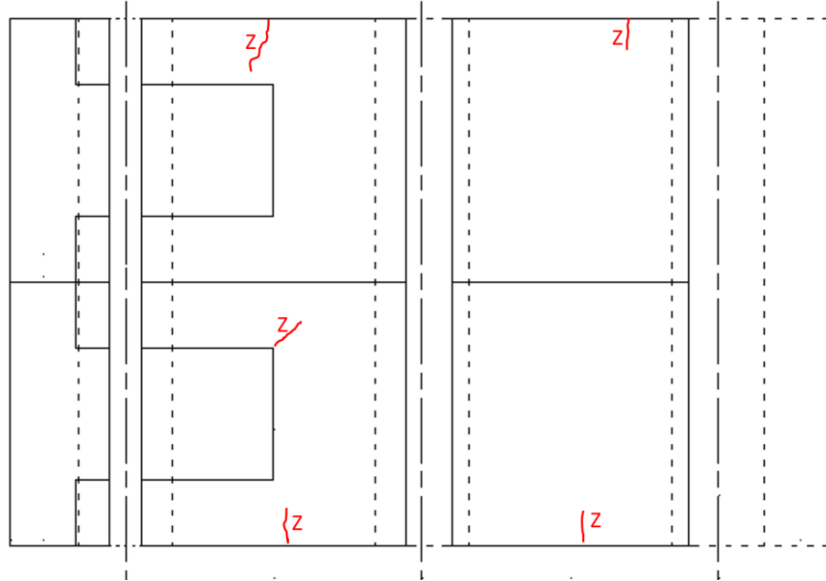
Prior to load application, a few hairline shrinkage cracks were found on top of the CIP concrete deck, as shown in Figure 29.

Figure 29. Crack map on the top surface of deck before load application

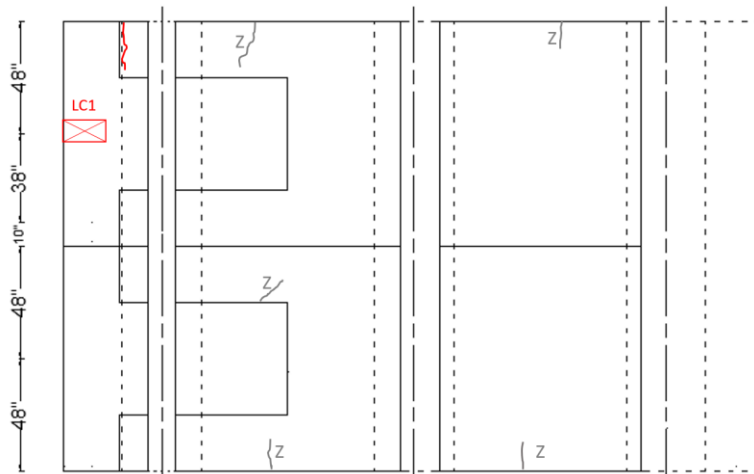
During LC1 through LC5, only one crack was generated, due to the load in LC1, as shown in Figure 30.

Figure 30. Crack map on the top surface of deck after LC1

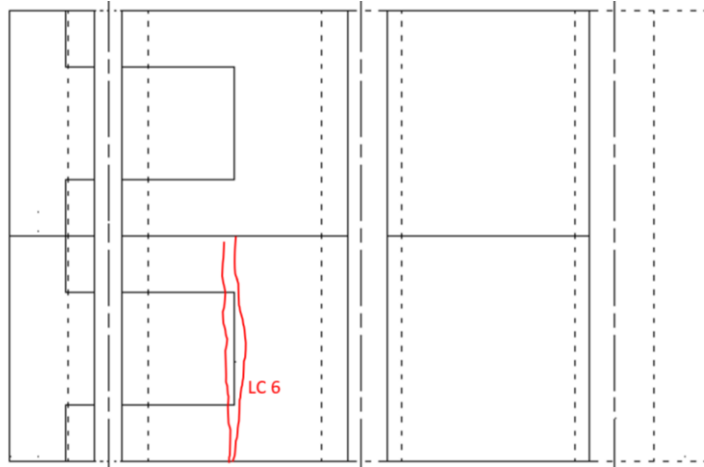
Figure 31 and Figure 32 show the cracking on the bottom surface of the deck after application of LC6 and LC7, respectively.

Figure 31. Crack map on the bottom after LC6

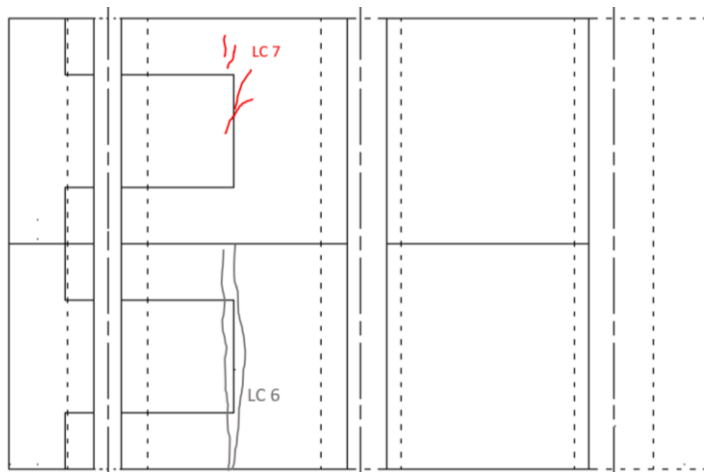
Figure 32. Crack map on the bottom surface of deck after LC7

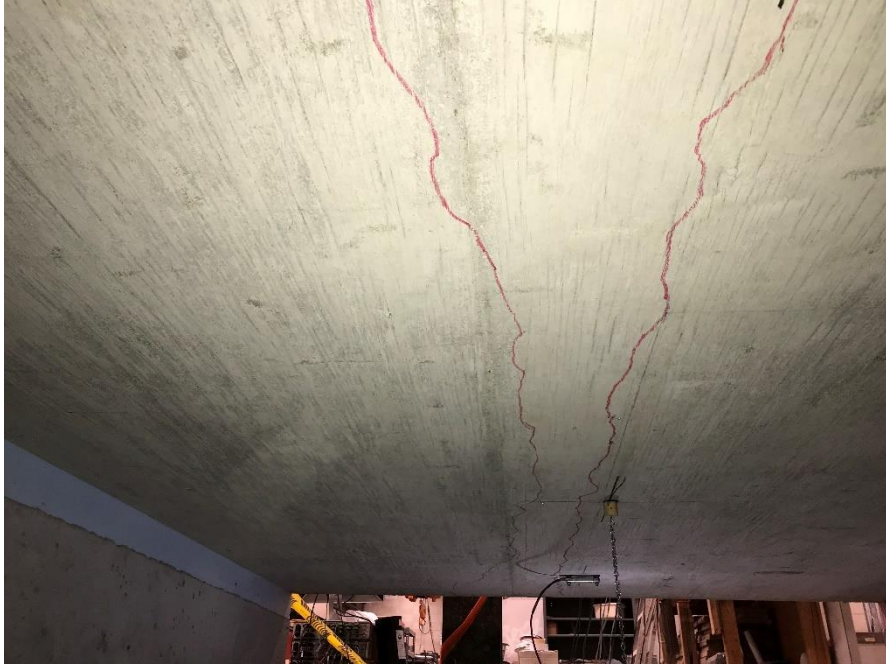
LC6 and LC7 generated cracks on the bottom surface of only the non-prestressed interior deck panels, as shown in Figure 33 and Figure 34.

Figure 33. Crack on the bottom surface of deck after LC6

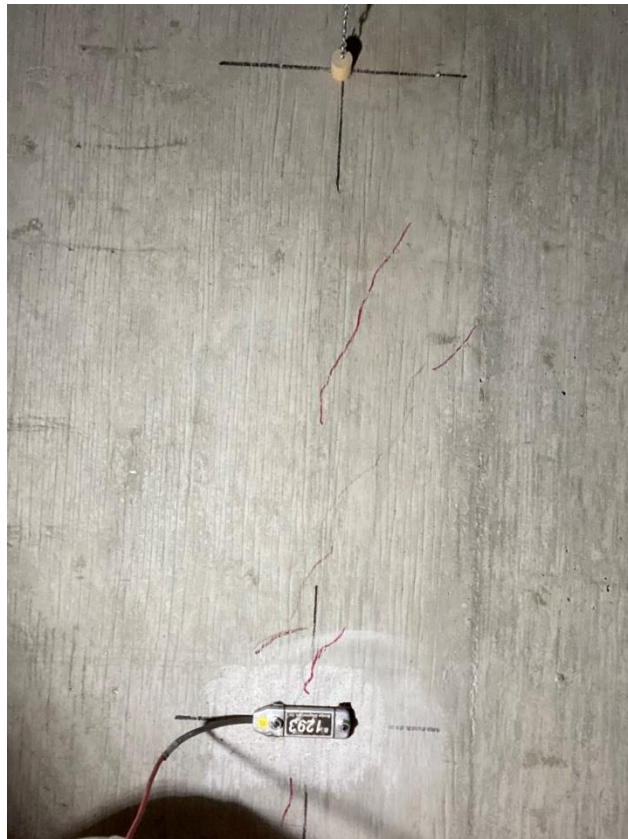
Figure 34. Crack on the bottom surface of deck after LC7

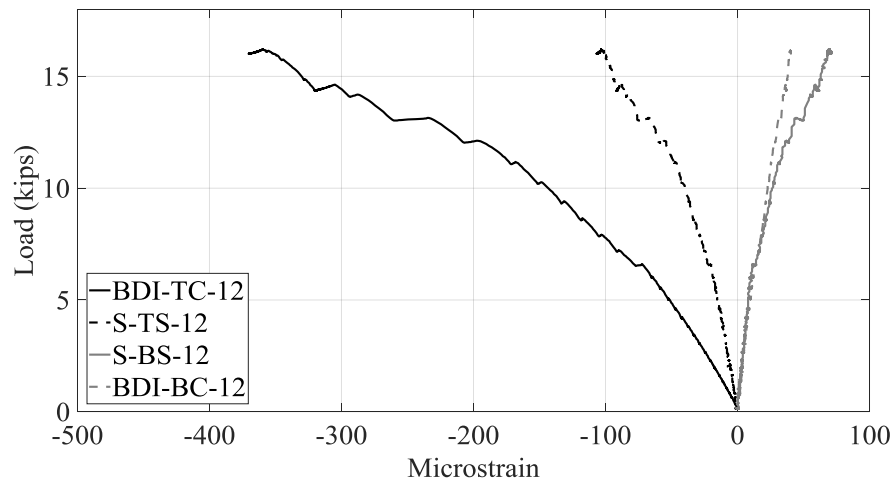
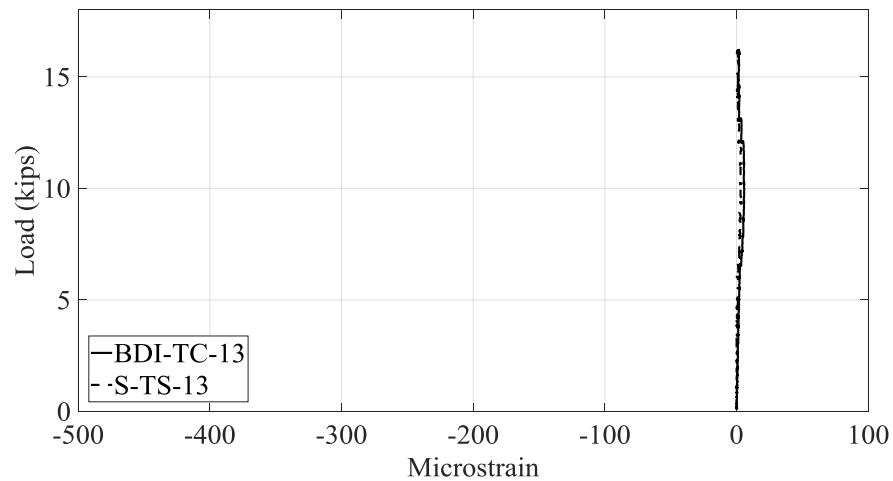
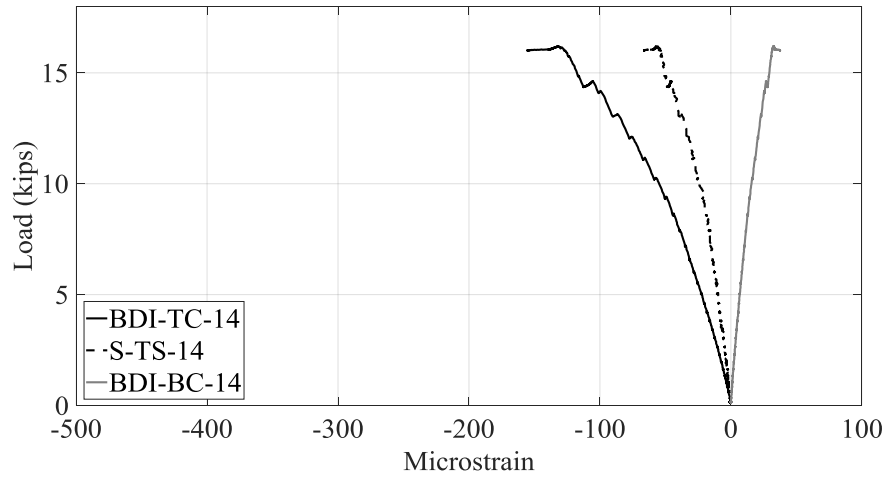
Figure 35 and Figure 36 plot the strain and displacement data from selected gauges for LC6 and LC7, respectively. Note that the displacement data for LC6 are not presented given the results were nearly zero. The strain data in Figure 35-a, -c and Figure 36-a, -b, and -c indicated that a positive moment was generated at the center of the deck between the girders.

a) Strain data at Location-12

b) Strain data at Location-13

c) Stain data at Location-14

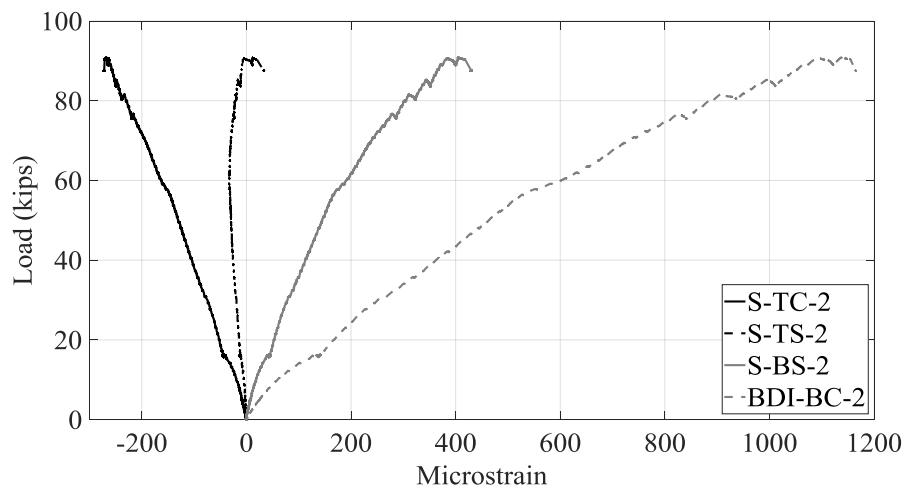
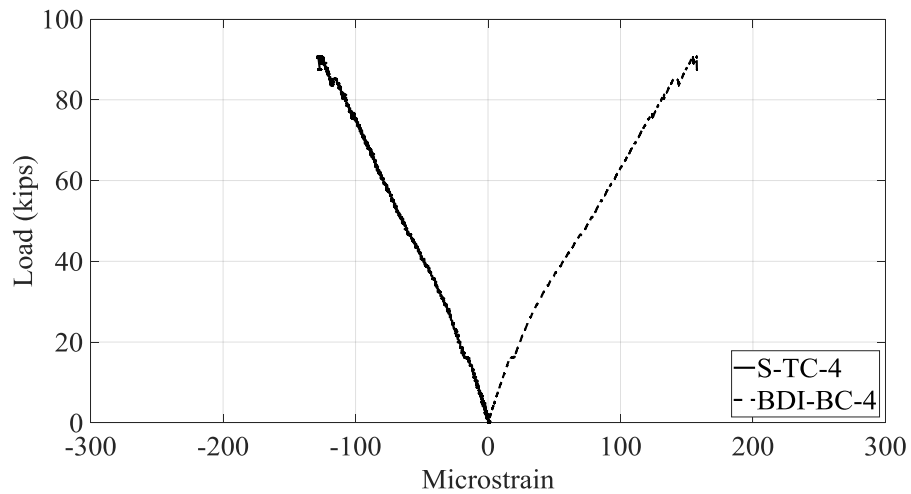
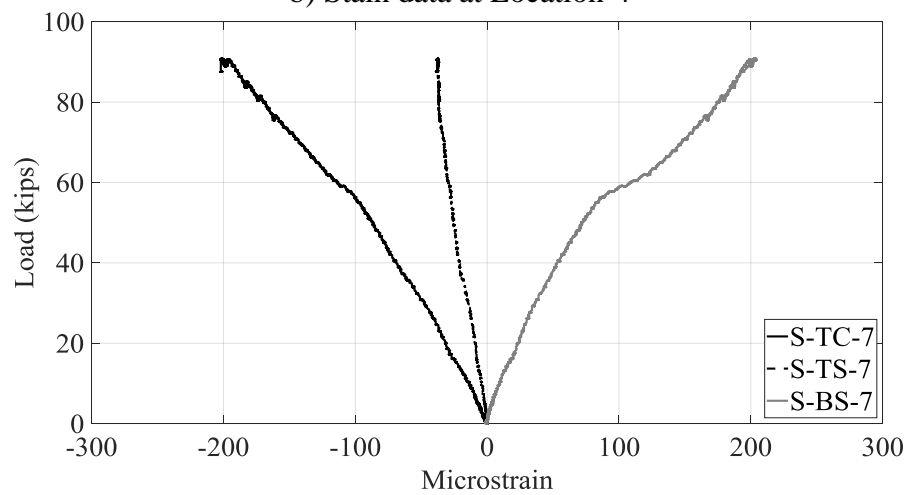
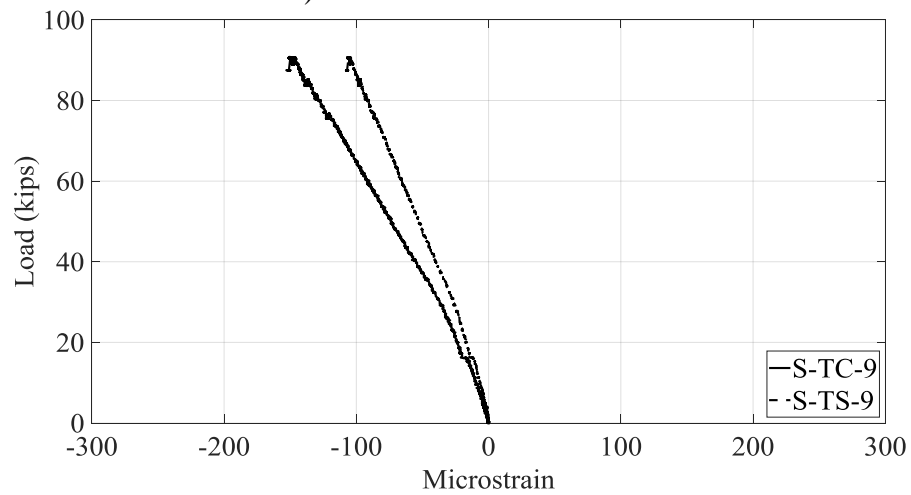
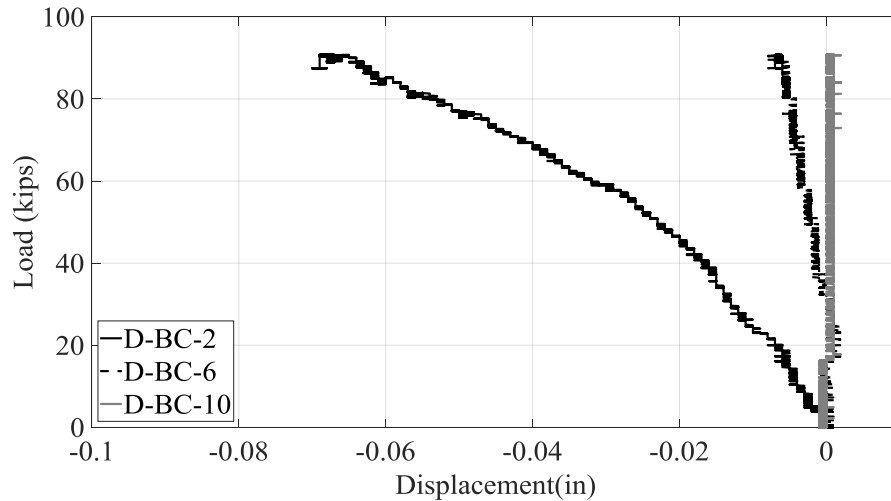
a) Stain data at Location-2

b) Stain data at Location-4

c) Stain data at Location-7

d) Stain data at Location-9

e) Selected displacement data (I)

The large strain measured from the strain gauge at the bottom of the deck surface (BDI-BC-2 in Figure 36-a) indicated that the gauge was over one or more cracks.

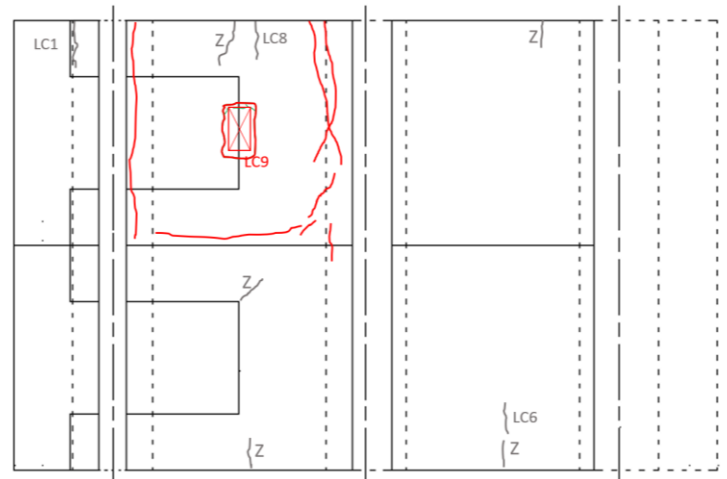
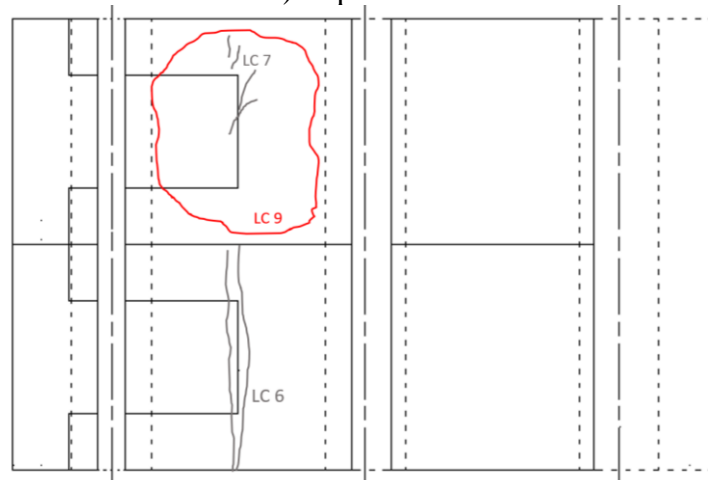
The cracks on the top and bottom surface were mapped after the completion of LC9, as shown in Figure 37.

a) Top surface

b) Bottom surface

Figure 37. Crack maps after LC9

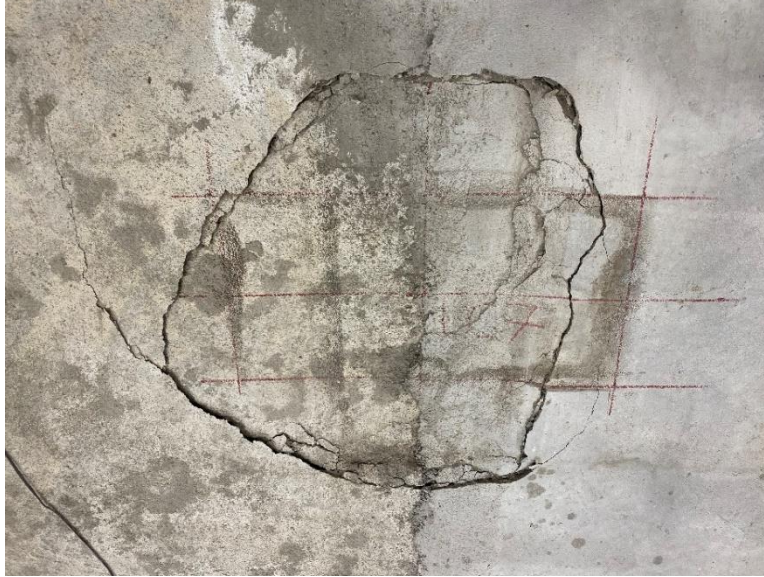
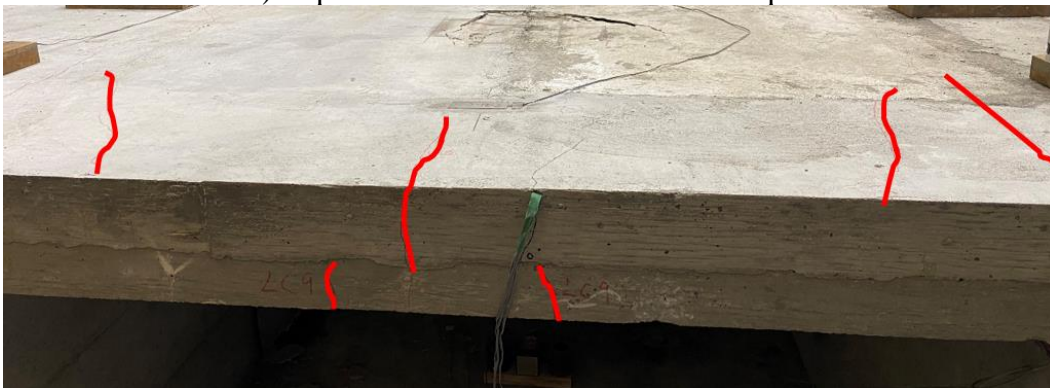
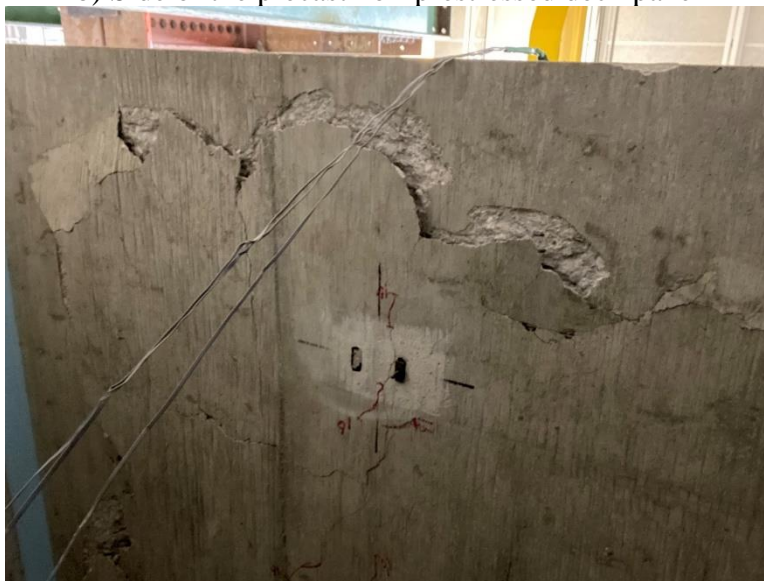
After the removal of the loading pad, punching shear failure was found, as shown in Figure 38-a.

a) Top of the deck after removal of load pad

b) Side of the precast non-prestressed deck panel

c) Spalling of deck concrete at the bottom of the deck

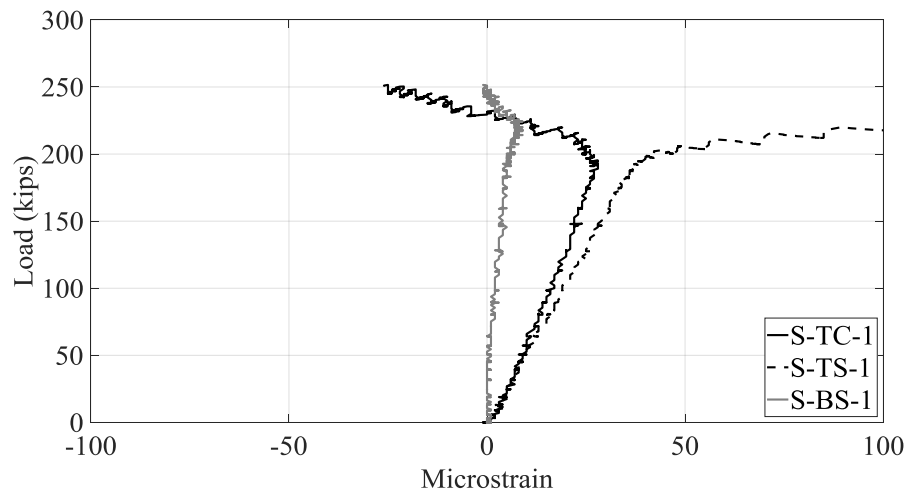
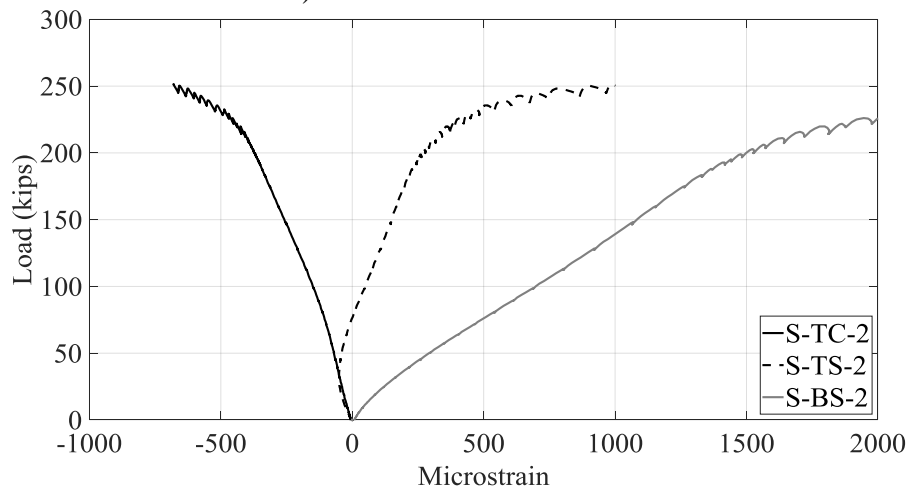
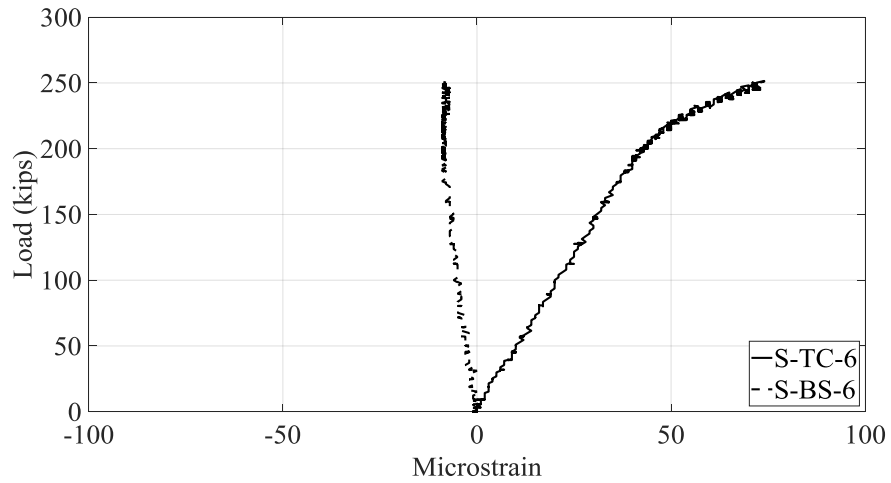
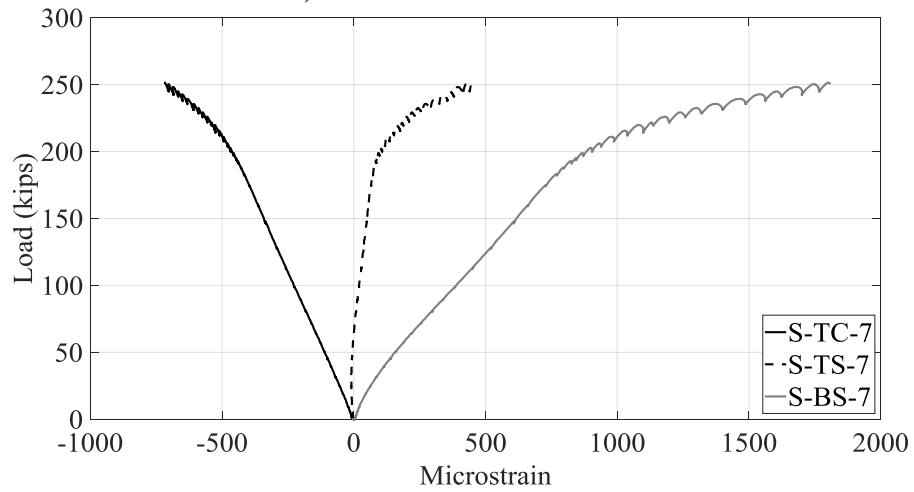
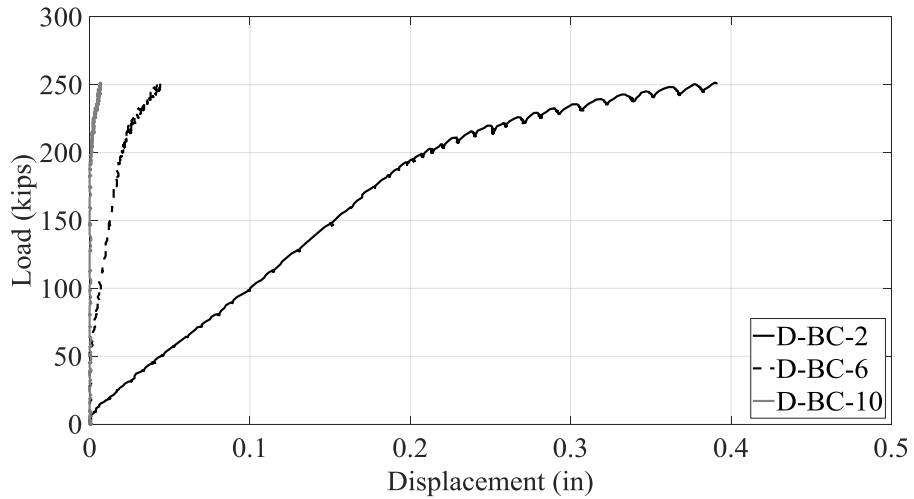
Figure 39 shows the strain and displacement data collected during LC9.

a) Stain data at Location-1

b) Stain data at Location-2

c) Stain data at Location-6

d) Stain data at Location-7

e) Selected displacement data

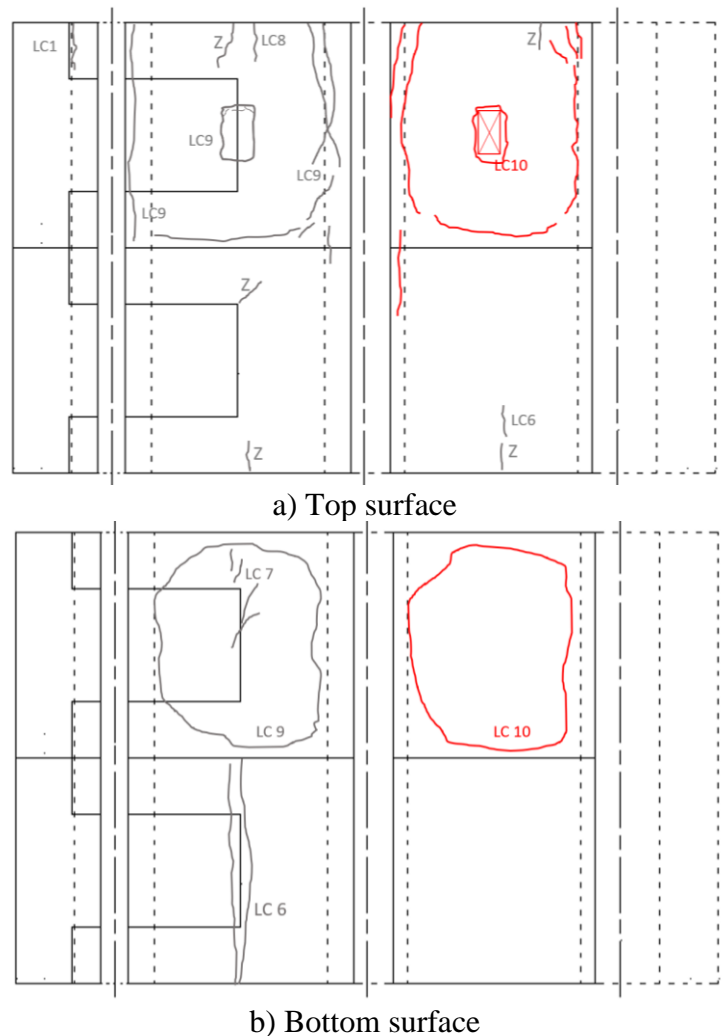
Figure 40 shows the crack maps of the top and bottom surface of the deck after LC10.

Figure 40. Crack maps after LC10

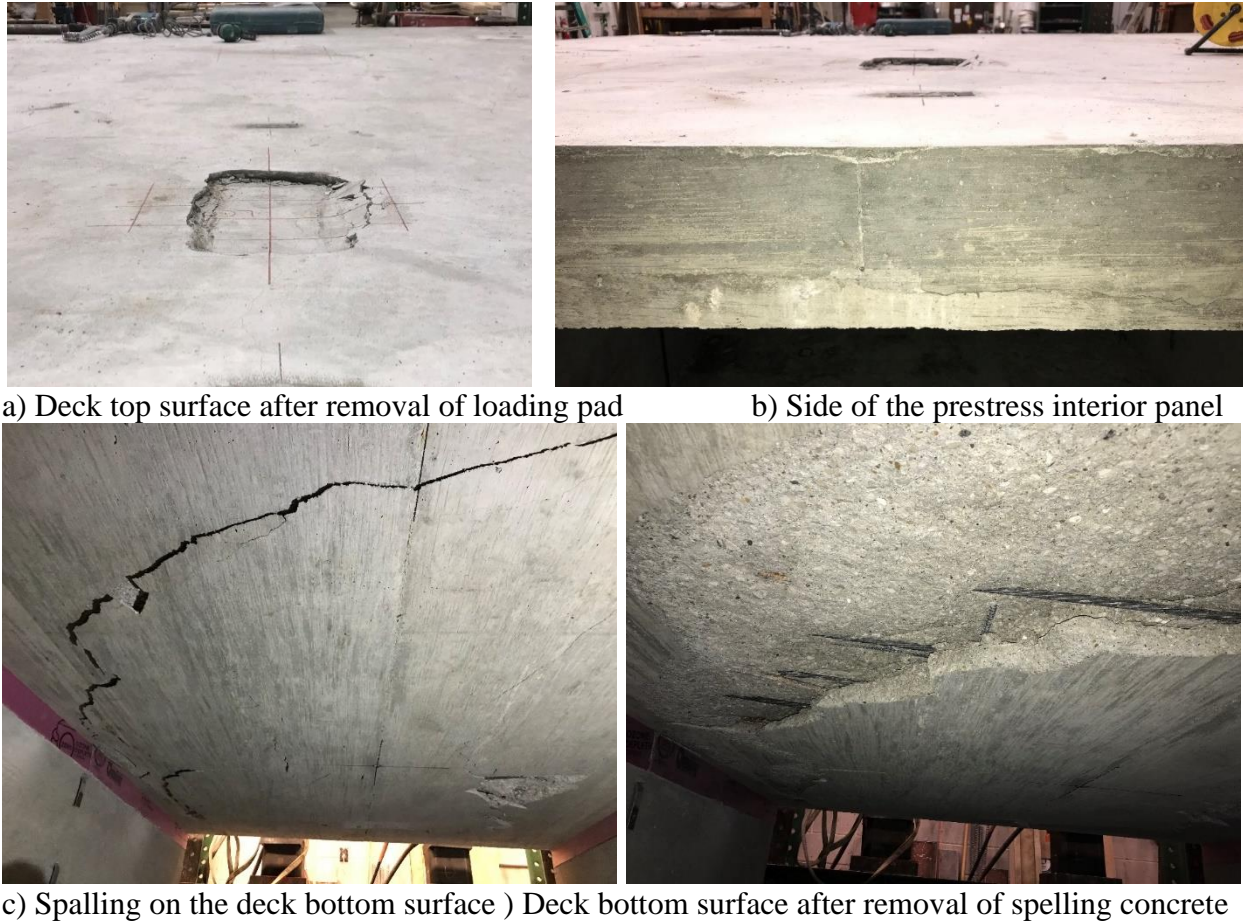
Figure 41-a shows the punching effect on the top deck surface directly underneath the loading pad.

Figure 41. Crack situation on the deck after LC10

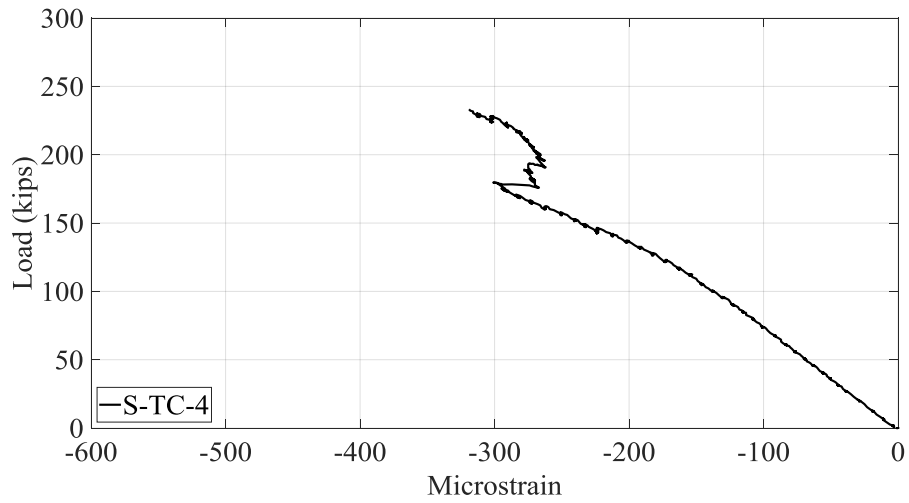
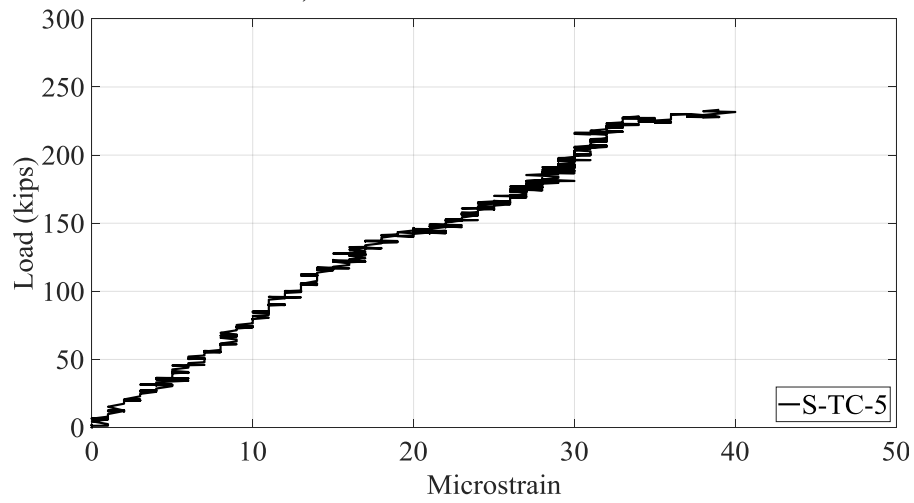
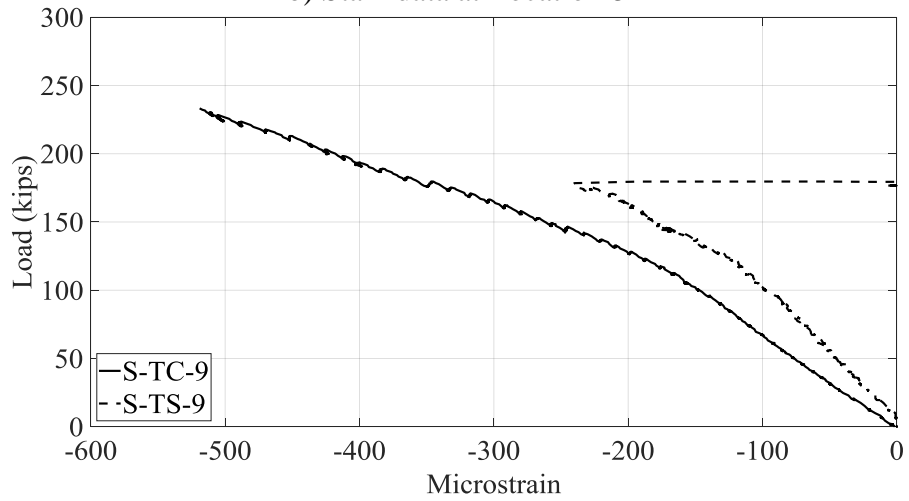
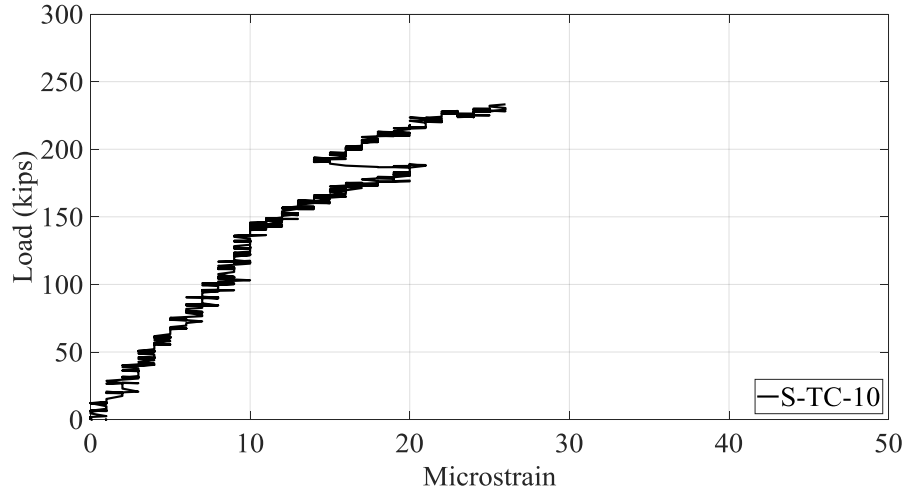
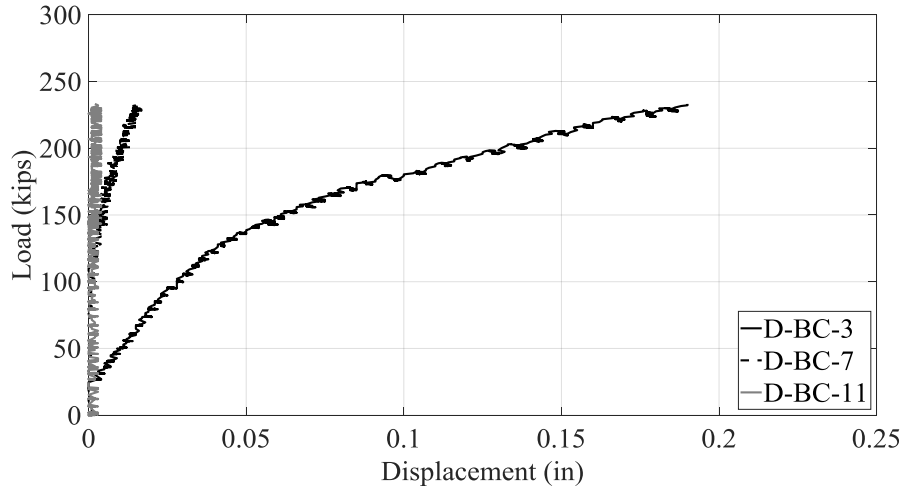
Figure 42 shows the strain and displacement data collected during LC10.

a) Stain data at Location-4

b) Stain data at Location-5

c) Stain data at Location-9

d) Stain data at Location-10

e) Selected displacement data
