# Evaluation of Penetrating Sealers for Concrete

**Literature Review**  
**May 2019**

National Concrete Pavement  
Technology Center

**Sponsored by**  
Iowa Highway Research Board  
(IHRB Project TR-765)  
Iowa Department of Transportation  
(InTrans Project 18-682)

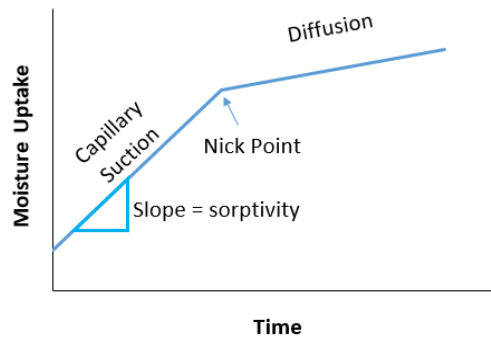
**Figure 1. Typical moisture uptake profile obtained during sorptivity testing**

The non-steady state transport will convert into a steady-state diffusion mechanism for elongated periods of contact between the liquid and concrete surface. Rate of water absorption is typically determined using the ASTM C1585 test method. An example of a moisture uptake profile typically obtained using this test is presented in Figure 1 (Liu and Hansen 2016, AASHTO PP 84).

Note the nick point separating the capillary suction and diffusion mechanisms  
After Liu and Hansen 2016

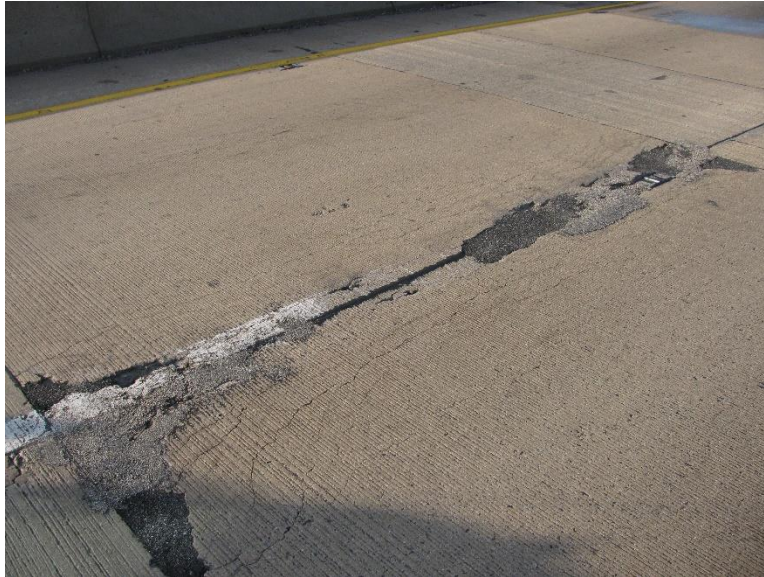
**Figure 2. Severe D-cracking in a pavement section in Pennsylvania inspected by the research team**

higher internal moisture content in comparison with mid-panel areas. Upon exposure to F/T cycles (3 to 20 years), these areas will exhibit cracking, as stated earlier, and progressive pavement distress will be the final outcome. (Kosmatka and Wilson 2016). Figure 2 presents a sample of D-cracking damage in concrete pavement.

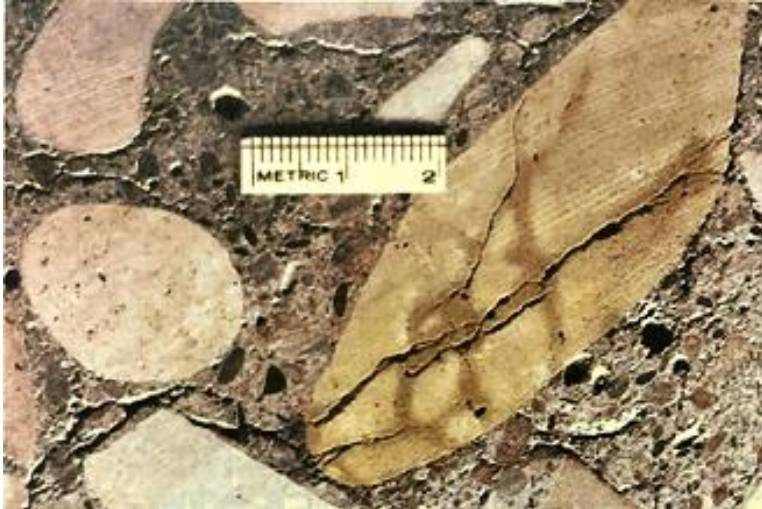
**Figure 3. Cracks propagate within the coarse aggregate structure**

The F/T resistance of aggregate is believed to be a factor of its porosity, absorption capacity, permeability, pore structure, and tensile strength (Kosmatka and Wilson 2016). If saturated to a critical degree, an aggregate with a high absorption rate may not be able to tolerate the expansive pressures caused by the water freezing inside. This can eventually result in cracking within the aggregate structure as shown in Figure 3.

It is generally reported that the coarse aggregates with high porosity values that contain medium-sized pores (within the range of 3.9 to 197  $\mu\text{m}$ . [0.1 to 5  $\mu\text{m}$ ]) are prone to F/T damage. The capillary forces in such pores can cause the aggregates to become saturated easily. At a certain rate of freezing, water in the pores cannot move out and thus develops internal pressure high enough to fracture the aggregate particle (Kosmatka and Wilson 2016).

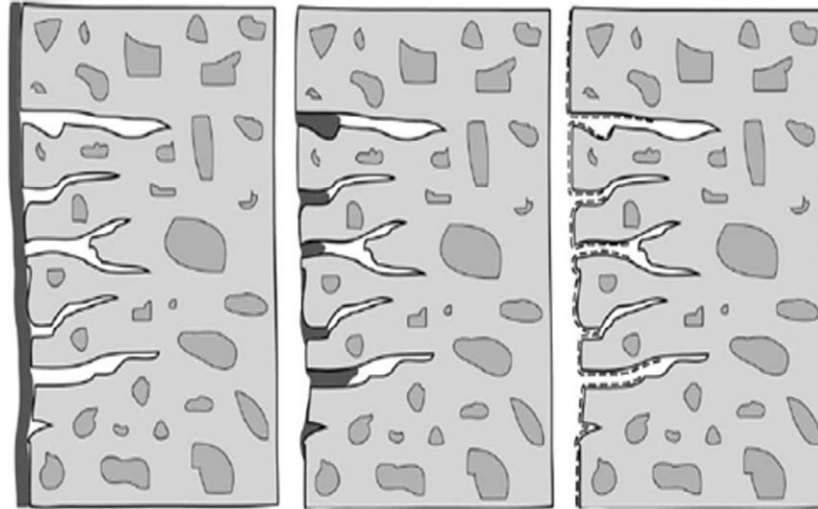
Surface treatment can be considered an additional measure for protection of concrete against ingress of deteriorating substances, e.g., chloride ions and moisture. Concrete sealers can be divided to three main categories based on their mechanism of action as shown in Figure 4.

Surface coatings

Pore blockers

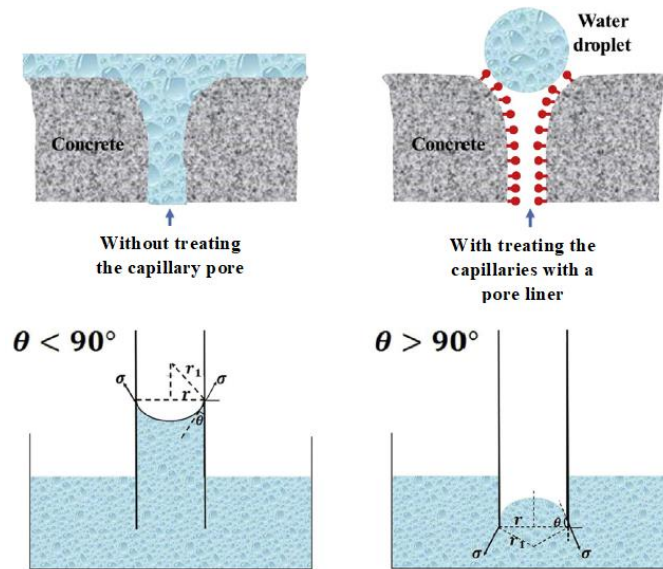
**Figure 5. Contact angle, meniscus formation, and capillary suction with (right) or without (left) a pore liner**

Given a contact angle of lower than  $90^\circ$ , capillary suction can occur spontaneously and in the form of an attraction between the liquid molecules and the porous substrate. This leads to a capillary rise and a concave meniscus as depicted in Figure 5.

In the case of a treated substrate where capillary pores are lined with a hydrophobic sealer, such pressure differences will be reversed and extra energy will be required for moisture penetration (Liu and Hansen 2016).

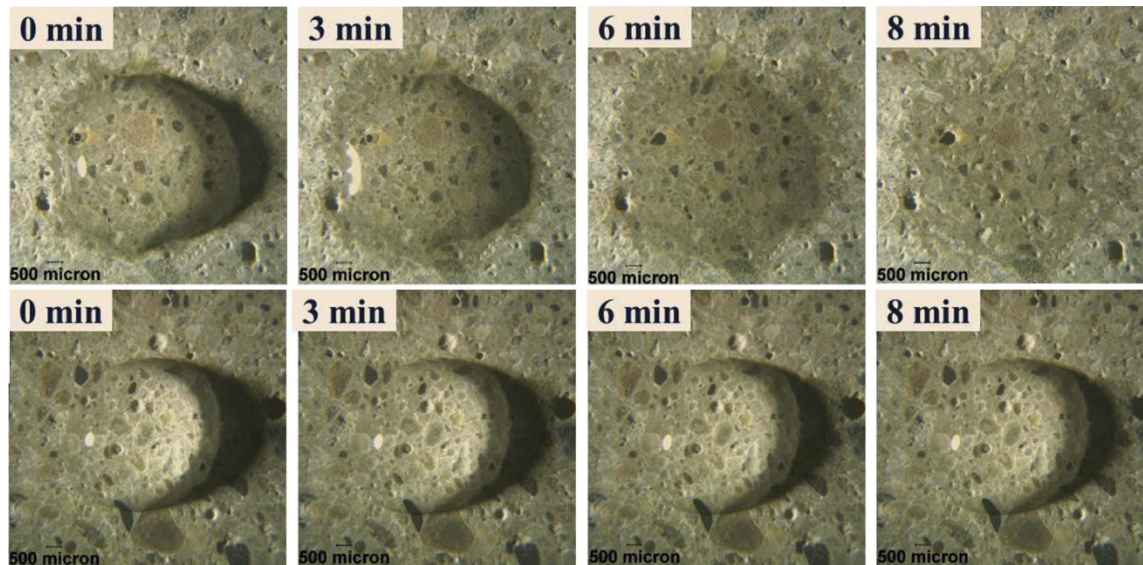
**Figure 7. Increase in contact angle due to the hydrophobic effect of silane with 40% active ingredient showing untreated control sample (top row) and silane-treated concrete (bottom row)**

Liu and Hansen (2016) investigated the effect of silane-based water repellents on F/T durability of concrete. Two sealers were used, one with 40% active ingredients and the other one with 100% active ingredients. Specimens from a laboratory investigation exhibited an increase in contact angle between water and the treated concrete surface, as presented in Figure 7, followed by significant reduction in sorptivity and moisture uptake.

Results obtained from testing the laboratory and field specimens indicated the positive effect of silane treatment on scaling resistance of the concrete with a high w/cm ratio exposed to deicers. However, the authors reported that the silane treatment failed to protect the concrete with an inadequate air-void system against bulk moisture uptake and internal distress caused by F/T cycles.

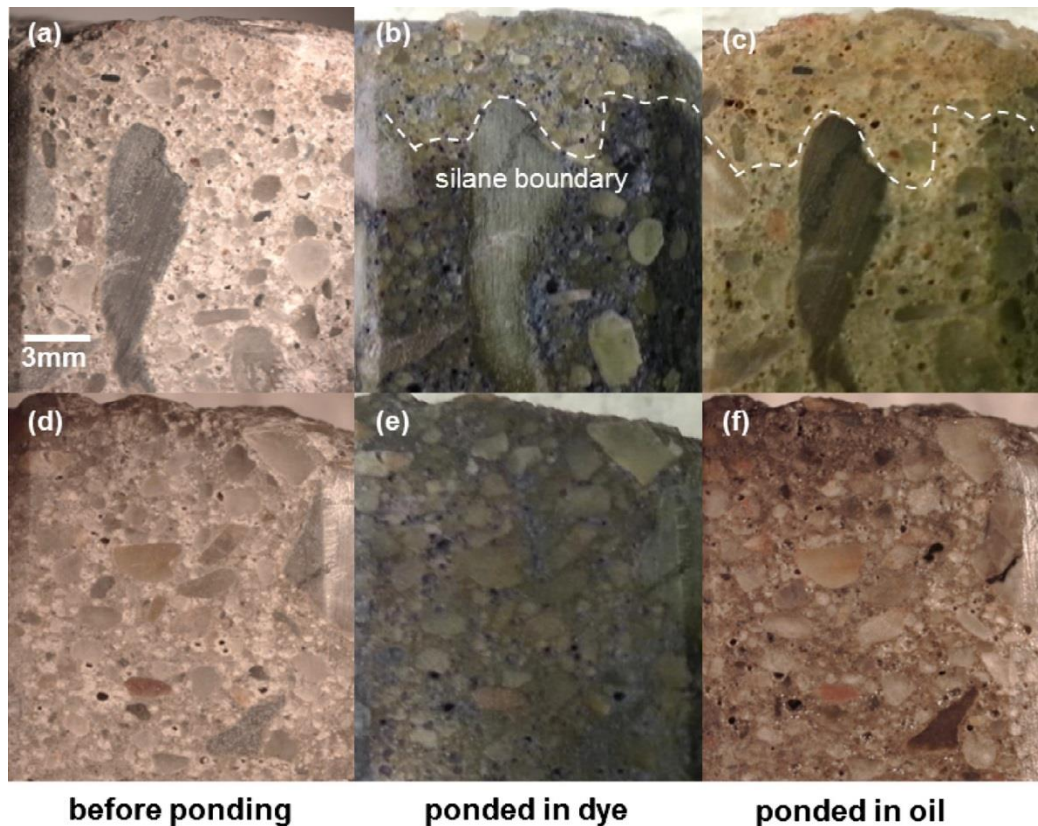
**Figure 8. Staining technique incorporated by Moradillo et al. (2016) to investigate the depth of silane-based sealer penetration into bridge deck concrete showing cores treated with silane (top row) and specimens without any treatment (bottom row)**

Moradillo et al. (2016) investigated the field performance and effective life of silane-based water repellents applied on bridge decks in Oklahoma. The study summarized data obtained from testing 360 concrete cores, extracted from 60 bridges in service for 6 to 20 years. The authors employed a visual technique, based on staining the split cores to determine the depth of sealer penetration as shown in Figure 8.

A time-dependent efficiency was reported by the authors, where 100% of the sealers younger than 12 years old exhibited a penetration depth of greater than 1/8 in. (3.2 mm) as the minimum requirement. This was reduced to 68% in the case of sealers applied over 15 years before testing, and further reduced to 16% for sealers between 17 and 20 years old. The authors also reported similar silane thickness for the travel lane and the shoulder areas, indicating minimal degradation due to abrasion. More importantly, fewer than 5% of the investigated samples exhibited deterioration of silane at the concrete surface, indicating minimal damage caused by ultraviolet light and weathering. The reduction in overall thickness of the silane layer over time, however, was reported to be mainly due to the interaction with the alkaline pore solution.
