# Minnesota DOT Experience with High Performance Dowel Bars

Maria Masten, P.E.

MnDOT Concrete Engineer

Spring 2026 NC2 Meeting – April 8, 2026

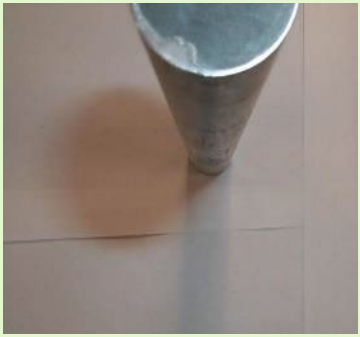
**Stainless Steel Clad  
with Steel Core  
Approved 2000**

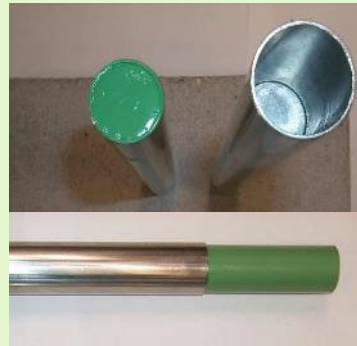
**Stainless Steel Tube with  
Steel Core  
Approved 2006\***

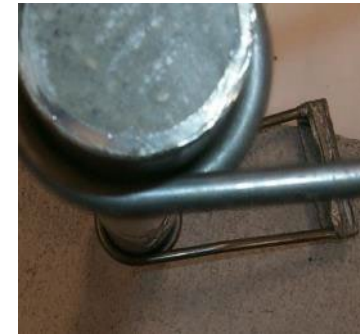
**Stainless Steel Tube  
with Grout  
Approved 2006**

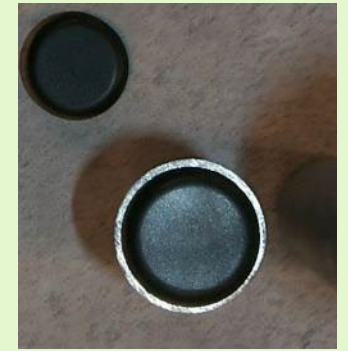
**Stainless Steel Pipe  
Approved 2006\***

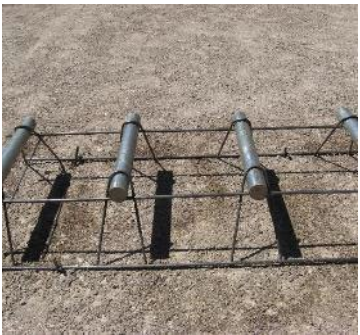
**Zinc "Clad" Rolled Alloy  
Sleeve  
Approved 2006**

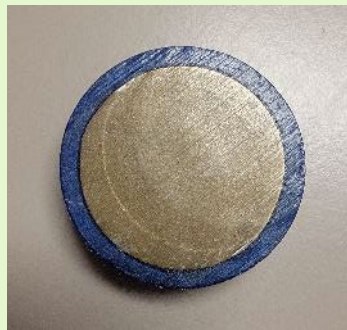
**Glass Fiber Reinforced  
Dowel over Carbon Steel Bar  
Approved 2013**

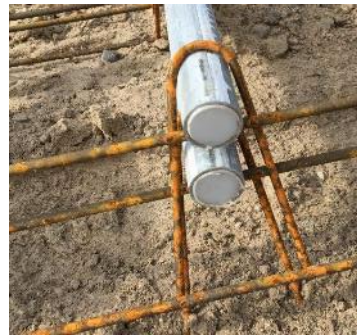
**Zinc Galvanized Steel  
Tube  
Approved 2016**

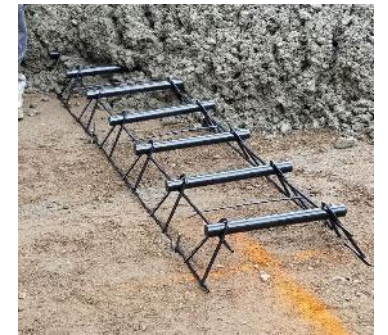
**Carbon Steel with A934  
Epoxy and Abrasion  
Resistant Overcoat  
Approved 2017\***

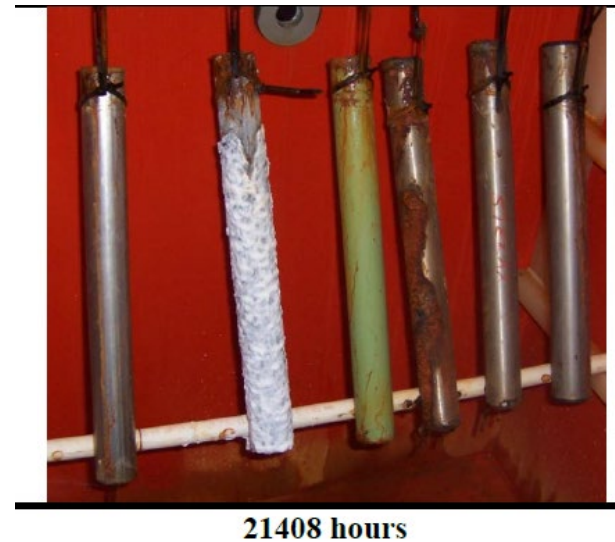
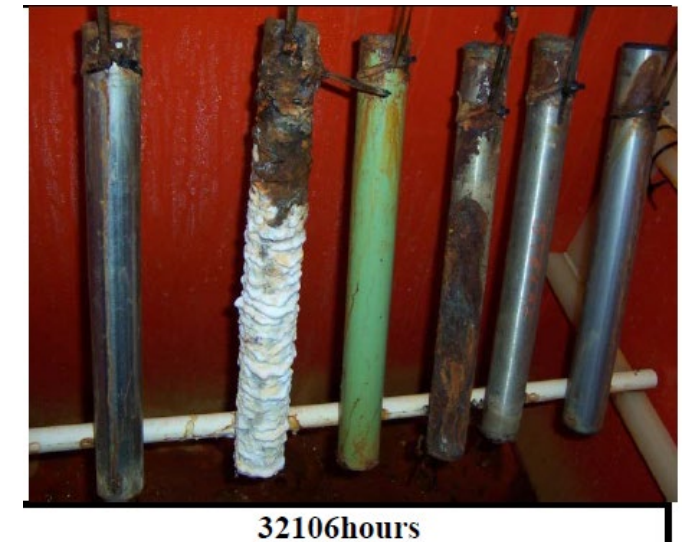
# MnDOT Salt Fog Corrosion Chamber (ASTM B117-09) – Testing performed in 2008 for 44 months

- 1 – Stainless steel tube with steel core
- 2 – Zinc clad carbon steel bar
- 3 – Epoxy coated steel bar
- 4 – Stainless steel clad bar
- 5 – Stainless steel clad bar
- 6 – Stainless steel tube with caps

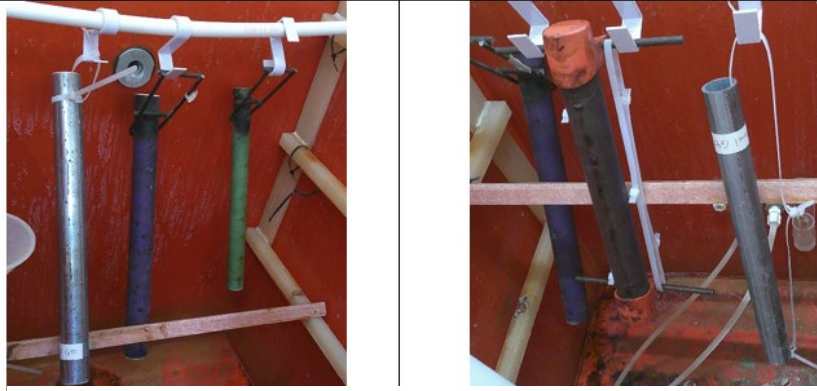
Week Zero

# MnDOT Salt Fog Corrosion Chamber (ASTM B117-09) – Testing performed in 2024 for 13 weeks

Appearing (Left to Right): Zinc galvanized tube without epoxy with caps on both ends; Zinc galvanized tube with A934 epoxy with caps on both ends; Epoxy coated dowel bar; Zinc galvanized tube with A934 epoxy with cap on one end; Zinc galvanized tube with A934 epoxy with plastic caps on both ends; Zinc galvanized tube without epoxy and no caps

# Conclusions – Salt Fog Corrosion Chamber Testing

- Showed minimal to no signs of corrosion
  - Stainless Steel Tube with Steel Core
  - Epoxy Coated Steel Dowel Bar
  - Stainless Steel Tube with Caps
  - Stainless Steel Clad (1 manufacturer)
  - Zinc Galvanized A934 Epoxy steel tube capped and with plastic cap
- Showed signs of significant corrosion (hydrozincite, aka “white rust”)
  - Stainless Steel Clad (1 manufacturer)
  - Zinc “Clad” Rolled Alloy with steel core
  - Zinc Galvanized steel tube (non-epoxy coated)

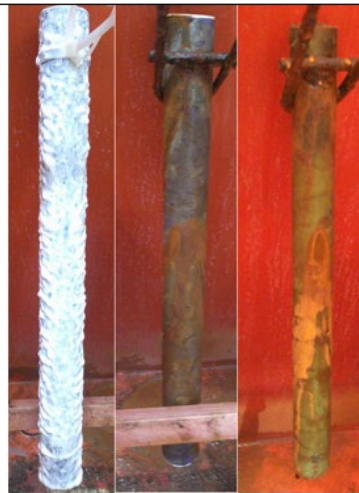
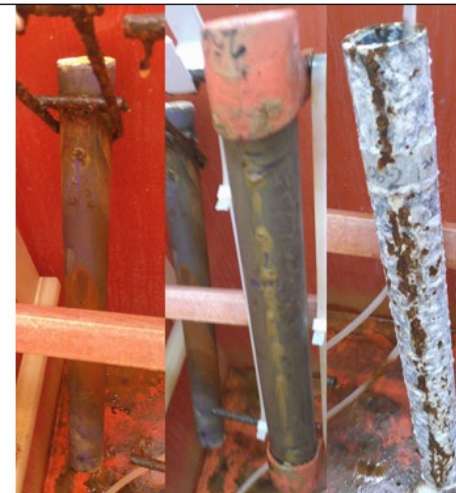
Week Thirteen (No pictures for Week Twelve)

Zinc Galvanized Tubes  
w/out epoxy      with A934 epoxy

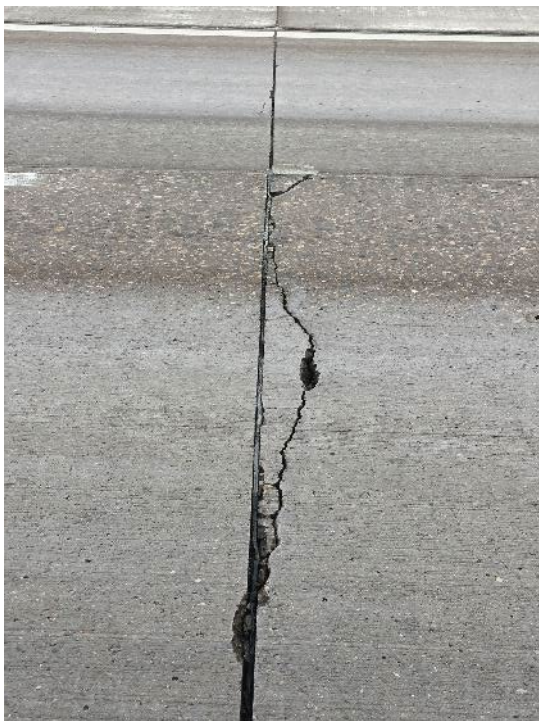
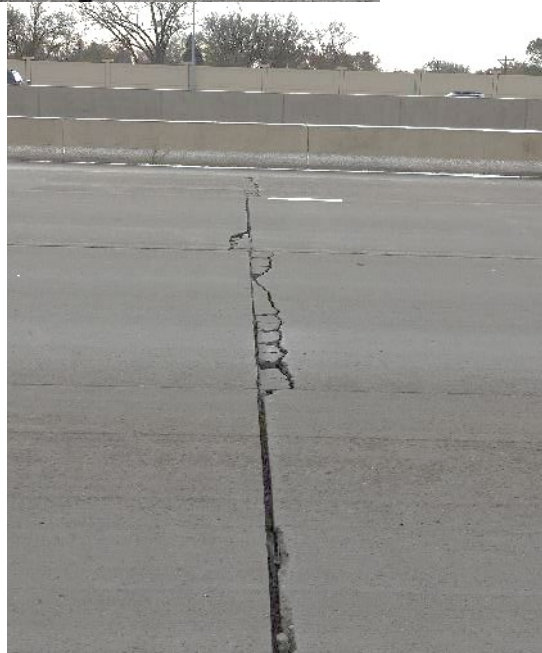
## MnDOT Experience – GFRP Coated Steel Bars

- **Used on 5 projects between 2014 and 2018**
- **Needed alternative solution for attaching bars to baskets**
- **Issues when installing dowel bars in header sections**
- **Concerns with recycling in the future**

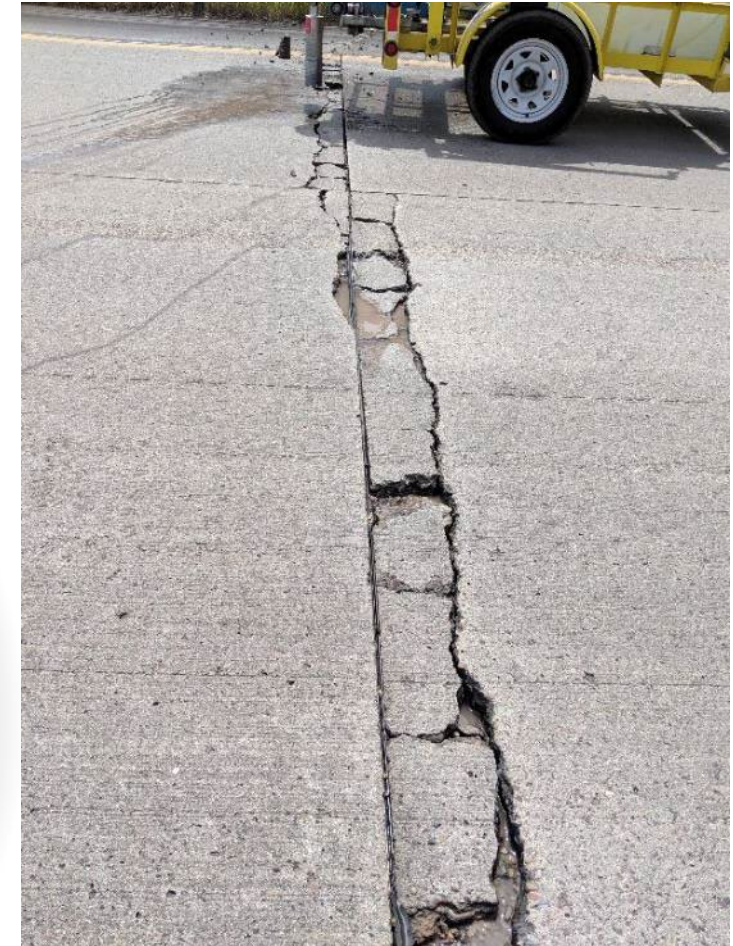
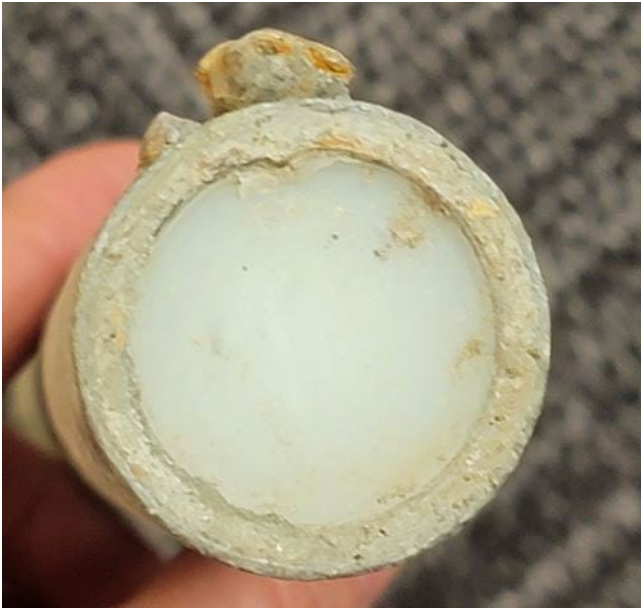
MnDOT  
Experience –  
Zinc Rolled  
Alloy Sleeve  
Bonded to  
Solid Steel Bar

- Used on 8 projects between 2007-2016
- In 2016, Started observing non-typical pavement distresses
- Removed from APL in 2020

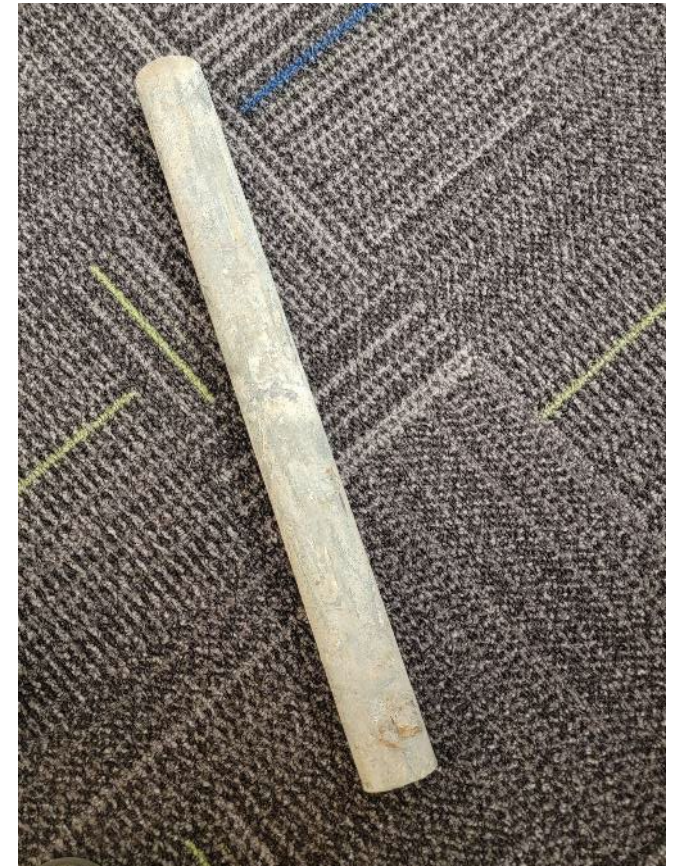
## MnDOT Experience – Zinc Galvanized Steel Tubes (non-epoxy coated)

- **Used on 1 projects between 2016 – 2017**
- **Due to issues with zinc clad bars, decided to core these bars also**
- **MnDOT was only State to allow non-epoxy coated**
- **Removed from APL in 2020 as a precautionary measure**

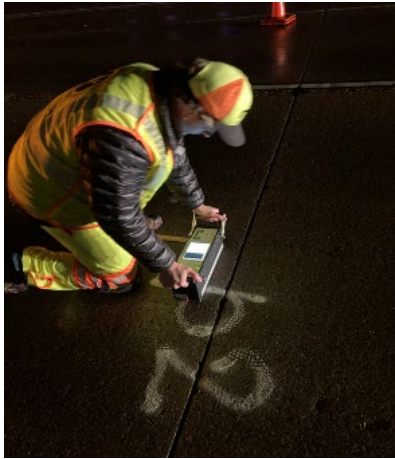
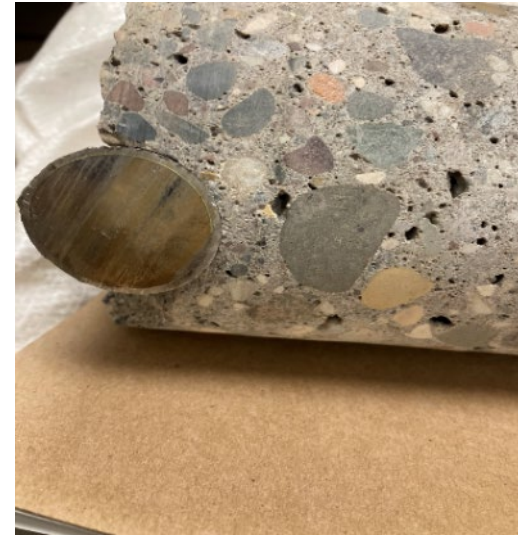
MIRA Testing  
(Red  
represents  
dowel bar)

# MnDOT High Performance Dowel Bars – 494 Bailey Rd Stainless Steel Clad with Steel Core

Placed 2003-  
2005

Cored 2020

15 years old

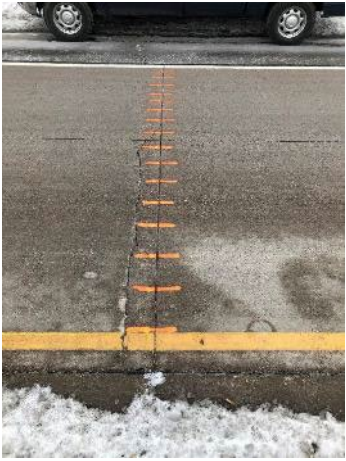
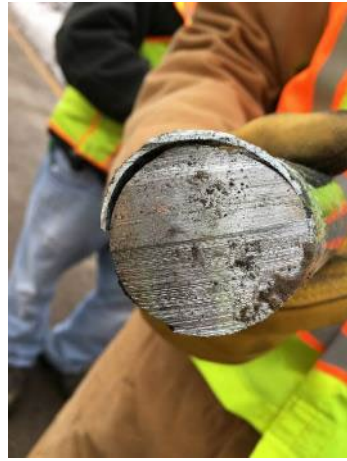
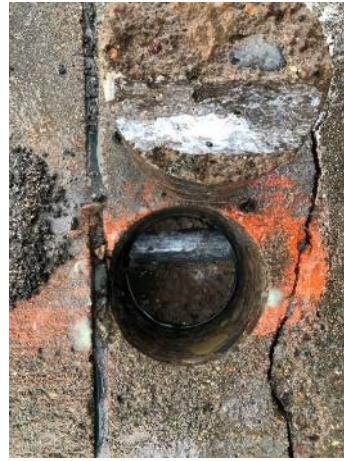
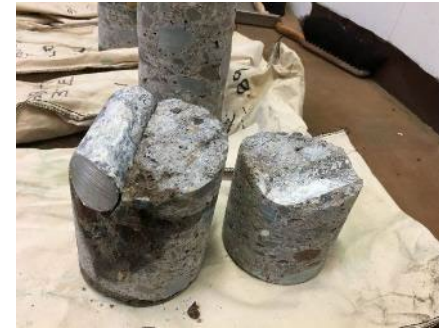
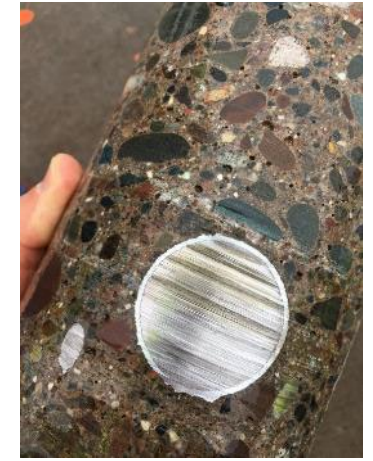
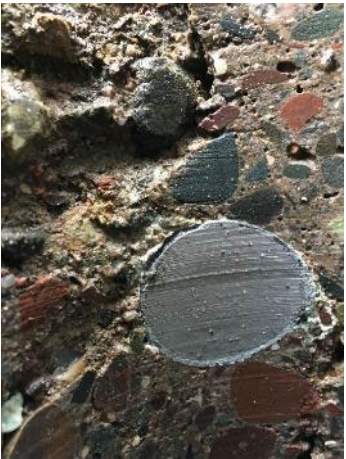
# MnDOT High Performance Dowel Bars – 35E/694 Zinc “clad” rolled alloy sleeve with steel core

Placed 2007-  
2009

Cored 2020

~12 years old

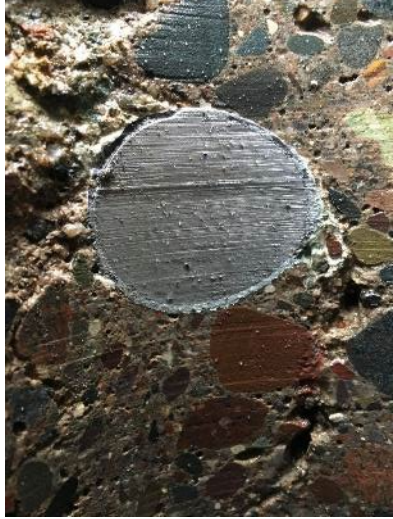
# MnDOT High Performance Dowel Bars – 35E/694 Zinc “clad” rolled alloy sleeve with steel core

Placed 2007-2009

Cored 2020

~12 years old

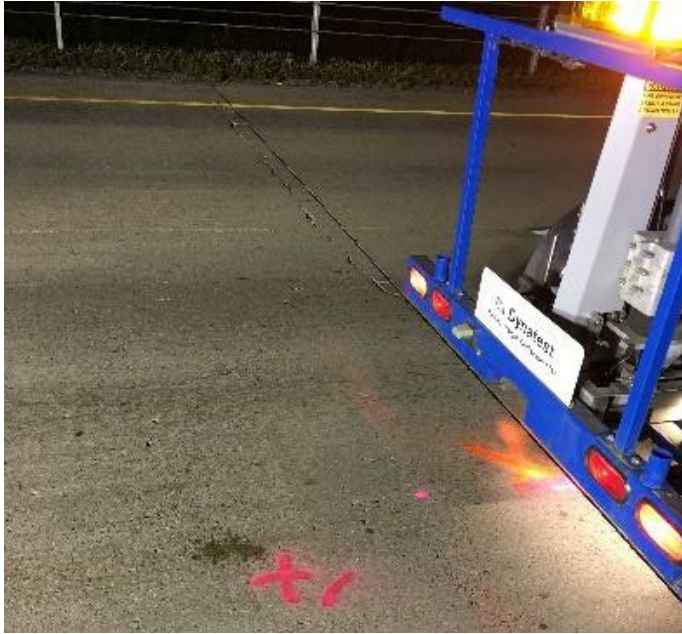
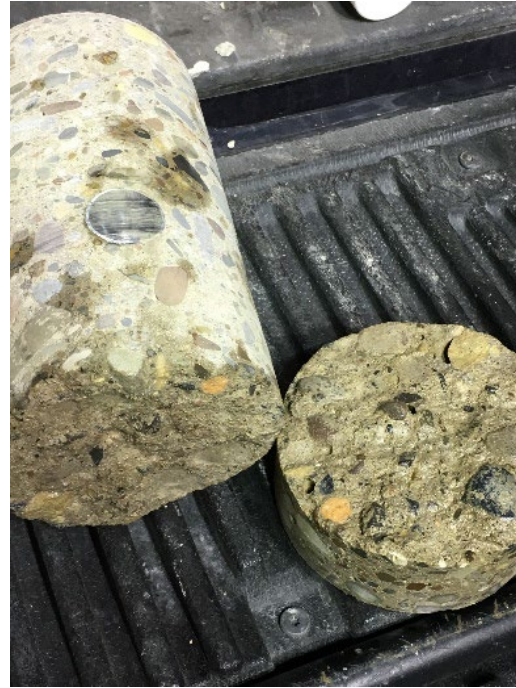
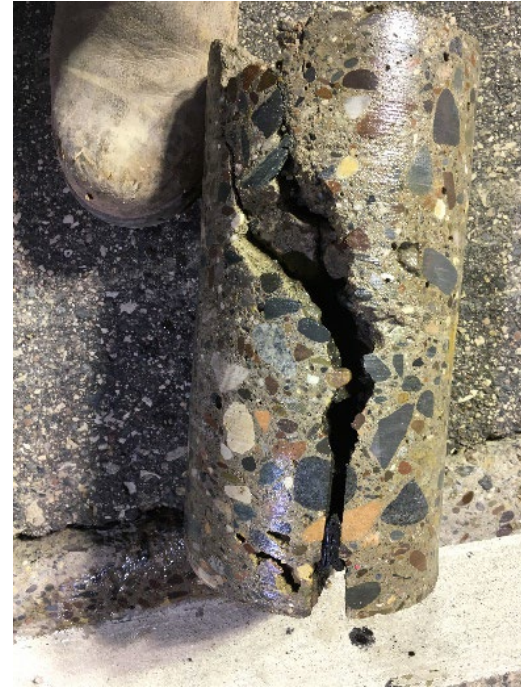
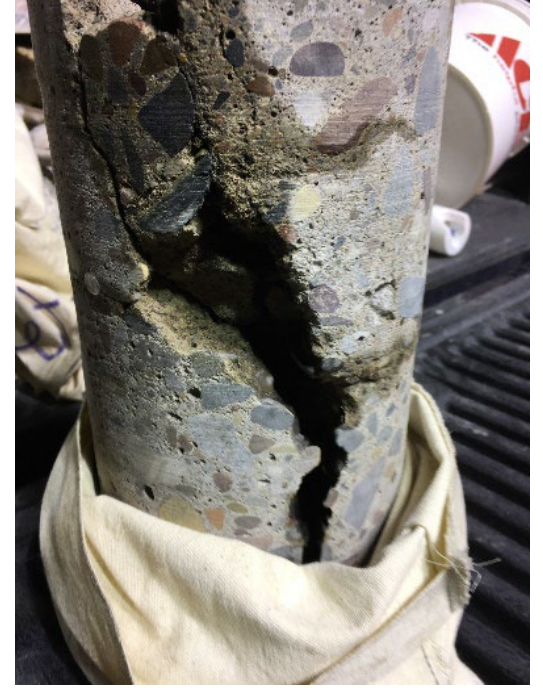
# MnDOT High Performance Dowel Bars – 694/TH 36 Zinc “clad” rolled alloy sleeve with steel core

Placed 2010  
Cored 2020  
10 years old

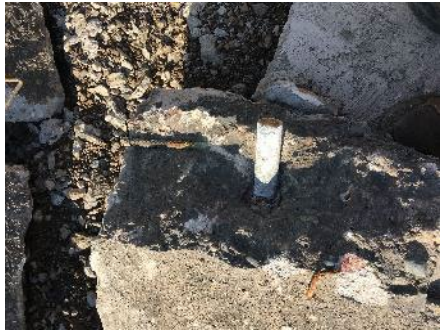
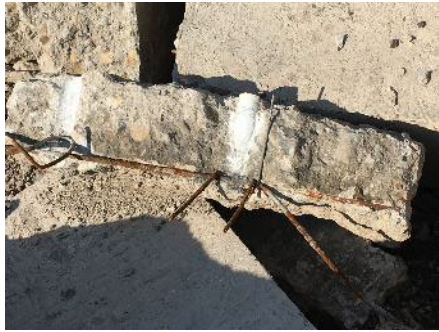
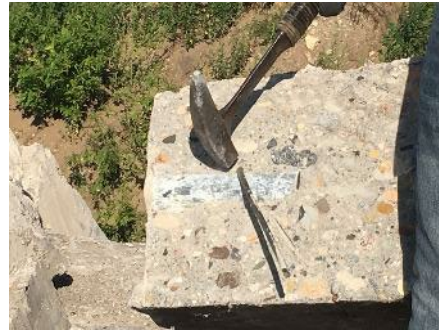
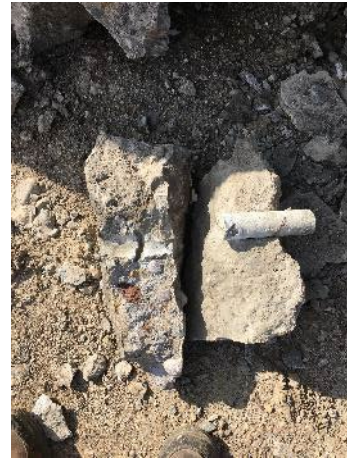
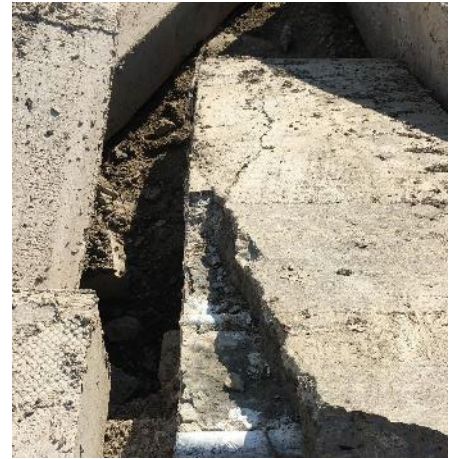
# MnDOT High Performance Dowel Bars – 35W/TH 62 Zinc “clad” rolled alloy sleeve with steel core

Placed 2008-  
2010

Cored 2020

~11 years old

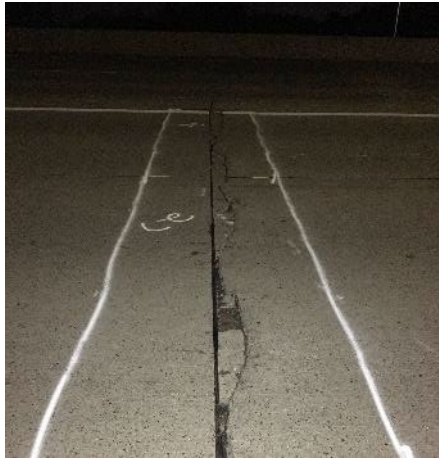
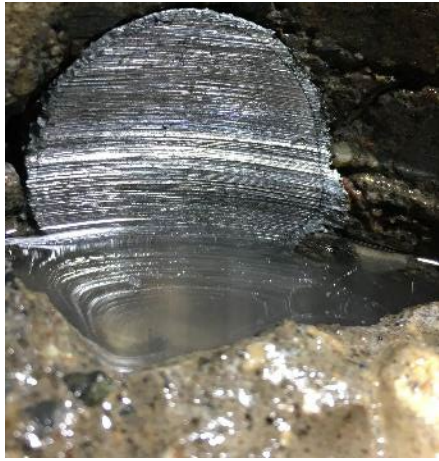
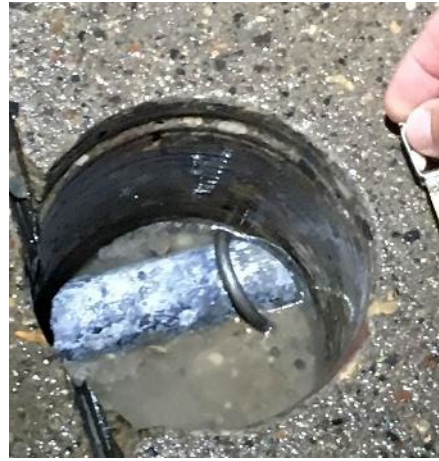
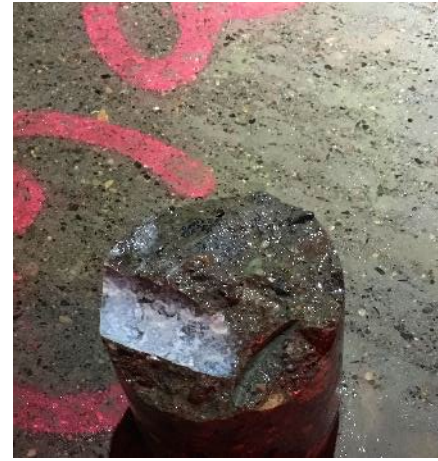
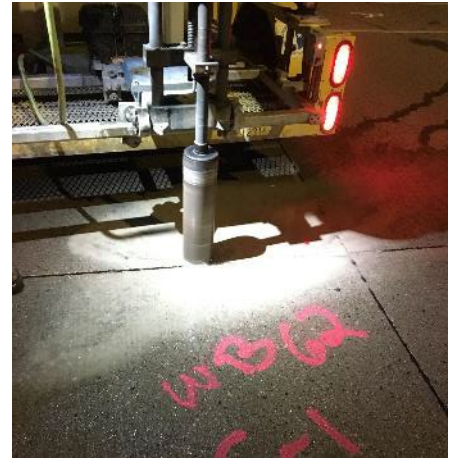
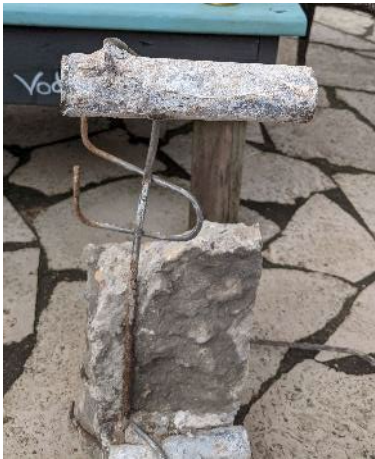
# MnDOT High Performance Dowel Bars – 35W/TH 62 Zinc “clad” rolled alloy sleeve with steel core

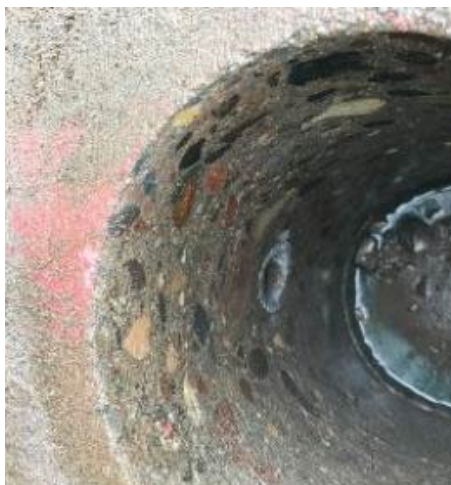
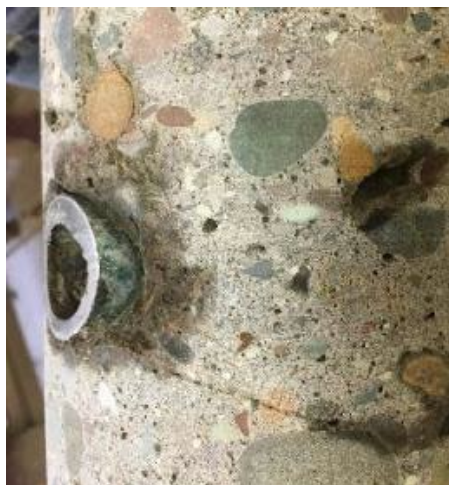
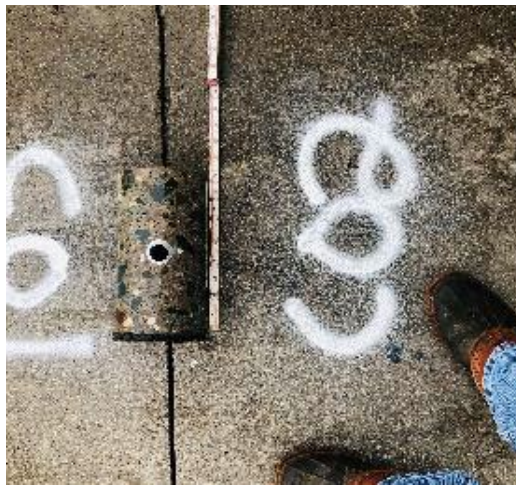
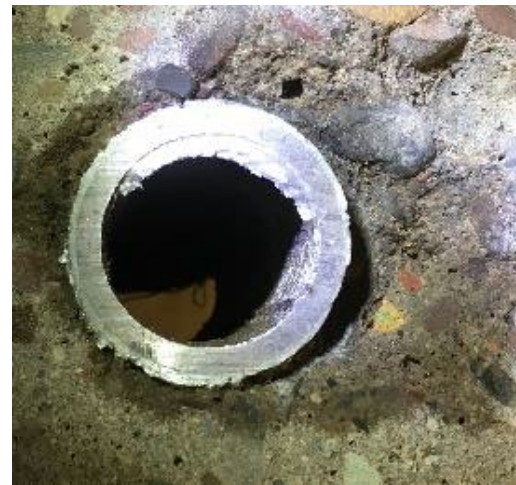
# MnDOT High Performance Dowel Bars – TH 694/Rice Street Zinc Galvanized Steel Tube (without epoxy)

Placed 2016

Cored 2020

4 years old

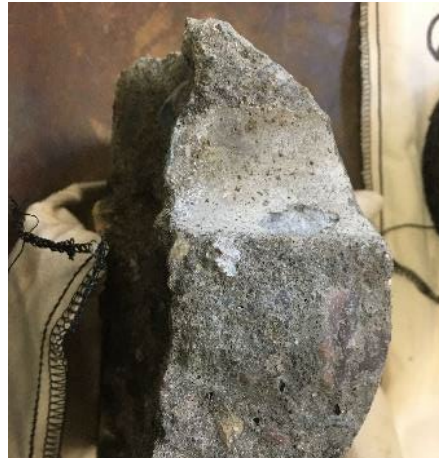
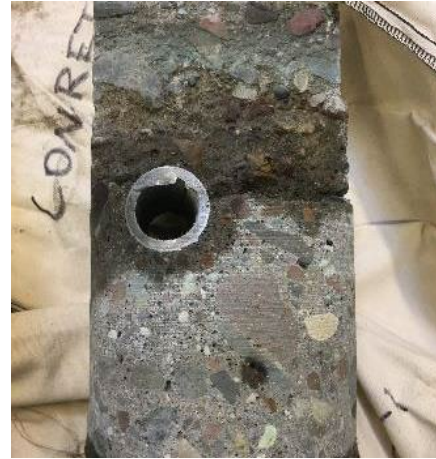
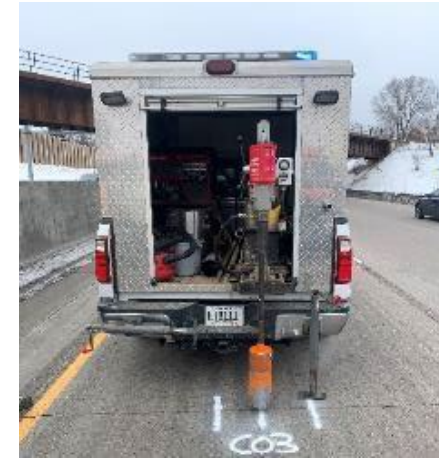
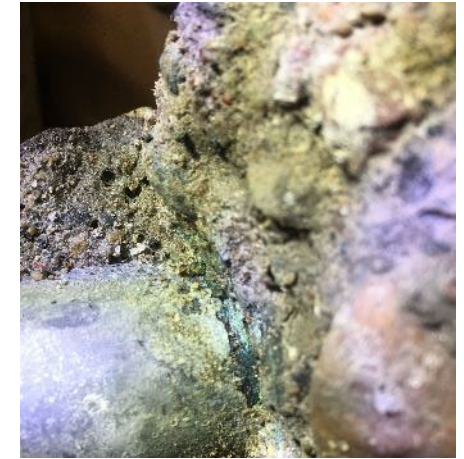
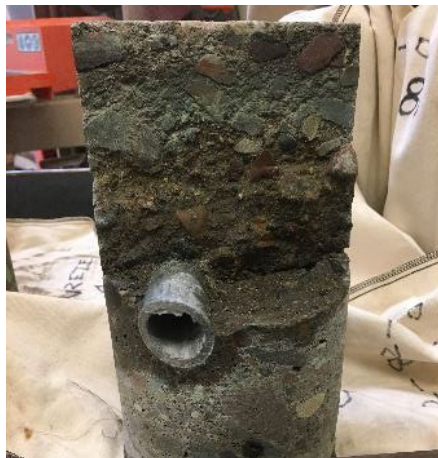
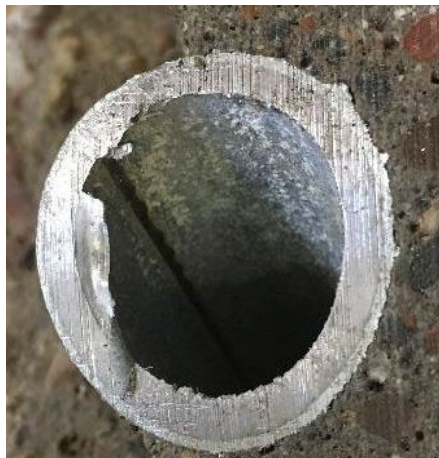
# MnDOT High Performance Dowel Bars – TH 694/Rice Street Zinc Galvanized Steel Tube (without epoxy)

Placed 2016  
Cored 2020  
4 years old

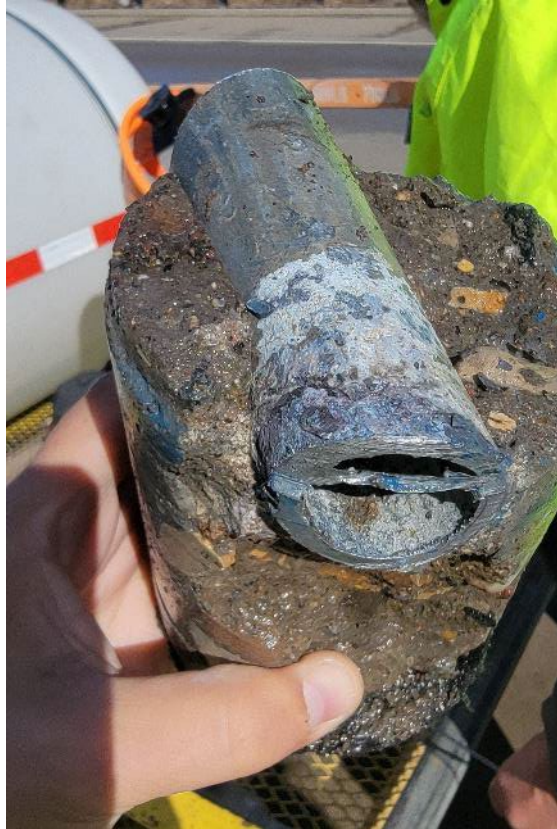
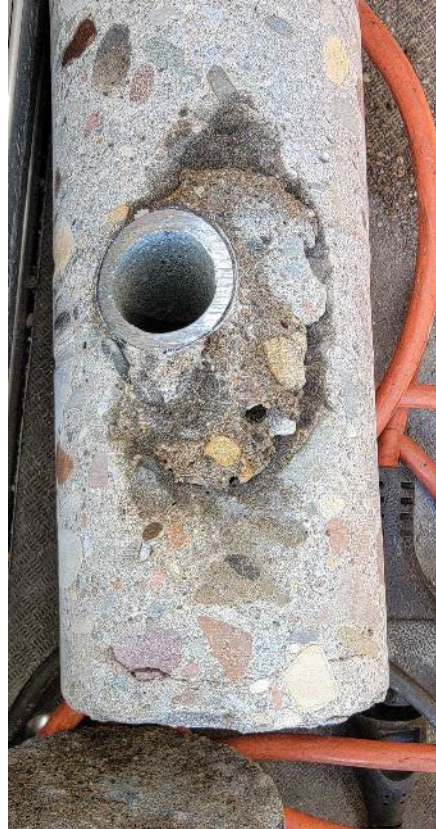
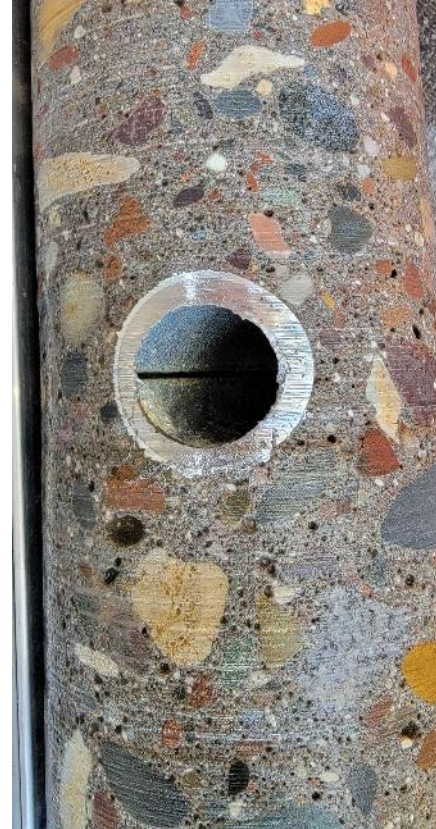
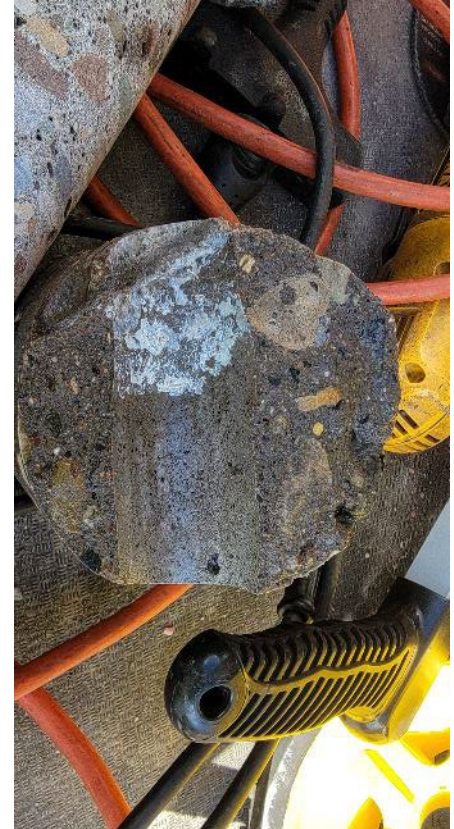
# MnDOT High Performance Dowel Bars – TH 694/Rice Street Zinc Galvanized Steel Tube (without epoxy)

Placed 2016

Cored 2025

9 years old

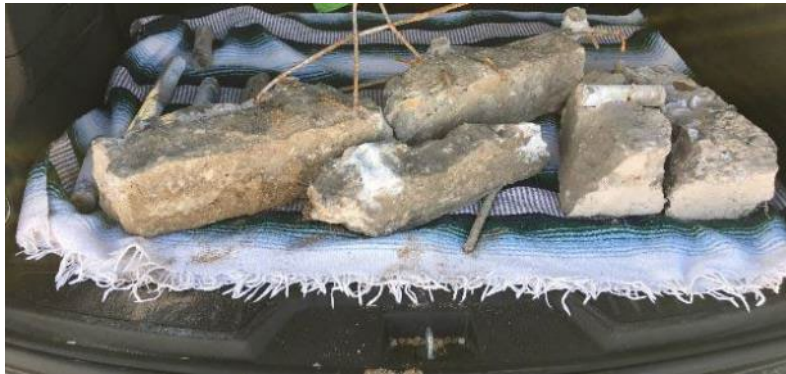
Photo: 13  
Sample ID: 62A  
Mag: 5x  
Description: Corrosion product coating a fragment of concrete originally located within the vertical fracture plane of the sample, as viewed at low magnification.

- Images show corrosion product coating the fracture plane and coating the zinc clad dowel bar
- Similar conditions observed in other zinc clad dowel bars from other projects

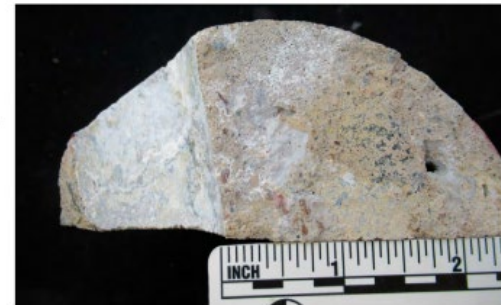
Photo: 16  
Sample ID: 62A  
Mag: 10x  
Description: White corrosion product lining the dowel bar impression, as viewed on saw cut and lapped cross section at low magnification.

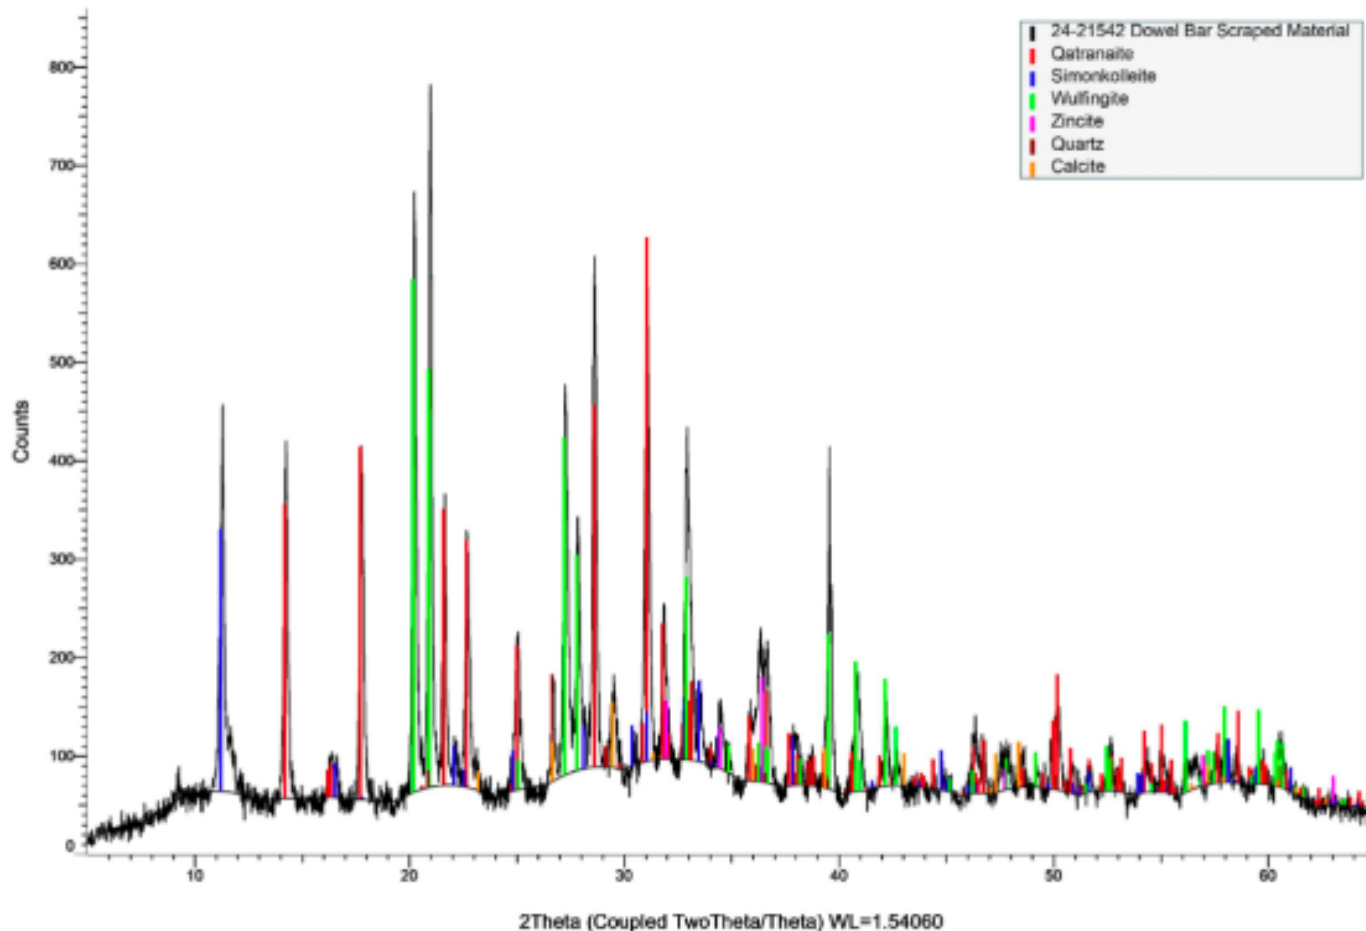
24-21542 MNDOT Dowel Bar Scraped Material Powder X-Ray Diffraction Rescan

- Elements found from Zinc Clad Dowel Bar Scraped Material
  - Qatranite (calcium hexahydroxodixincate dihydrate)
  - Simonkollite (zinc hydroxchloride)
  - Wulfingite (zinc hydroxide)
  - Zincite (zinc oxide)
  - Quartz
  - Calcite
- Similar conditions observed in zinc clad dowel bars from other projects (4 analysis from 3 projects)

**Description:** X-ray diffraction pattern of scraped corrosion product from dowel bar.

- The original petrographic analysis on TH 694 in Oakdale showed traces of other corrosion products which were not initially considered when the original search was for Hydrozincite. In practice, other corrosion products are more likely to occur than would hydrozincite.
- Subsequent corrosion products observed included Wulfingite and Zincite and a final revisiting of the samples resulted in a detection of a very strange and relatively rare product called Qatranite.
- Initial petrographic analysis showed a preponderance of Simonkollite which is a product that would occur in the presence of air water and deicing compounds.
- Zincite, Wulfingite and Qatranite are products that would form in the presence of air and water and would not need deicers to form. The Chemical formula of Hydrozincite suggests that it can be overwhelmed by deicing compounds to result in Simonkollite.

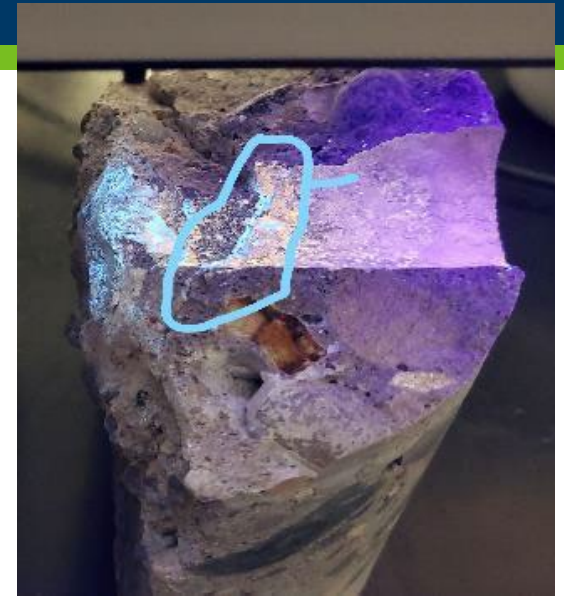
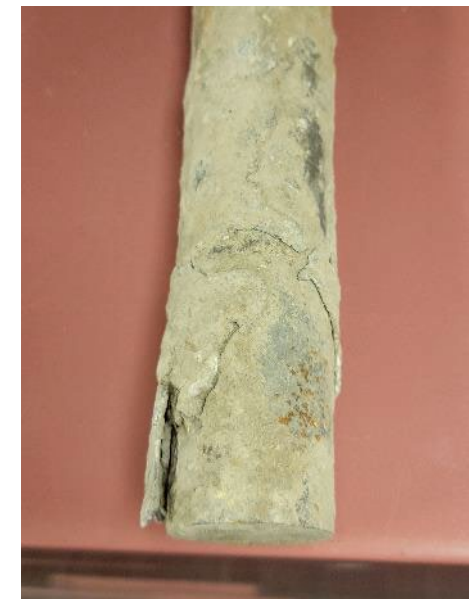
- Field performance of the pavement sections containing zinc clad dowel bars has exhibited non-typical cracking at the surface
- As a precautionary measure, field coring of zinc galvanized dowel bar (non-epoxy coated) were also cored
- Coring identified some type of volume changes related to the zinc in both types of dowel bars, resulting in a white substance appearing on the outside of the dowel bar and in some cases, expanding into the adjacent concrete surface.
- It seems the joints locked up either due to the zinc corrosion product or the zinc cladding sleeve breaking away from the dowel bar causing a non-uniform section for the joint to expand and contract.
- Other High Performance Dowel Bars (solid stainless and stainless steel clad) sections have not exhibited this abnormal cracking nor displayed any sort of “corrosion” when cored

- Some concerns with application/lack of proper application of form release agent in the field and if that contributed to the zinc clad and zinc galvanized dowel bars locking up the joints or a chemical reaction between the form release and the zinc product
- MnDOT now requires dowel bars and dowel baskets to be dipped in a waxy bond breaker material. (Effective June 2020)

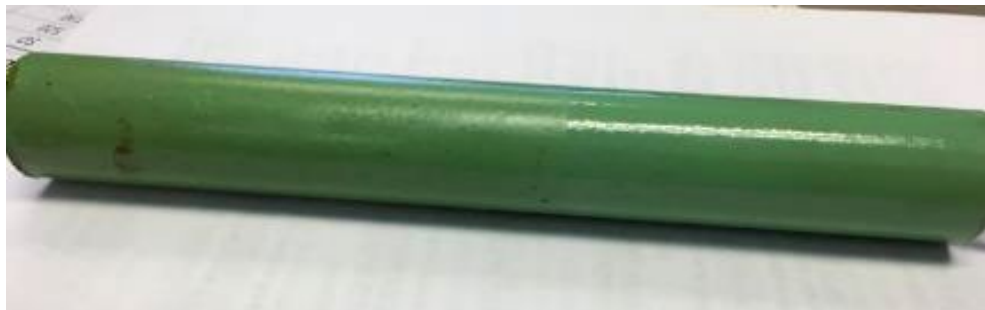
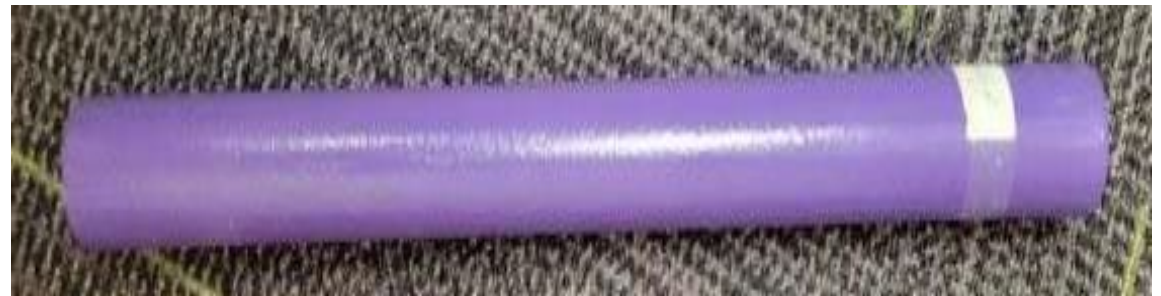
- In 2026, most new projects will require ASTM A1078, Type 2 purple epoxy coated dowel bars to replace Type 1 green epoxy dowel bars.
- Purple dowel can be substituted for the green dowel.
- Discussed regional specifications for epoxy coating
  - ND, SD, IA, WI – Michigan already allows
