Forensic Investigation of West Des Moines Street Projects

Thomas Van Dam, Ph.D., P.E.
Principal

IA Better Concrete Conference - 2025

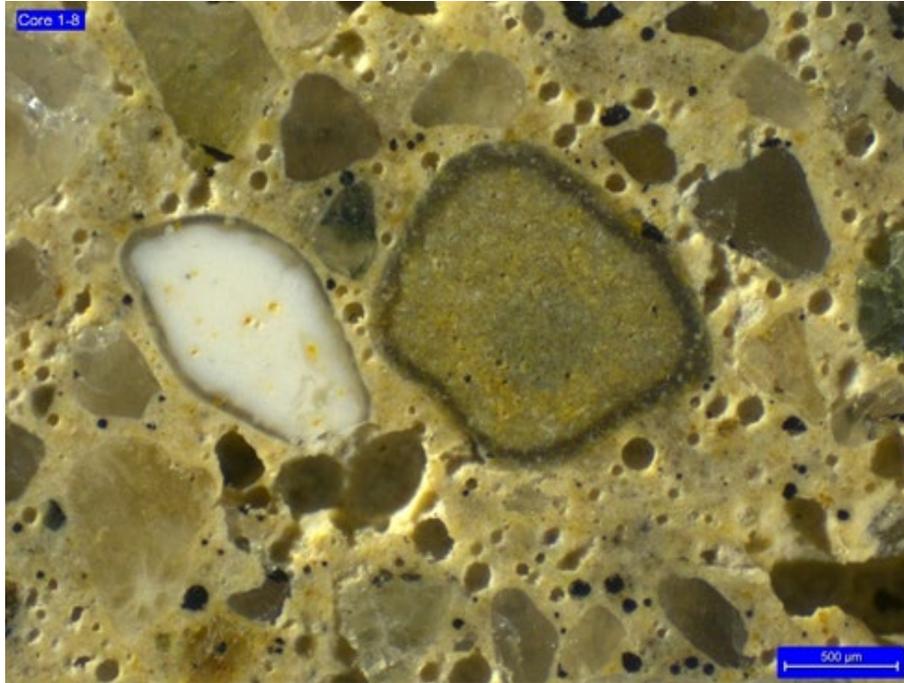
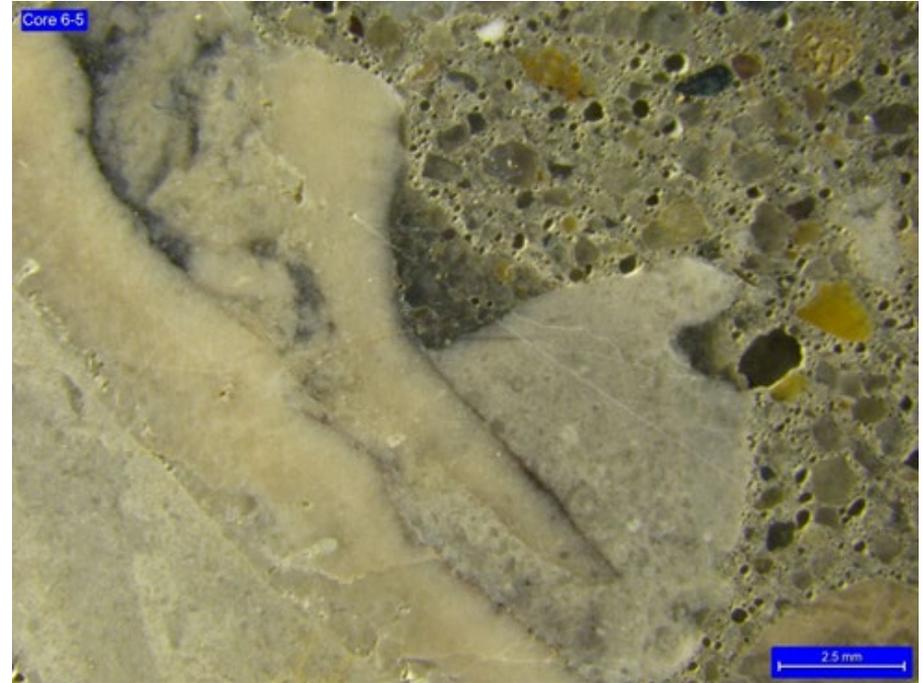
Reactive Aggregates and Veneers

- Concrete is compositionally similar, containing crushed limestone and cherty limestone coarse aggregate and siliceous and calcareous fine aggregate in an air-entrained, portland cement and fly ash paste
 - Projects Nos. 5 and 7 also have quartzite coarse aggregate
 - Some fine aggregate particles are alkali-silica reactive
- The paste varied in hardness and dark grey veneers were frequently observed at the interface of the coarse aggregate particles with the paste in all examined cores
 - Indicative of retempering and/or incomplete initial mixing
