Investigation of West Des Moines Pavements Constructed with Type IL Cement

NCC Spring Meeting

San Diego, CA | April 7, 2026

Leif G. Wathne, PE
Tom Van Dam, PhD PE

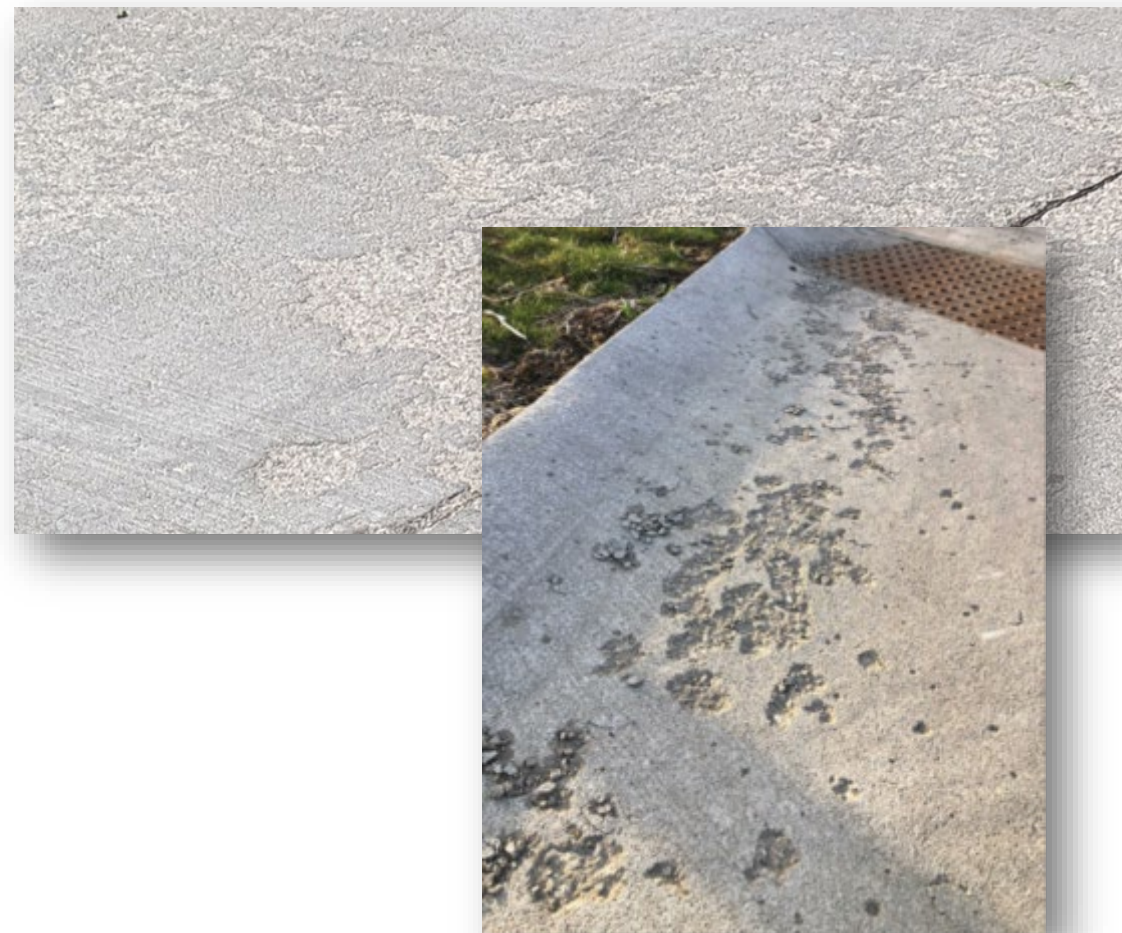
- The City of West Des Moines observed some issues with concrete pavements constructed in 2022 through 2024
 - Lower reported strength
 - Weak surfaces (i.e., wear/abrasion and scaling)
 - Questions raised about the role of change to Type II cement

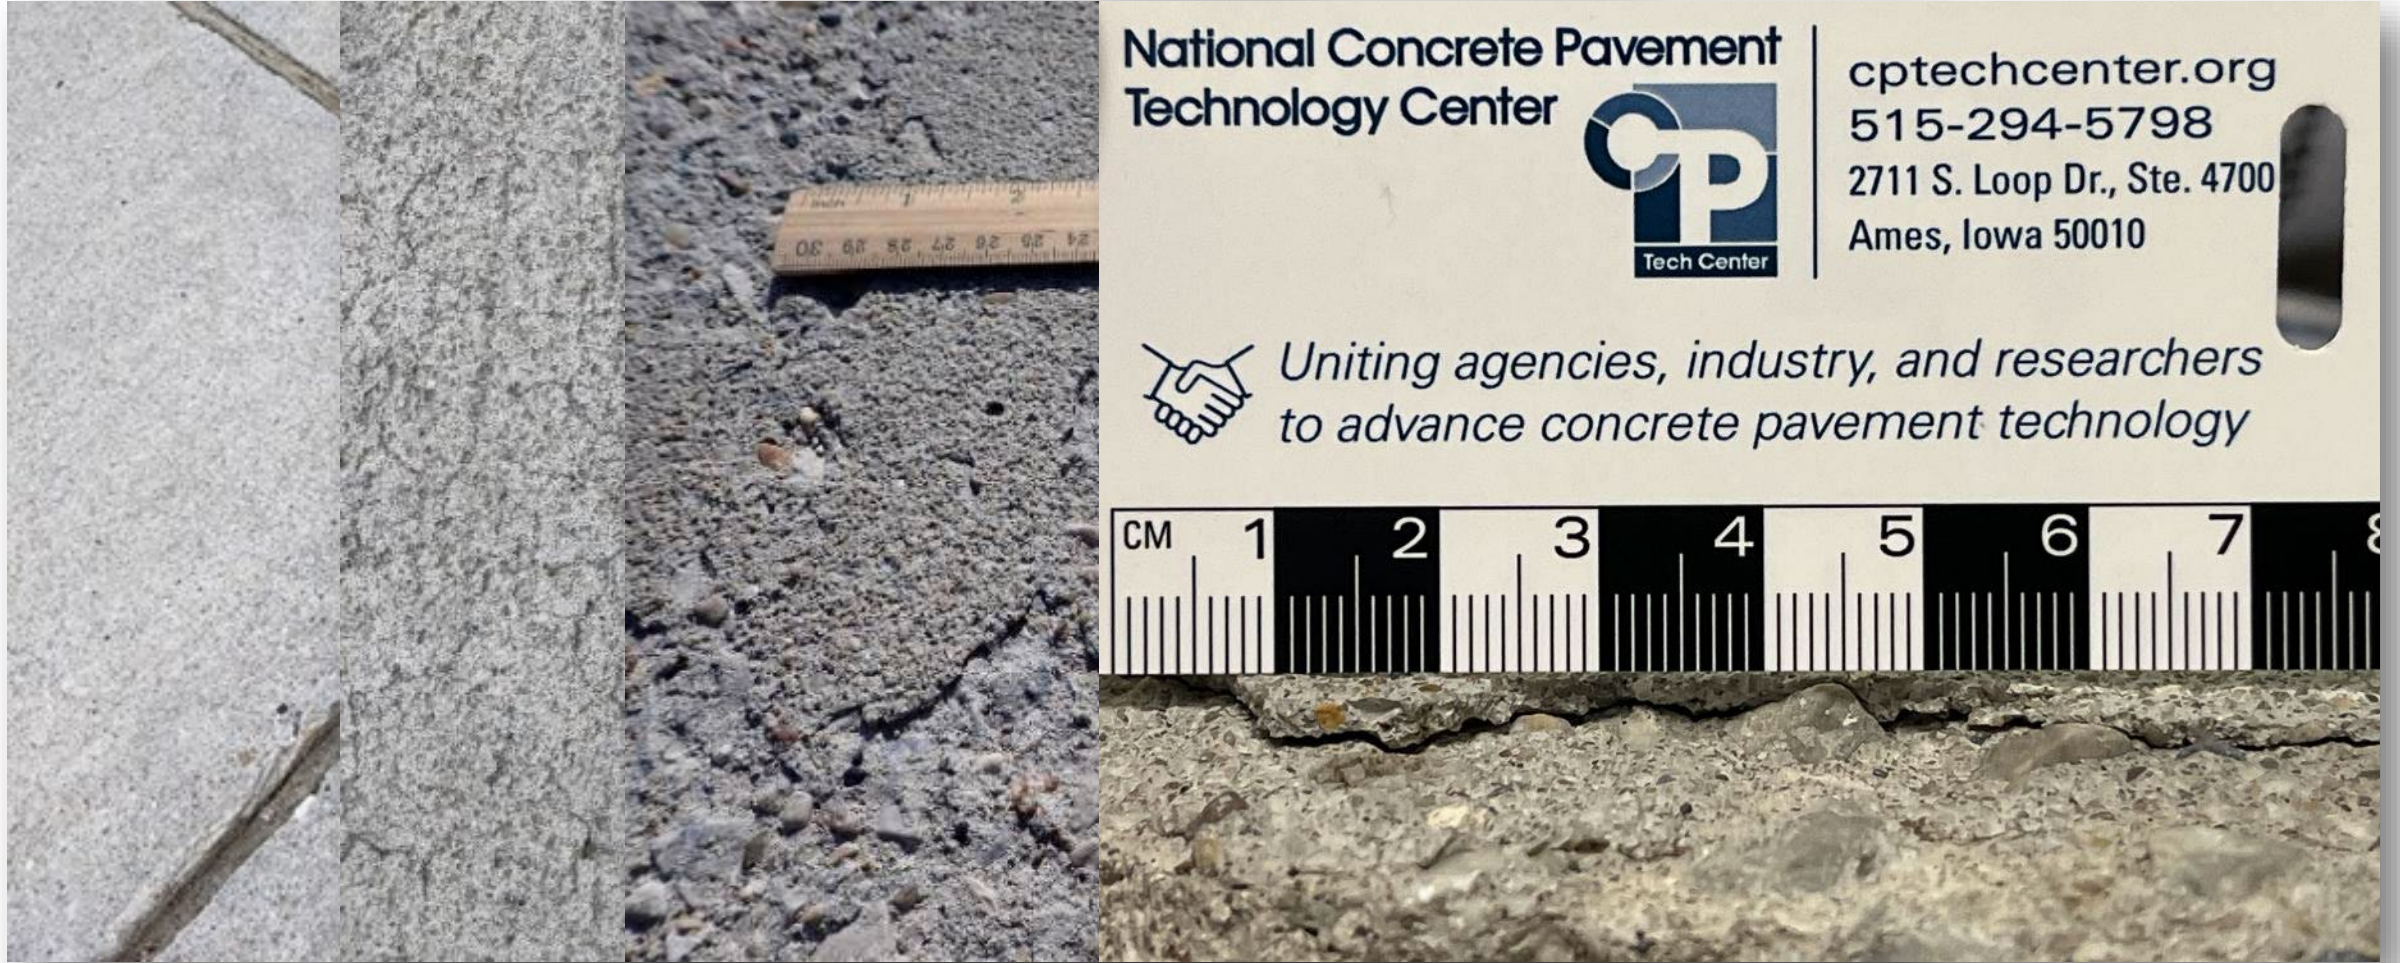
Other Observations

- Overall, the projects are not 'bad', but there are concerning trends
 - Other than the really bad part of Project No. 1, which already has been removed...
 - Minor scaling, evidence of abrasion, minor joint spalling/deterioration
 - City feels something seems a bit 'off' compared to past projects
- 'Poor' areas are largely isolated...does this point to 'means and methods' versus universally a materials issue?

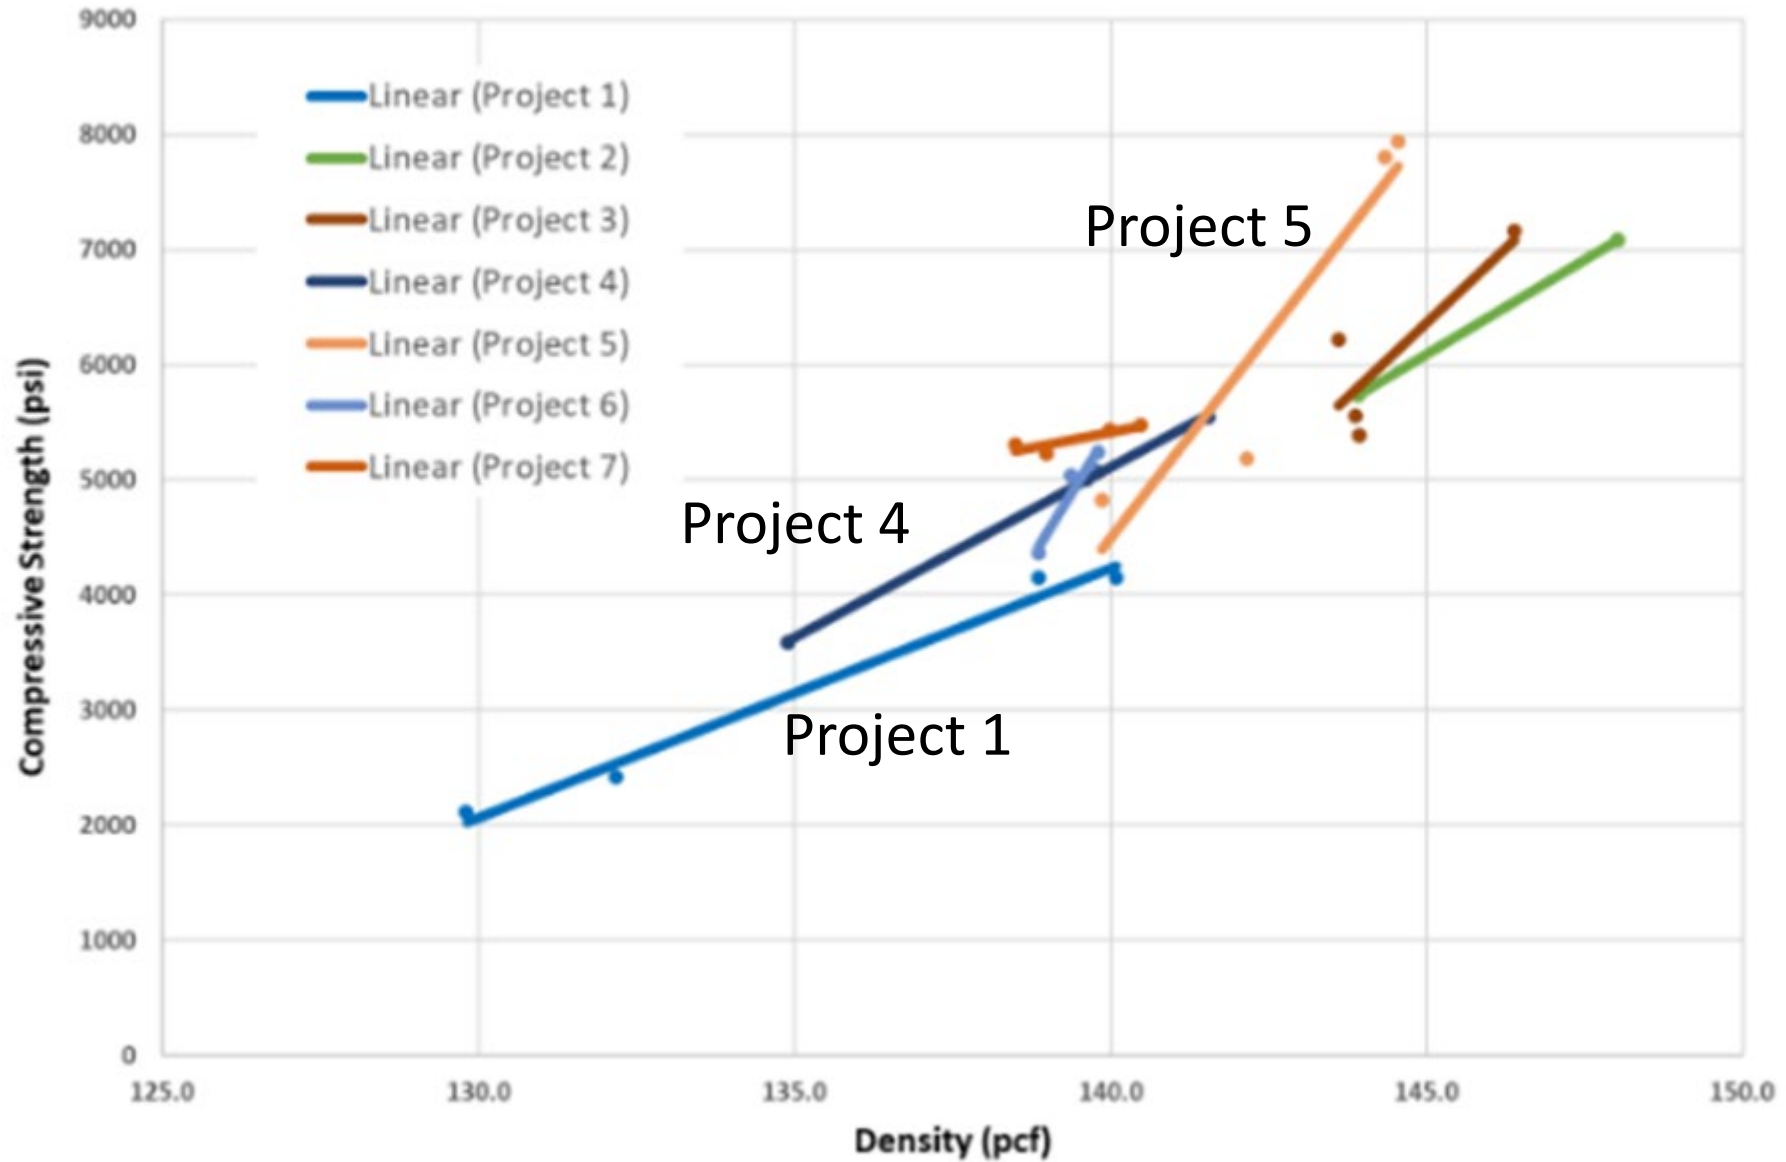
Compressive Strength vs. Density

- With regards to strength, even within the same project, it can be highly variable
 - Strongly linked to the density, which is linked to air content
 - Overall, the air was high, and in some cases, too high
 - With a few exceptions, the paste-aggregate bond is good
- Evidence of poor initial mixing or late retempering in all concrete
 - Dense veneers with little to no air present in all cores evaluated
 - Air-void systems are often irregular with evidence of clustering and chains
 - There is evidence of limestone dust along aggregate boundaries
 - Very likely from the limestone aggregate (...dusty aggregate)
