Caltrans Research: Chain Wear

Spring 2026 NC² Meeting

Chain Requirements & Accelerated Pavement Wear

56A0418-001 FIELD EVALUATION OF PCC SURFACE HARDENERS AND POLYESTER INLAYS FOR 03-NEV-80

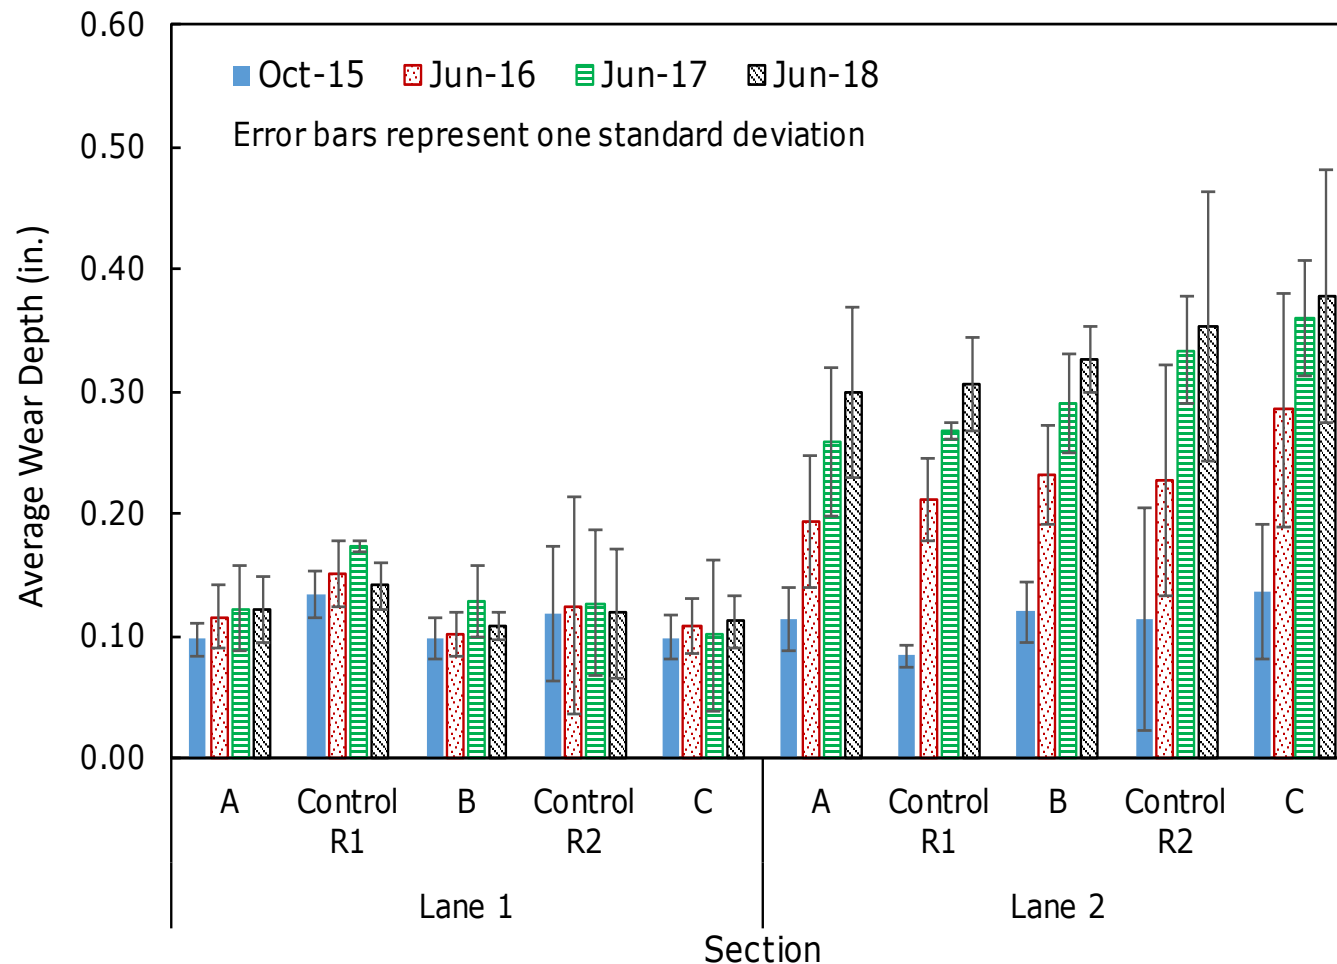
Surface Hardener Performance

- Similar change in Lane 2 wear depths across sections
- Annual surface elevation measurements confirm findings

- Surface hardeners were ineffective in reducing surface wear.
 - After three winter seasons, experimental sections exhibited similar wear to the control sections.
- No conclusions regarding the effectiveness of a re-application of lithium silicate after one winter.
- Grooves (in ground and grooved locations) remained after the first winter but were worn away after the second winter.

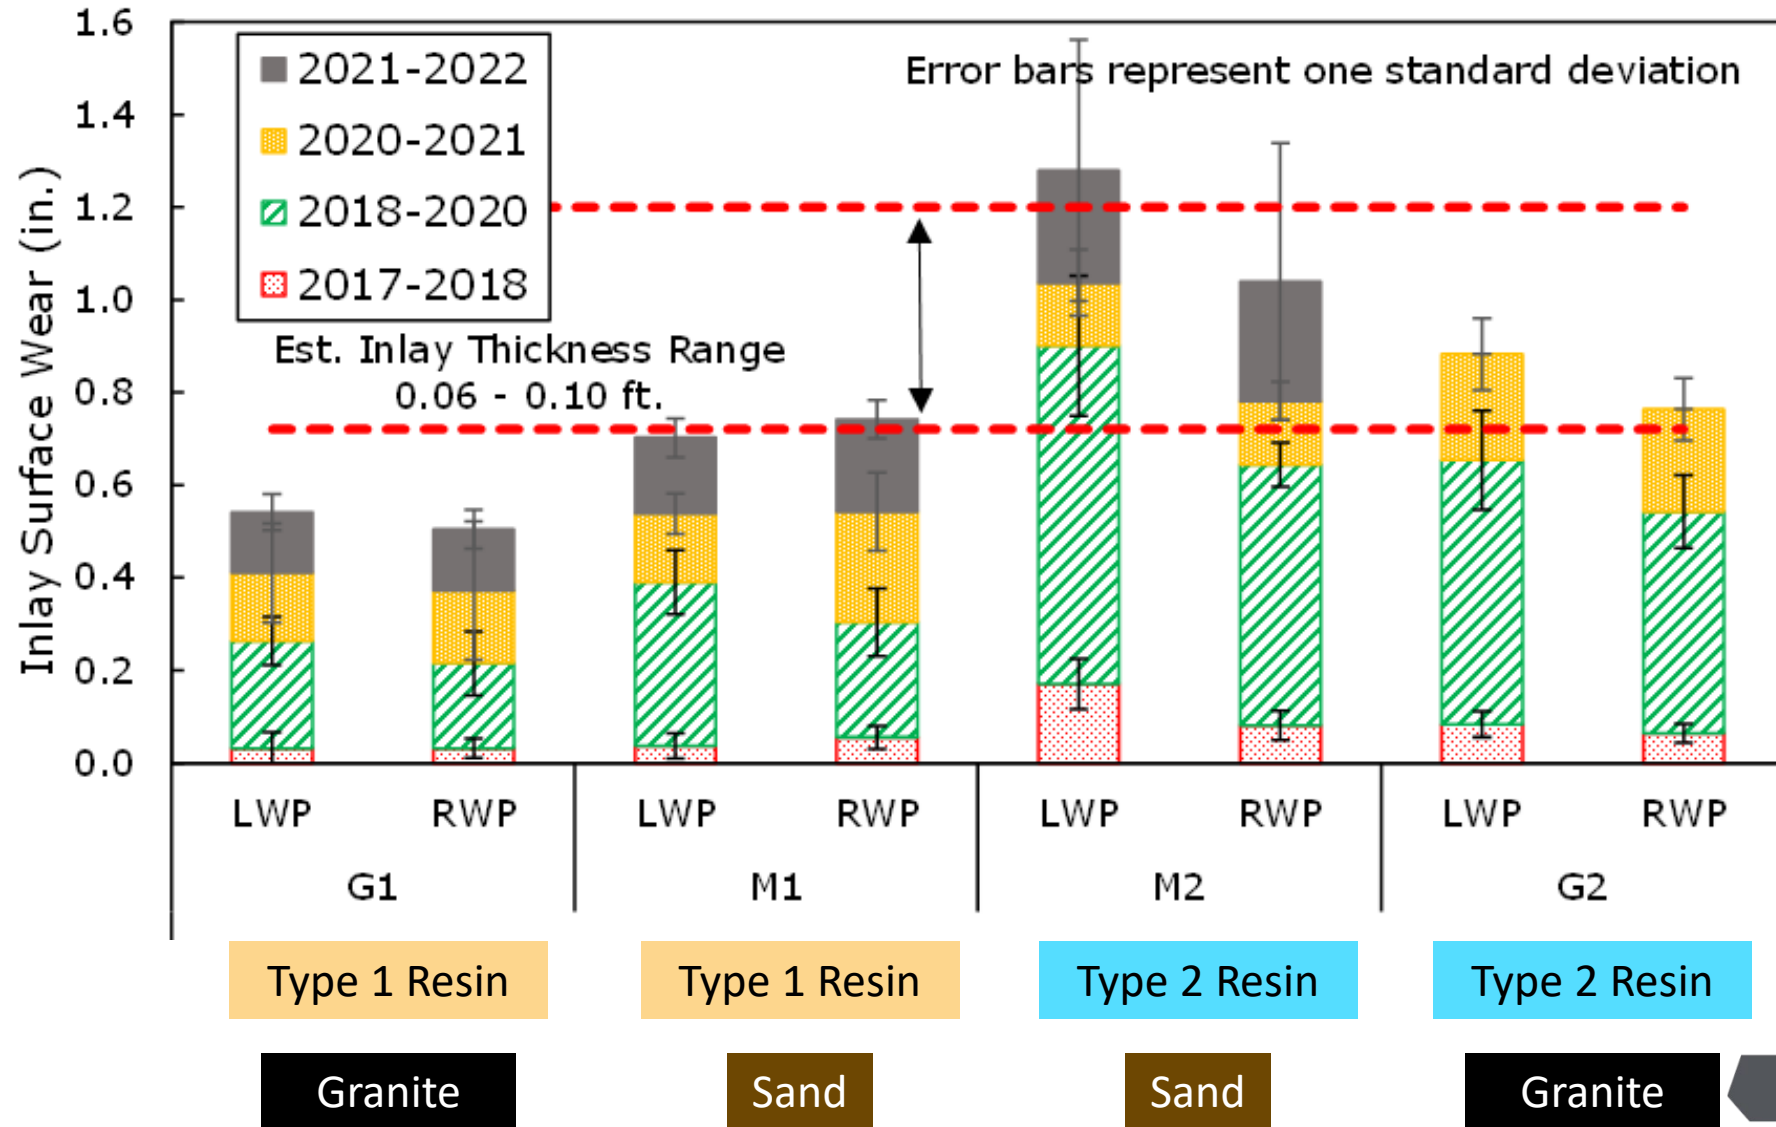
Inlay Surface Wear from Dipstick Measuring

- Data confirmed **Resin 1** outperforms Resin 2 and **granite** performs better than sand (with Resin 1).
- Materials carried forward into next experiment.

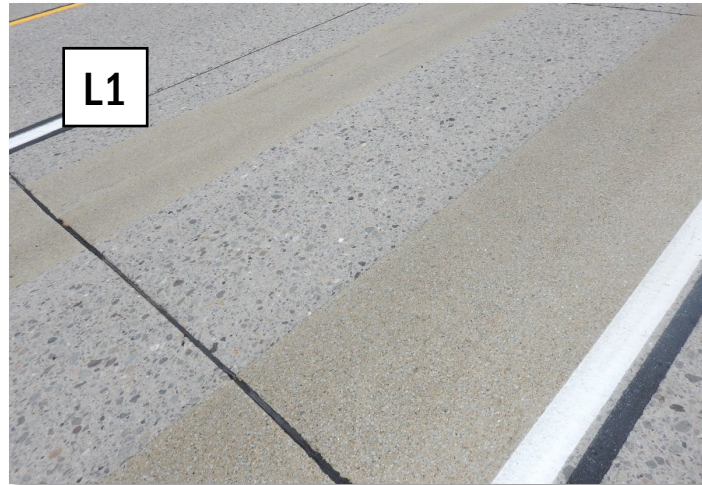
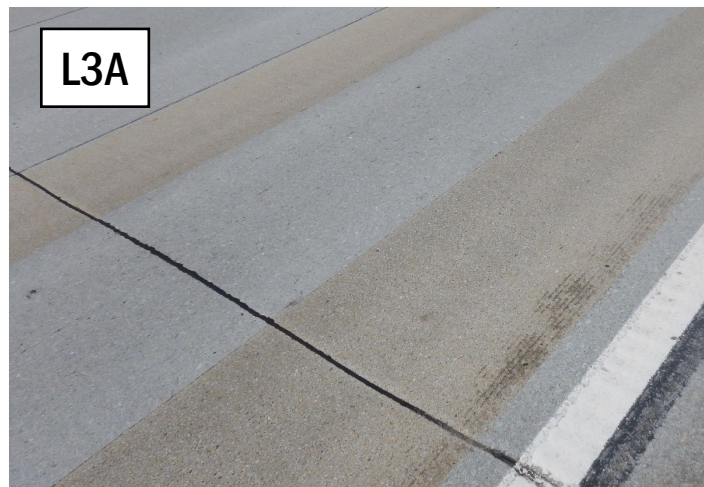
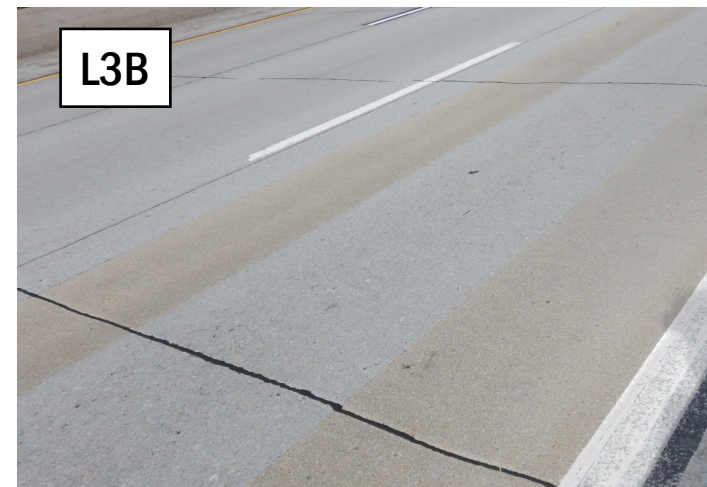
- Inlay conditions in 2022

- The average inlay wear was 0.34 in. (L1), 0.36 in. (L3A), and 0.50 in. (L3B).
- Data suggest tire chains cause more wear in uphill segments than downhill segments
 - L1 had similar or less wear than L3A and L3B
 - L1 exposed to ~1.6 times more chained trucks
- After 3rd winter, underlying concrete was visible in isolated areas

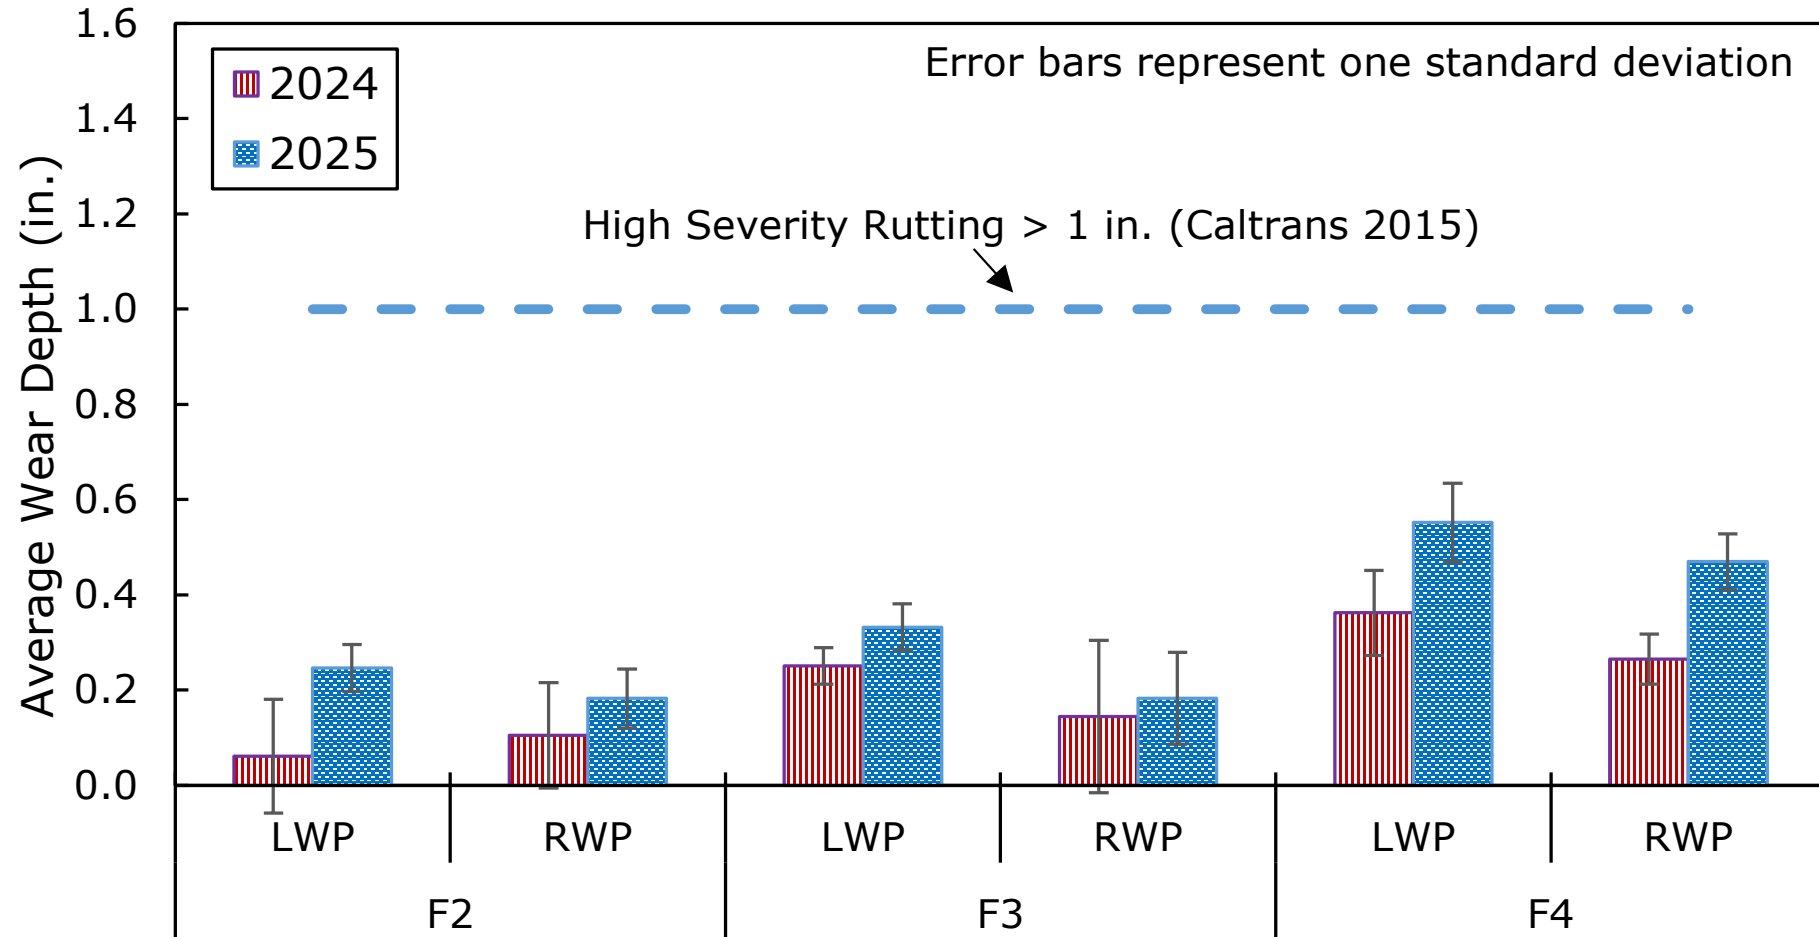
2023 Experimental Inlays

- **Section F2 (Control):** Showed less wear (0.22 in. avg. cumulative). However, construction (grind/fill vs. fill) technique and materials appeared different between wheel paths.

- **Section F3 (Polyester + Bauxite):** Averaged 0.26 in. cumulative wear. The left wheel path showed more advanced wear. Some right wheel path areas appear to have been re-inlaid.

- **Section F4 (Epoxy + Sand):** highest experimental wear (0.51 in. avg. cumulative). Defined wear channels were present, but no underlying concrete was exposed. Uphill grade and exposed to highest chain truck traffic of all 2023 sections.

- **Experimental vs. PPC Inlays**
 - Standard Inlays (L3A, L3B) had significantly higher wearing rates compared to Experimental Inlays (F2, F3, F4) and experienced significantly less chained truck traffic

- **However:** F2 also used standard materials as L3A and L3B but less wear
 - Appears to be less wear in downhill grades (consistent with previous study)
