# **STRATEGIES FOR CONCRETE PAVEMENT PRESERVATION**

**Volume III: Case Studies**

**June 2026**

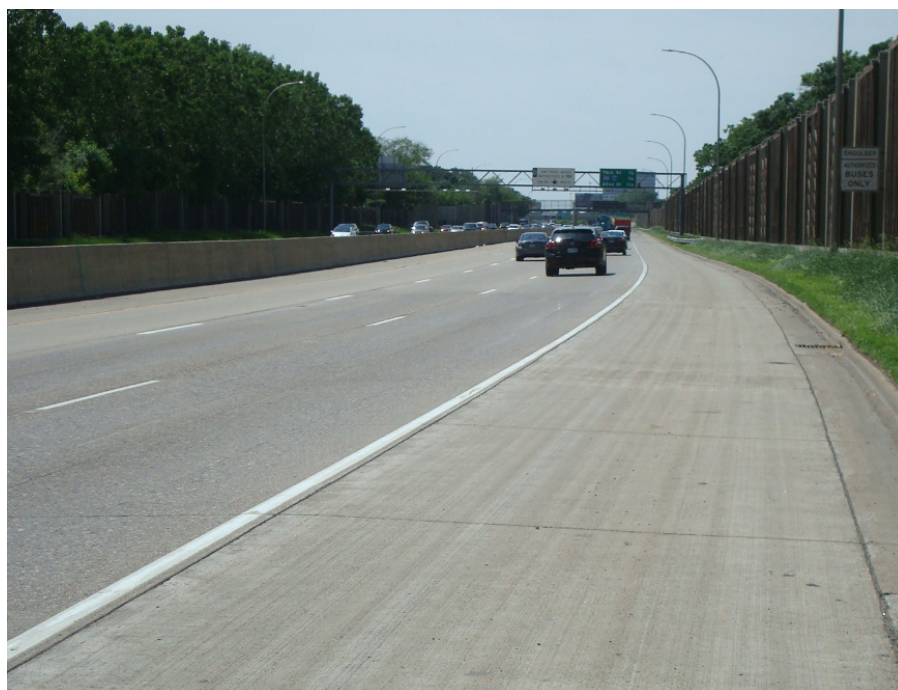
Figure 2-5. Overview of I-35W pavement.

A field visit during the summer of 2018 revealed that the entire section was still in generally good condition, with sporadic presence of joint and corner deterioration, with temporary patching to address some of these distresses. The joint sealant appeared to be missing or damaged at a few locations. Figure 2-5 shows an overview of I-35W, and figure 2-6 presents some photographs of typical distresses observed.

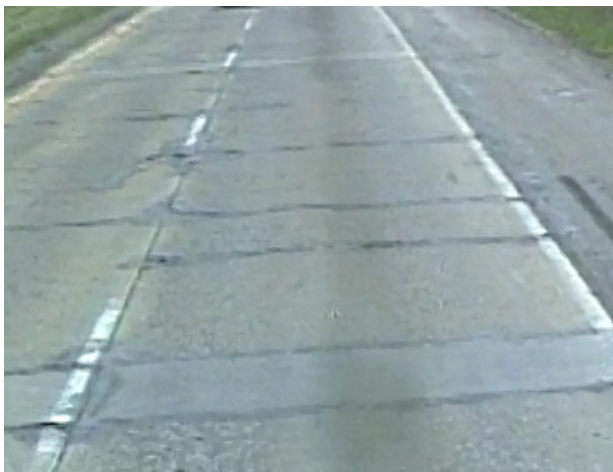
**Figure 3-2. Typical condition of JRCP prior to UBOL.**

Prior to the placement of the UBOLs, intermittent repair of concrete joints, cracks, and patches was performed to provide a suitable paving platform. No details on the specific types or quantities of repair were available from the project records. Figure 3-2 illustrates the typical concrete condition prior to the placement of the UBOLs.

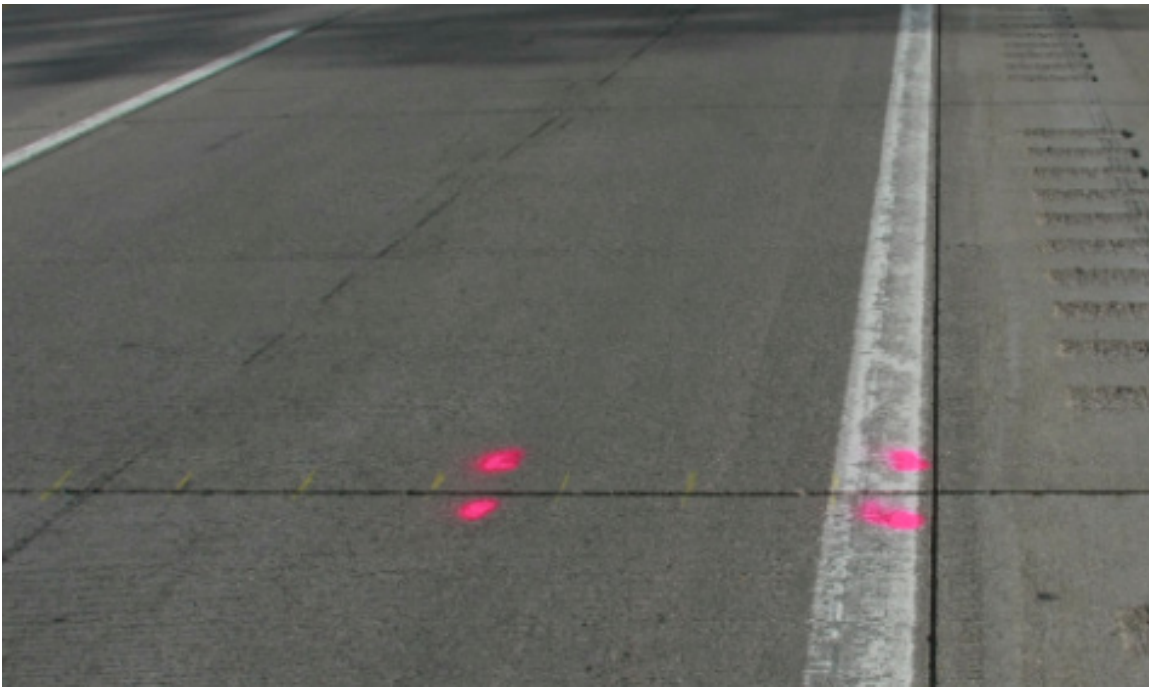
**Figure 3-4. UBOL concrete surface in 2011.**

A 2018 site visit revealed the following distresses in the overlay sections: a few low- and medium-severity transverse cracks, minor surface wear, joint seal deterioration, and isolated spalling. In comparison, the reconstructed sections passing under bridges exhibited more advanced distresses. Figures 3-4 and 3-5 present examples of the pavement condition in 2011 while figures 3-6 and 3-7 show the condition in 2018.

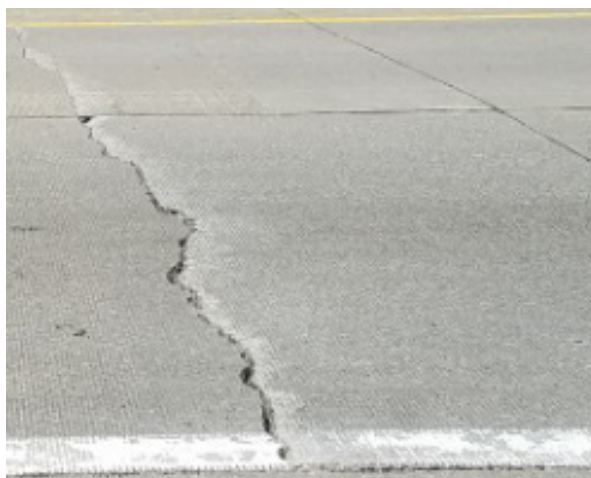
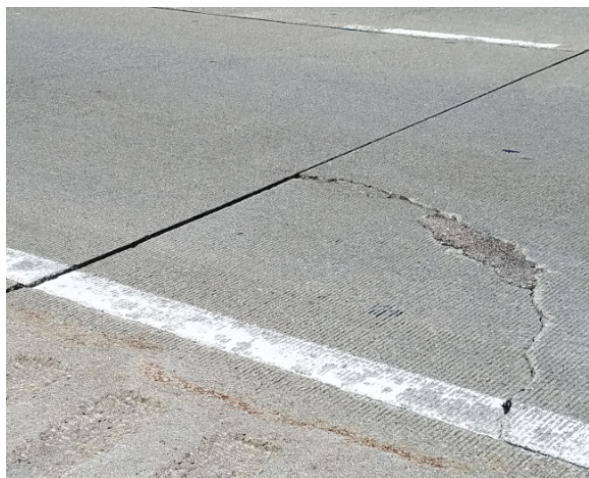
**Figure 3-7. Example of medium-severity, mid-panel crack (left image) and corner break (right image) in 2018.**

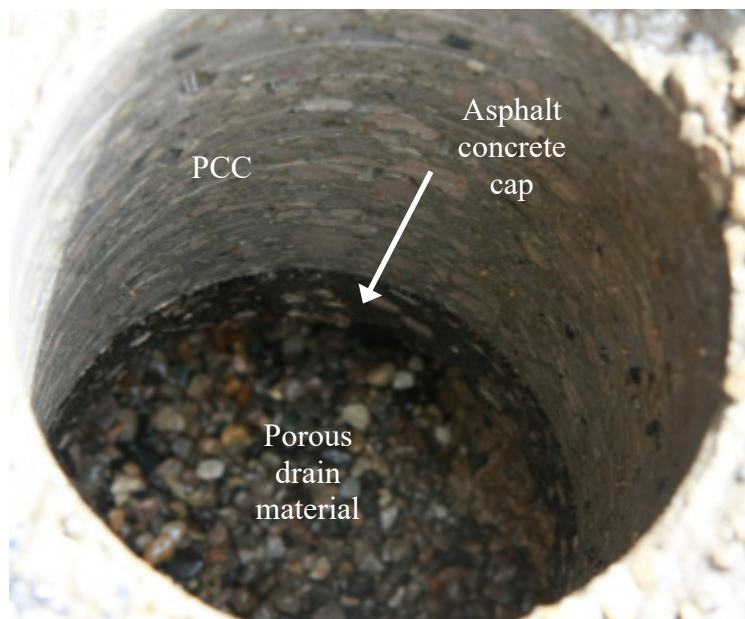
The UBOs on U.S. 23 were one of eight Michigan case studies highlighted in a 2013 research report prepared by Hansen and Liu and were one of three projects that exhibited good performance, noting that no slabs in the northbound direction were cracked as of 2011. Forensic investigation showed an asphalt concrete cap in some sections that blocked the path to the underdrains (see figure 3-11). Records note periodic outlet cleaning but no pavement maintenance.

One of the conclusions from the study was that good drainage was essential to a long-lasting unbonded concrete overlay. This included planning for drainage during design and proper construction. Joint faulting was measured in the outer wheel-path and transverse joint edge and was found to be insignificant over a 500-foot (152 m) test section. It was concluded that pumping was minimal on this project despite the asphalt cap found over the edge drain (Hansen and Liu 2013).

**Figure 3-11. Example of asphalt concrete cap over edge drain.**

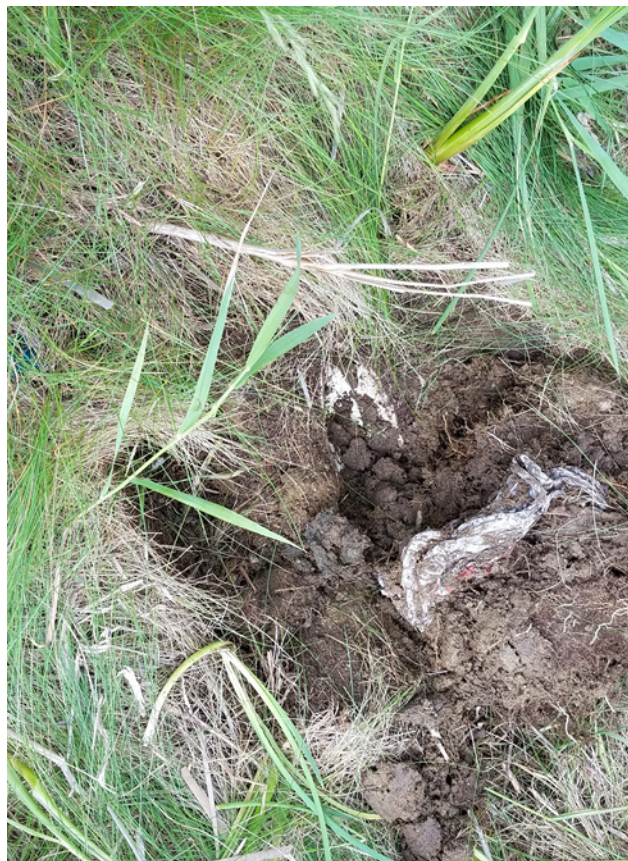
As a note, drainage outlets were inspected as part of the 2018 site visit. In general, it was observed that the outlets were not being maintained, and some were clogged by vegetation as shown in figure 3-12. In a few isolated locations, the lack of drainage was linked to evidence of pumping and slab cracking as shown in figure 3-13.

**Figure 3-12. Drainage outlet blocked by vegetation after being exposed with a shovel.**

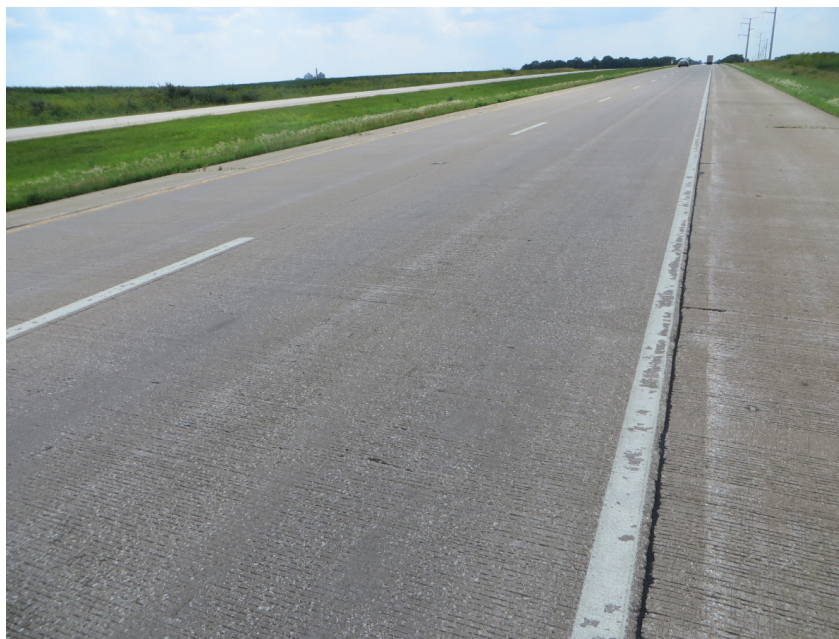
**Figure 4-6. Overview of I-74 WB project in 2018.**

A 2019 site visit revealed that the CRC overlay was performing well (see figure 4-6 for an overview of the westbound lanes). Distresses observed included spalling along transverse cracks, punchouts, isolated full-depth repairs, and longitudinal cracking (see figures 4-7 through 4-9).

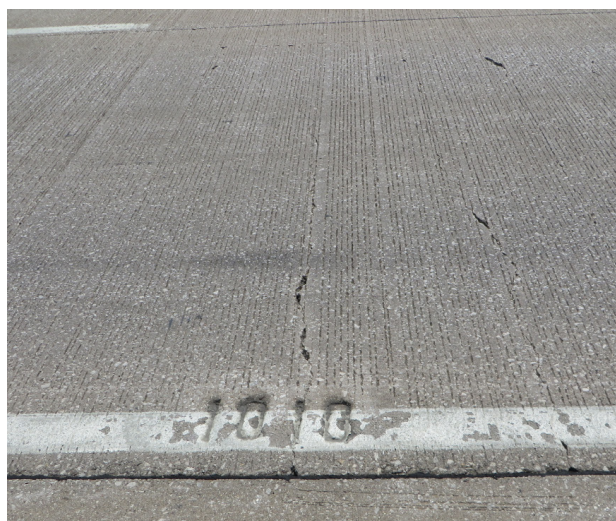
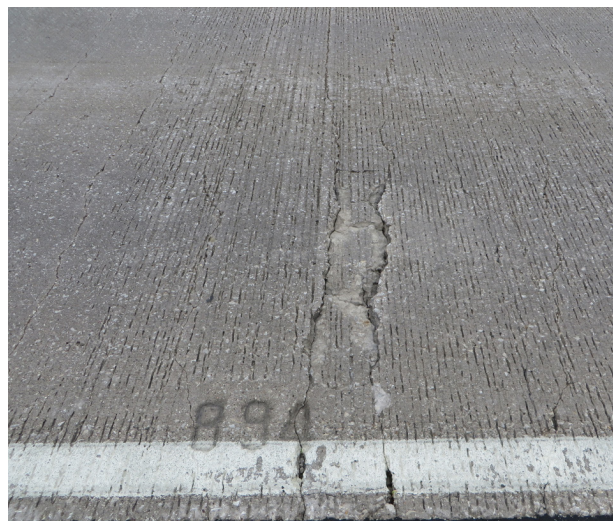
**Figure 4-7. Spalling along transverse crack (left) and punchout (right).**

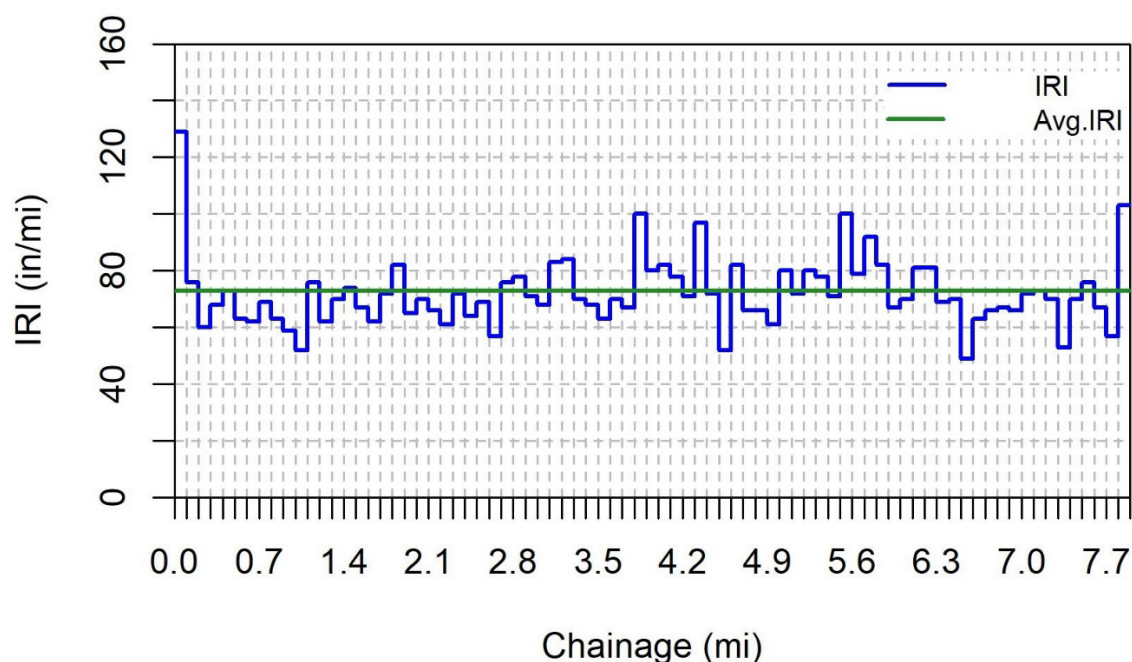
IDOT monitors the roughness of its road network using the International Roughness Index (IRI). In 2000, the IRI for the project site on WB I-74 was recorded at 70 inches/mi (1,105 mm/km). In 2016, the average IRI of 71 inches/mi (1,121 mm/km) was recorded with infrequent low severity longitudinal cracking and popouts, 1 to 3 punchouts per mile, and less than 6 percent of the area patched. The pavement was still rated as being Excellent condition. A survey in 2019 (by the project team using its automated data collection equipment) revealed an average IRI of 73 inches/mi (1,152 mm/km) for the driving lane of the section. Figure 4-10 presents the 2019 IRI values over the length of the project reported on 0.1-mi (0.16 km) intervals.

**Figure 4-10. IRI profile for the driving lane of I-74 WB project.**

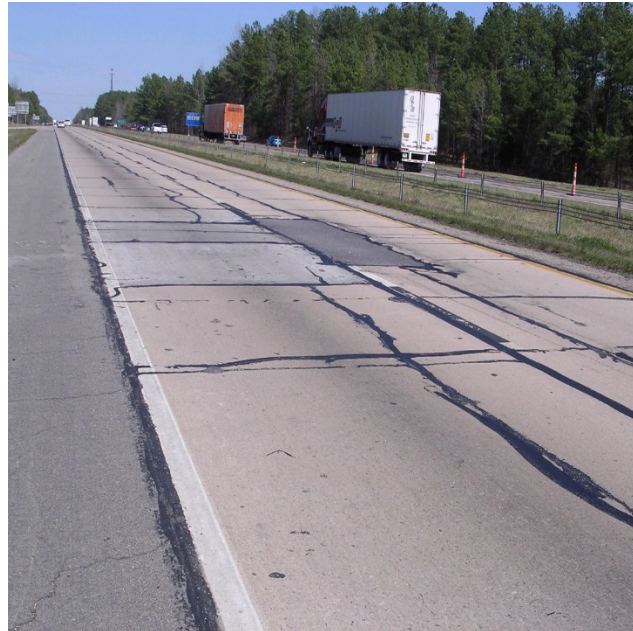
By 1997 (after 26 years of service), the original CRCP was exhibiting serious cracking and had been repaired in several locations (see Figure 5-2). A 10-inch [250-mm] unbonded jointed plain concrete overlay was placed over a 2-inch [50-mm] permeable asphalt interlayer on the CRCP. Full-depth repairs were performed prior to overlay placement. Project bid tabulations (Oman Systems, Inc. 2019a) suggest that these repairs were undoweled and totaled approximately 12,975 s.y. [10,849 m<sup>2</sup>].

**Figure 5-2. Typical CRCP condition prior to overlay in 1997 (source: Morrison 2017).**

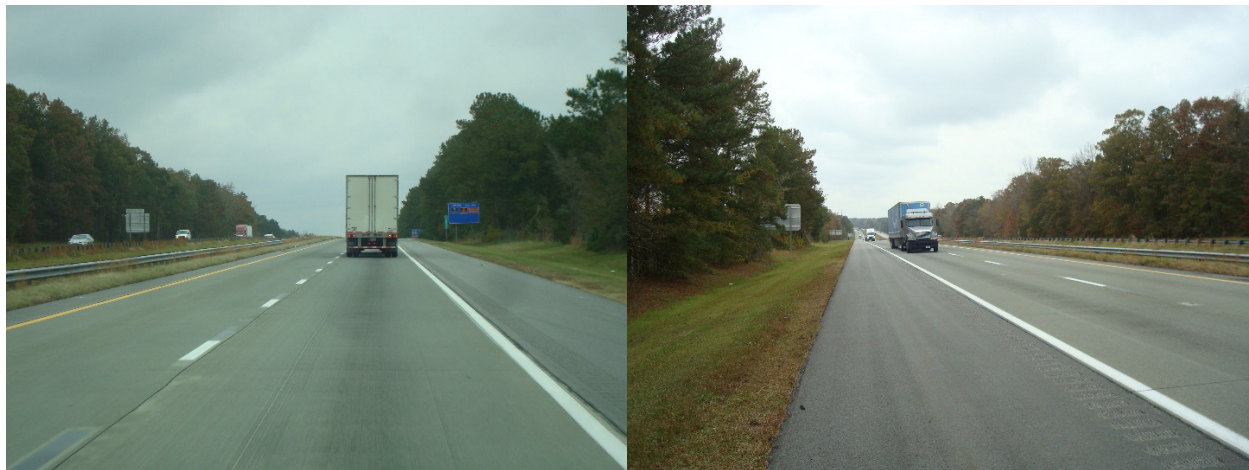
A field visit during November 2018 verified that the pavement is still in very good condition after 21 years of service. Typical pavement conditions (no cracking or other distresses, excellent ride quality) are shown in Figure 5-6.

**Figure 5-6. Typical 2018 pavement conditions on NC I-85 overlay project.**

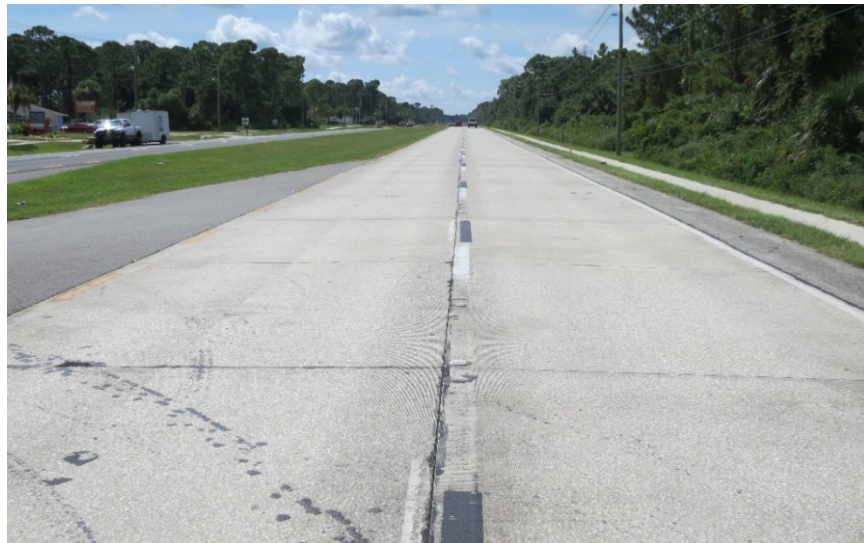
A 2018 field visit revealed that the overall project was in fair to good condition, but some of the slabs exhibited transverse cracking, corner breaks, and light to moderate joint faulting. Corner breaks were observed only on the thinner (6- and -7-inch [152- and 177-mm]) slabs, and the test section with the 20-ft (6.1-m) joint spacing exhibited the highest amount of cracking (Greene et al. 2018). Low- to moderate-joint seal damage was also observed throughout the section. Figure 6-3 shows an overview of site, and figures 6-4 through 6-6 show the typical site conditions.

**Figure 6-3. Overview of concrete overlay, SB U.S. 1 in 2018.**

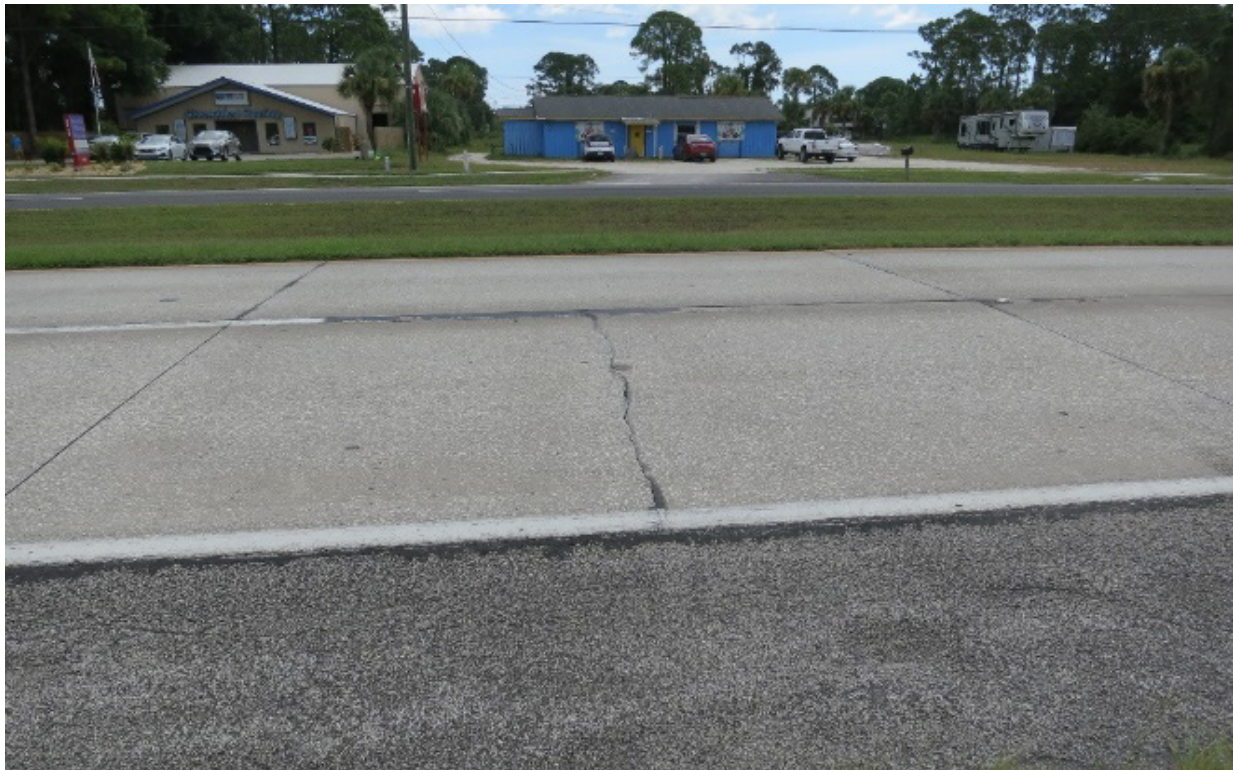
**Figure 6-4. Example transverse cracking on 20-ft panel observed in 2018.**

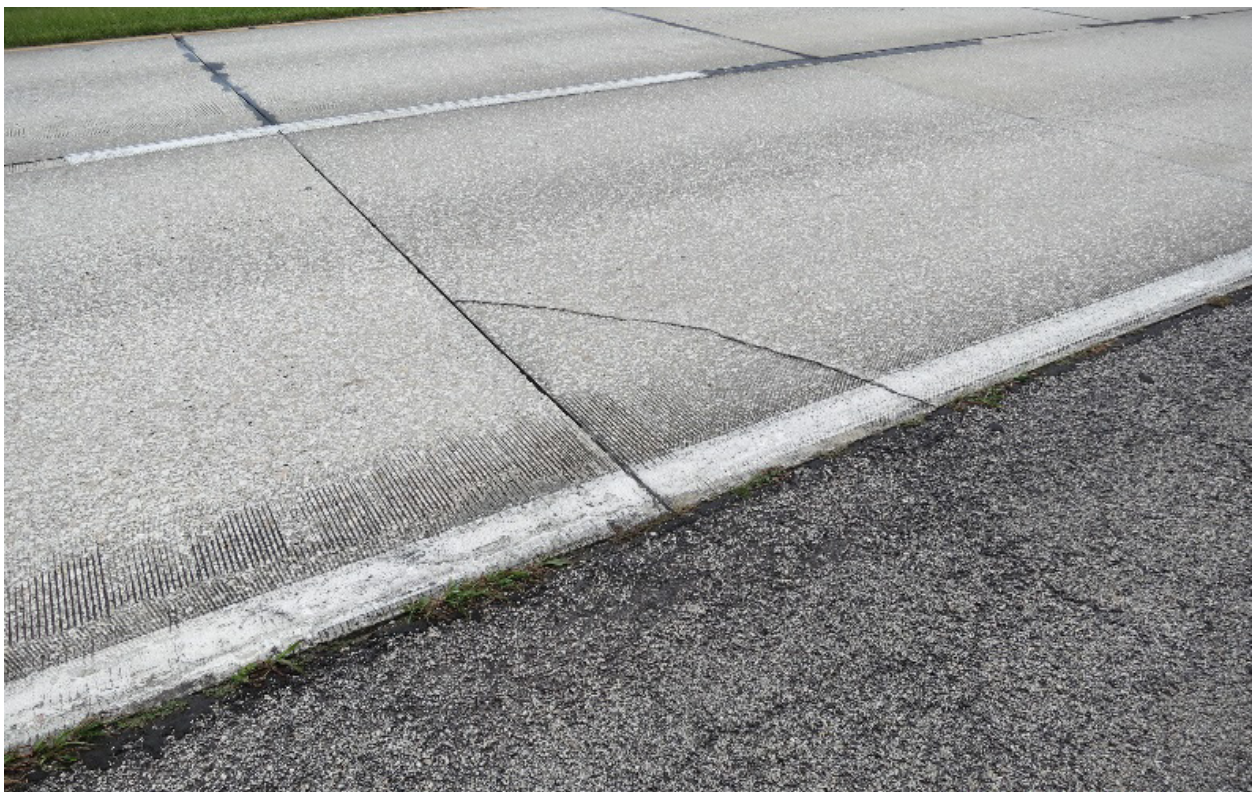
**Figure 6-6. Corner break on control section in 2018.**

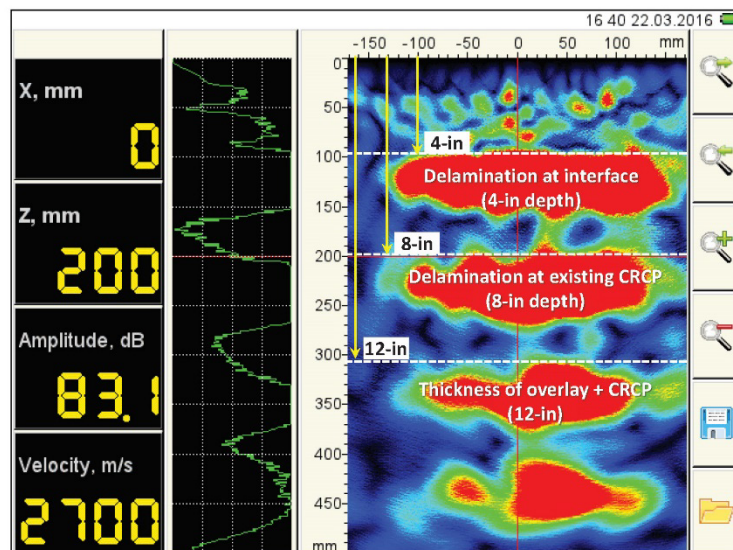
Figure 7-7 shows the FWD deflections at TCJs were much larger than deflections in other areas (Choi et al. 2018). Ultrasonic scanning detected delamination between the overlay and original pavement and also within the existing CRCP (near mid-depth, along the plane of the reinforcing steel – see figure 7-8). The delamination and mid-depth cracking disappeared a short distance away from the TCJ (see figure 7-9).

Figure 7-8. Ultrasonic test image near BCO transverse construction joint (Choi, et al., 2018).

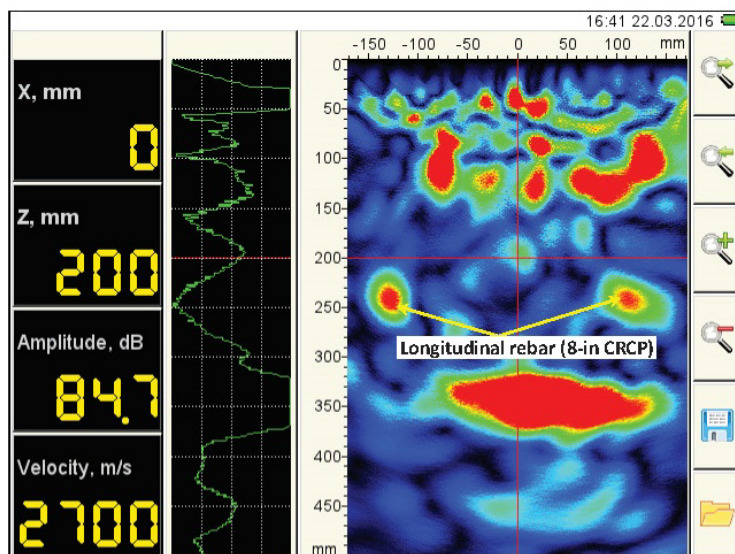
**Figure 7-9. Ultrasonic test image away from BCO transverse construction joint (Choi et al. 2018).**

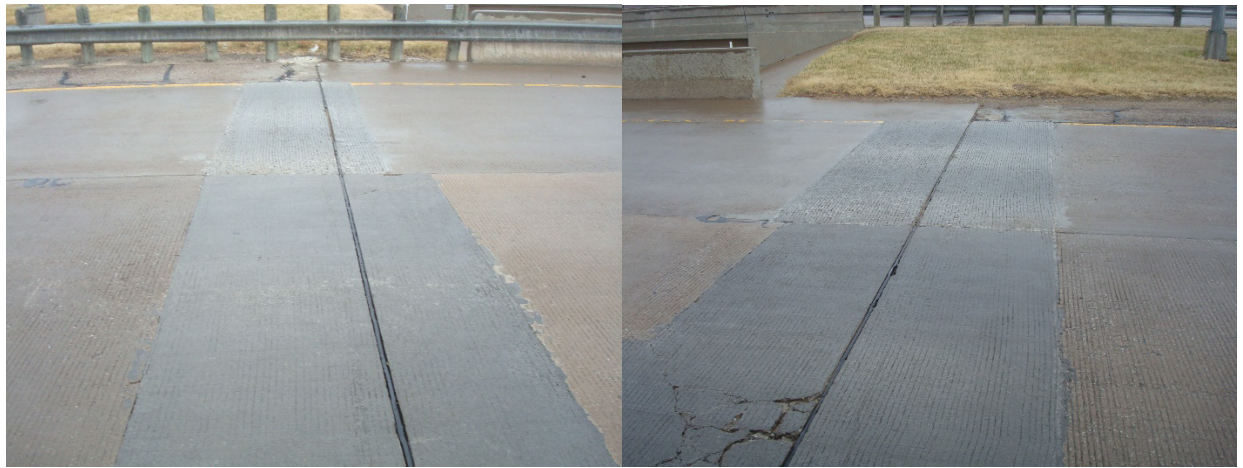
- A few wide transverse cracks (mainly in the outer lane of 2-lane sections and the middle lane of 3-lane sections), as shown in figure 7-11.
- Maintenance (patching) performed in 2016 at some bridge approach transitions (see figure 7-12).
- Two patches placed in 2018 on the southbound ramp to Hatton Road (see figure 7-13).
- Occasional concrete deterioration around transverse construction joints (see figure 7-14).
- A few small areas of concrete deterioration (possible loss of bond and breakup of overlay - see figure 7-15).

**Figure 7-12. Typical 2016 patching at bridge approach transitions.**

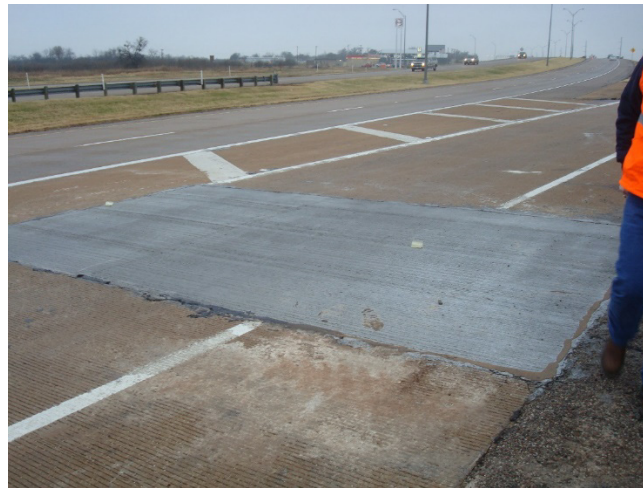
**Figure 7-13. Patch at the southbound exit to Hatton Road.**

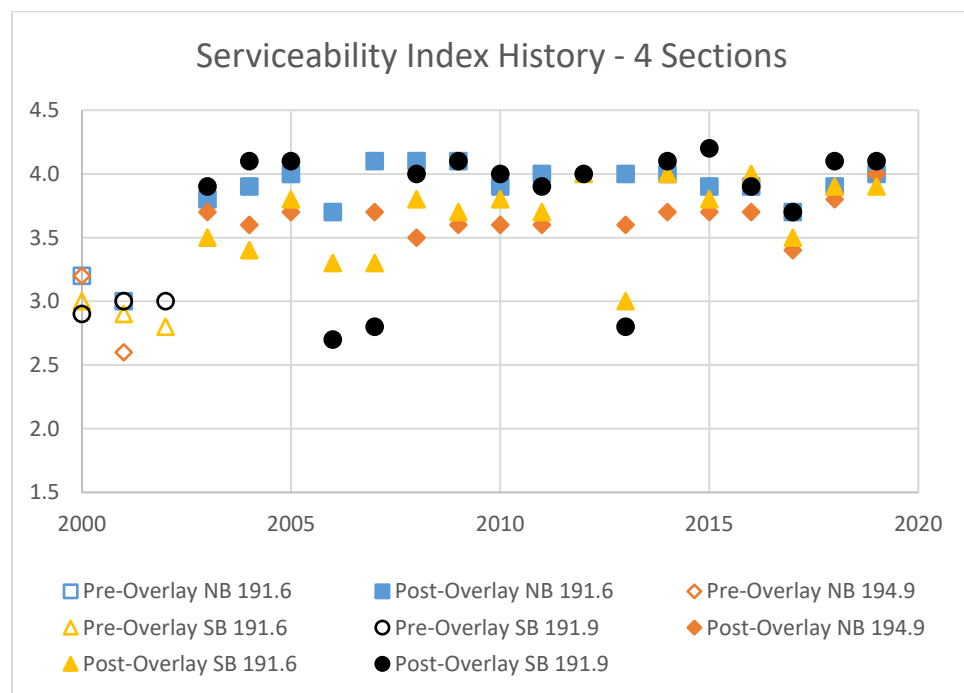
**Figure 7-16. Serviceability index history (2000 – 2019) for four representative sections of U.S. 289 (data source: TxDOT PMIS).**

Figures 7-16 through 7-18 show the distinct improvement in pavement ride index, distress score and condition score following the 2002 bonded overlay construction. Slight improvements in all three measures are also apparent after the 2016 CPR project. What is most evident is the consistently high level of service and low levels of distress present on this project since the 2002 overlay construction; very little deterioration in pavement condition or ride quality has been observed.

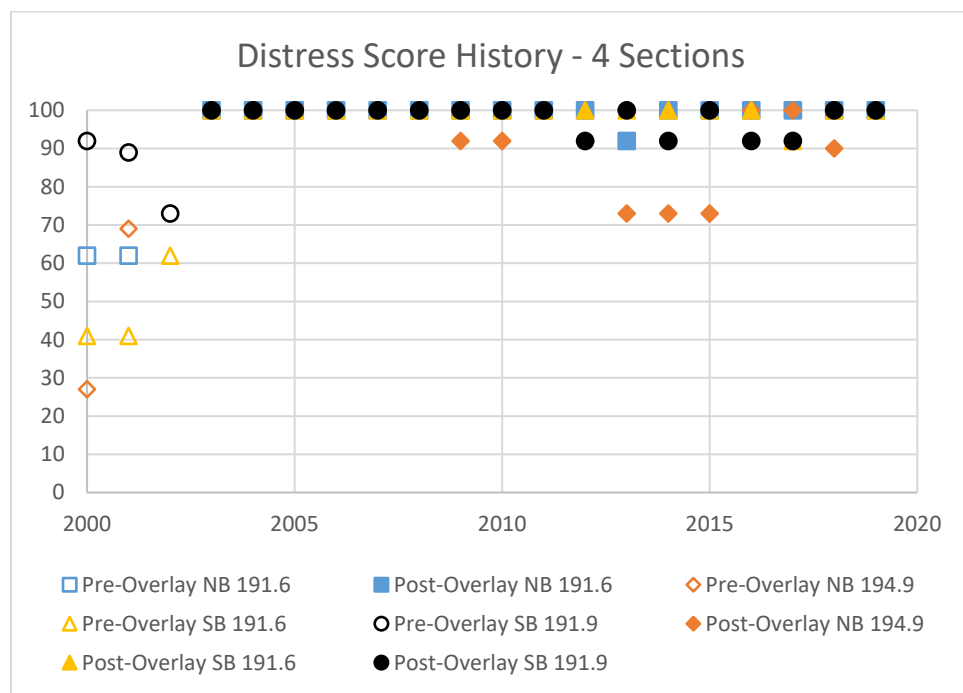
**Figure 7-17. Distress score history (2000 – 2019) for four representative sections of U.S. 289 (data source: TxDOT PMIS).**

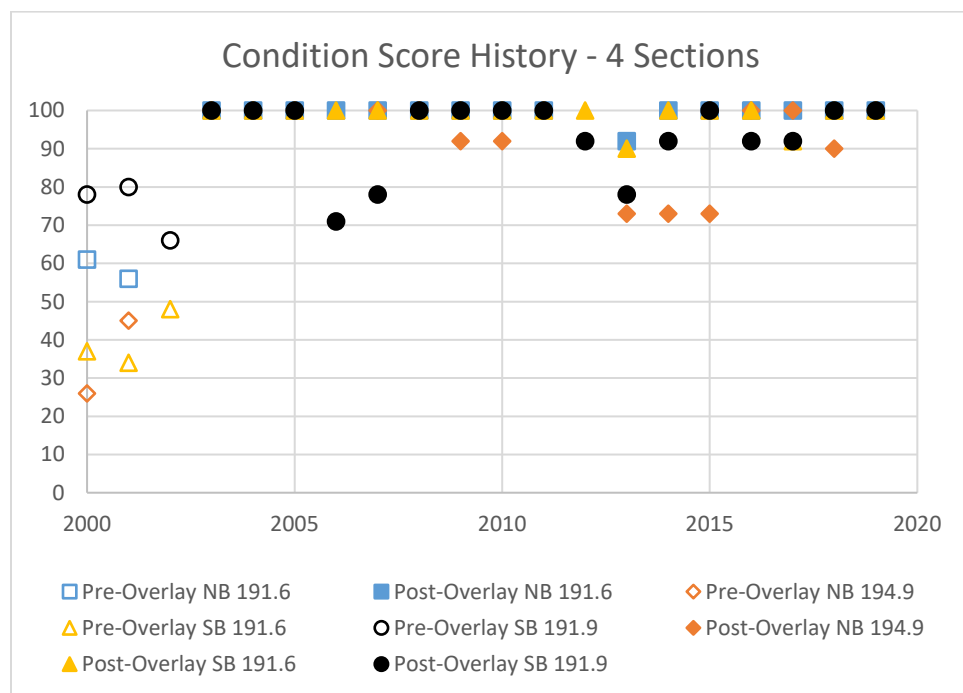
**Figure 7-18. Condition score history (2000 – 2019) for four representative sections of U.S. 289 (data source: TxDOT PMIS).**

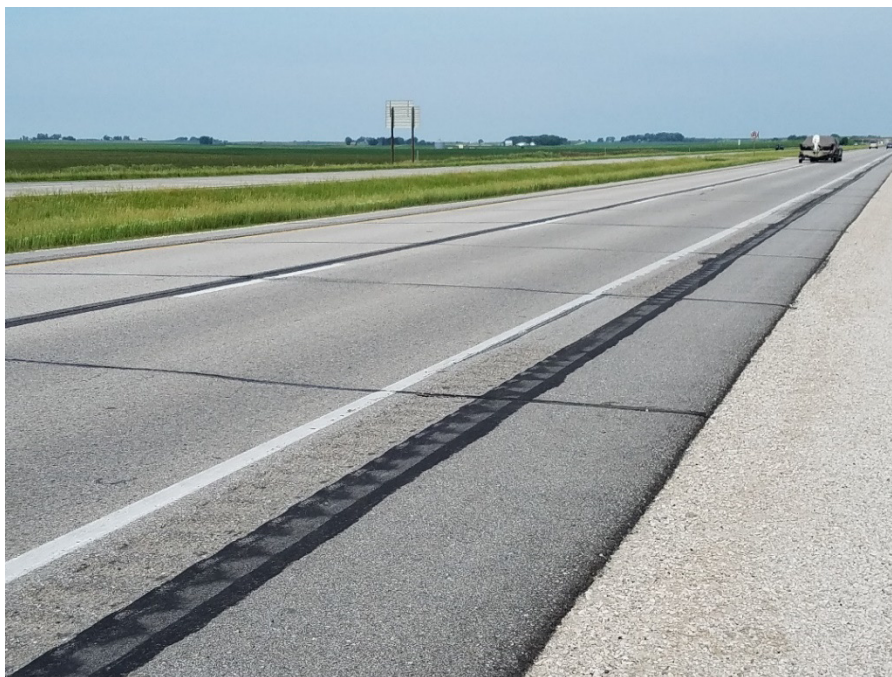
A 2018 site visit revealed that the westbound lanes, still overlaid with HMA, exhibited medium- to high-severity joint reflection cracking along the entire stretch of the section. Maintenance efforts using crack seal application were evident. Figure 8-10 shows an overview of the westbound lanes of U.S. 20 while figure 8-11 presents a close-up of the typical transverse joint reflective cracking.

**Figure 8-10. Overview of U.S. 20 WB with HMA overlay in 2018.**

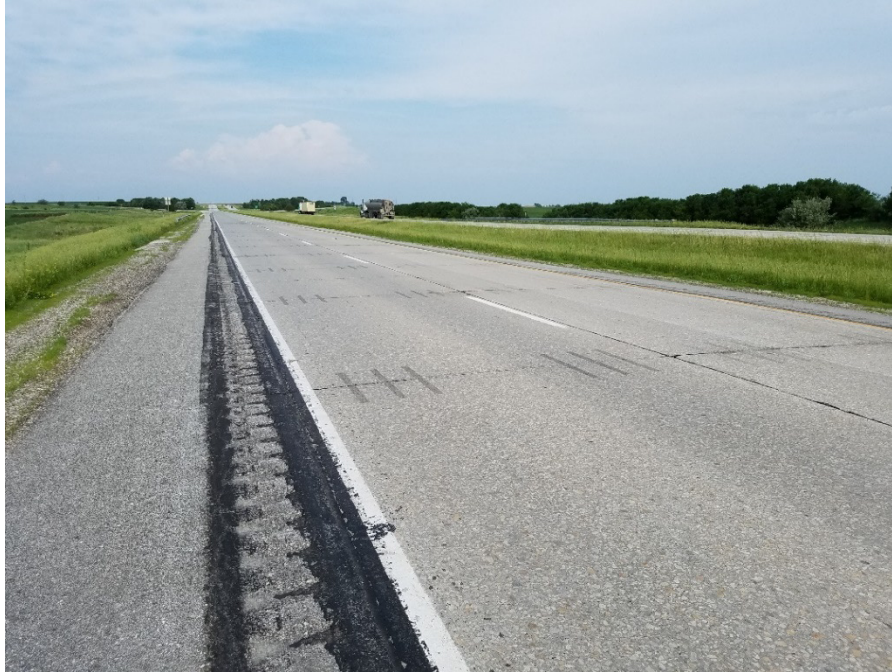
On the eastbound lanes that had received DBR and diamond grinding, joint seal deterioration, minor to severe spalling on some joints, and some medium- to high-severity mid-panel transverse cracks were noted. Figure 8-12 shows an overview of the eastbound lanes of U.S. 20, and figures 8-13 and 8-14 present examples of joint seal damage, spalling, and mid-panel transverse cracking observed on some slabs.

**Figure 8-12. Overview of U.S. 20 EB with DBR and diamond grinding in 2018.**

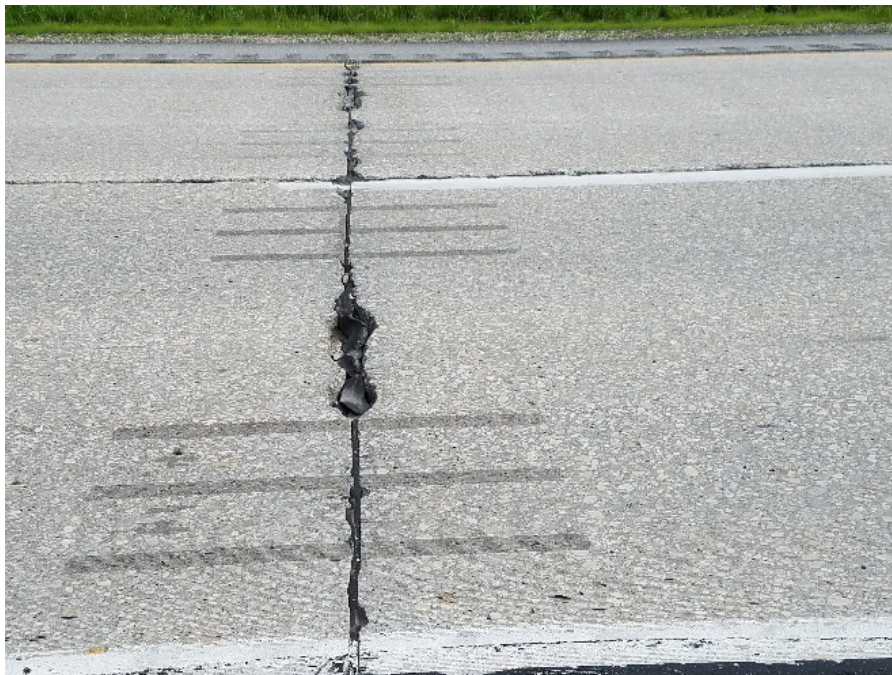
**Figure 8-13. Example of spalling and joint seal damage on U.S. 20 EB in 2018.**

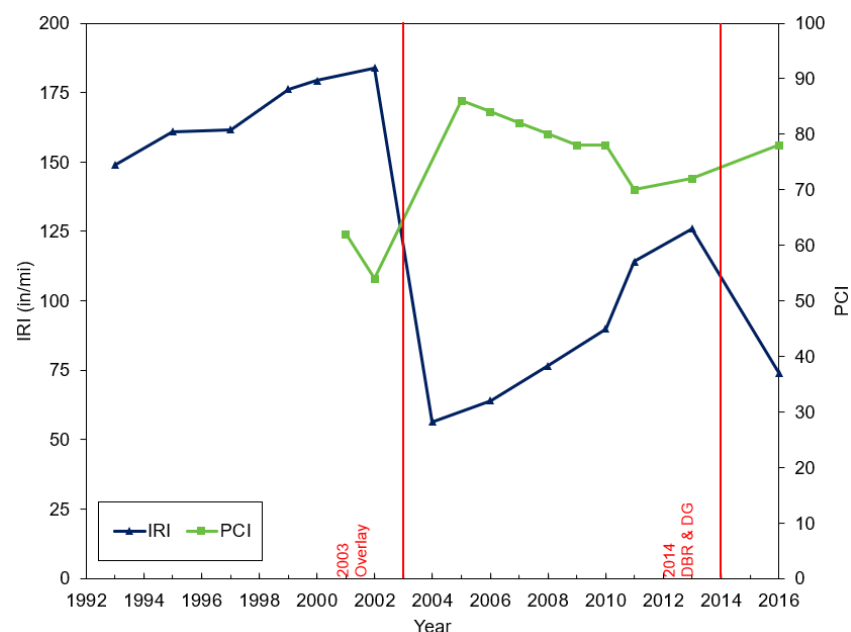
**Figure 8-15. Time-series for IRI and Friction, EB U.S. 20 EB (Data source: Iowa DOT).**

The effects of the 2003 AC overlay and the 2014 concrete rehabilitation on surface smoothness are clearly evident, with a decrease in IRI after each treatment. In terms of overall condition, after the 2014 rehabilitation the PCI increased to same level as it was in 2010.

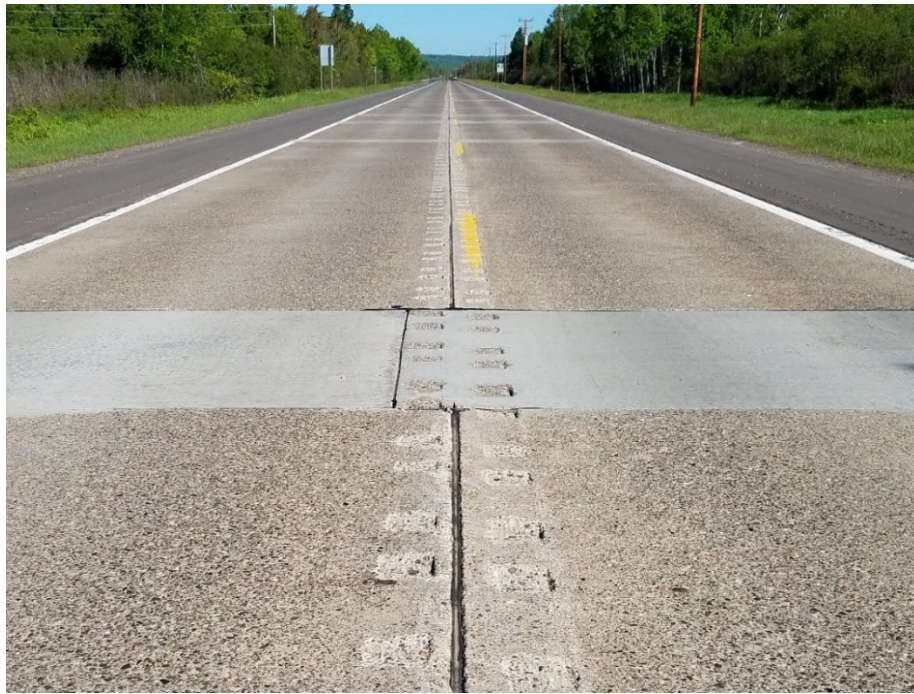
A site visit to the project was performed in 2018. Distresses observed during that site visit included a few low- and medium-severity transverse cracks, joint sealant deterioration, isolated

spalling (particularly at the longitudinal joint) that has been patched with asphalt material, one area of slab settlement, and some general surface wear. Figures 9-4 through 9-7 present examples of the 2018 pavement condition.

**Figure 9-4. View of the project showing full-depth repairs and worn concrete surface.**

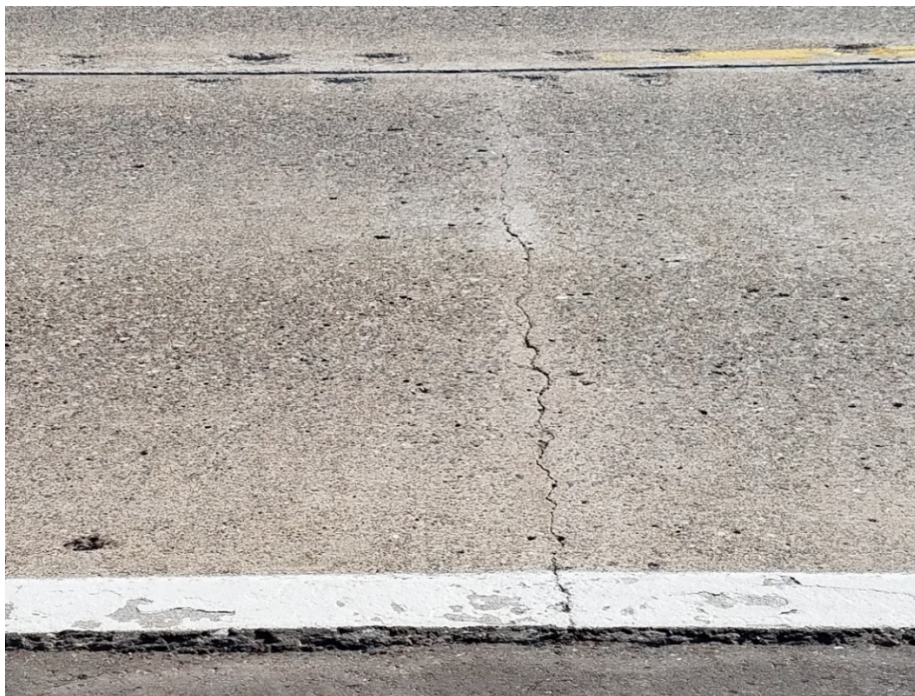
**Figure 9-5. Low-severity mid-panel crack.**

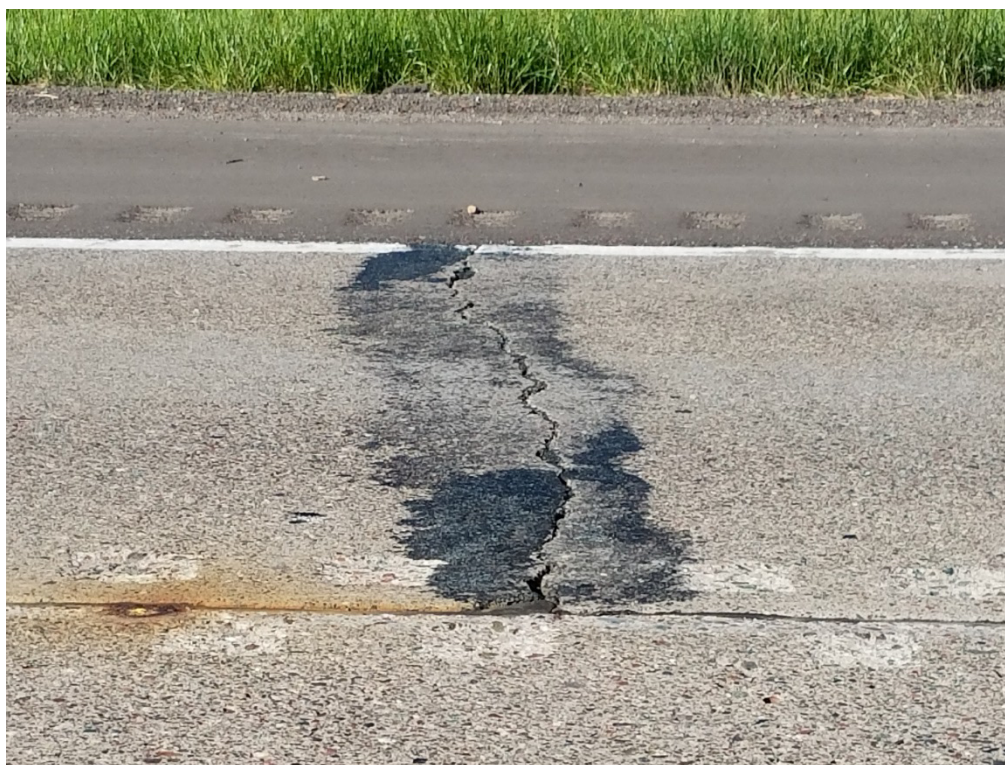
**Figure 9-6. Medium-severity mid-panel crack with temporary asphalt “repair.”**

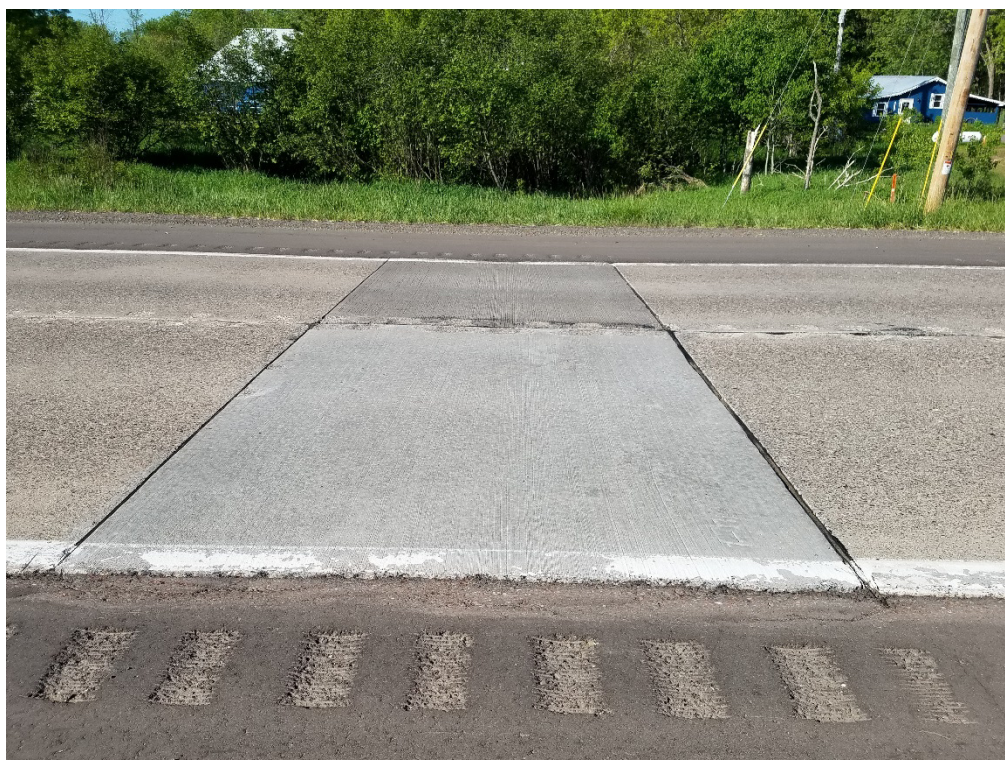
**Figure 9-7. Typical full-depth joint repair.**

The color differences are indicative of patches placed at different times; the darker repair was placed in 2007, and the lighter repair was placed in 2017.

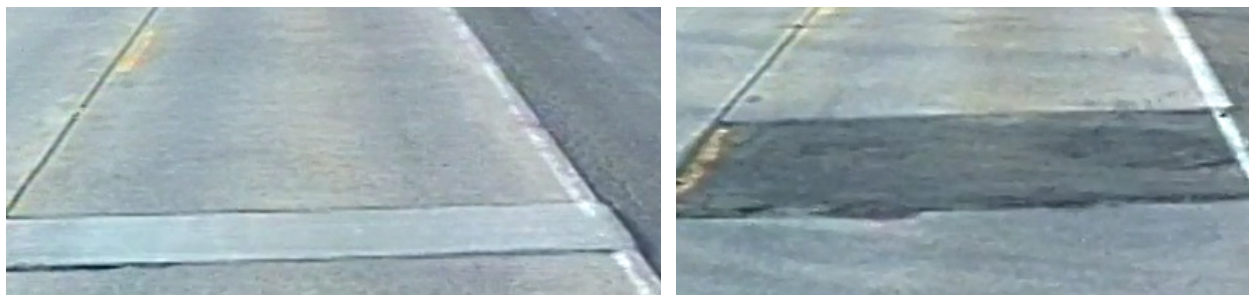
Maintenance repairs on the concrete section are evident in MDOT video records, collected in or prior to 1998. Figure 8 shows examples of concrete and asphalt repairs that are seen in the 1998 MDOT video log within the project limits. A review of the 1998 video log identified approximately 20 to 25 concrete repairs and 8 to 10 asphalt repairs in each direction (northbound and southbound).

**Figure 9-8. Example of repairs prior to 1998.**

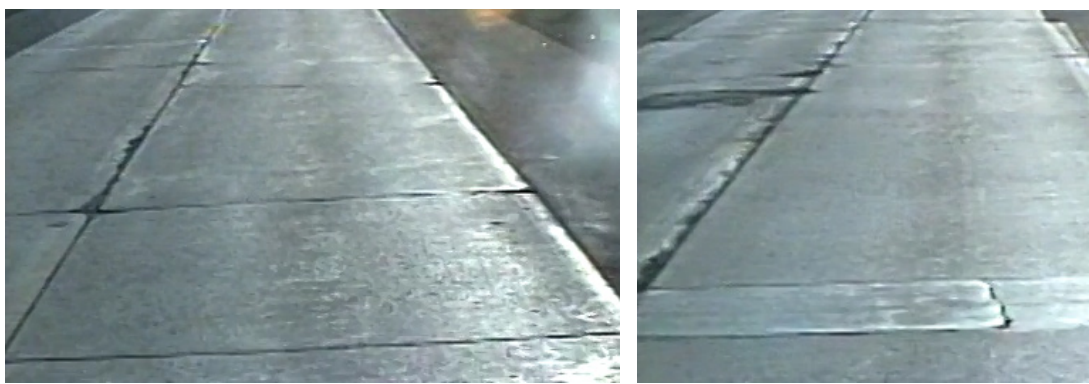
The first documented major rehabilitation in 2000 included full-depth repairs and joint resealing on the southeastern sections and removal of approximately 900 ft (274 m) of concrete at the northwestern project limits. Documents did not specifically state why the 900 ft (274 m) section of concrete was removed; however, the 1998 MDOT video log showed the section to be more severely deteriorated (figure 9-9) than the remainder of the project with significantly more cracking and joint deterioration. A potential explanation for this poorer performance is that this northwestern section, which was constructed on 18 inches of unclassified pit materials, may not have had adequate support compared to the southeastern sections that were constructed on 5 to 7 ft (1.5 to 2.1 m) of stamp sands.

**Figure 9-9. Examples of 1998 concrete condition prior to removal in 2000.**

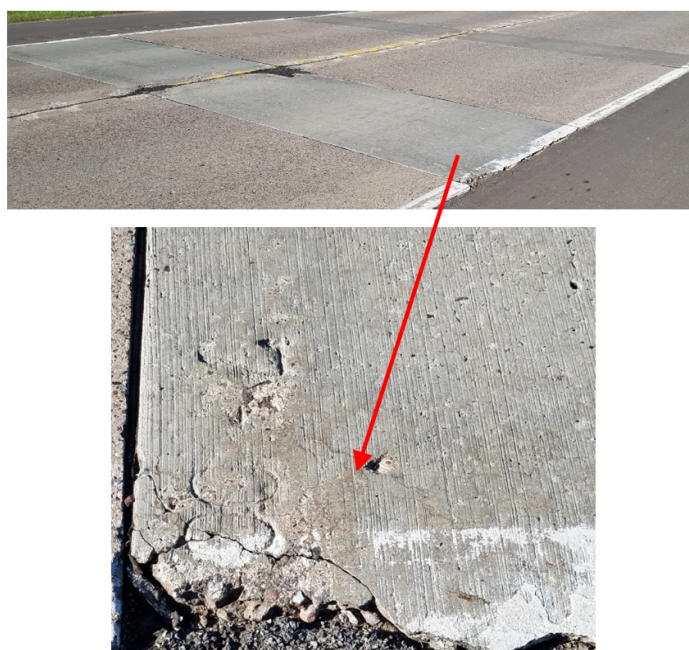
Subsequent rehabilitations featuring full-depth concrete repairs and joint resealing took place in 2007 and again in 2017 to repair additional deteriorated joints and cracks and replace full-depth repairs that had themselves failed. In particular, the concrete material used in the 2000 repairs appeared to be susceptible to materials-related distress (MRD), potentially due to the high cementitious content and use of calcium chloride accelerator, and many of the repairs had to be reconstructed in the 2007 project.

The 2018 visual assessment identified MRD in many of the remaining repairs that were placed in 2000. The MRD took the form of map cracking and corner spalling; an example is shown in figure 9-11. Some patches appeared to deteriorate rather quickly and were replaced in 2007, while others were replaced in 2017. In other instances, the original concrete adjacent to the repair deteriorated resulting in this material as well as the repair being removed and replaced with a new, larger repair. This experience emphasizes the need to construct full-depth repairs carefully with the goal of having a service life consistent with the remaining life of the pavement.

**Figure 9-11. Example of 2000 repair condition in 2018 showing map cracking and corner spalling.**

As indicated, over time MDOT has reduced the cement contents in these high-early-strength mixtures and switched from calcium chloride to non-chloride accelerator, largely to improve the long-term durability of the repairs.
