# **STRATEGIES FOR CONCRETE PAVEMENT PRESERVATION**

**Volume III: Case Studies**

**June 2026**

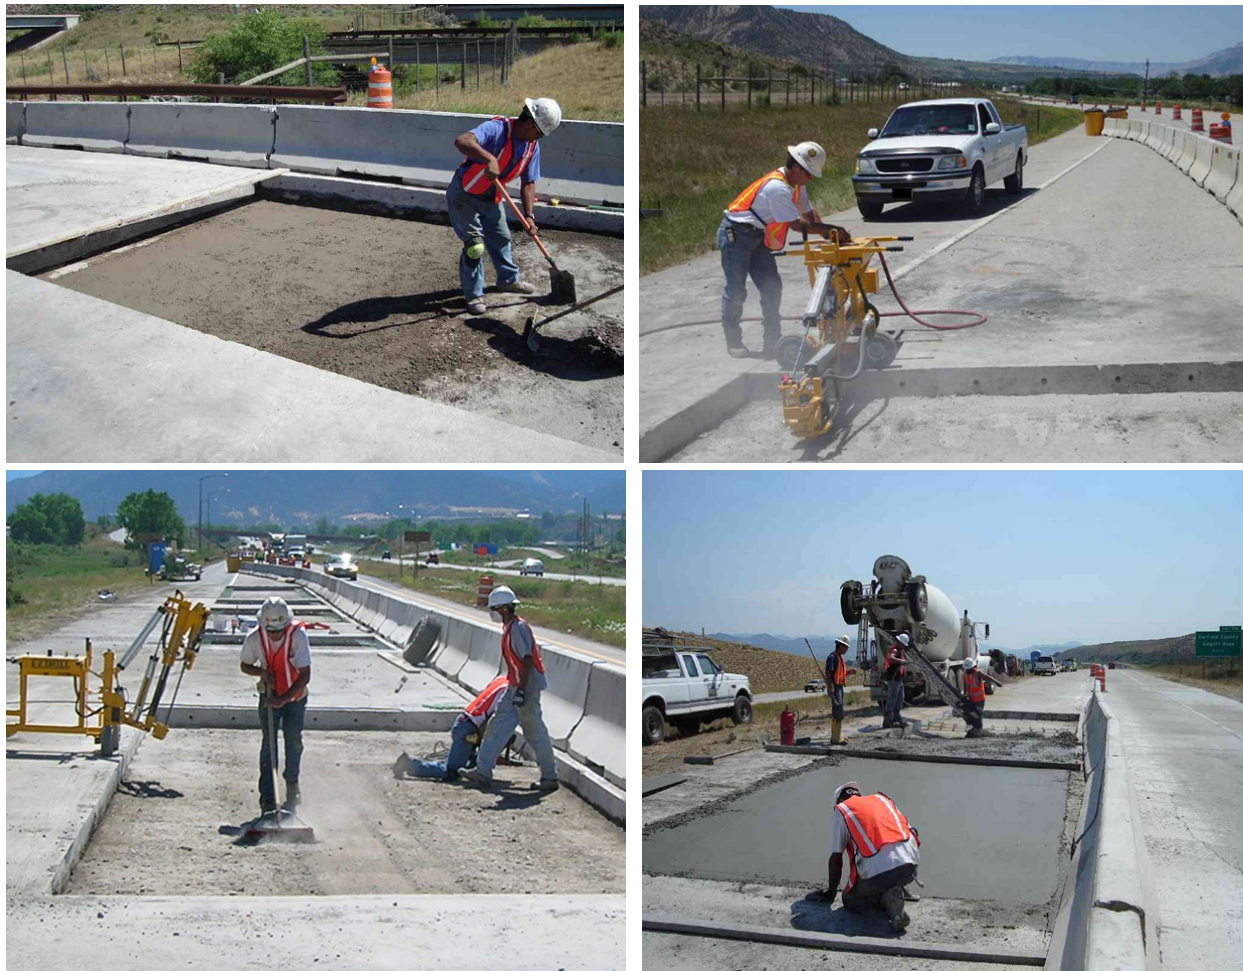
**Figure 10-5. 2005 full-depth repair construction (Necessary and Lemasany 2006).**

Distressed pavement panels were replaced in both directions in 2004. In most areas, the repair was done across both lanes and both shoulders over several panels of length, but some repairs were confined to one or both travel lanes and short distances. Plans called for joints in the newly placed slabs to be placed in the same locations as previous joints with skews to match existing joints in adjacent slabs. Unlike the original transverse joints, the repair joints were constructed with doweled joints (5 dowels per wheel path on 12-inch [300mm] centers with the outermost dowels located 6 inches [150 mm] from the nearest longitudinal joint).

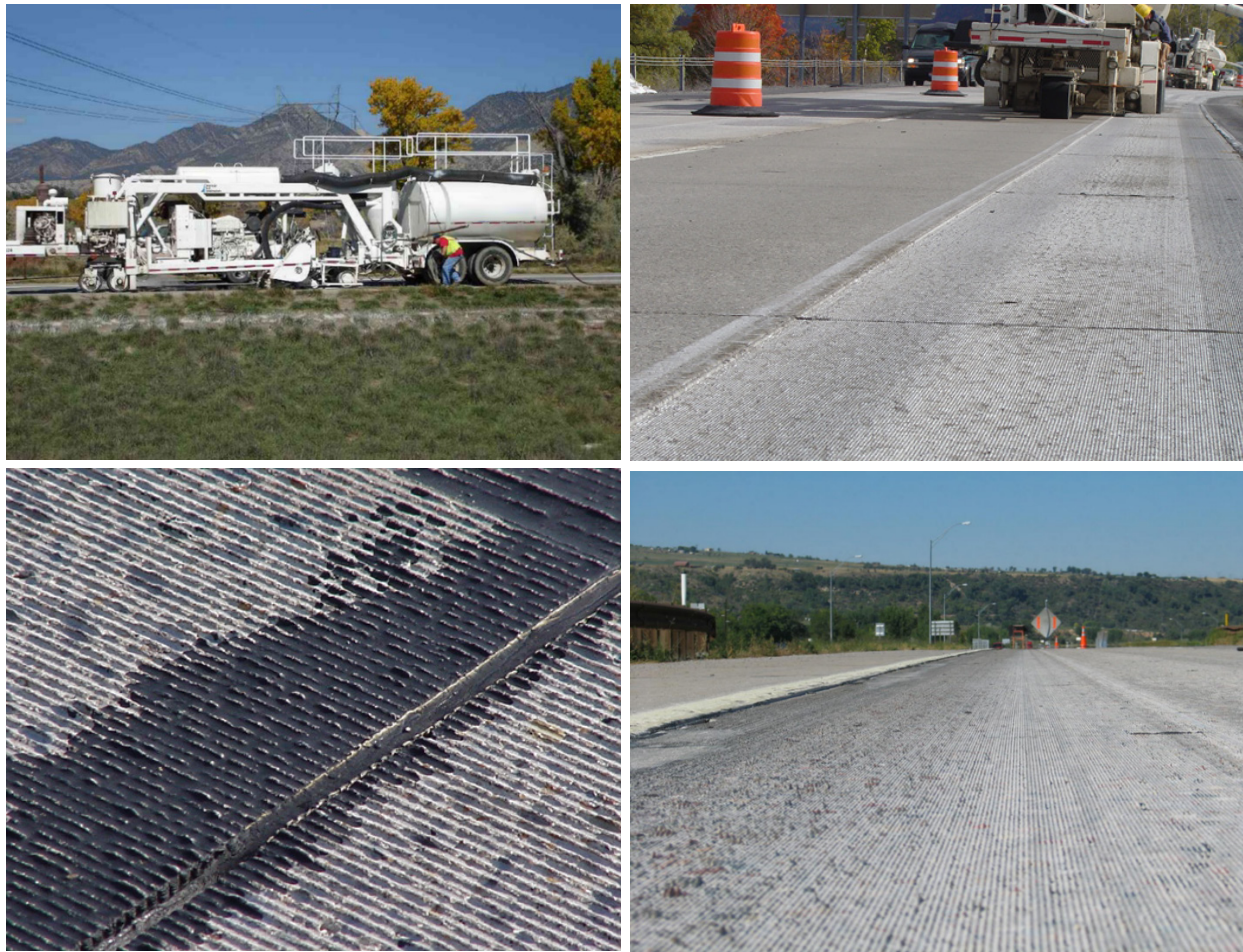
**Figure 10-6. 2005 diamond grinding work (Necessary and Lemasany 2006).**

This work was primarily a blanket diamond grind of the entire project (329,912 s.y. [274,914 m<sup>2</sup>] of grinding), but it also included a small amount (1199 s.y. [1003 m<sup>2</sup>]) of additional concrete pavement patching, rumble strip grinding (22,532 lineal feet [6868 m]) and weather sensor installation. The purpose of the grinding was to re-establish a uniform textured surface, but also to remove the significant surface “rutting” caused by tire chains and studded tires (see Figure 10-4). Photos of the 2005 repair and grinding work are presented in Figures 10-5 and 10-6.

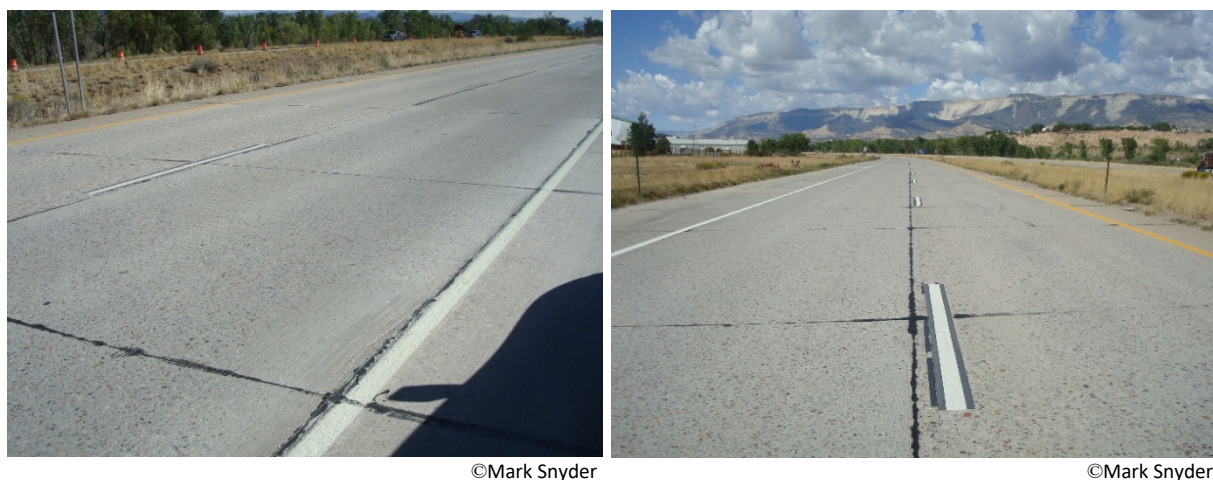
Typical conditions consisted of original and/or replaced panels in generally good overall condition (see Figure 10-8) but often with longitudinal cracking (especially in the passing lane because of the very wide panels created by not sawing a longitudinal contraction joint with the inside shoulder – see Figure 10-9). There was also widespread shallow surface cracking that could be related to drying shrinkage or some type of material-related distress (e.g., ASR), as shown in Figure 10-10; sampling and testing would better define the nature of this cracking and its potential impact on future pavement performance. It can be seen in many of the photographs that the transverse joints are generally tight (with extruded joint sealant), possible evidence the panel expansion that often accompanies ASR.

**Figure 10-8. Examples of typical good overall pavement condition.**

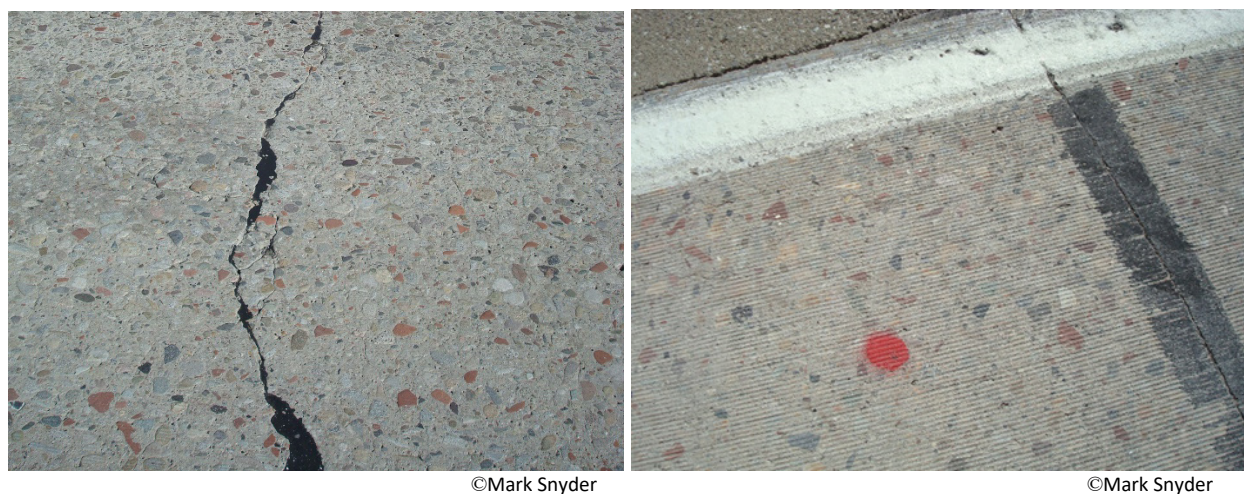
There was very little surface texture remaining from the 2005 blanket diamond grinding, but more texture was observed in the panels that were apparently placed and diamond ground in 2014 (see Figure 10-11). Original panels were easily differentiated from 2004-2005 and 2014 repair panels by slight differences in color and significant differences in the particle sizes of the concrete aggregate (much larger stones in the original concrete), as shown in Figures 10-11 and 10-12.

**Figure 10-11. Examples of typical surface texture in original pavement (left) and replaced panels (right).**

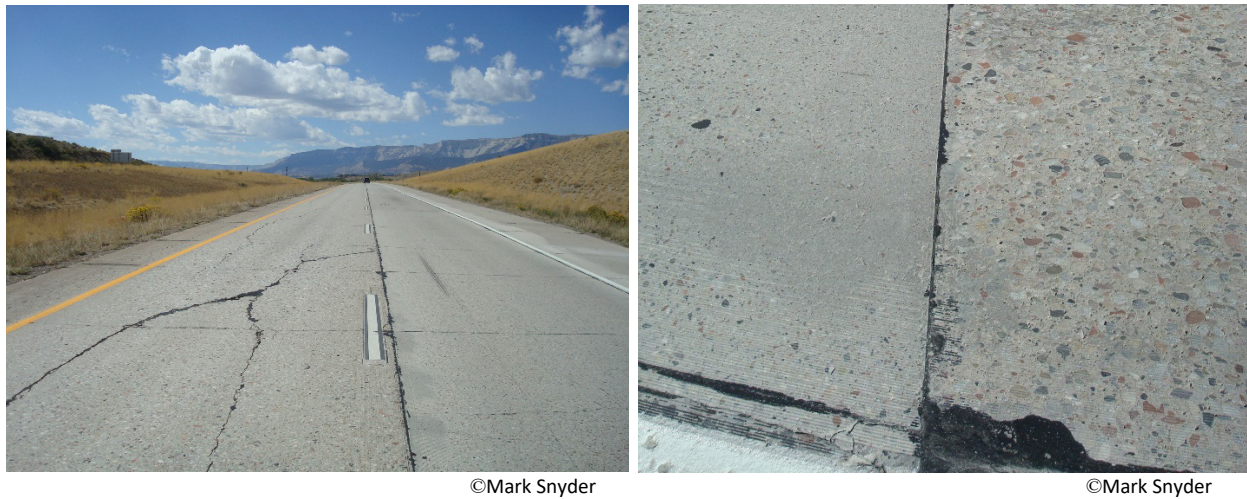
**Figure 10-12. Examples of visible concrete color and aggregate size differences between original pavement and full-depth repairs.**

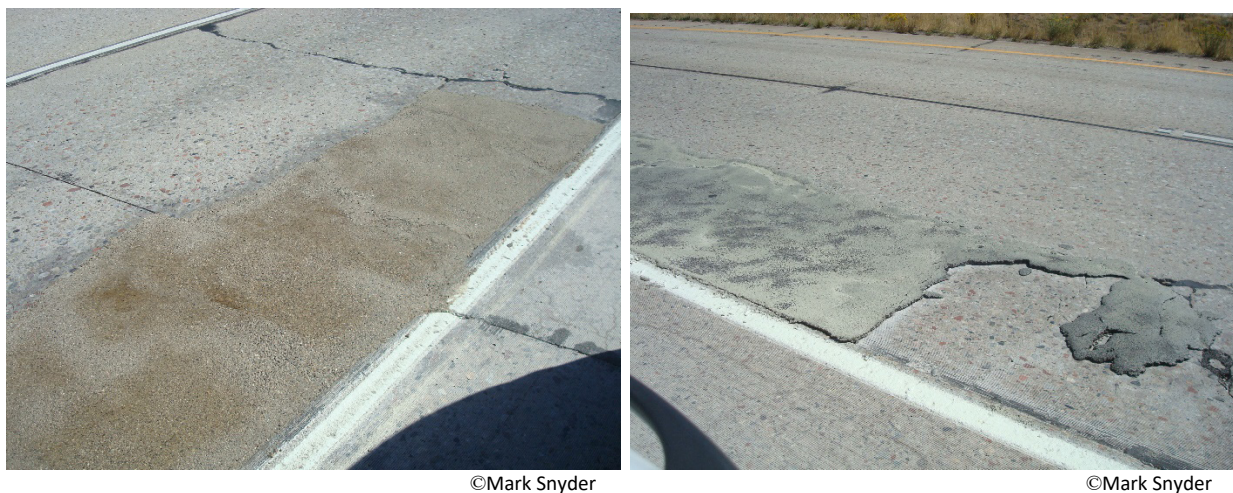
Some areas exhibited high levels of distress, including shattered slabs (panels with several cracks, generally both longitudinal and transverse cracks), settled panels, and deterioration around and between cracks (see Figure 10-13). The previously described surface cracking was more severe in some areas as well, and there were a few areas where thin surface patching materials had been placed (apparently by CDOT maintenance forces, because this type of work was not described in the plans and bid documents for the 2003-2005 and 2014 rehabilitation activities), as shown in Figure 10-14.

**Figure 10-14. Examples of use of thin, partial-depth material along settled panel lane-shoulder joints.**

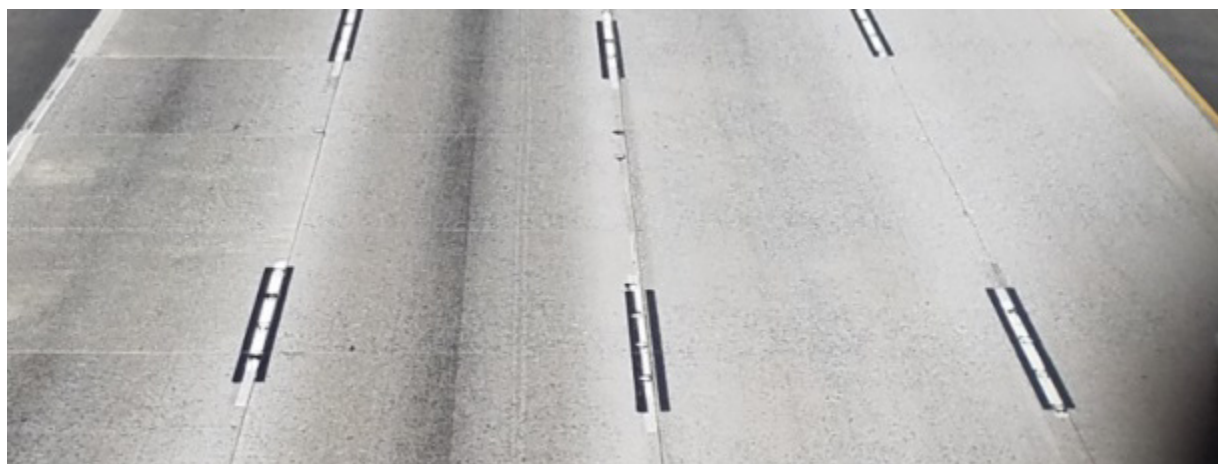
A site visit to the project was performed in 2018. Distresses observed during the site visit include a few low and medium severity mid-panel cracks, surface wear, joint sealant deterioration, isolated spalling (particularly at the longitudinal joint) that has been patched with asphalt material, and one area of slab settlement. Figures 11-3 and 11-4 present examples of the 2018 pavement condition.

**Figure 11-3. View (towards oncoming traffic) of the existing concrete pavement in 2018. Left two lanes are original concrete pavement.**

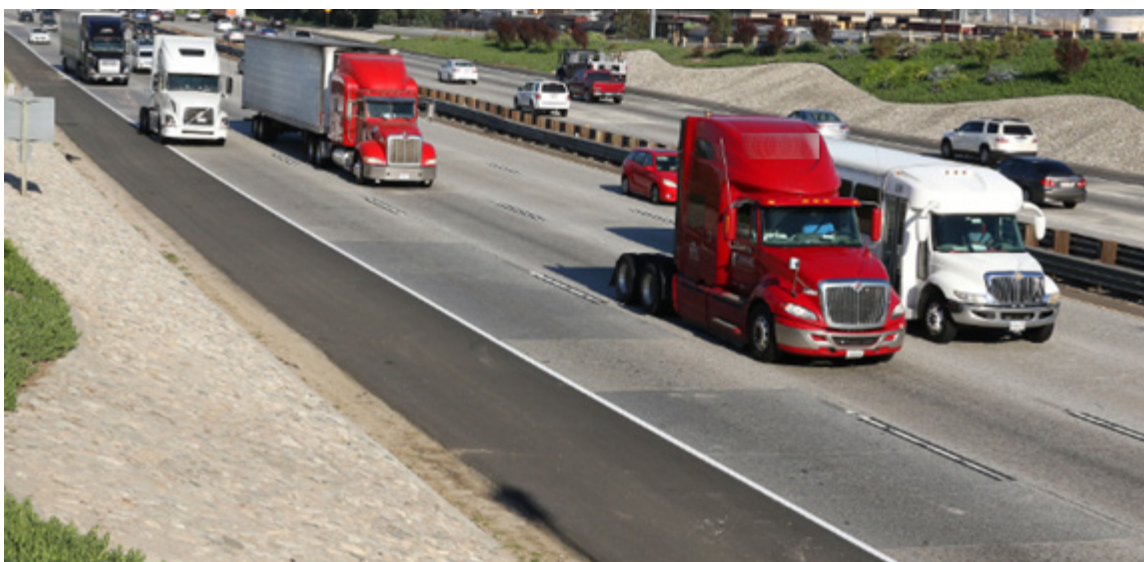
**Figure 11-4. Example view of existing concrete pavement in 2017 showing replaced slabs. Left two lanes (in photo) are original concrete pavement.**

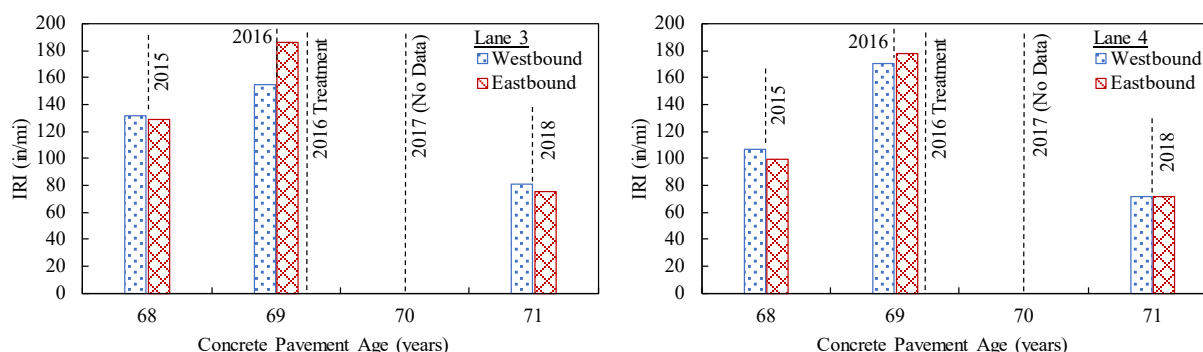
Figure 11-5 shows time series IRI data from 2015 through 2018 for lanes 3 and 4, in both directions. Available Caltrans data showed that the average IRI for both outer lanes (3 and 4) in the eastbound and westbound directions, prior to the last CPR, were 182.1 in/mi (2.8 m/km) and 162.6 in/mi (2.5 m/km), respectively. Two years after CPR these IRI values in the eastbound and westbound directions remained below 80 in/mi (1.3 m/km) at 73.4 in/mi (1.1 m/km) and 76.6 in/mi (1.2 m/km), respectively. Caltrans IRI threshold for a poor ride is set at 170 in/mi (2.6 m/km) (Caltrans 2018), this shows the efficacy of diamond grinding.

**Figure 11-5. Time-series IRI performance data (created from Caltrans data).**

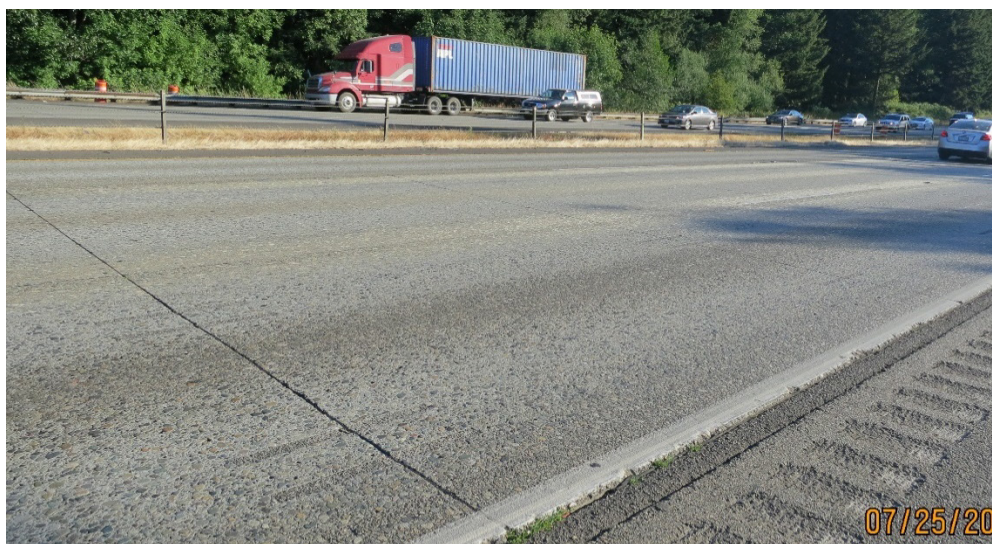
A project site visit was performed in 2018. Distresses observed during that visit included low- and medium-severity mid-panel cracks, surface wear, isolated joint and crack spalling, and severe wheel path wear (from studded tires) in some panels replaced during the previous CPR projects. Figures 12-3 through 12-7 present examples of the 2018 pavement condition.

**Figure 12-3. View of outer lane and adjacent shoulder (northbound direction).**

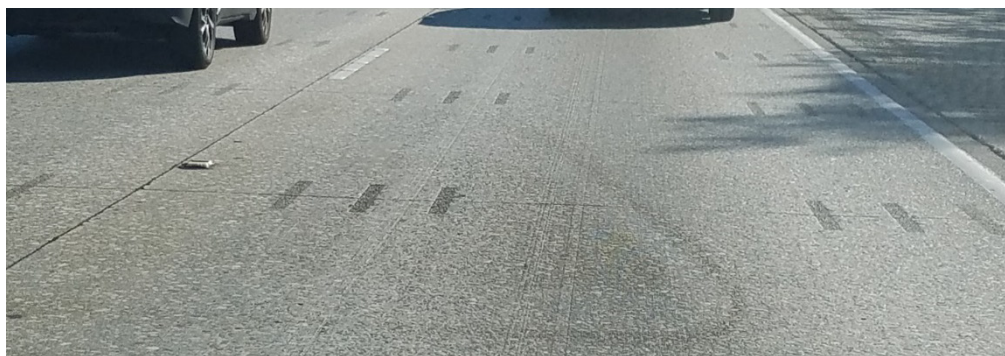
**Figure 12-4. View of the northbound project showing dowel bar retrofitting and texture produced by diamond grinding in outer (truck) lane) constructed in 1996.**

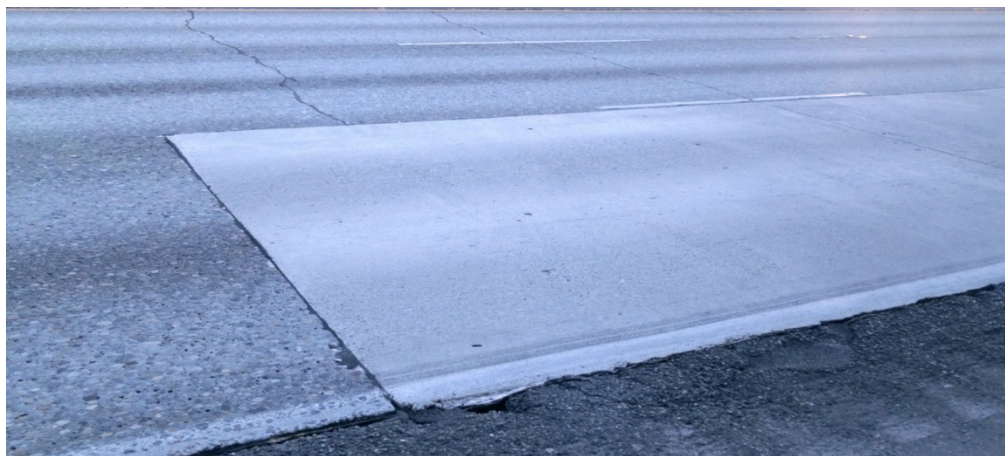
**Figure 12-5. Slab replacement in outer (truck) lane and medium-severity transverse crack in center and inner lanes.**

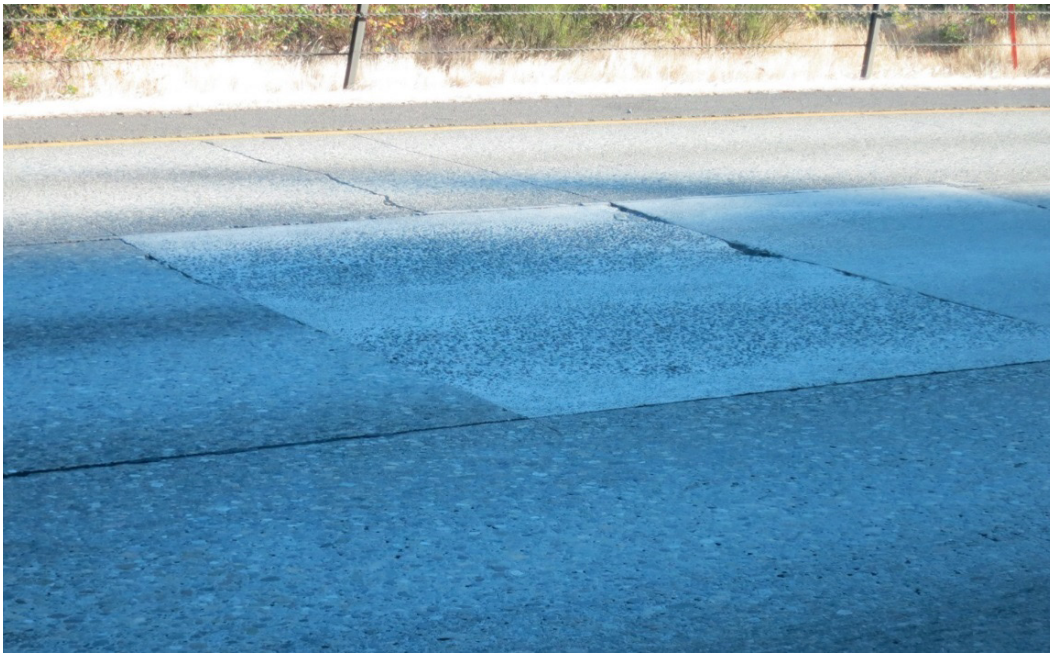
**Figure 12-6. Replaced slabs showing signs of severe surface wear from studded tires.**

- **Rutting from studded tires remains a concern.** Surface wear as the result of studded tires was observed to be severe in some of the slab replacements reinforcing the idea that concrete used for repairs should have similar or better wear resistance and durability (based on location and/or service conditions) than the concrete being replaced.

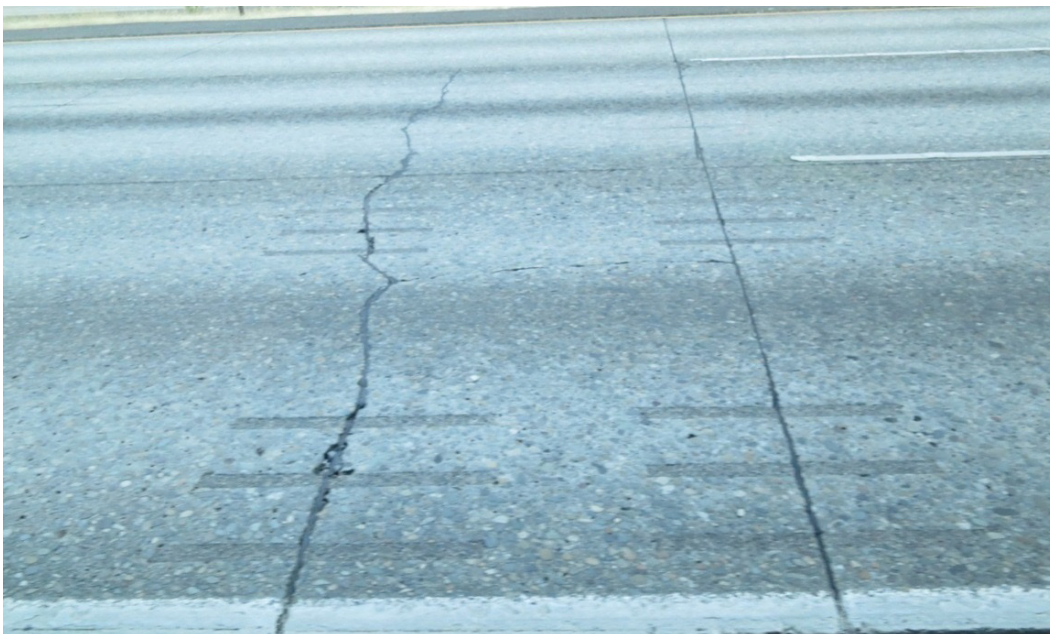
**Figure 12-7. Dowel bar retrofit across transverse joint and crack.**

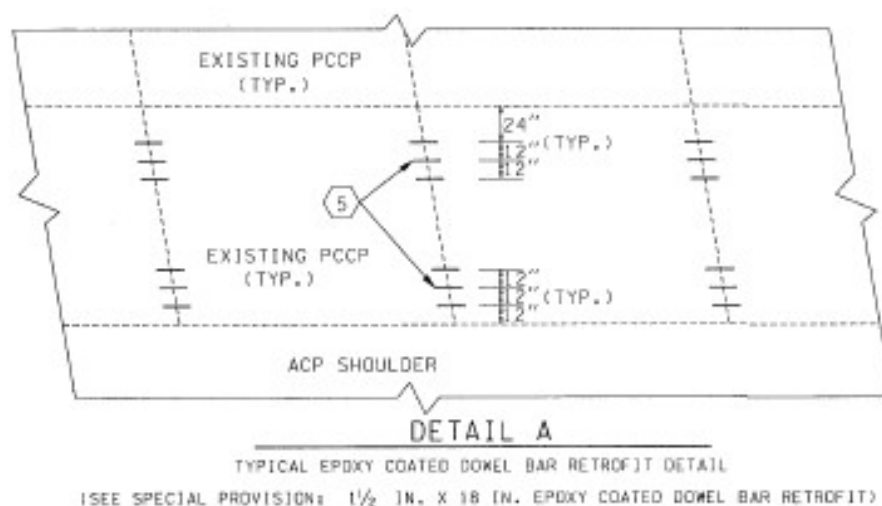
**Figure 12-8. Dowel bar retrofit details.**

The dowel bar retrofit plan called for the placement of 18-inch (457 mm) long, 1.5-inch (38-mm) diameter epoxy-coated smooth dowel bars. The tie bars used in the cross stitching were required to be #5 deformed bars. Construction details for the dowel bar retrofit and cross-stitching are shown in figures 12-8 and 12-9, respectively.

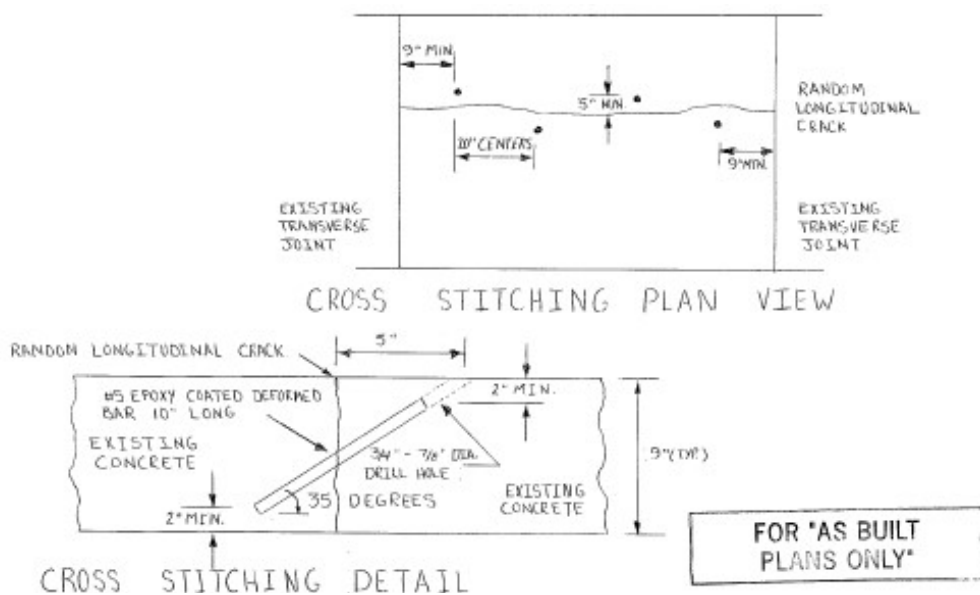
**Figure 12-9. Cross-stitching details for longitudinal cracks.**

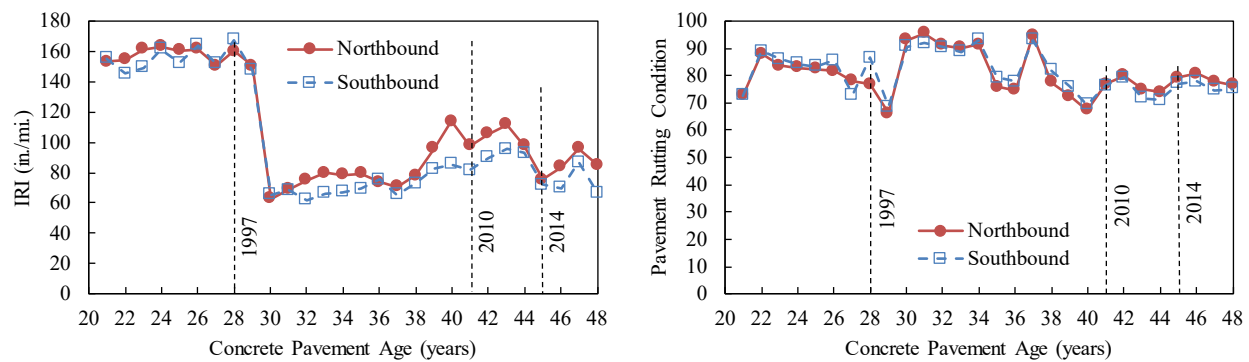
Figure 12-10 shows time-series IRI and PRC data for the outer lane of the project from 1990 until 2017. After the first major rehabilitation in 1996 and 1997, the IRI dropped from a value of about 160 inches/mi (2525 mm/km) to an IRI value of approximately 60 inches/mi (947 mm/km). After the 2010 CPR, the IRI dropped slightly (approximately 16 inches/mi [253 mm/km]), likely due to the slab replacements that were performed in the outer lane. According to WSDOT, the reduction in IRI after 2010 may be due to data collection problems encountered with new equipment acquired by the State in 2008. Regardless, the data demonstrates that the CPR conducted in 1996/1997 was highly effective in not only dramatically improving ride quality, but in sustaining it for the next 20 years.

**Figure 12-10. Time-series performance data (created from WSDOT data).**
