Iowa DOT – Deck Overlays & UHPC Experience

Todd Hanson, P.E., Iowa DOT
PCC Materials Engineer

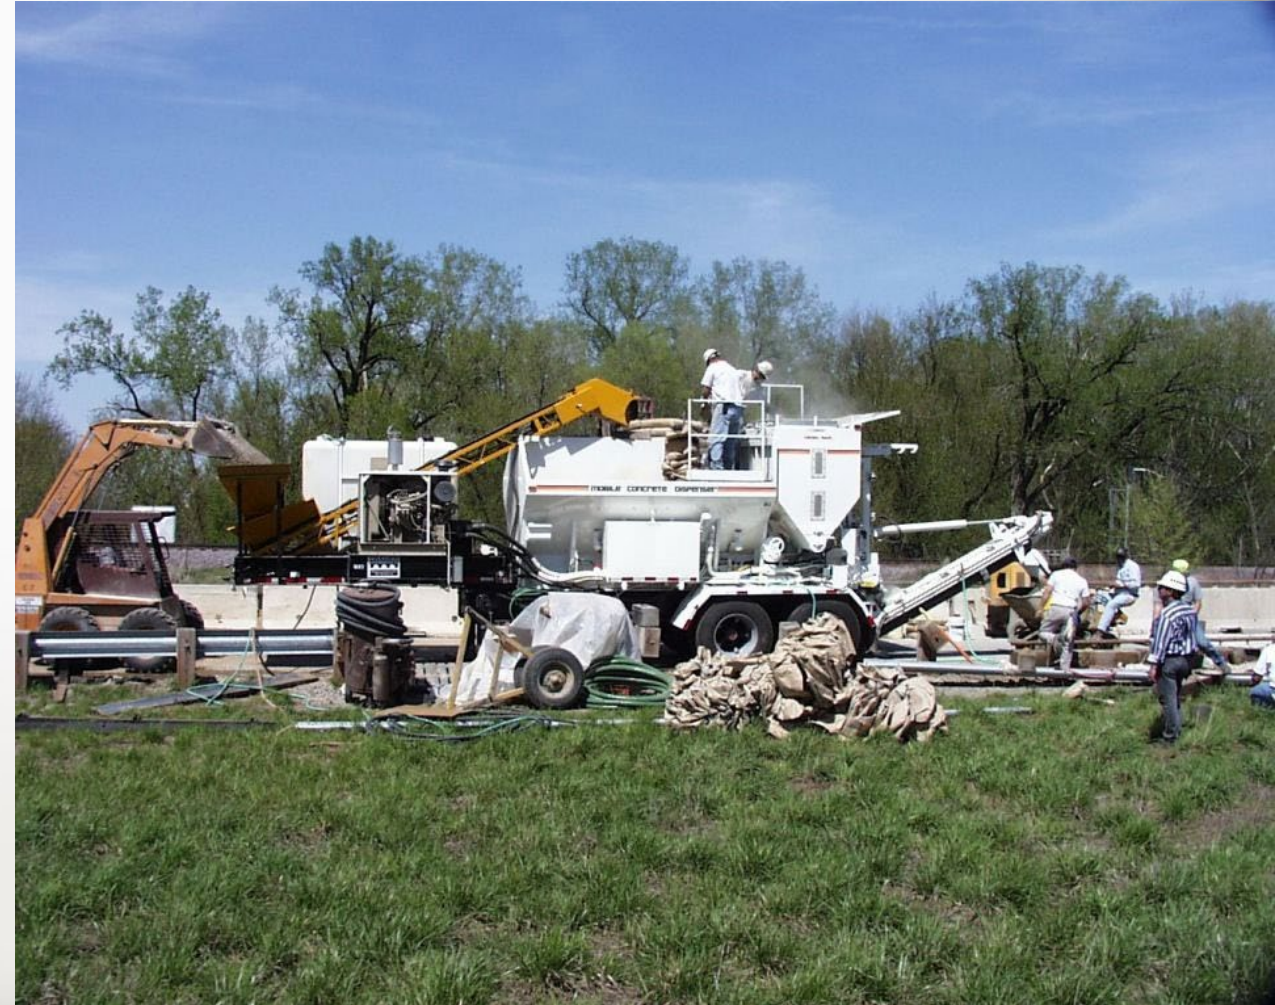
History of Iowa Deck Overlays

- Low slump deck overlay mid 1960s (Iowa Method)
- Class O Mix
- 825 lb/cy - $\frac{3}{4}$ " slump
- Volumetric mixer

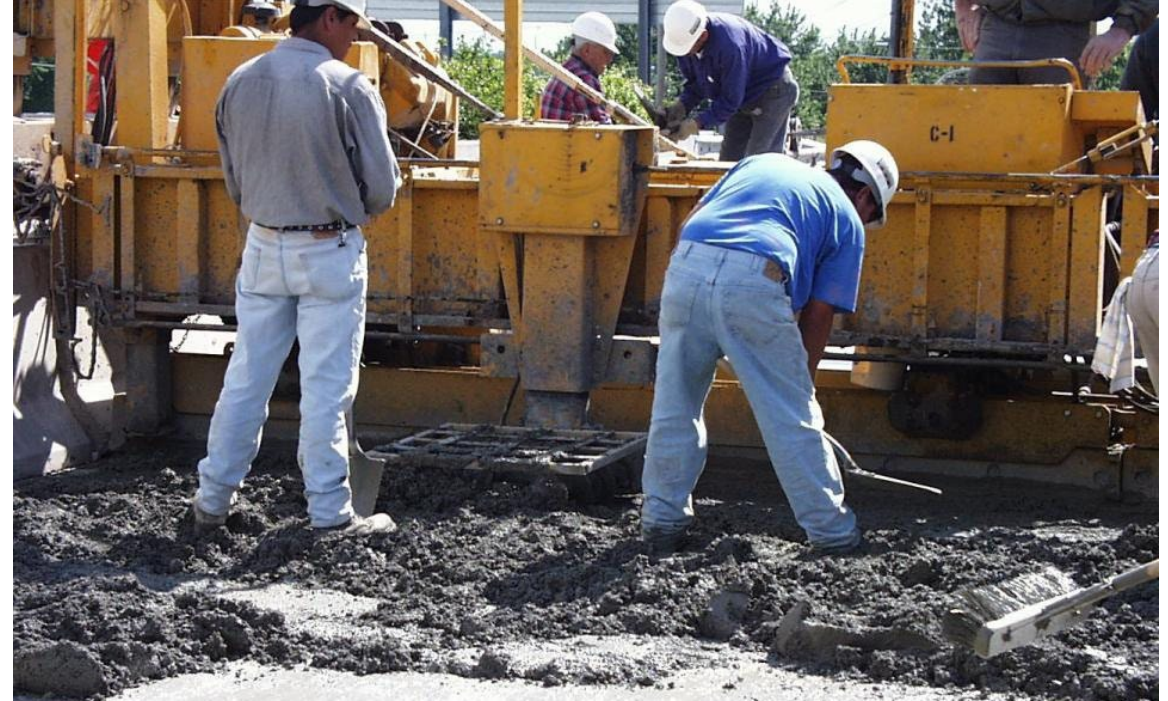
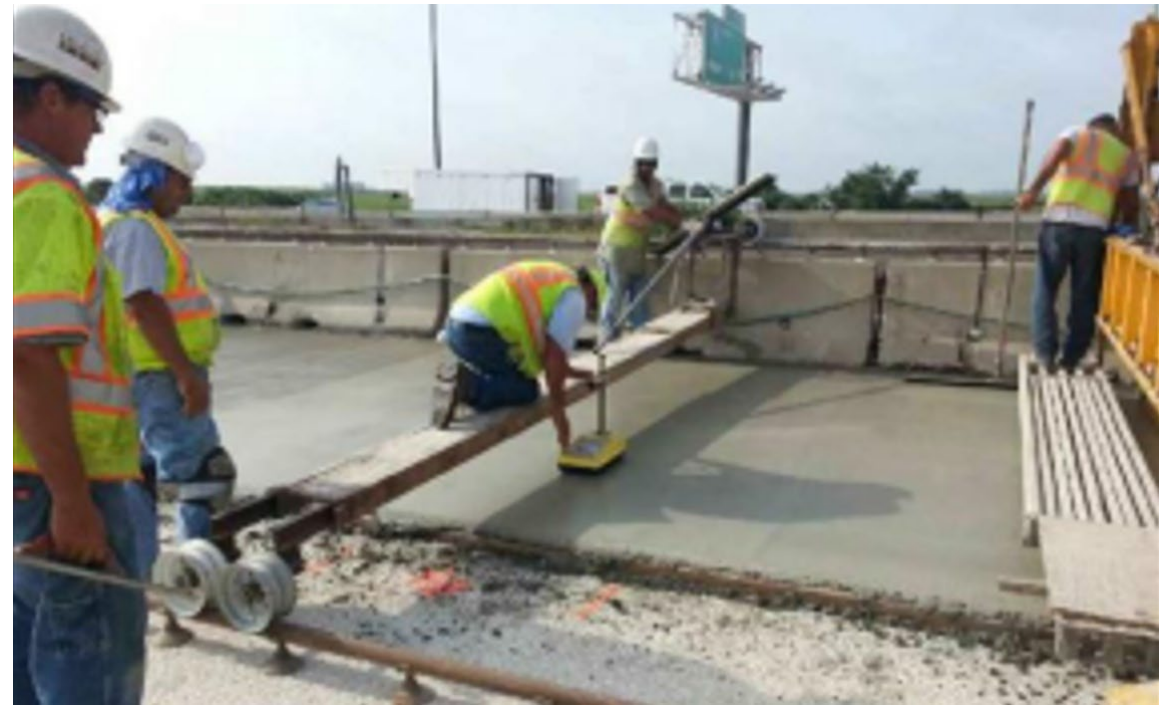
History of Iowa Deck Overlays

- Vibrated into place
- 98% rodded density tested by nuclear gage
- Experience more cracking than in the past

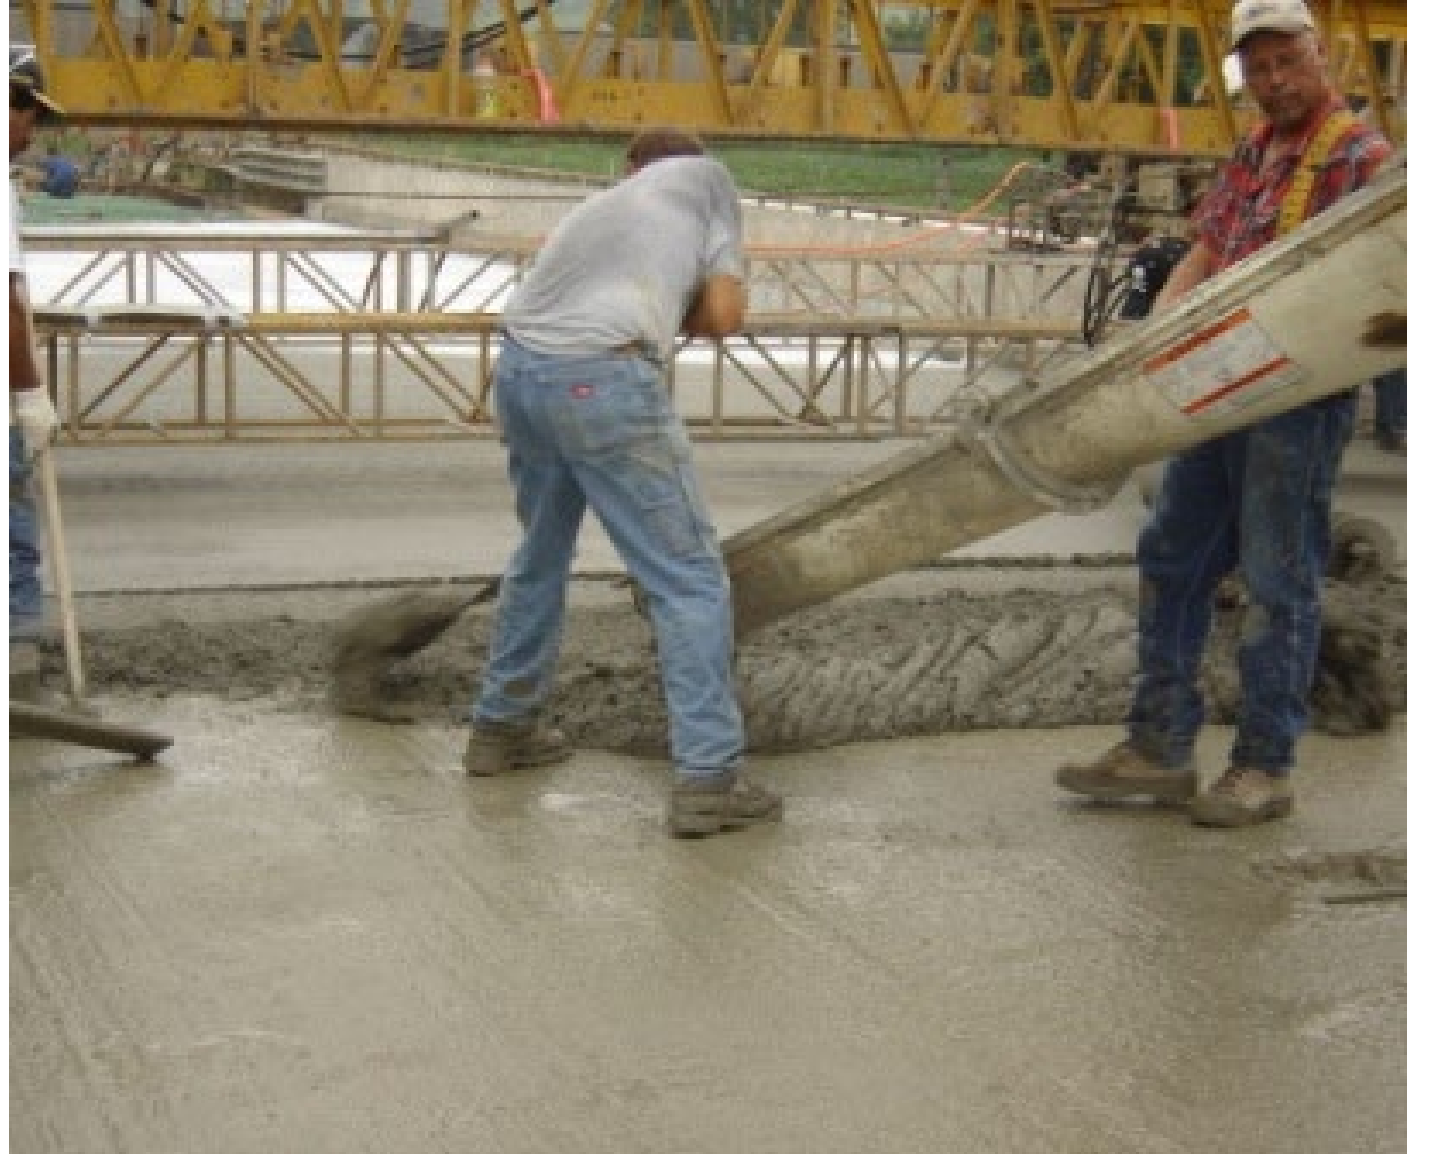
History of Iowa Deck Overlays

- After 9/11 - nuclear gage requirements increased
- 2004 - HPC-O mix
- Use of slag, fly ash & Mid range WR
- Higher slump mix allowed ready mix
- Conventional bridge deck machine

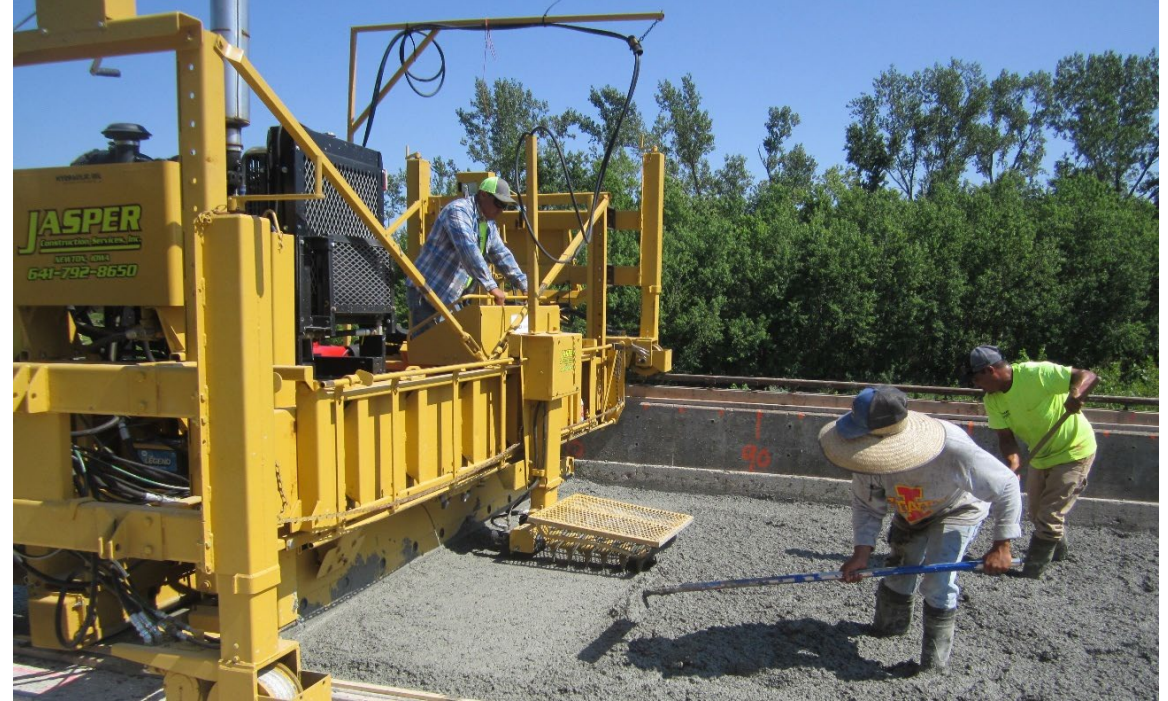
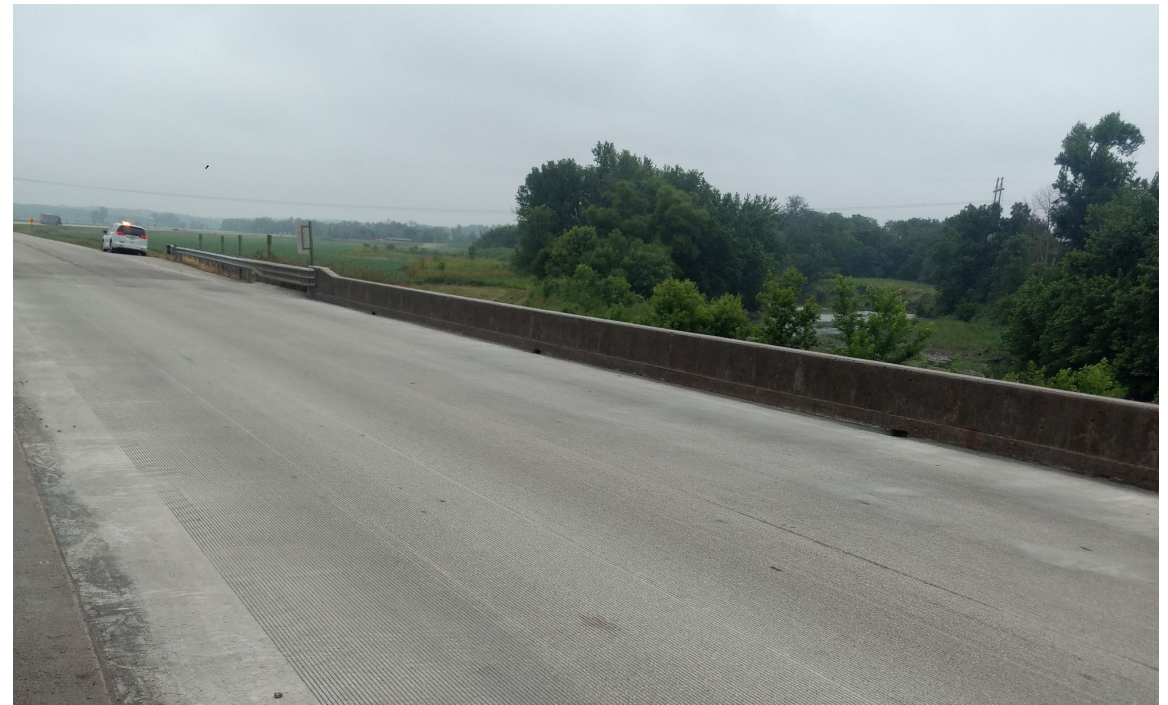
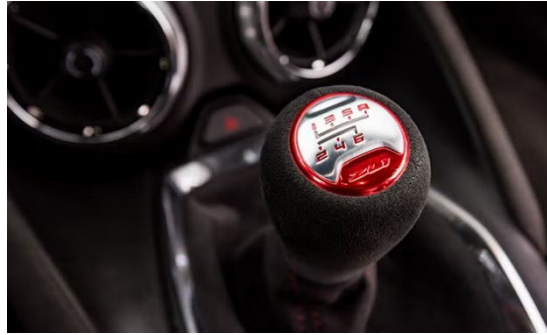
History of Iowa Deck Overlays

- HPC-O mix - Lower permeability but still some cracking issues
- Fibers have helped
 - Jasper IA 117
 - 4 lb/cy macrofibers

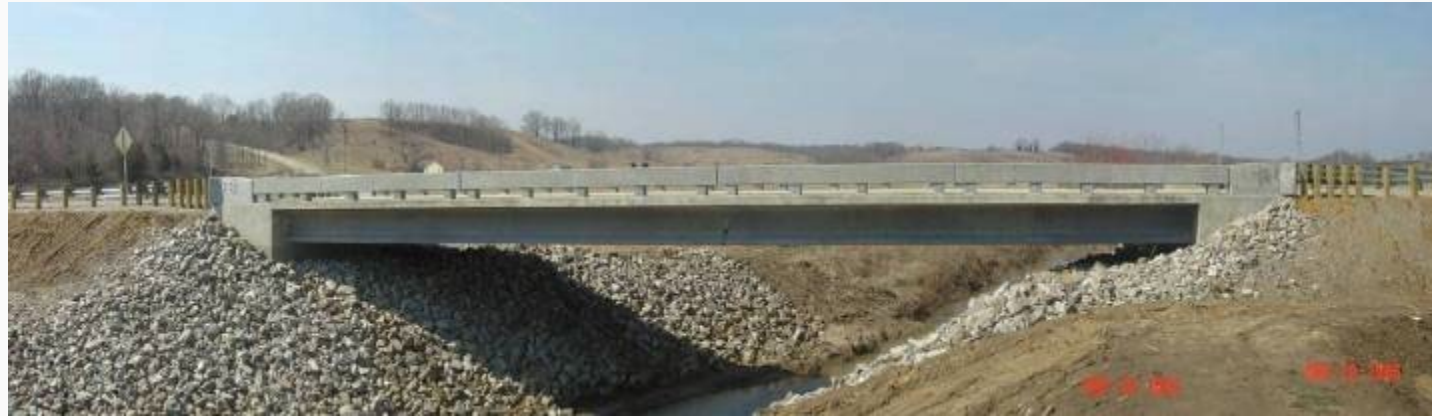
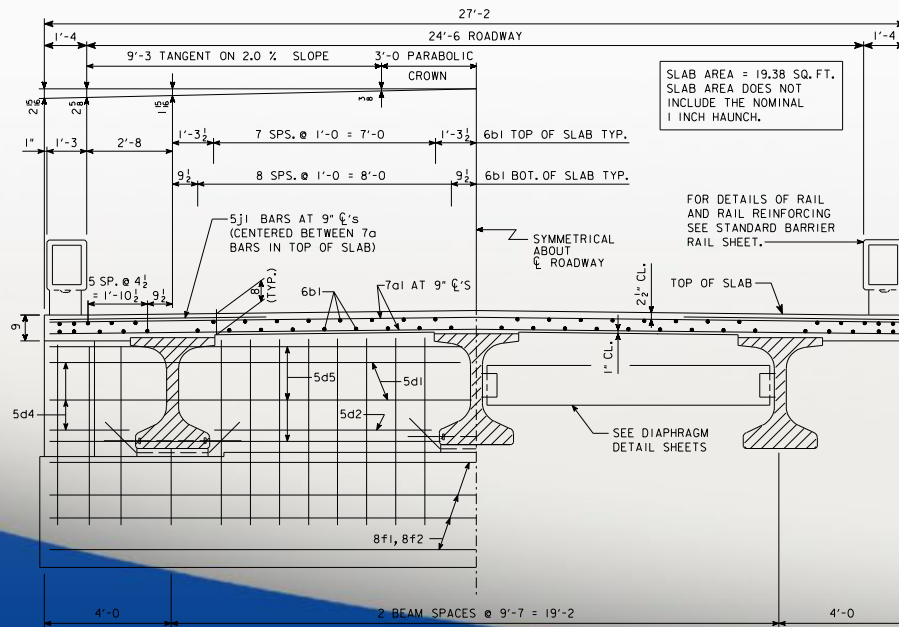
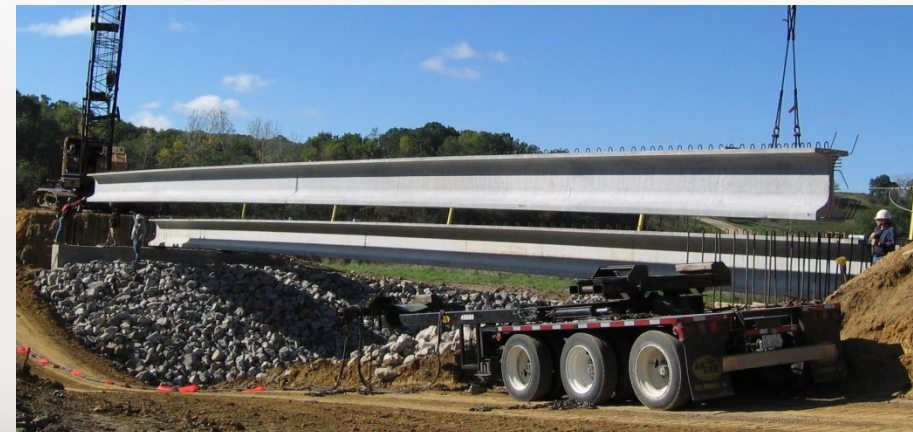
2006 First UHPC I-Girder Bridge in North America, Wapello County

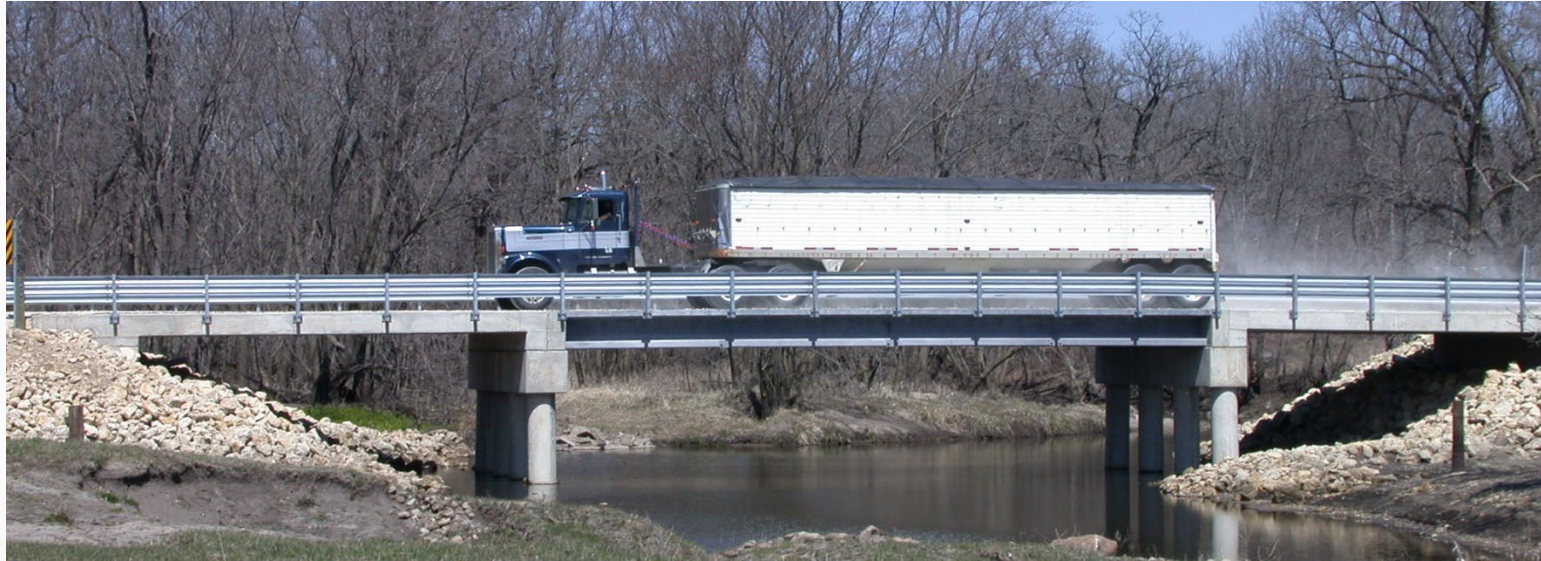
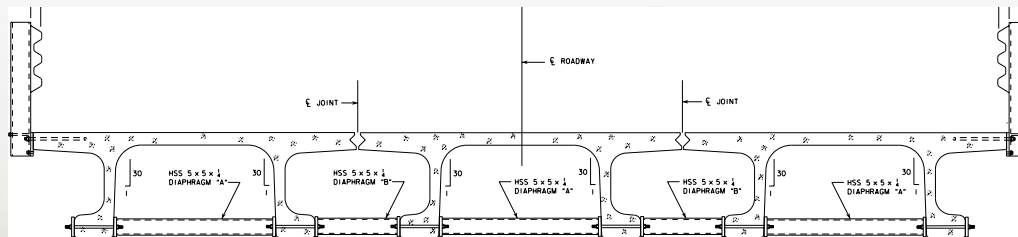
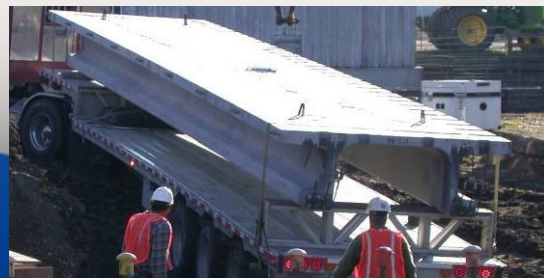
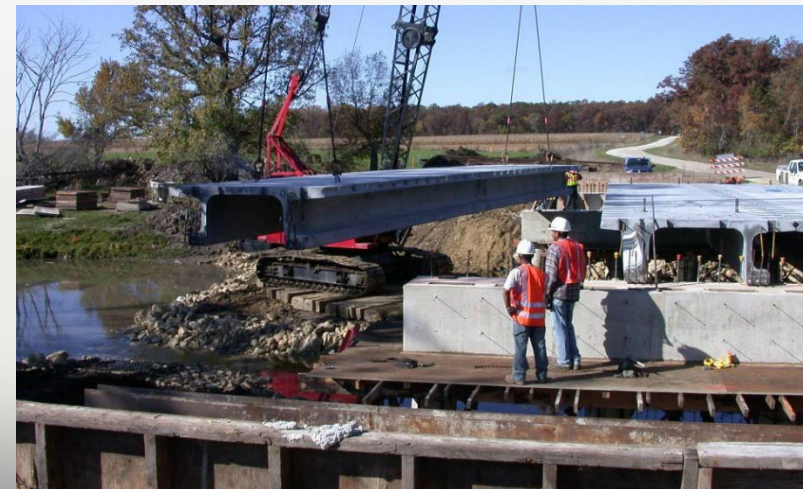
2008 First UHPC PI-Girder Bridge in North America, Buchanan County

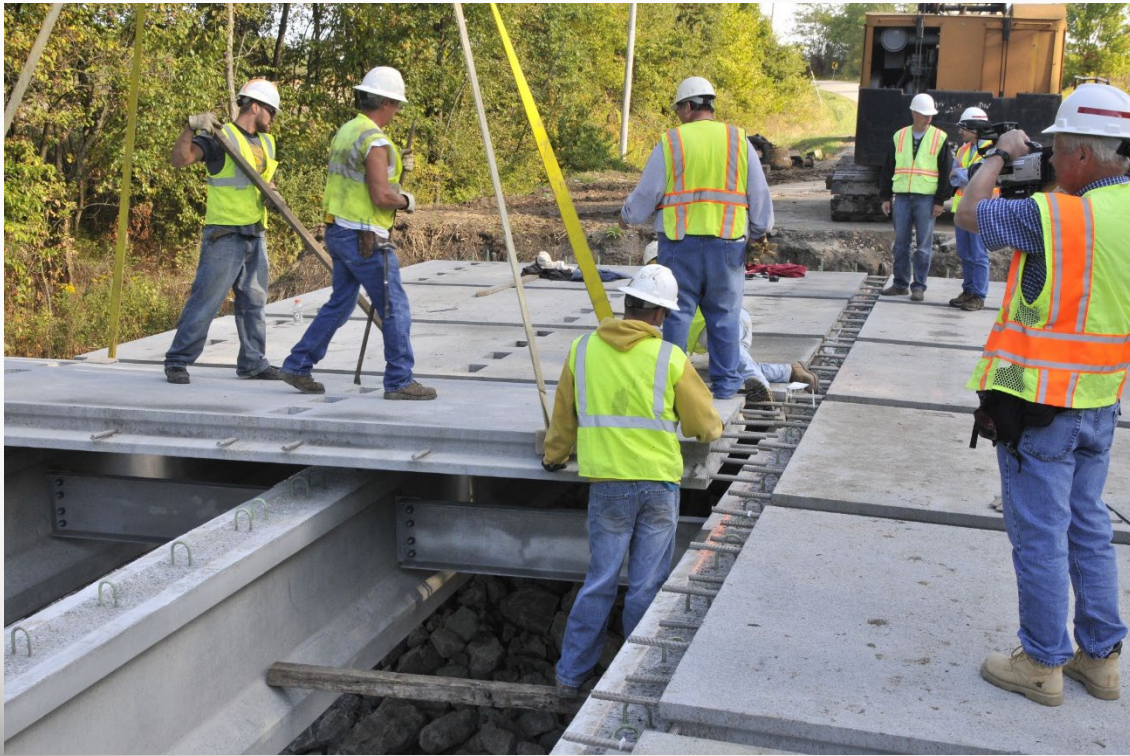
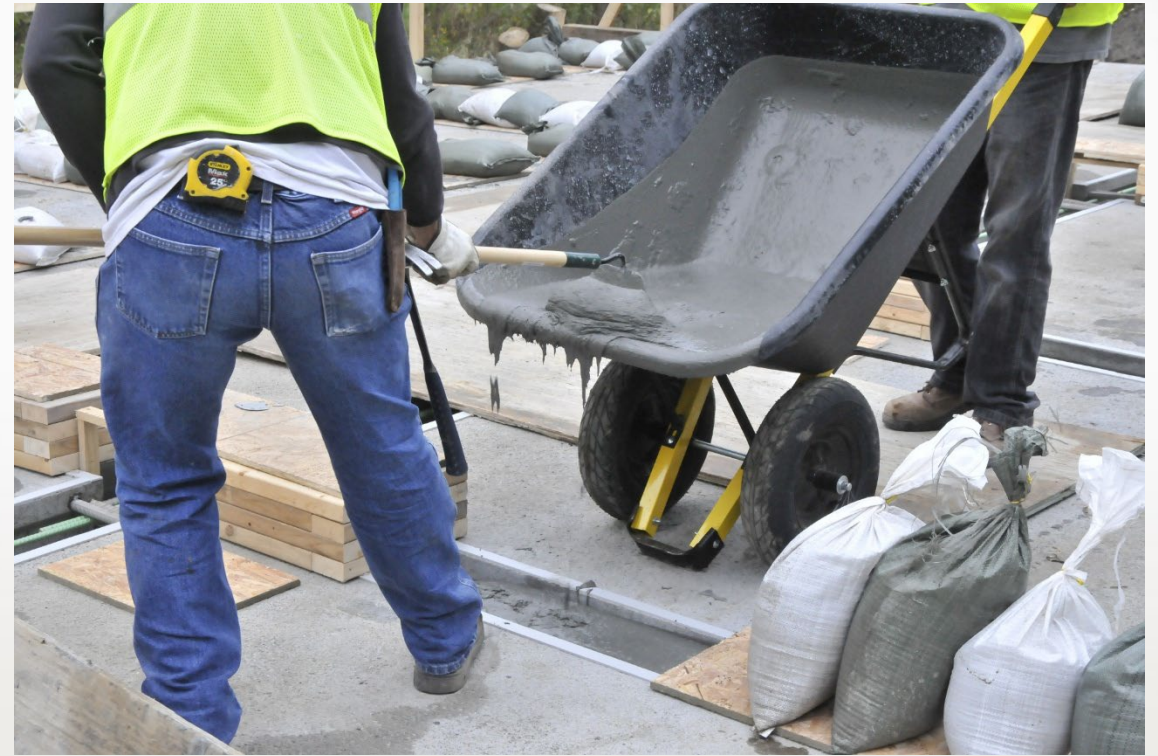
2011 UHPC Waffle Deck Wapello County

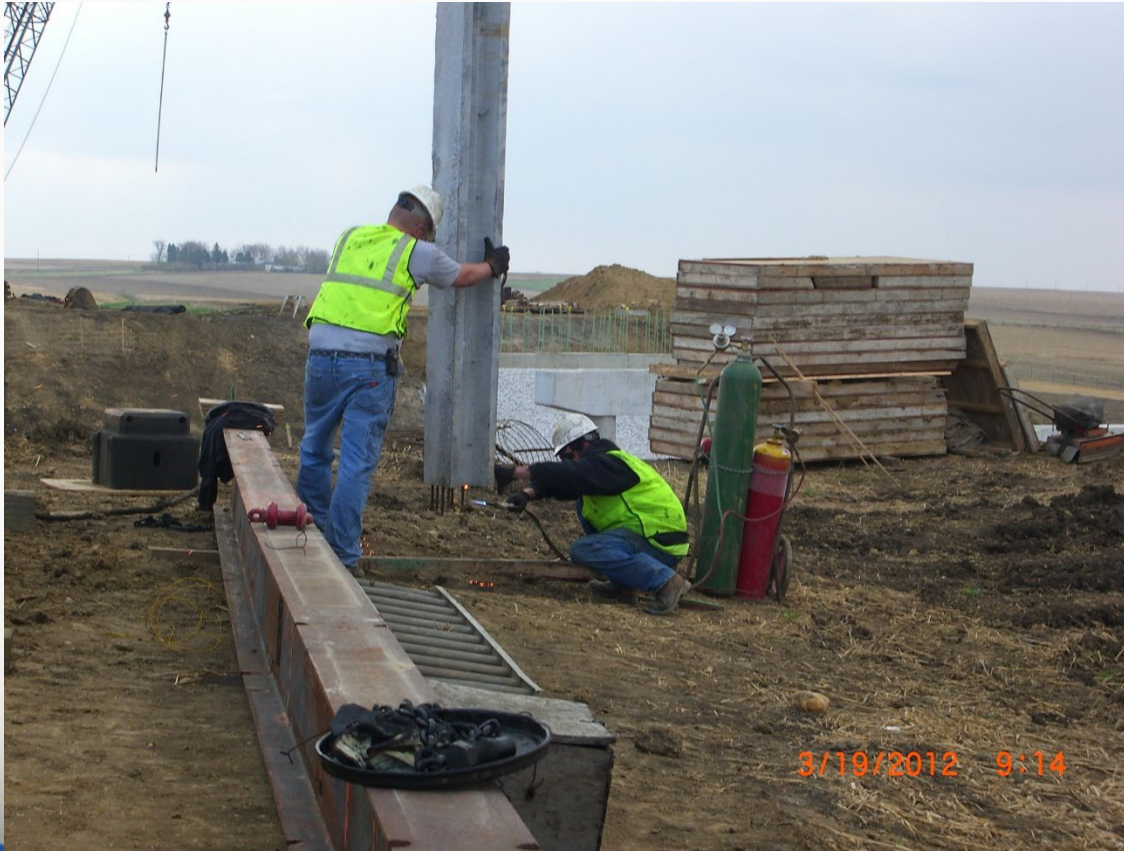
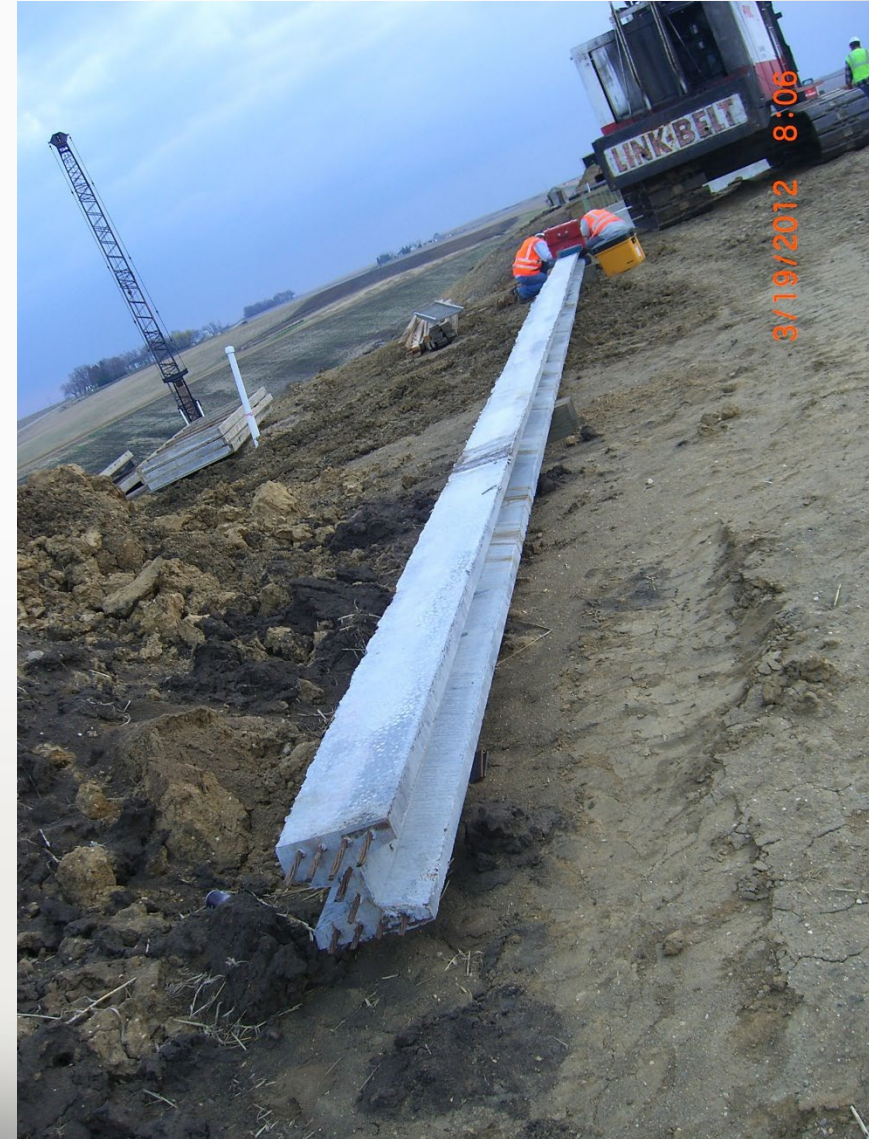
2012 UHPC Precast Piling Sac US 20

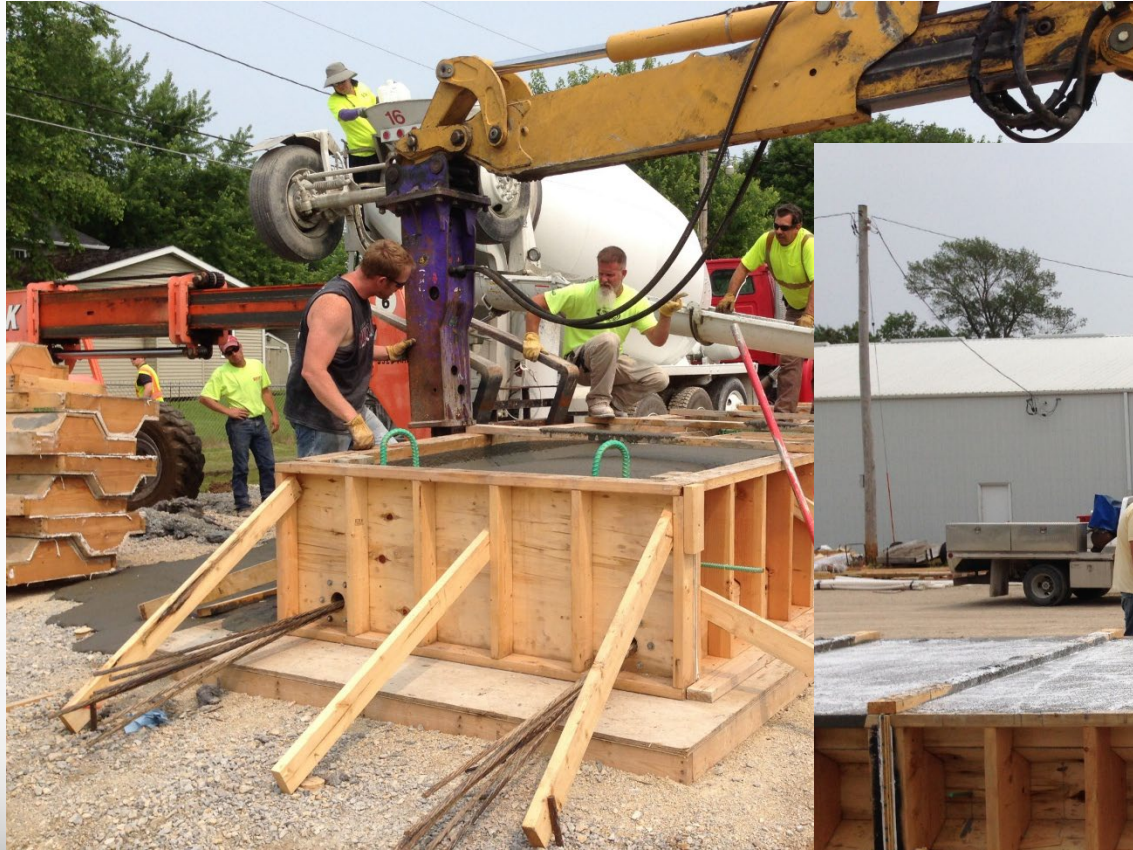
2015 UHPC Beam Buchanan Co

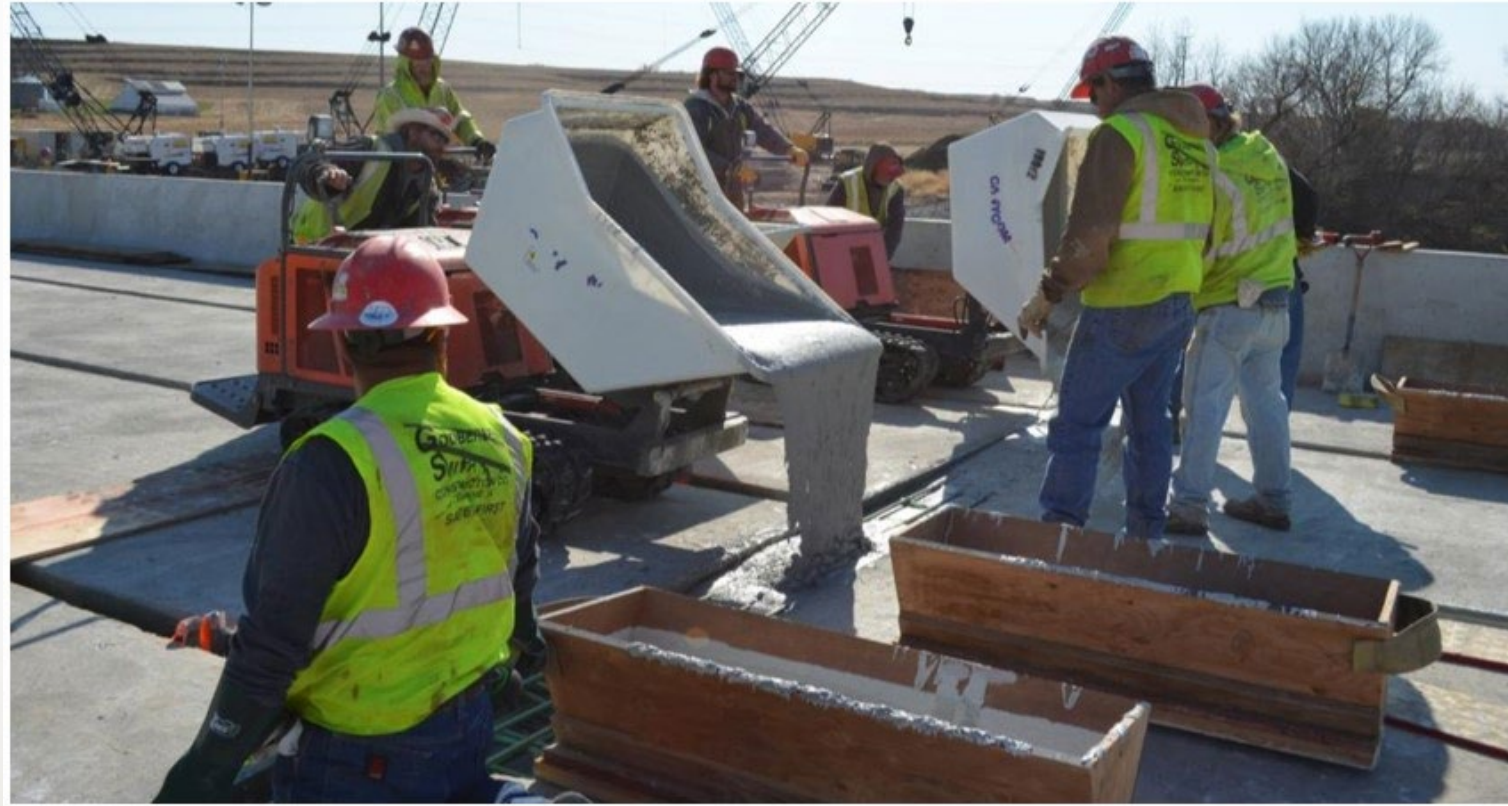
UHPC Other Applications

- ABC deck connections
- ABC post lateral slide connections
- Beam end repair

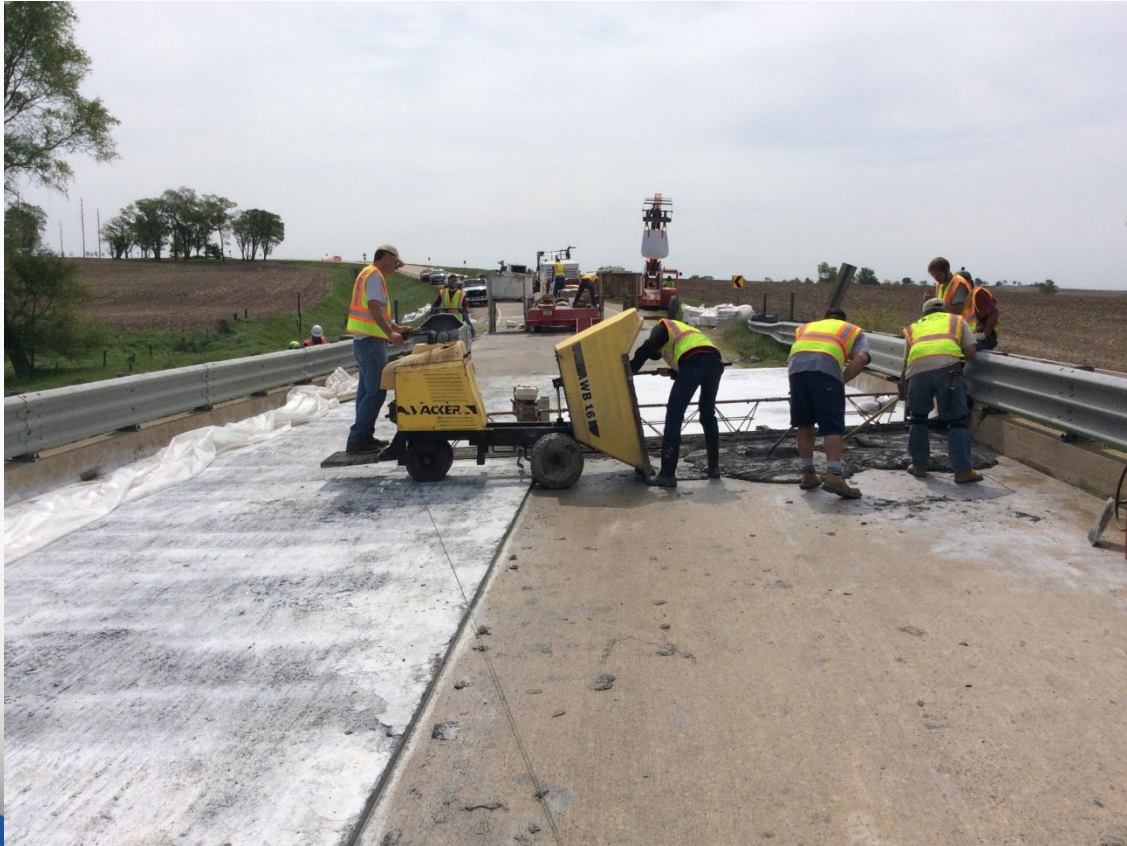
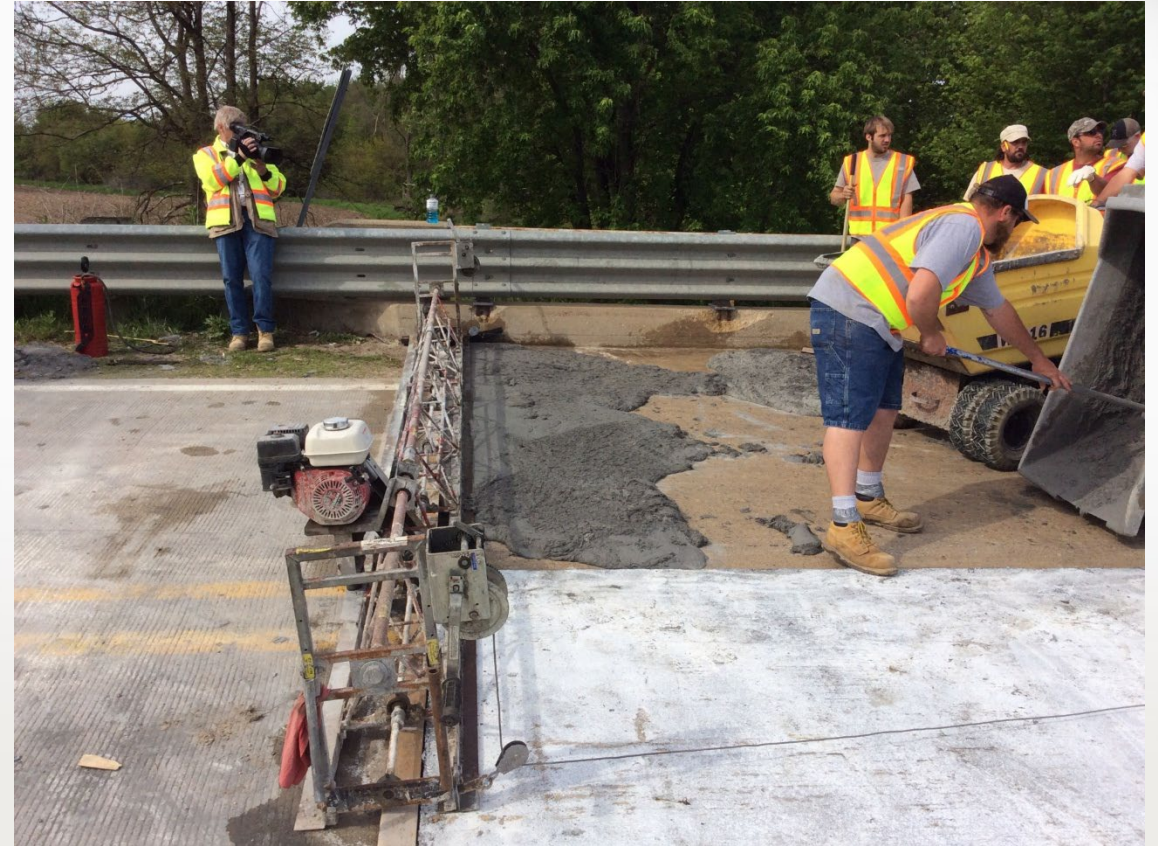
2016 UHPC Deck Overlay Buchanan Co

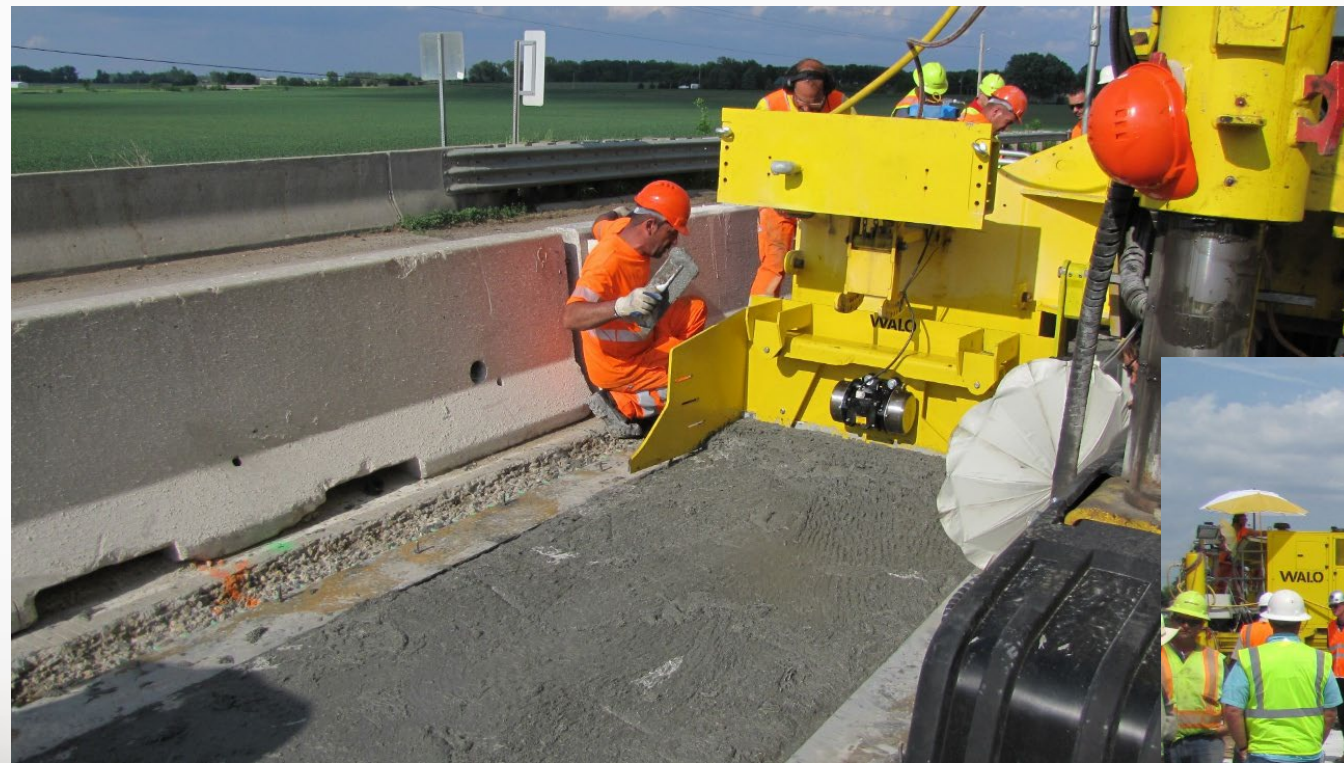
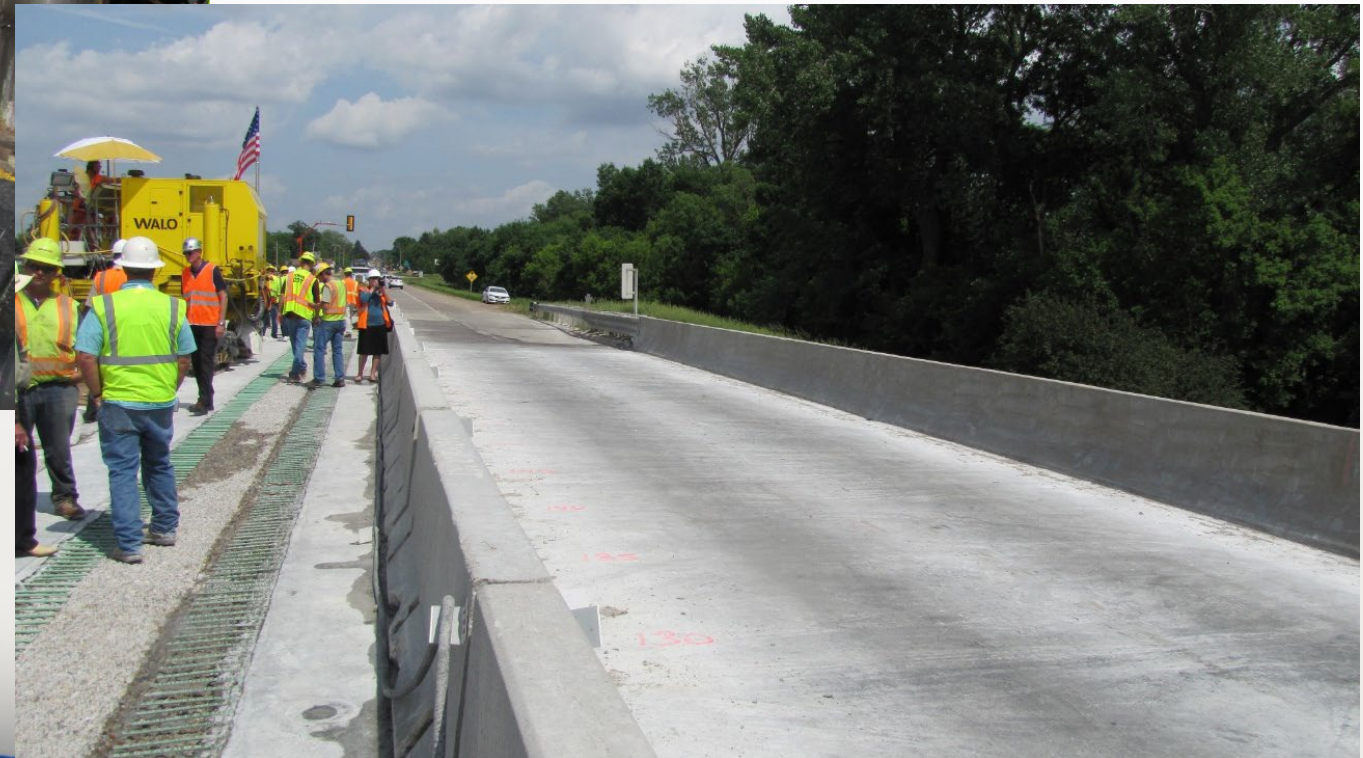
2018 UHPC Deck Overlay US 18 Sioux Co

- Sioux US 18
- Two lift – second lift depth $\frac{1}{4}$ "
- Delamination of surface

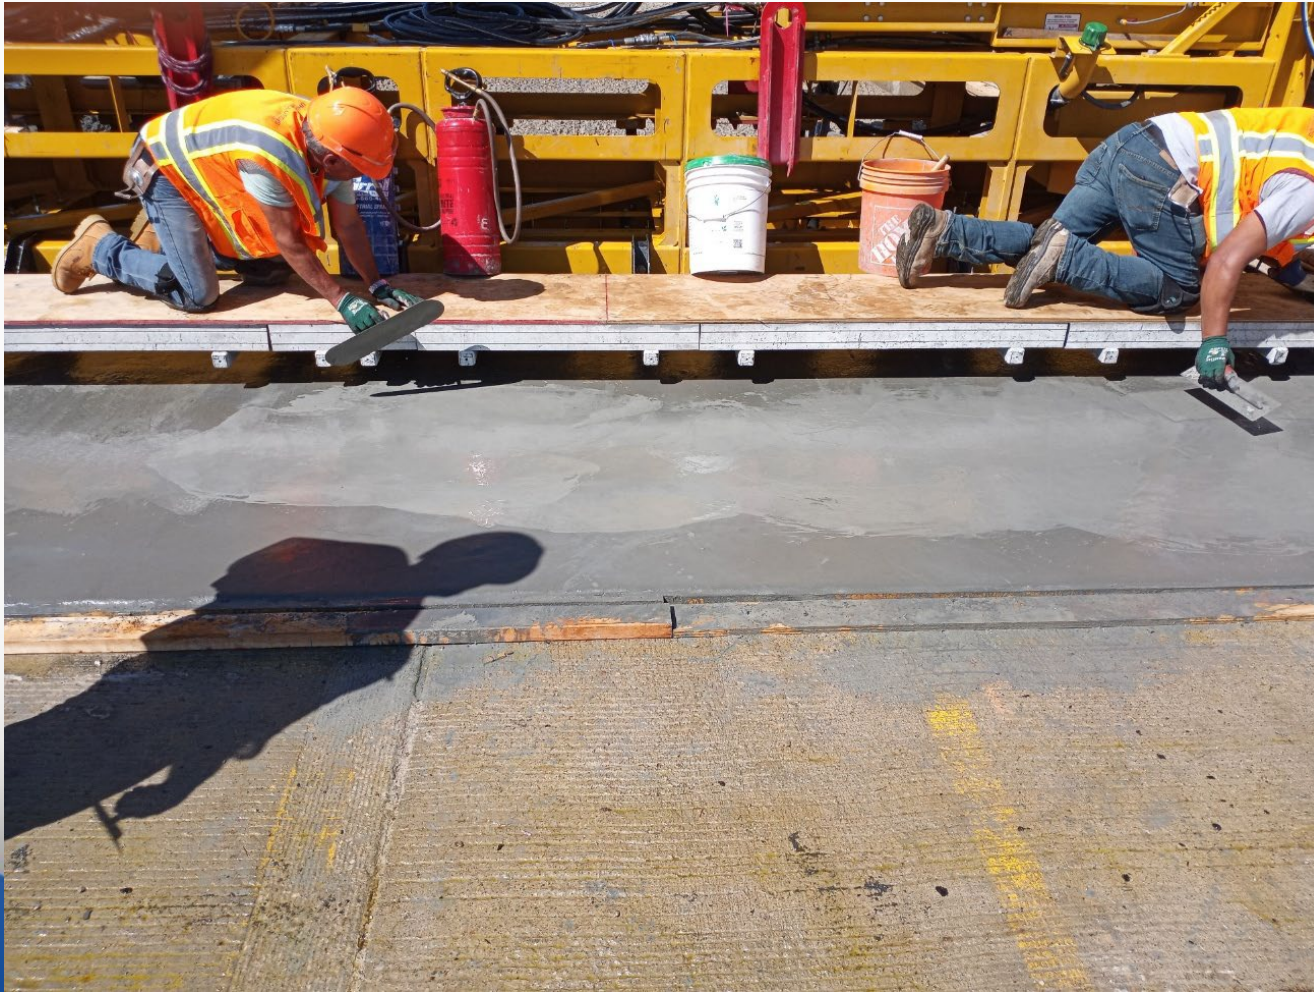
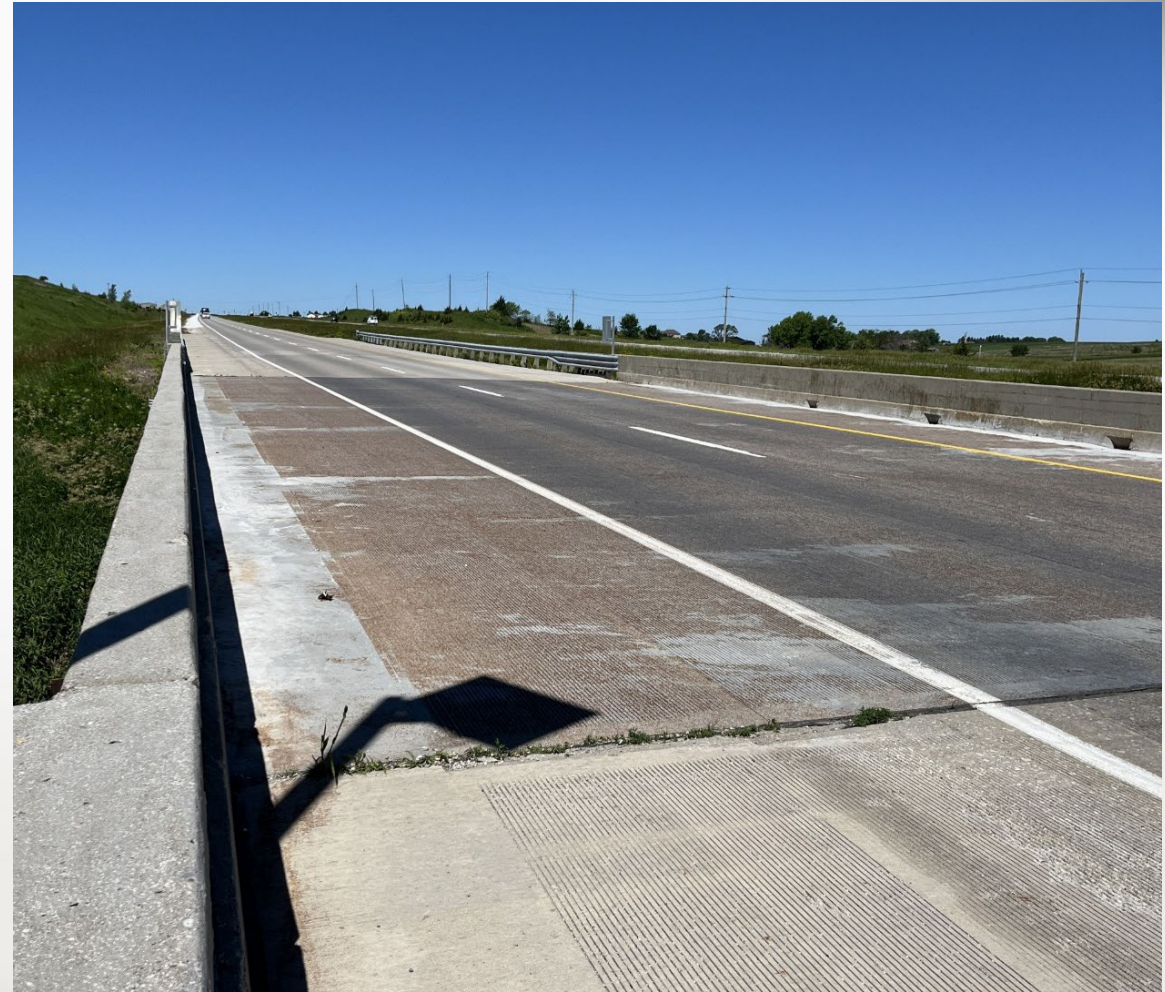
2022 UHPC Deck Overlay Jasper IA 163 EB
