Iowa DOT – Deck Overlays & UHPC Experience

Todd Hanson, P.E., Iowa DOT
PCC Materials Engineer

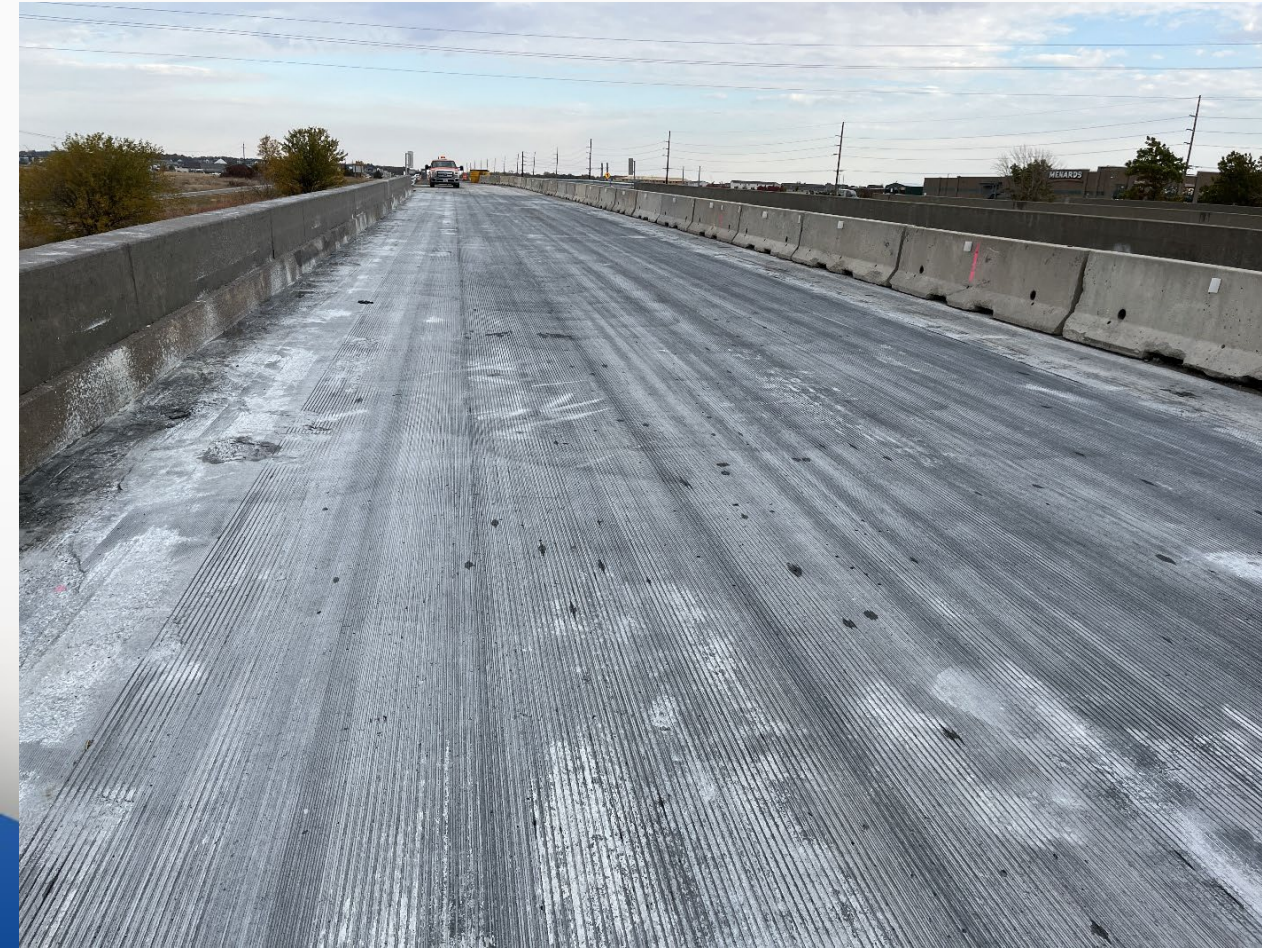
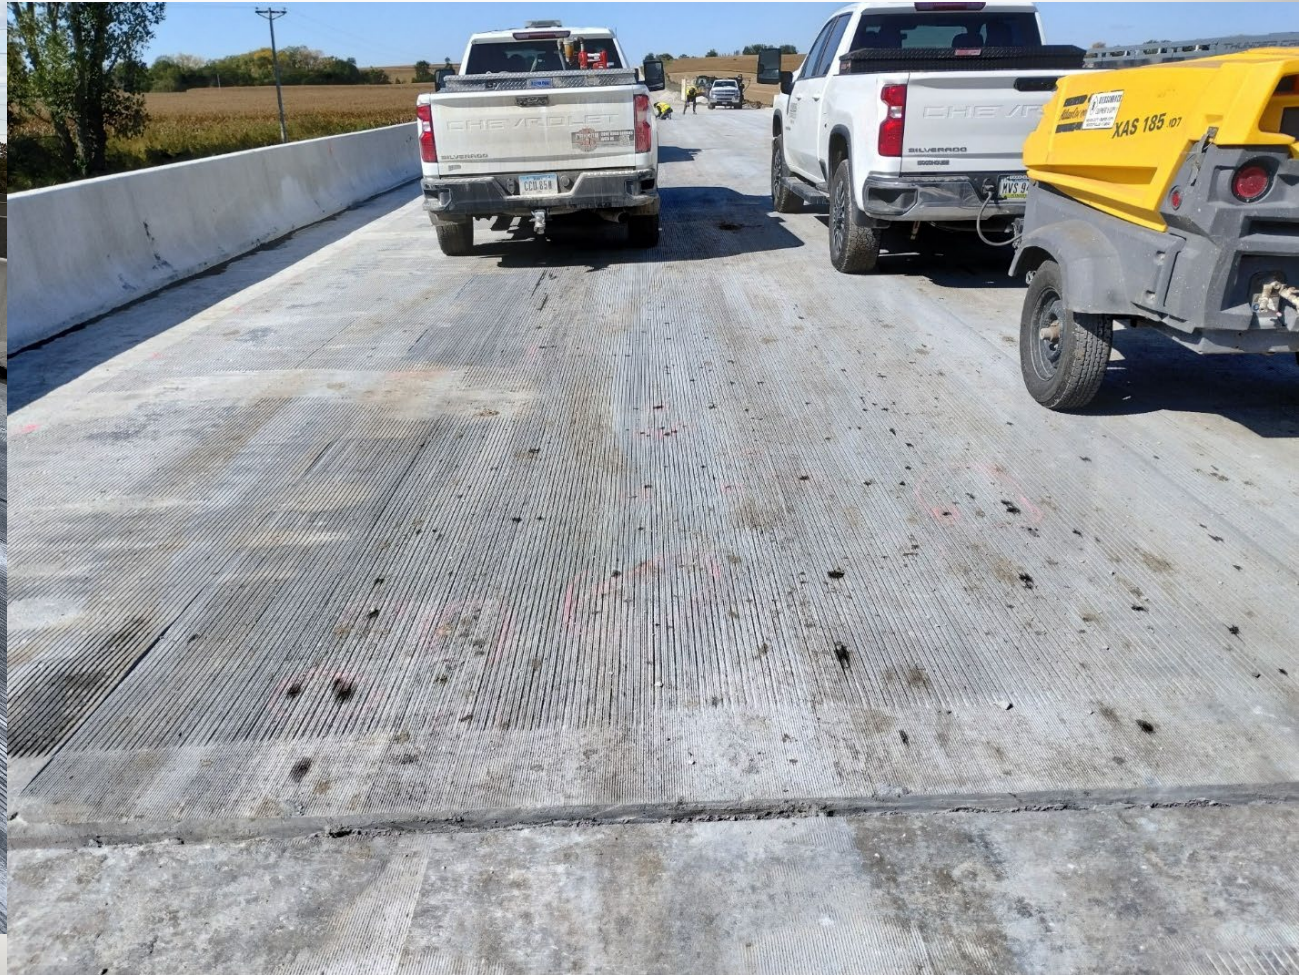
2023 UHPC Deck Overlay Cass Co IA 92

- Cass IA 92
- Introduction of fibers caused fiber balls
- Continuous feed of fibers
- Do not drop in clumps
- Epoxy repaired

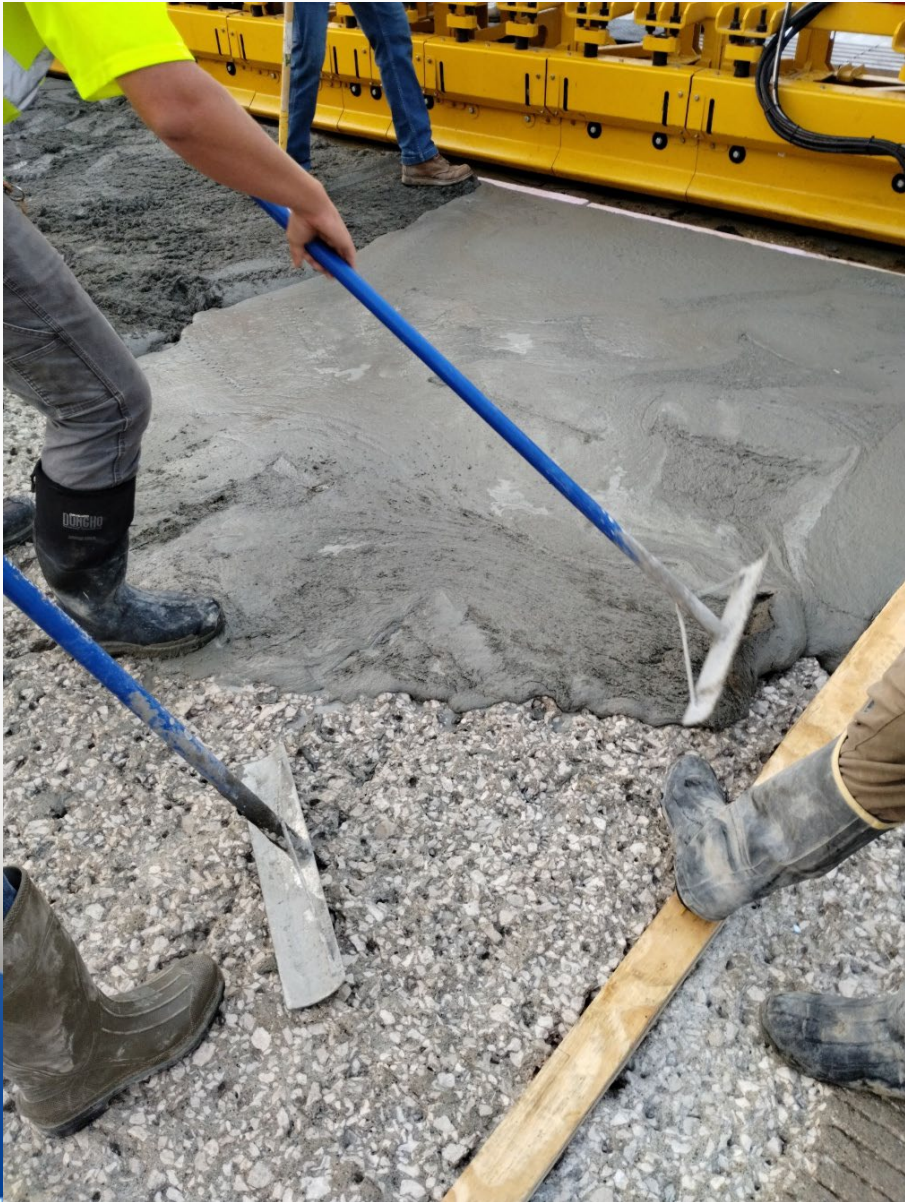
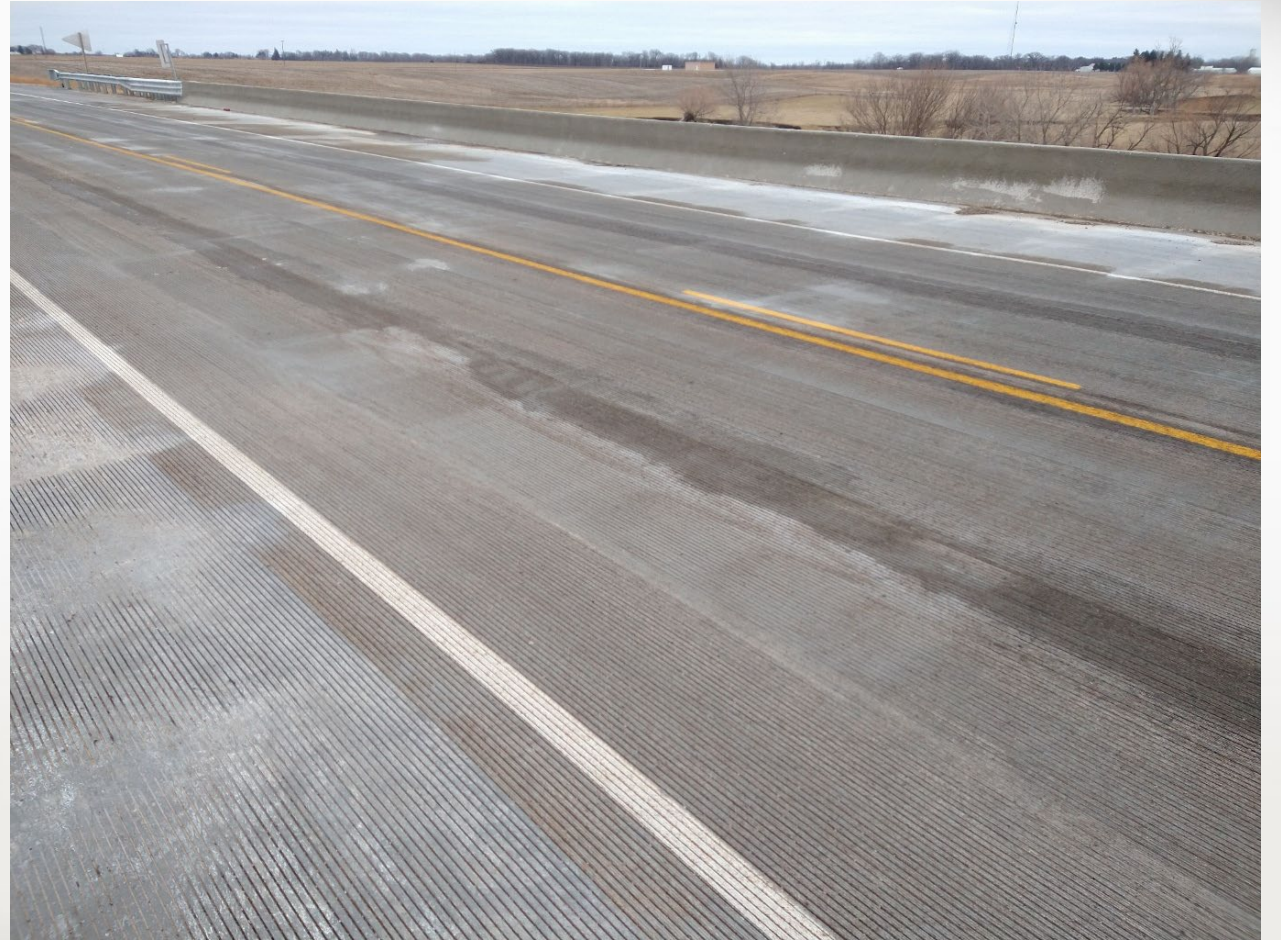
2023 UHPC Overlay Humboldt US 169

- Humboldt US 169
- Lots of Cracking
- HMWWM sealed

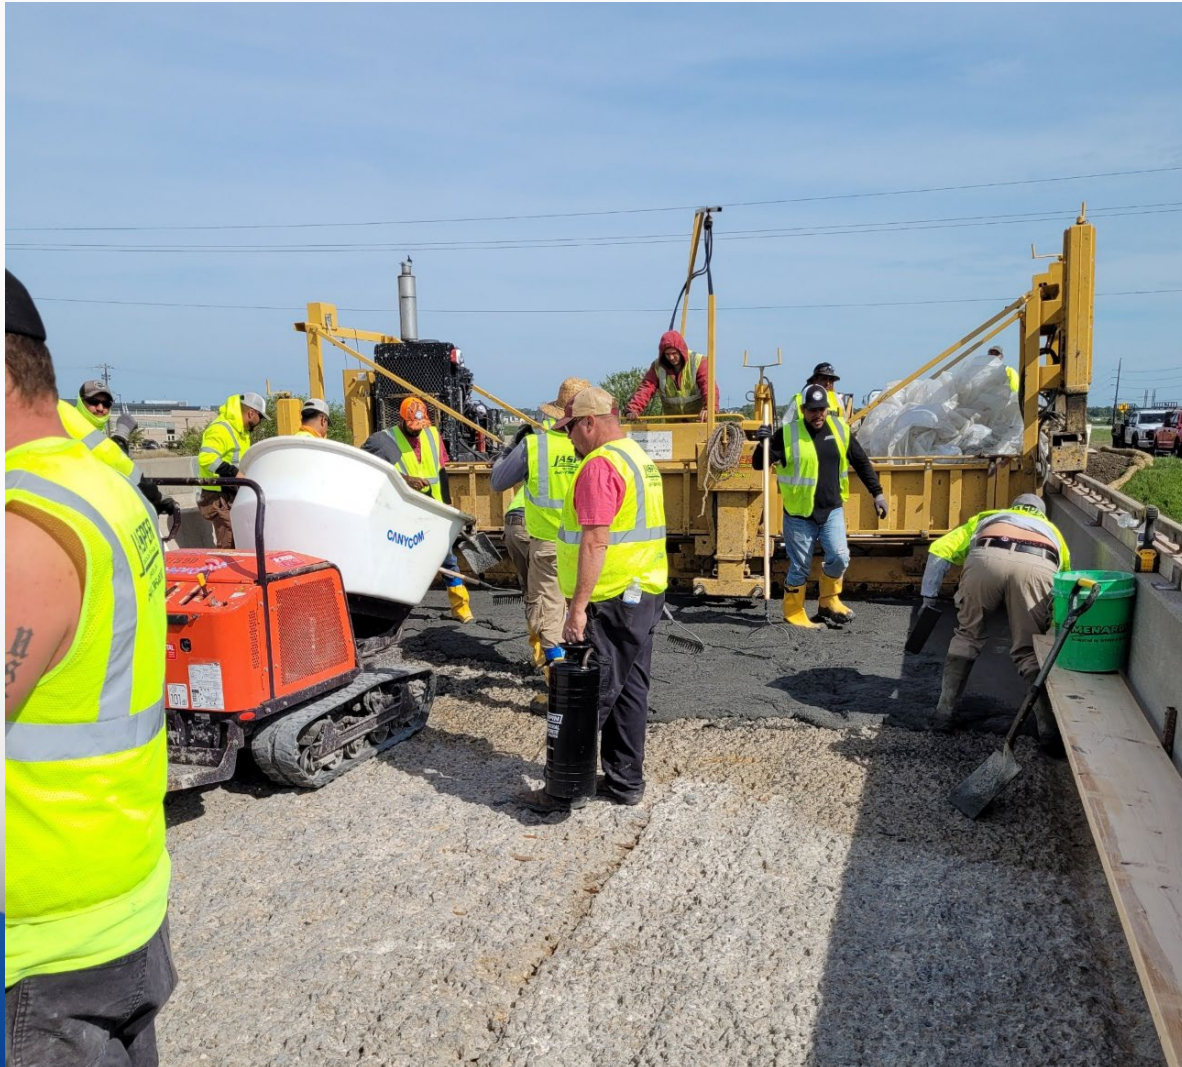
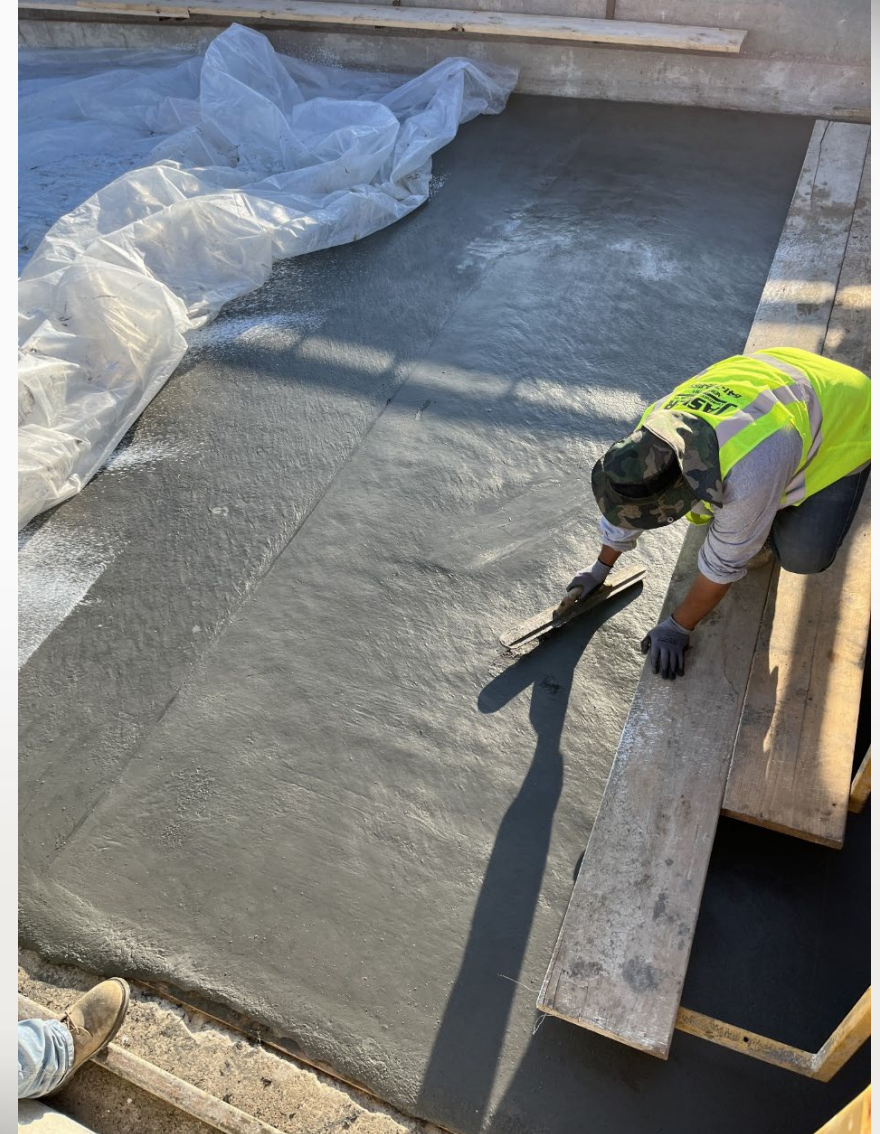
2024 UHPC Deck Overlay Polk Co IA 141

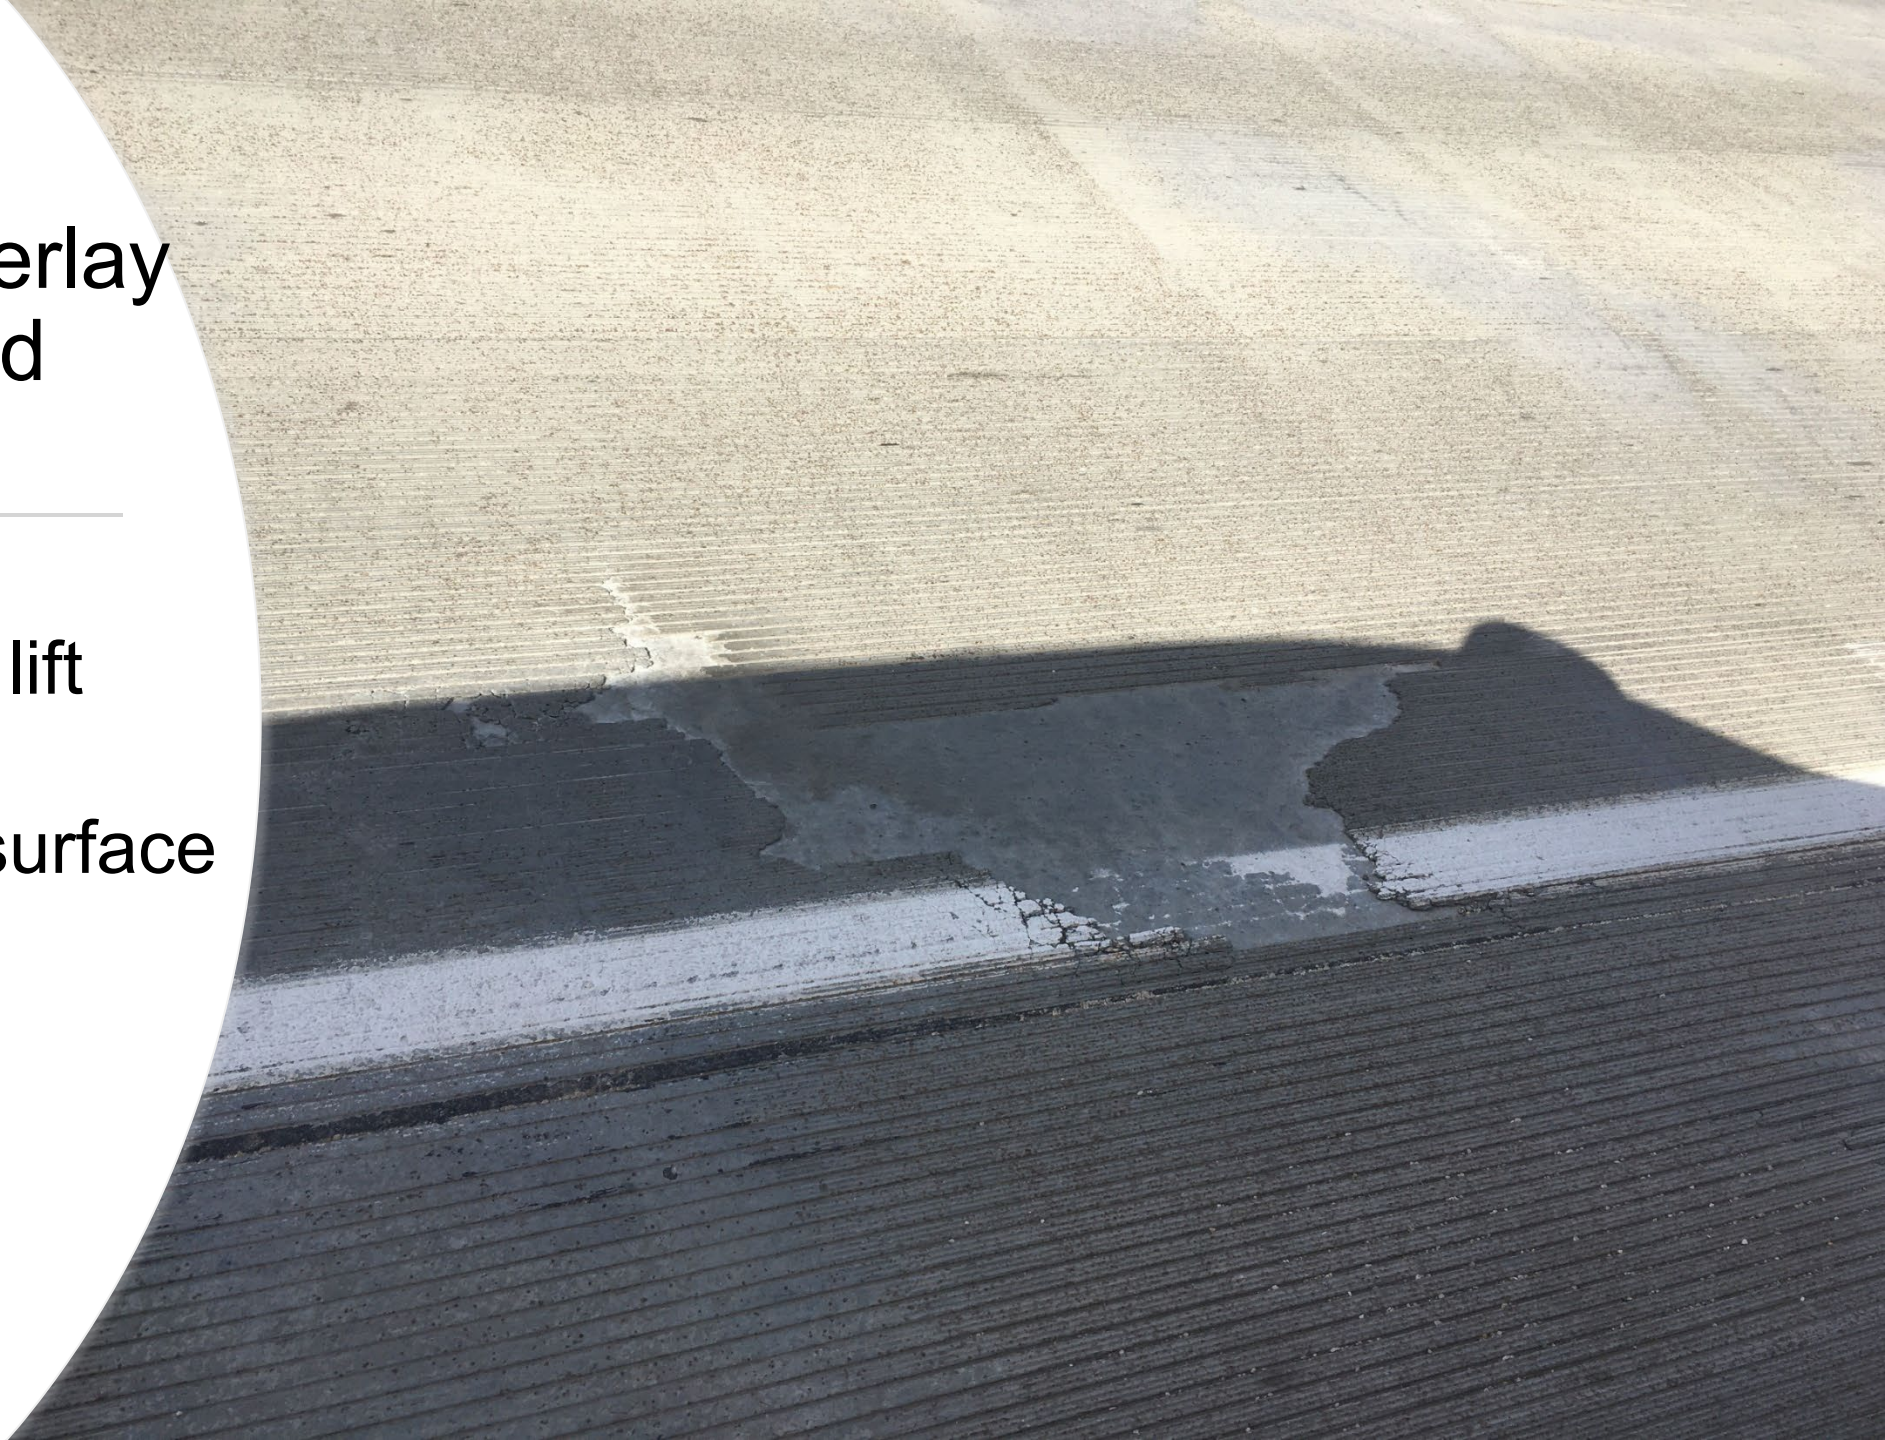
UHPC Deck Overlay Lessons Learned

- Sioux US 18
- Two lift – second lift depth $\frac{1}{4}$ "
- Delamination of surface

- Expensive material to have problems
- Do not use thin two lift
- Slowly feed fibers to avoid clumping
- Variance in material suppliers
- Mixing equipment have extra available
 - RM truck or high shear mixer
- Environmental conditions impact on finishing and curing
- Timing of grinding and grooving operations

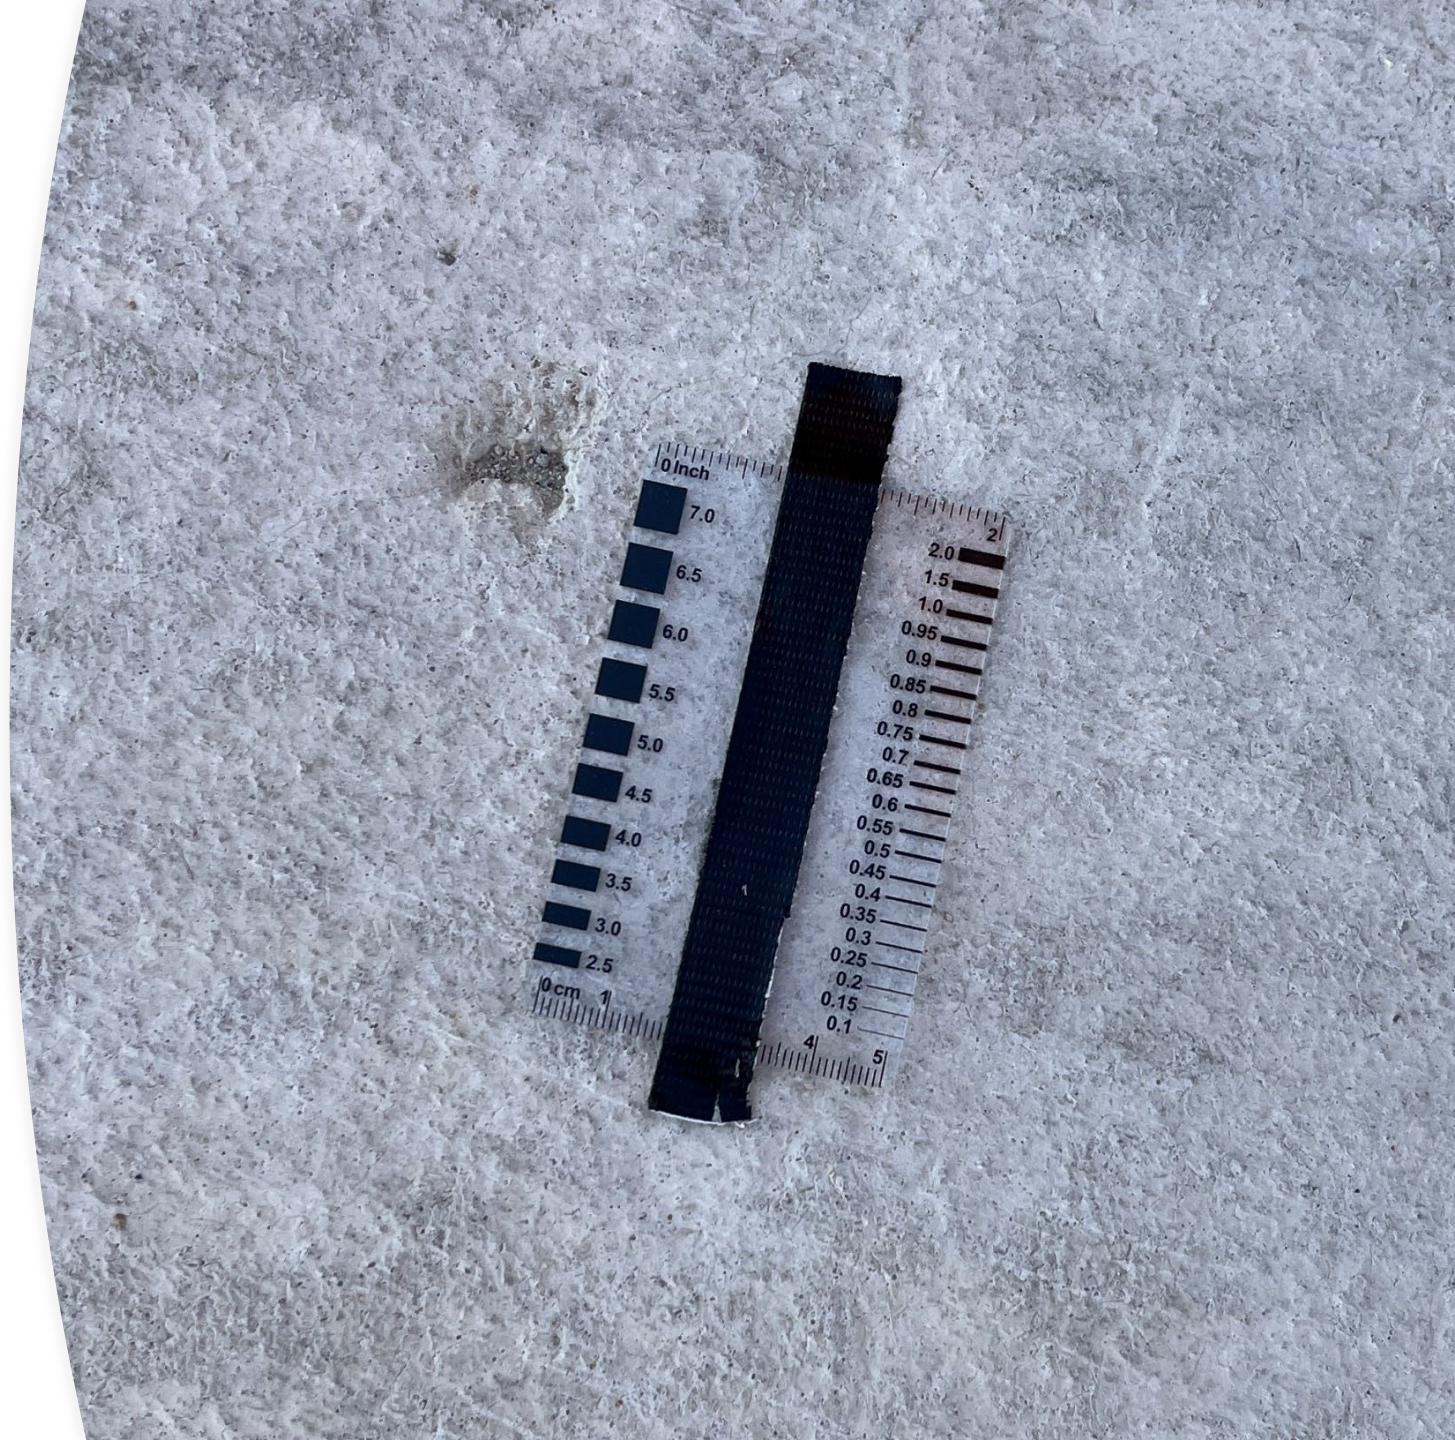
UHPC Deck Overlay Lessons Learned

- Polk IA 141
- Air bubbles trapped in mix
- Common with thixotropic material
- Epoxy filled

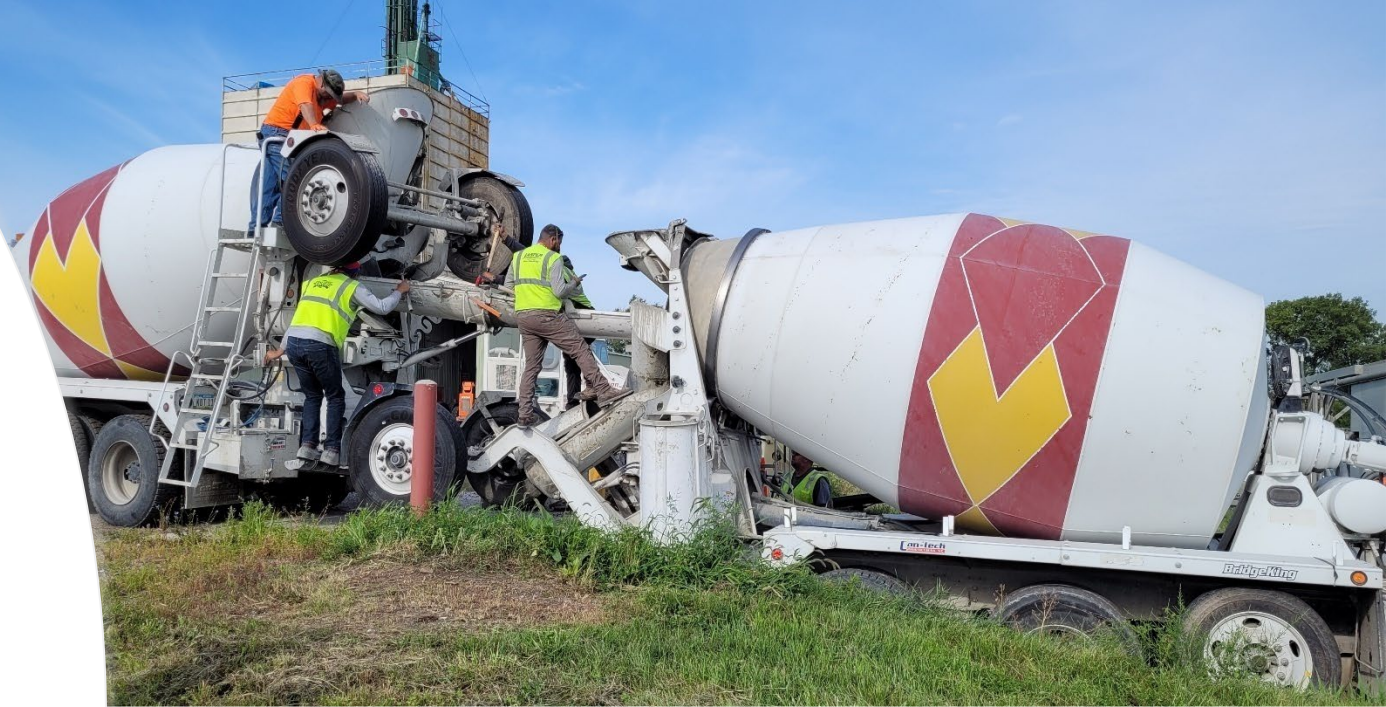
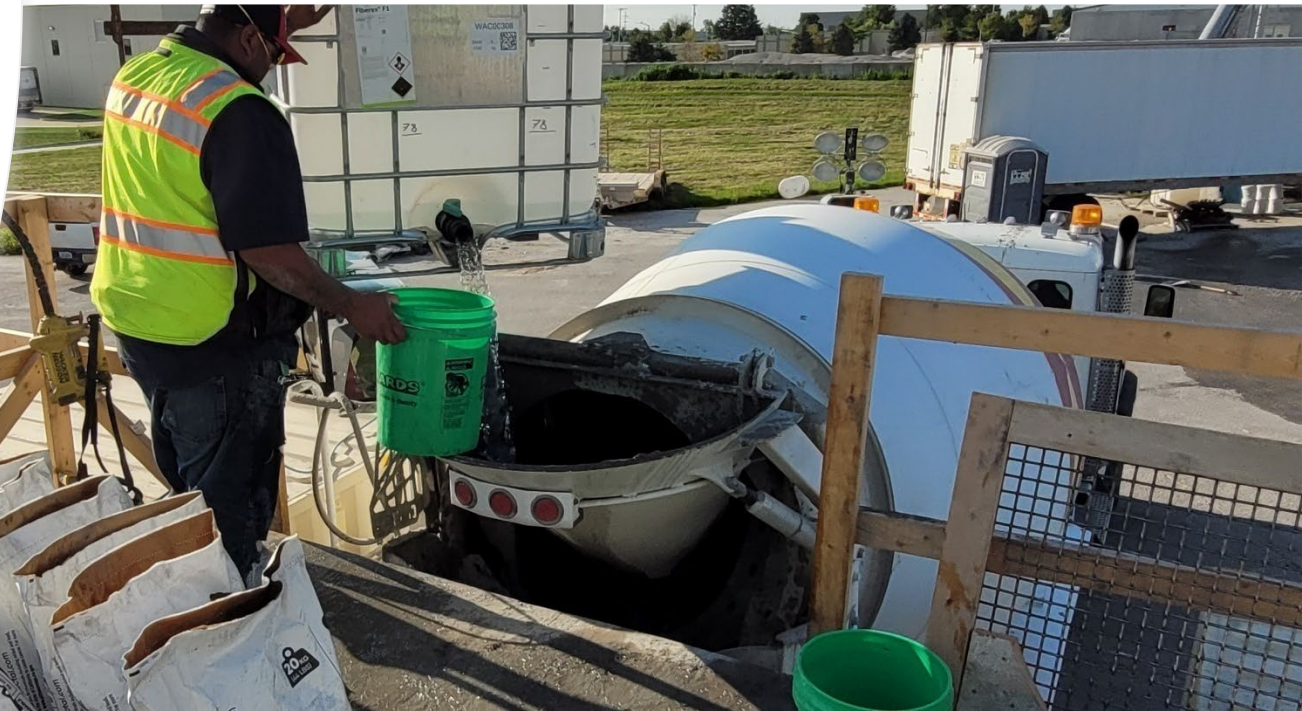
UHPC Deck Overlay Lessons Learned

- Polk IA 141
- Mixer truck transmission broke down
- Had to transfer material from one truck to another

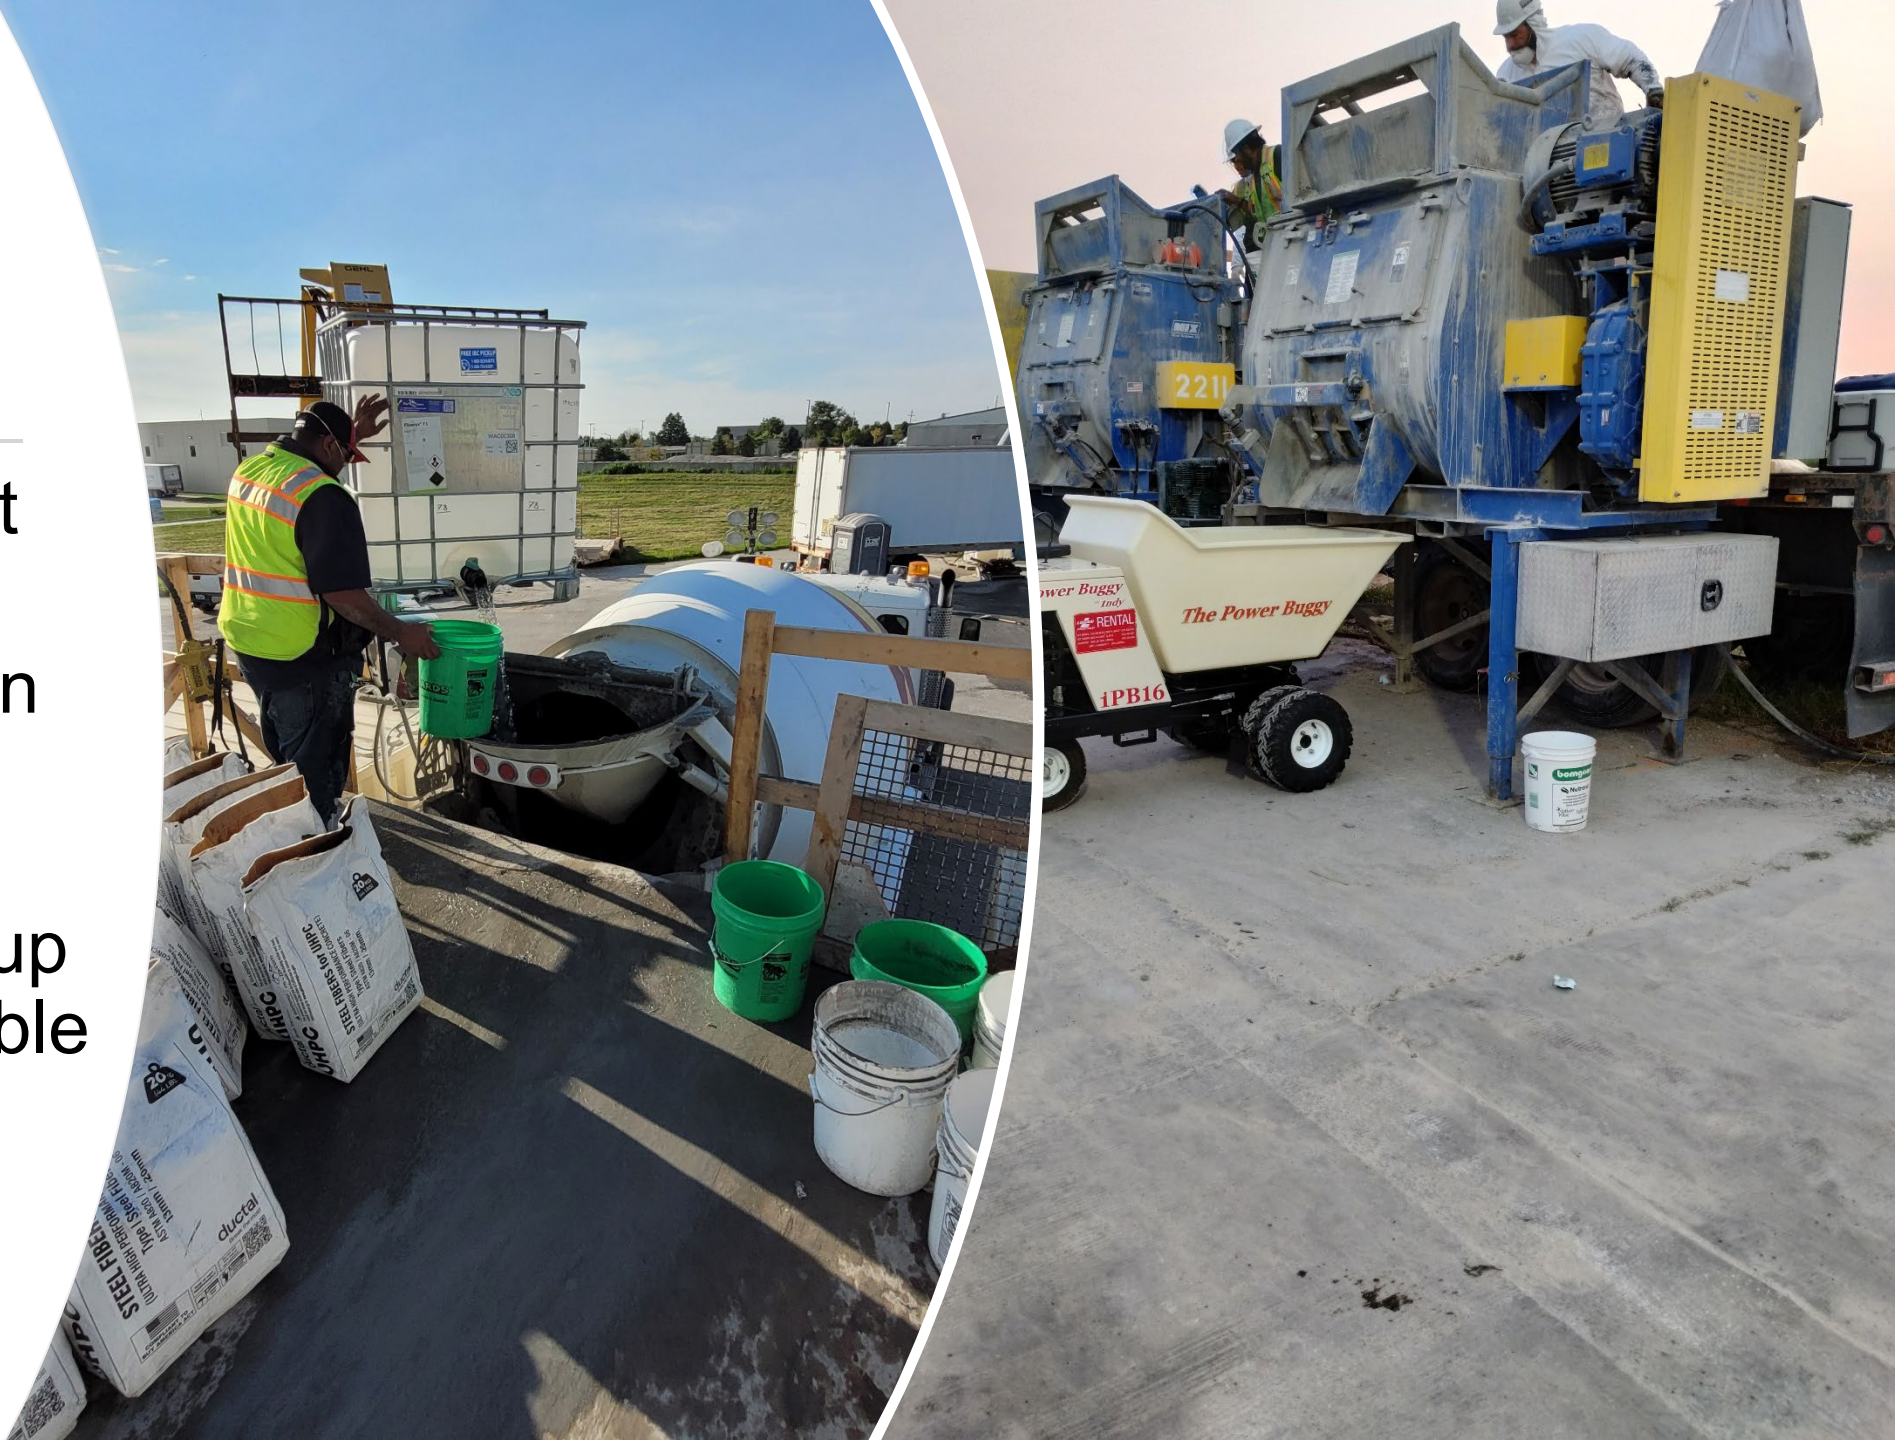
UHPC Deck Overlay Lessons Learned

- Mixing Equipment
- RM truck or high shear mixer – plan for introducing materials
- Ensure that backup equipment available

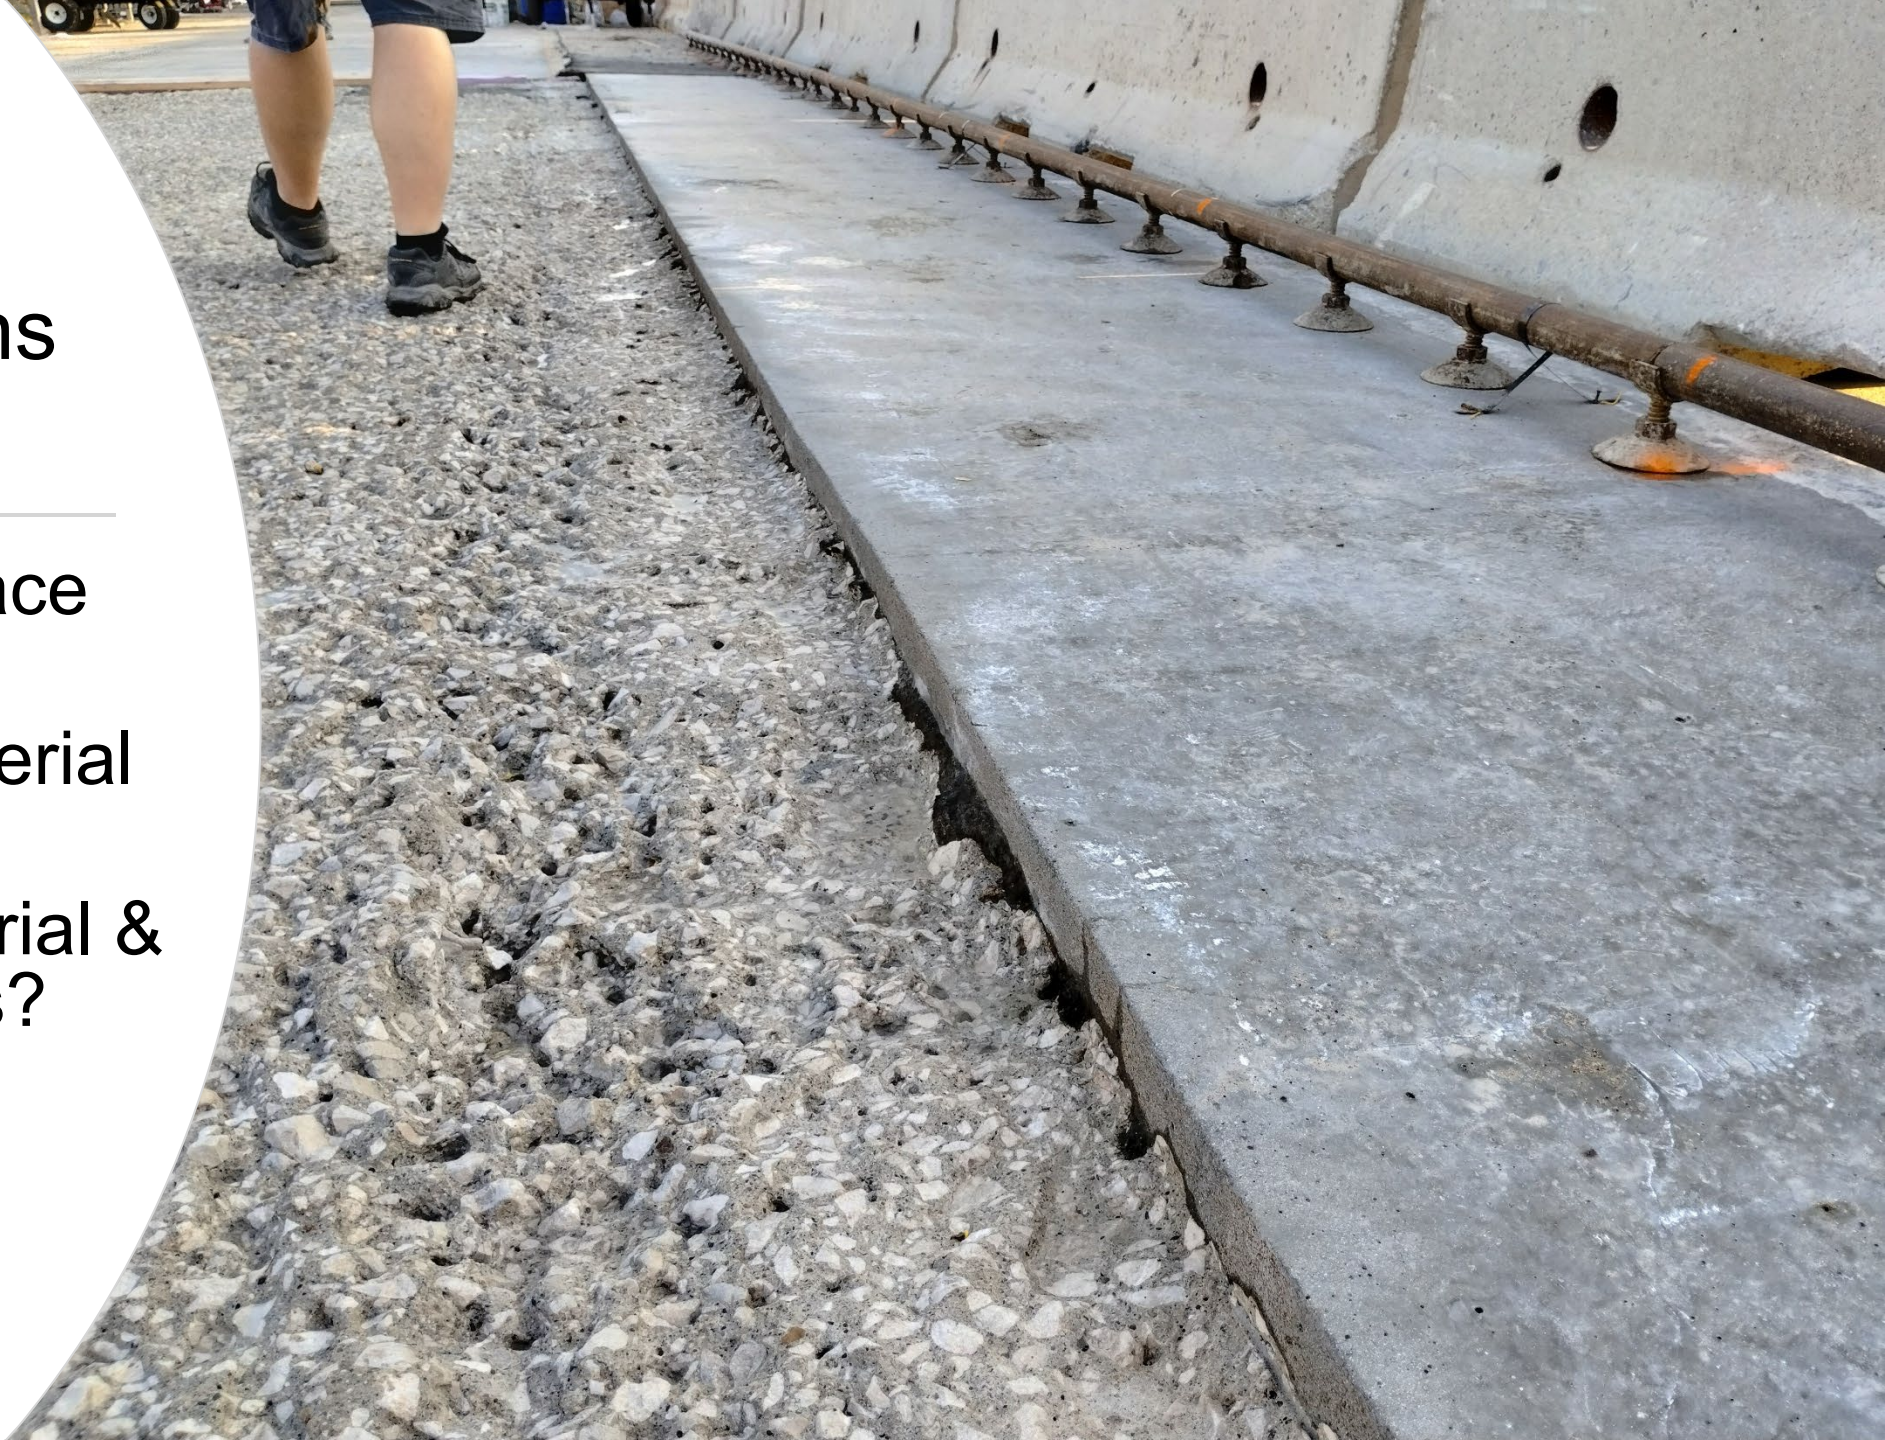
UHPC Deck Overlay Lessons Learned

- Aggressive Surface Hydrodemolition
- Extra UHPC material quantity needed
- Thixotropic material & fibers fill all voids?
- Shot blast or hydroblast

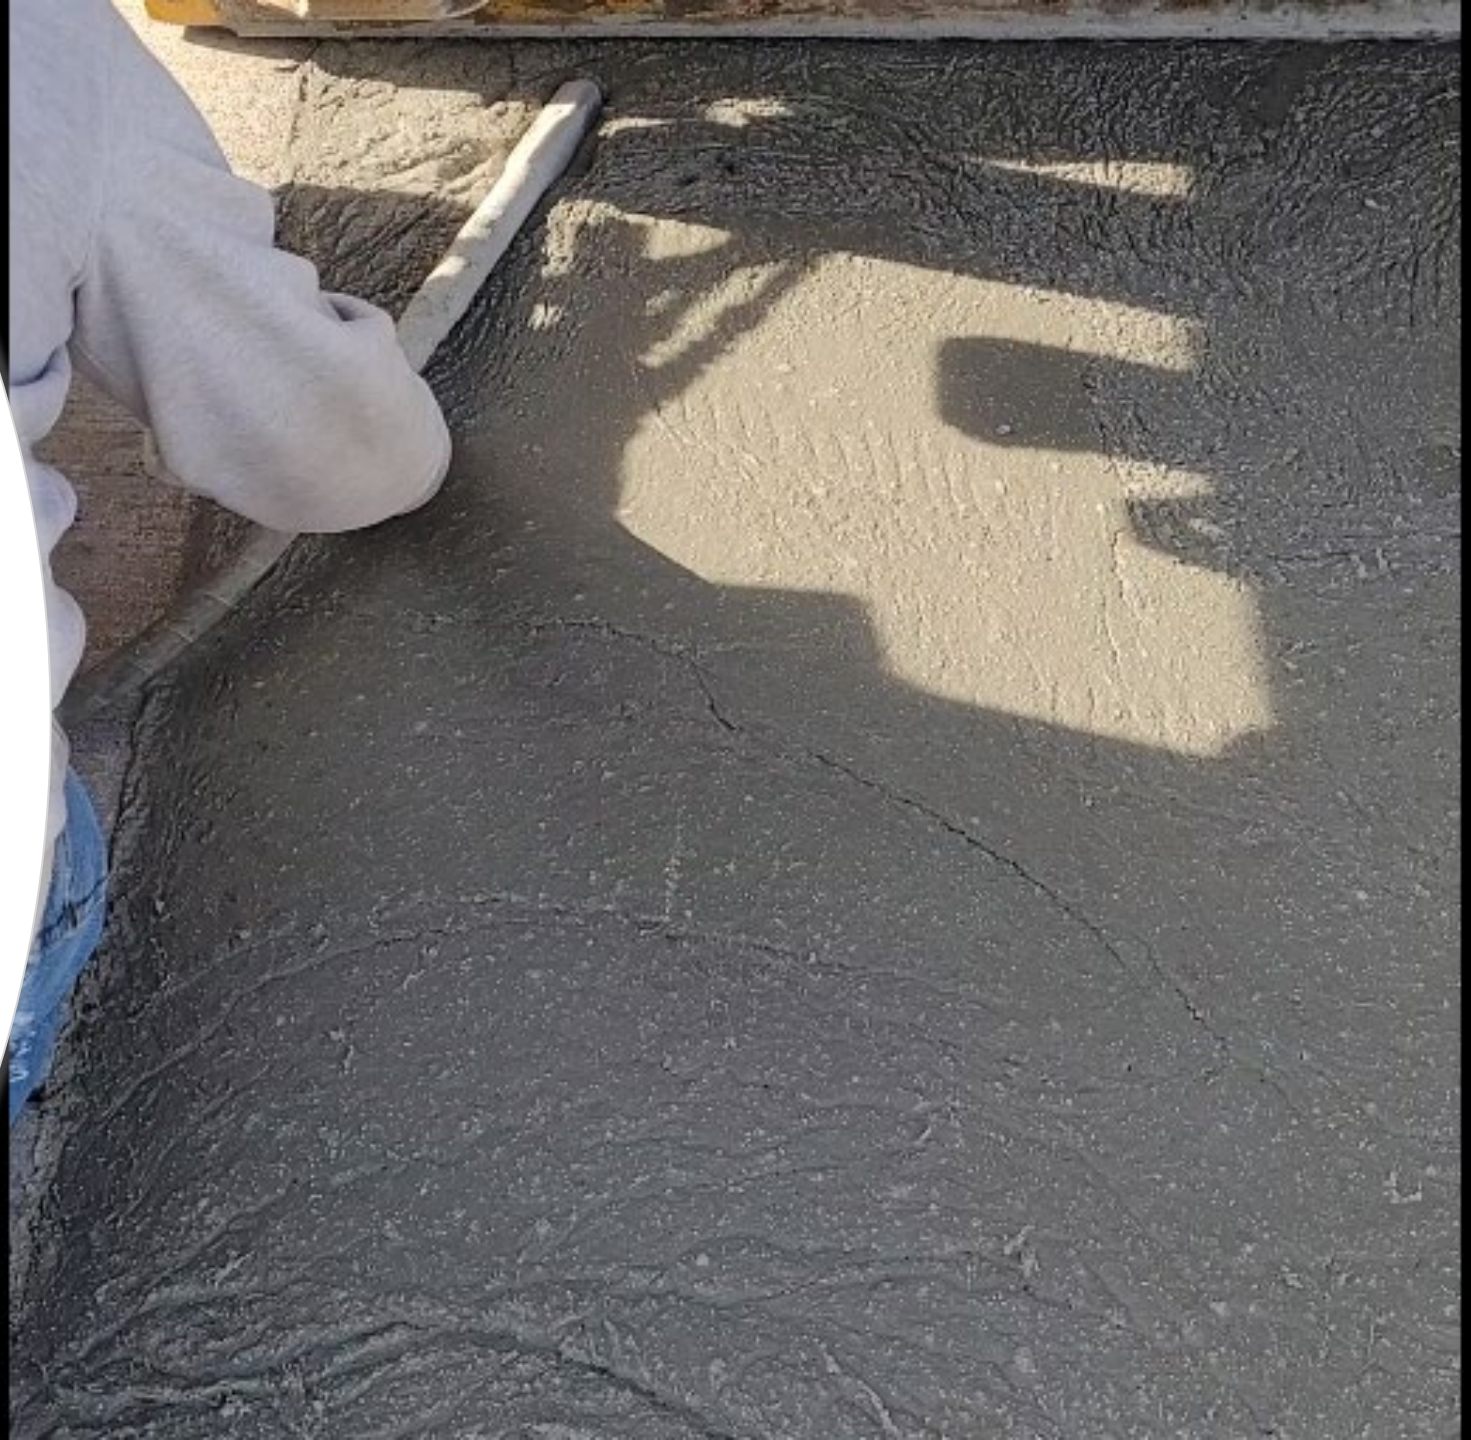
UHPC Deck Overlay Lessons Learned

- Low w/c mix can form elephant skin
- Keep mix temp below 80°F
- Colloidal silica finishing aid available
