Iowa DOT – Deck Overlays & UHPC Experience

Todd Hanson, P.E., Iowa DOT
PCC Materials Engineer

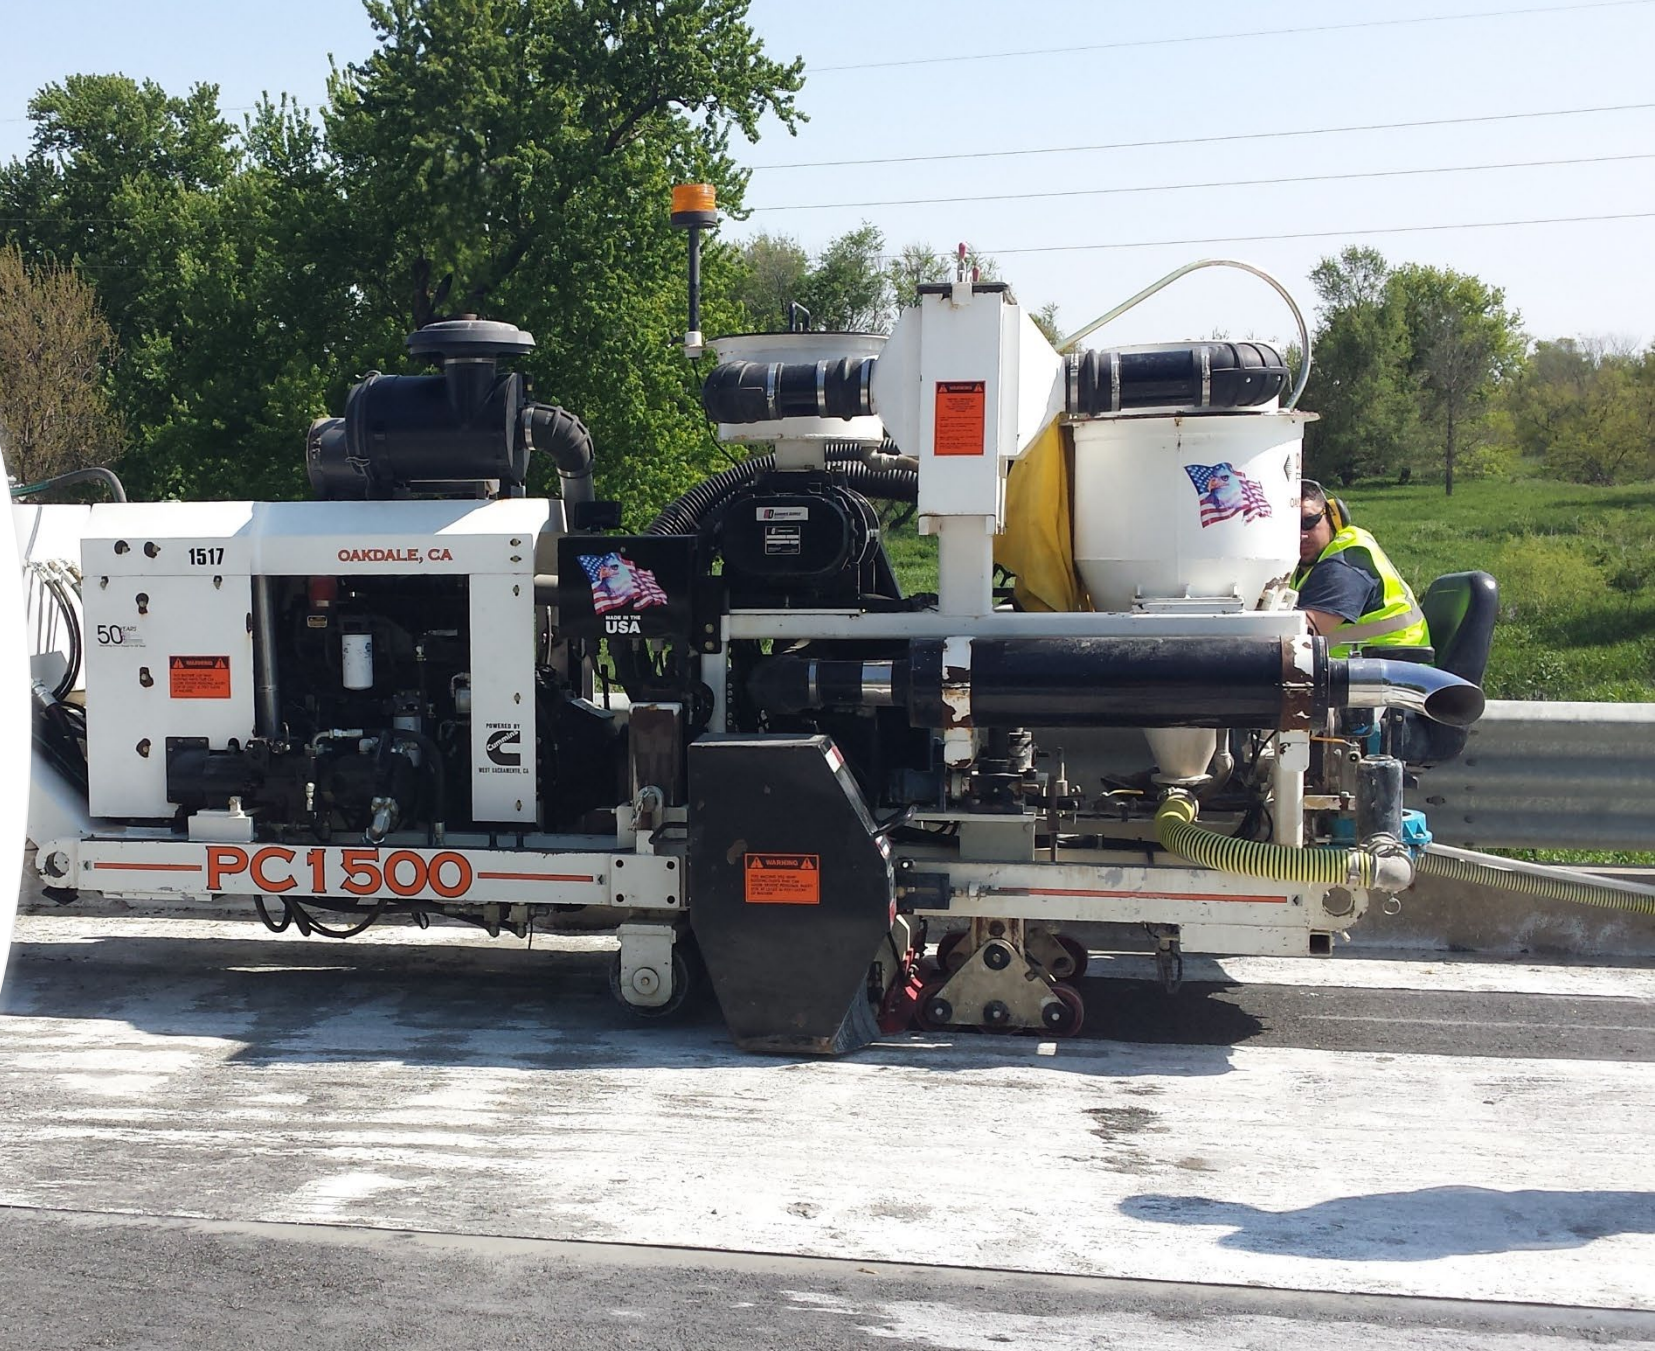
UHPC Deck Overlay Lessons Learned

- Grinding & grooving timing
- Begin at ~12 ksi compressive strength
 - 3-4 days
- For smooth cutting rather than tearing the material

- Expensive material to have problems
- Do not use thin two lift
- Slowly feed fibers to avoid clumping
- Variance in material suppliers
- Mixing equipment have extra available
 - RM truck or high shear mixer
- Environmental conditions impact on finishing and curing
- Timing of grinding and grooving operations

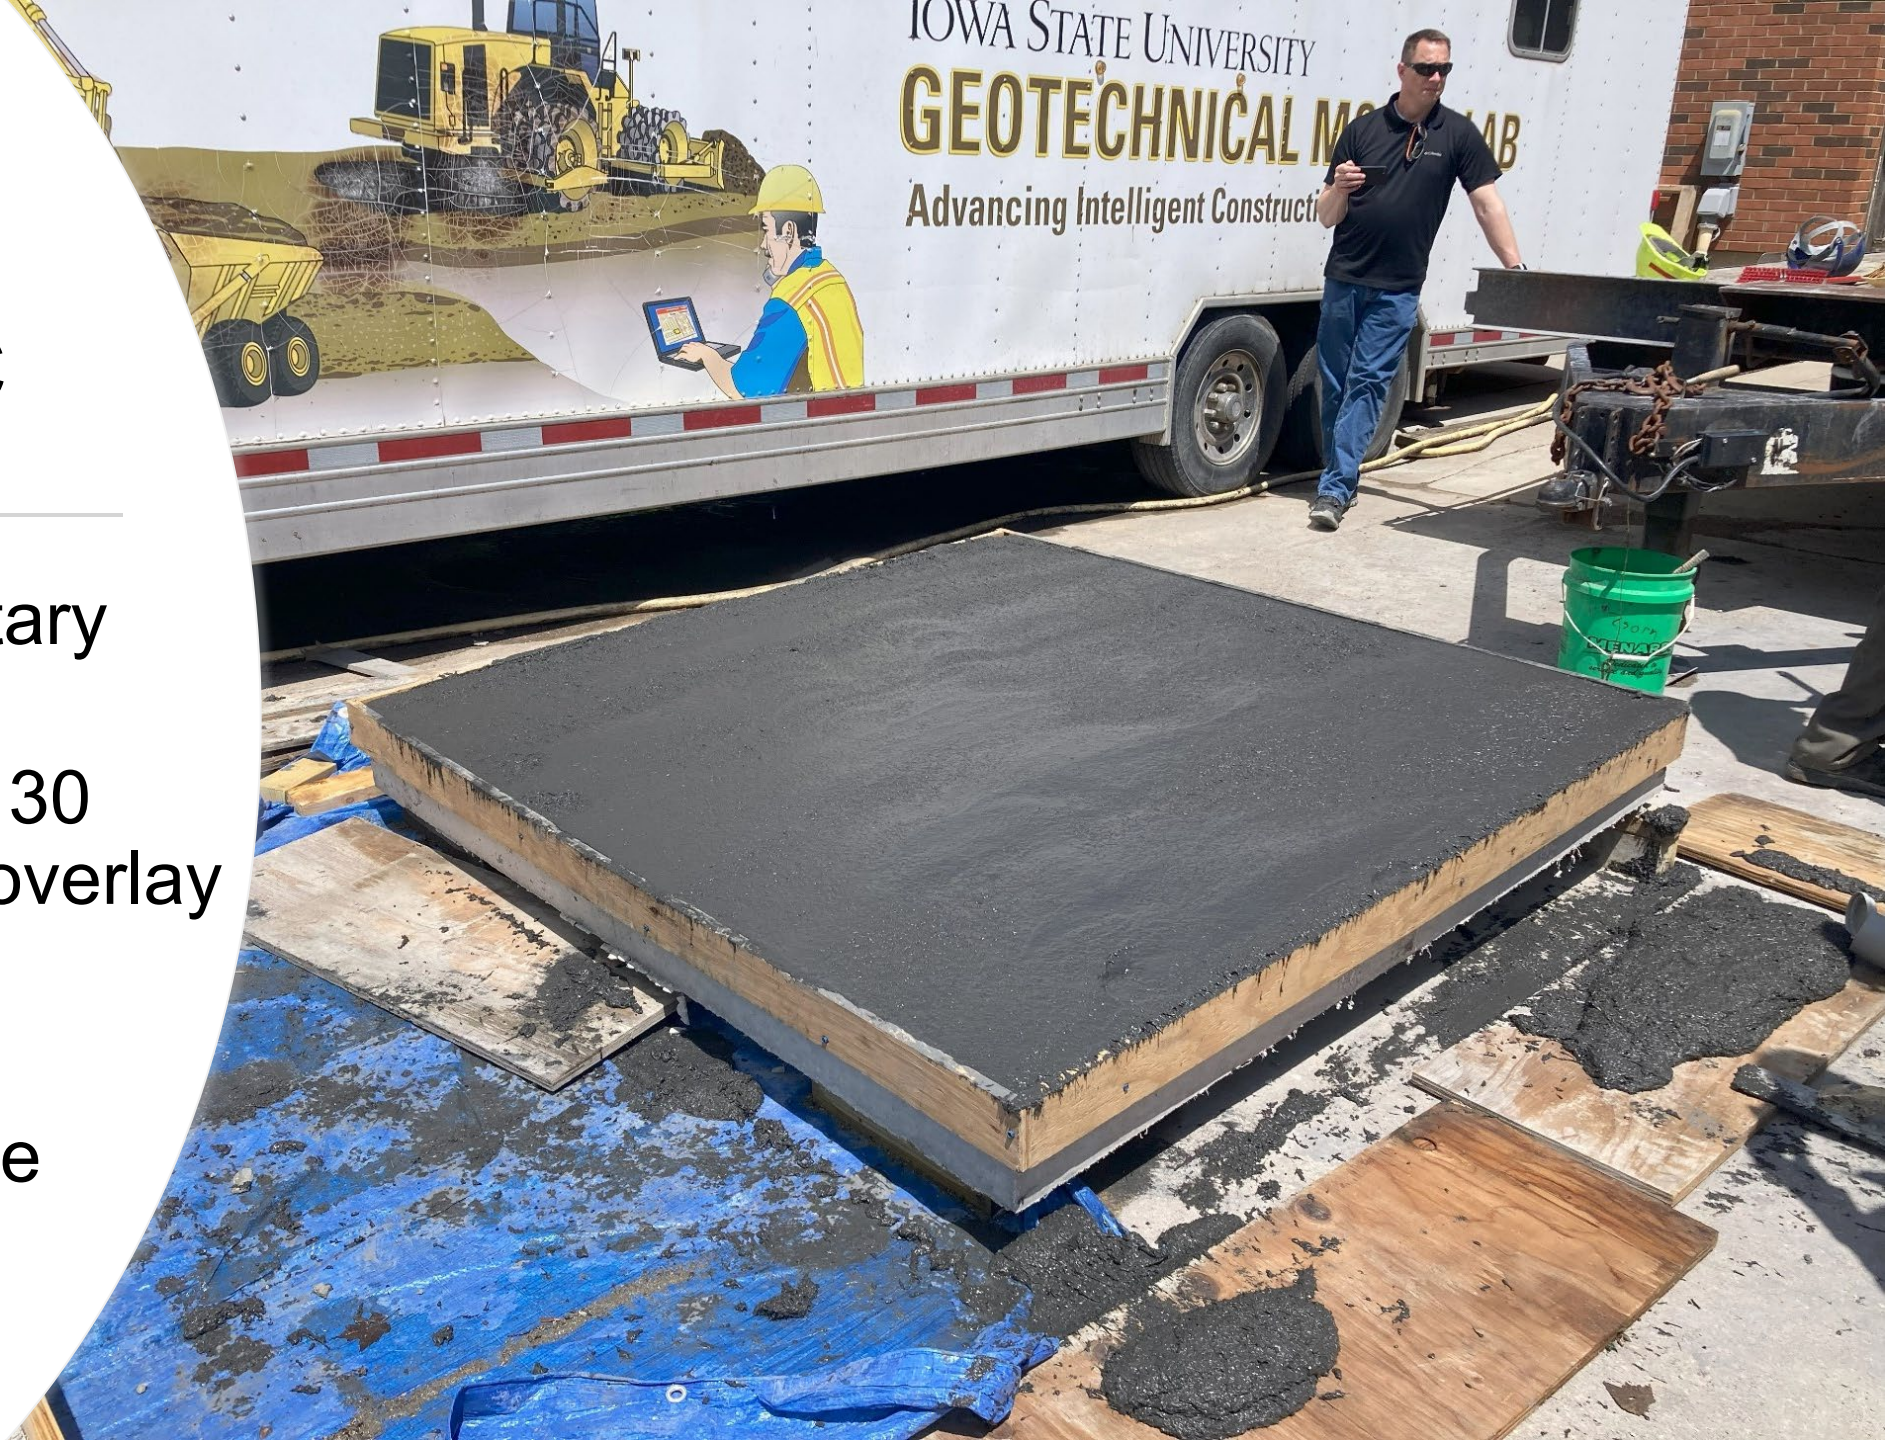
Future UHPC

- ISU Non-proprietary mix
- Crawford Co US 30 UHPC-NP deck overlay in 2026
- SP-230382
- Shot blast surface
