GUIDE TO THE PREVENTION AND RESTORATION OF EARLY JOINT DETERIORATION IN CONCRETE PAVEMENTS

DECEMBER 2016

National Concrete Pavement
Technology Center

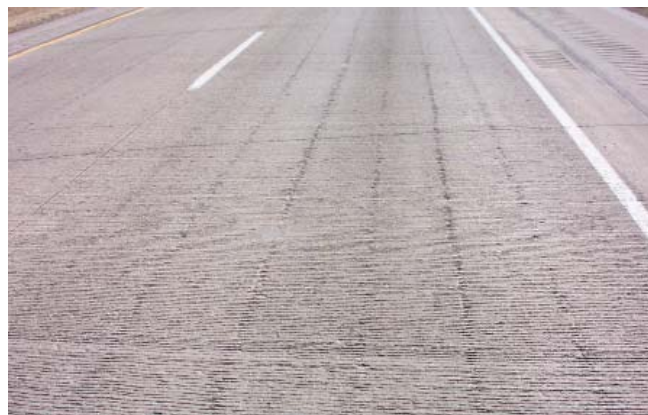
Figure 1-3. Vibrator trails

In 1991 a section of U.S. 20 in Hamilton and Webster counties, which was placed in 1987, began to show visible deterioration at the joints and along vibrator trails (Figure 1-3). Similar deterioration began to appear on several other paving projects placed between 1986 and 1994. Several research projects identified the cause as a loss of air at the joints and in the vibrator trails, increasing the pavements' exposure

to freeze-thaw damage. Solutions were also identified to avoid similar problems in new pavements: require vibration monitoring equipment to ensure proper vibration speed and control, improve workability through optimized aggregate gradations, and increase the use of slag cement in the mixture.

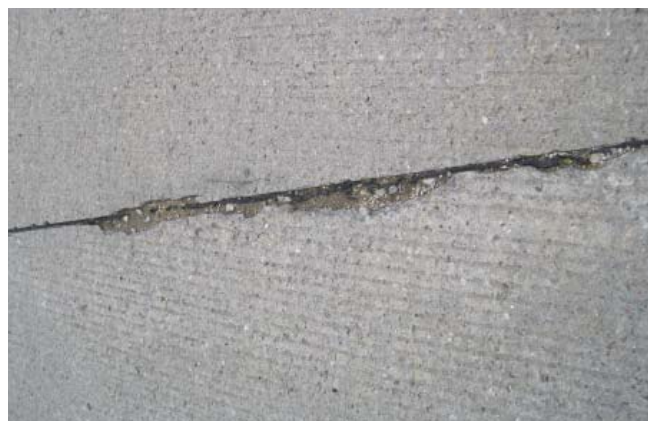
Figure 1-4. Joint deterioration (Photo courtesy of Jim Grove, FHWA)

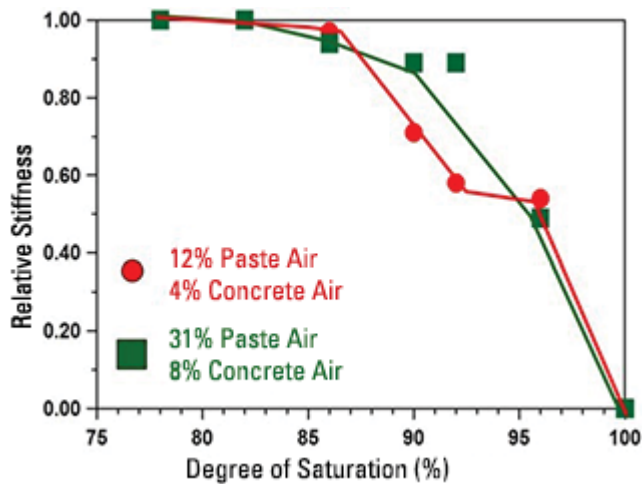
Figure 2-1. Influence of the DOS on stiffness degradation due to freeze-thaw damage (Li et al. 2011)

For degrees of saturation below the critical DOS (e.g., 85 percent in Figure 2-1), freeze-thaw damage is generally not observed to occur even after a large number of freeze-thaw cycles. As soon as the DOS exceeds the critical DOS (in this case 85 percent), damage initiates in the material, regardless of the quantity and quality of the air system. This implies that once the critical DOS is reached, even a single freezing

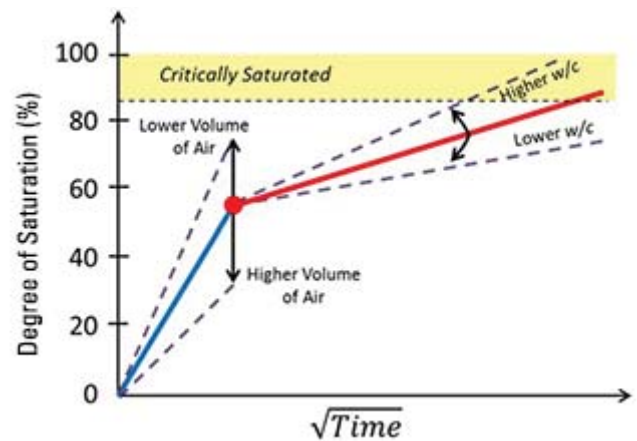
Figure 2-2. A conceptual illustration of the sorption-based freeze-thaw model

Entrained air can improve freeze-thaw durability by reducing the DOS in concrete (Li et al. 2011, 2016). Air-entraining admixtures stabilize air bubbles generated during mixing to add large (approximately 0.002 to 0.050 in.), stable, air-filled voids to the paste portion of the concrete (Mindess and Young 1981). These entrained air voids provide air-filled voids that reduce the initial DOS, as shown in Figure 2-3 (i.e., the initial saturation is the saturation that occurs during the first 24 hours, as denoted by the nick point or transition from the

blue to the red line in Figure 2-2). Figure 2-3(a) shows that both air content and water-to-cement (w/c) ratio contribute to the initial DOS when the same amount of cement is used in a mixture. As the w/c ratio increases and air content decreases, the concrete is closer to critical saturation after only a short time of exposure to water. The mixture composition can also impact the slope of the secondary absorption (red line in Figure 2-2), with data shown in Figure 2-3(b) for a straight cement mixture. Preliminary data have shown that this can

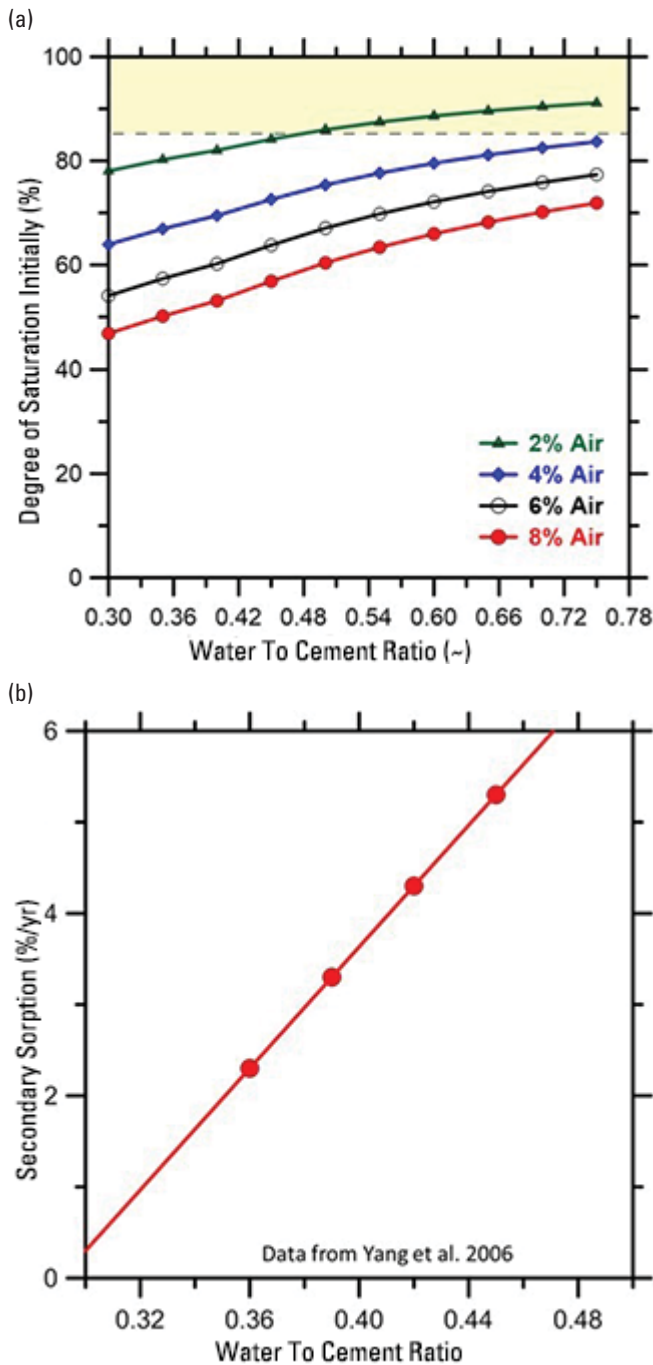
Figure 2-3. Influence of (a) the w/c ratio and air content on SMatrix and (b) the w/c ratio on the secondary sorption (Todak et al. 2015b)

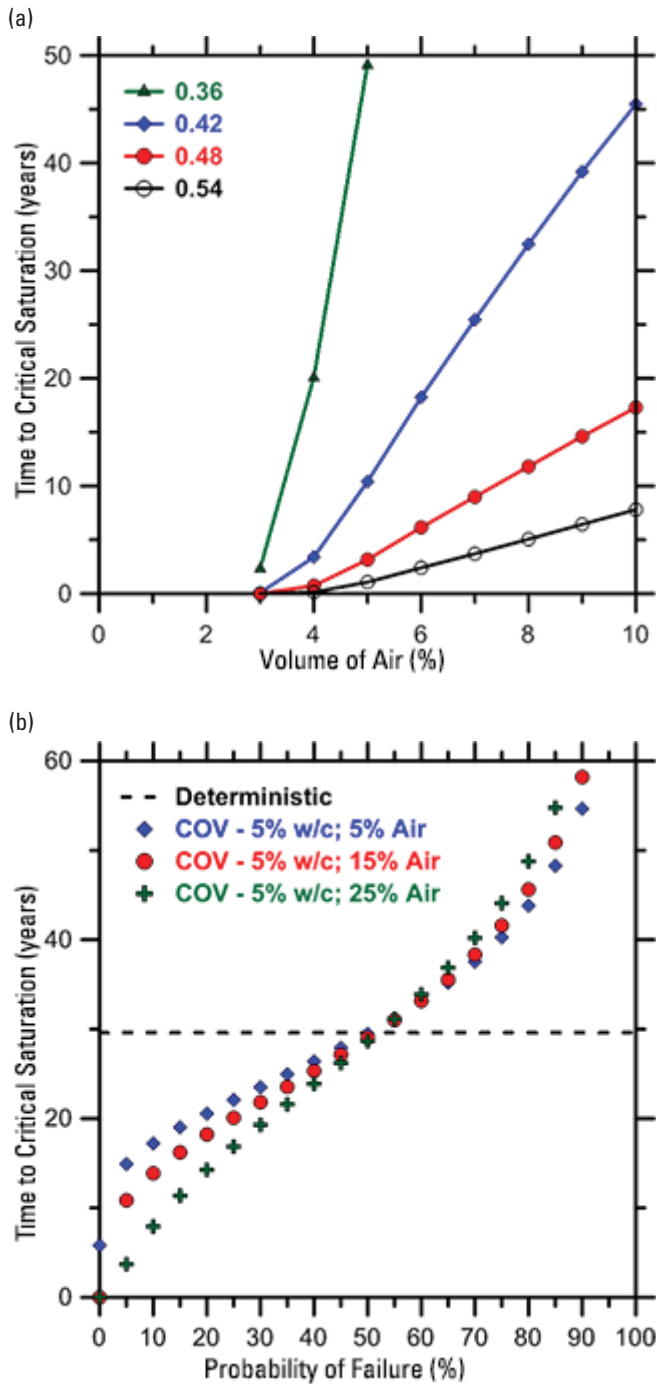
Figure 2-4. The influence of w/c ratio and air volume on the time required for 20 percent of the concrete to reach critical saturation (assuming 5 percent COV in w/c ratio and 15 percent COV in air content)

Variability in the concrete mixture can impact the life-cycle performance of the concrete. The Monte Carlo simulation model was used to indicate the influence of variation in w/c ratio (fixed at 5 percent coefficient of variation, COV) and variation in air content (5 percent, 15 percent, and 25 percent COV). The variation in the air content corresponds to 95 percent of the data ranging between 5.4 percent and 6.6 percent for the case with 5 percent COV, 4.2 to 7.8 percent for 15 percent COV, and 3.0 to 9.0 percent for the 25 percent COV. It can be noted from Figure 2-4(b) that the deterministic prediction of the time to saturation is similar to the time predicted for 50 percent of the elements to fail. It is interesting to note, however, that higher variability in air content (5 to 15 to 25 percent COV) results in time of failure of 17.2, 13.8, and 7.9 years, respectively. This would imply that despite the average air content, which is the same for each of these cases, repairs would need to be performed at an earlier age for systems with a higher variability. This clearly indicates the importance of controlling the variation in the air content during production. This needs to be balanced, however, with an understanding of how accurately the air content can be measured (Pellinen et al. 2005).

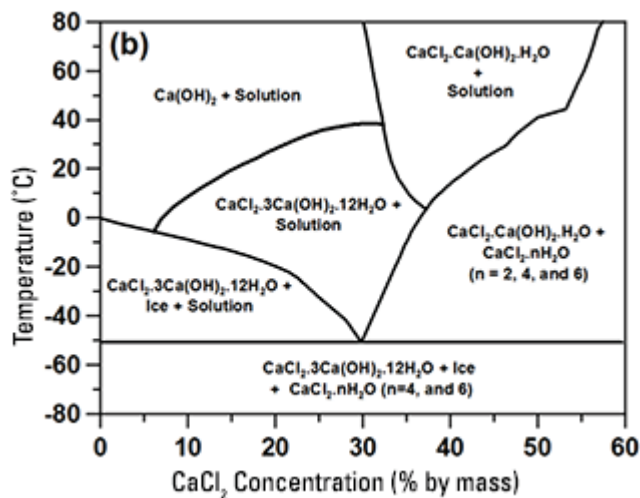
Figure 2-5. Phase diagrams illustrating the temperature for calcium oxychloride formation when hydrated cement paste is brought into contact with calcium chloride solution (Farnam et al. 2016)

The second type of reaction that may be observed, and that can cause more damage to concrete, occurs between calcium chloride and calcium hydroxide ($\text{Ca}[\text{OH}]_2$) (CH in cement chemistry shorthand) to result in calcium oxychloride ($\text{CaCl}_2 \cdot 3\text{Ca}[\text{OH}]_2 \cdot 12\text{H}_2\text{O}$), as shown in Equation 4. Calcium oxychloride is expansive and can result in damage to the cement matrix. Greater amounts of calcium oxychloride form at higher concentrations (Farnam et al. 2014; Farnam et al. 2015a) and at temperatures greater than freezing, as shown in Figure 2-5 (Farnam et al. 2016).

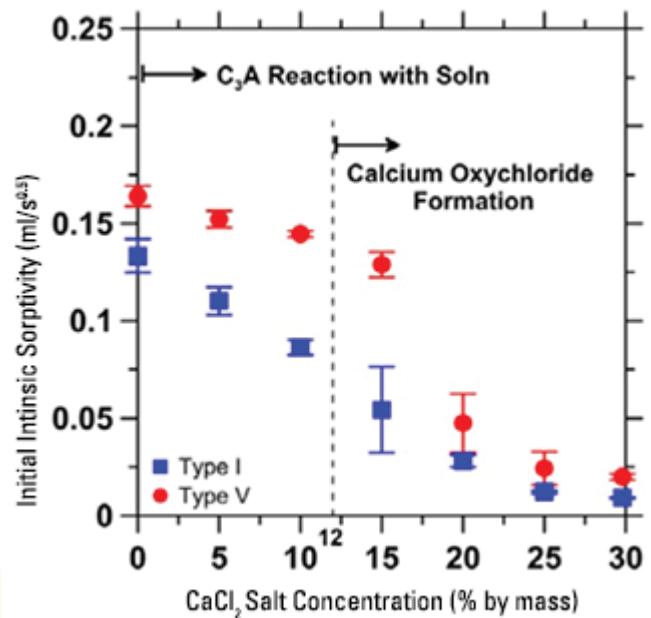
Figure 2-6. Reduction in the rate of water absorption due to salt reactions

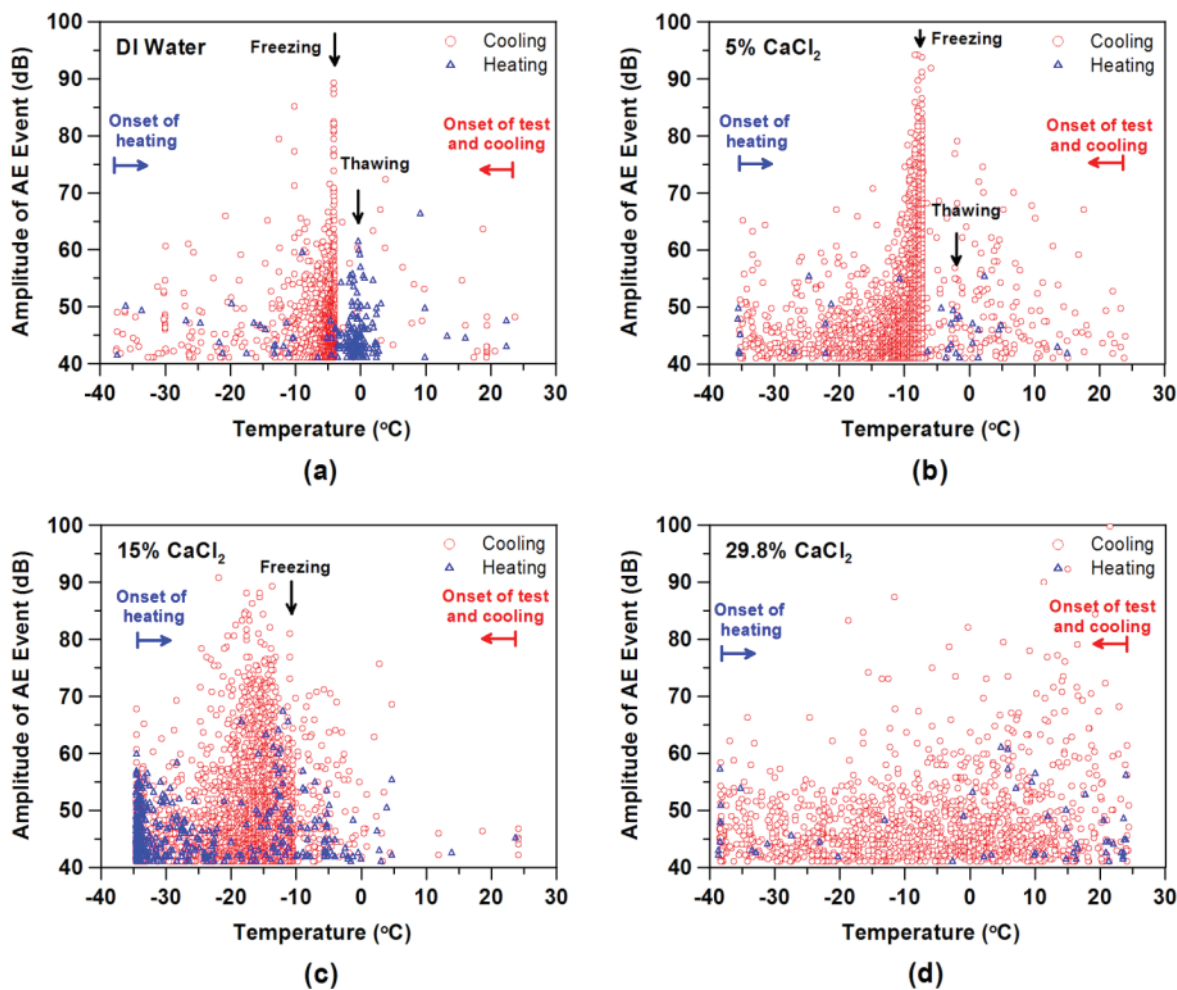
Figure 2-7. Passive AE events versus temperature during cooling and heating for mortar specimens saturated with (a) deionized water; (b) 5 percent CaCl_2 solution; (c) 15 percent CaCl_2 solution; and (d) 29.8 percent CaCl_2 solution (scattered AE activity can be seen for the 29.8 percent concentration)

Acoustic emission (AE) was used by Farnam et al. (2015a) to listen for crack development in samples saturated with 0, 5, 15, and 29.8 percent CaCl_2 solutions (Figure 2-7). For the lower concentrations, a small amount of cracking was noticed as the temperature decreased from room temperature. These cracks are due to the difference in the coefficient of thermal expansion between the aggregate and the matrix. When the freezing begins to occur (-5°C for 0 percent CaCl_2 , -8°C for 5 percent CaCl_2 , and -12°C for 15 percent CaCl_2), however, the acoustic activity increases dramatically, indicating that cracking is taking place because of the expansion caused by the ice formation inside specimen pores (Figure 2-7c). Cracking, however, begins at higher temperatures for samples with a higher concentration upon contact with solution for specimens saturated by 20, 25, and 29.8 percent CaCl_2 (shown in Figure 2-7d). It should be noted that the samples in Figure 2-7 were stored at 23°C (which is consistent with calcium oxychloride; see Figure 2-5), because the formation of calcium oxychloride can cause cracking due to volume expansion.

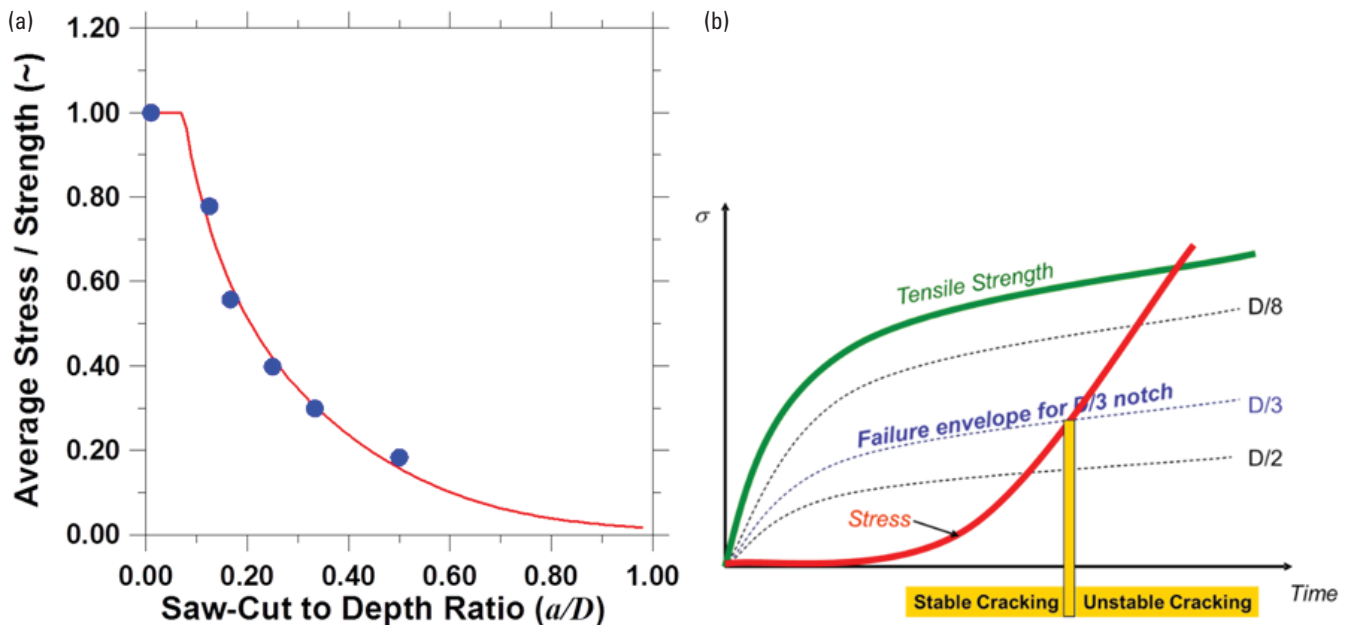
Figure 2-8. (a) Strength and stress development for concrete pavements as a function of saw-cut depth, and (b) the saw cut stress-to-strength ratio

as shown in Figure 2-8 in the previous chapter. Taylor and Wang (2015) discuss a device (P-wave propagation) that can predict the sawing window for early-entry and conventional saws.

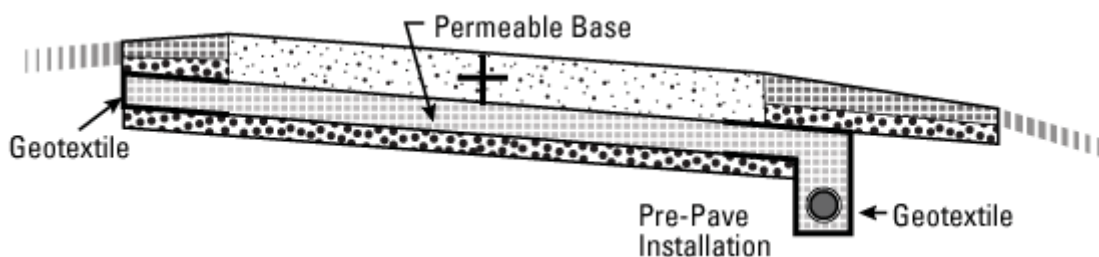
Figure 3-1. Typical cross section of subsurface drainage system

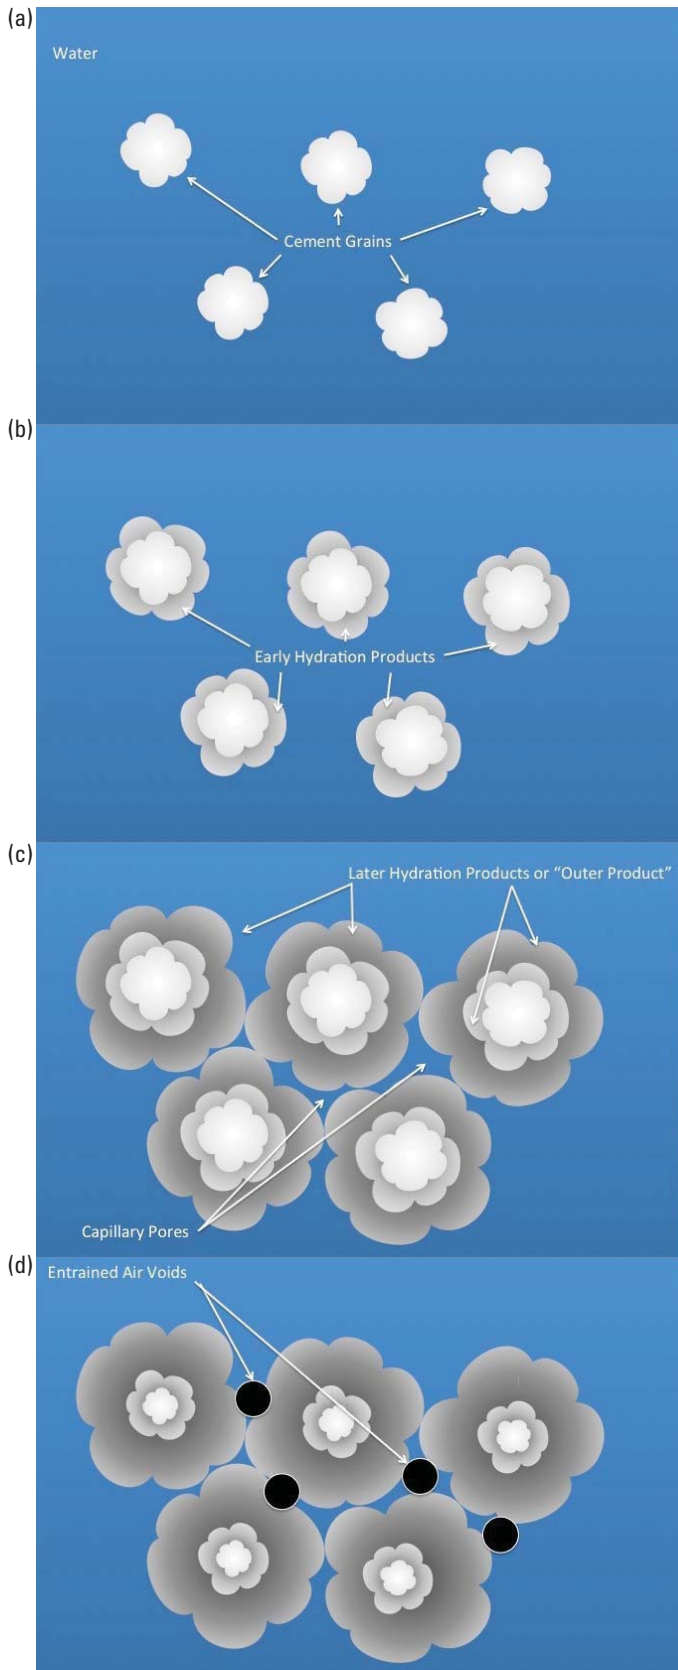
Figure 3-2. Cement grain dispersion and development of hydration products and capillary pores

The hydration of cement essentially produces two principal phases, CSH and CH. The C-S-H phase is considered to be the "cementing" phase whereas the CH phase is present but has little cementing value. The CH forms in platelike crystals that easily fracture. More important, CH is soluble in water. Further, the solubility of CH increases as the temperature decreases. This means when concrete is exposed to water at a temperature near the freezing point, the CH will dissolve more readily. Some of the dissolved CH may re-precipitate within the concrete, but some will exude or otherwise be lost. This process creates an increased permeability and more water ingress, and the process accelerates. As described in chapter 1, the CH is a reactant in the calcium oxychloride

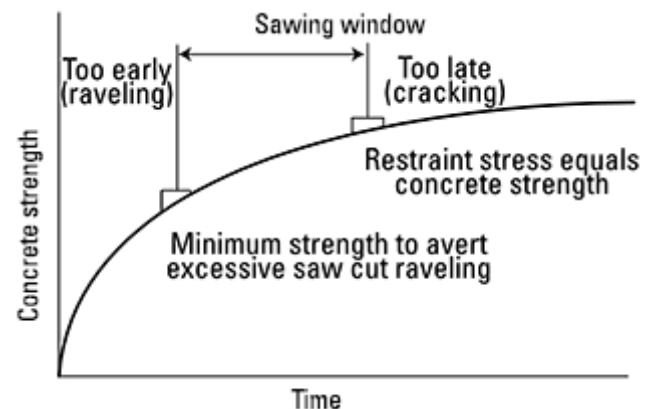
Figure 3-3. Sawing window

Most important, select the correct sawing window. There is no one correct answer for when to saw. The window is determined by the mixture and conditions of placement. In general, the sawing window begins when concrete strength is sufficient for sawing without excessive raveling along the cut; see Figure 3-3. Taylor et al. (2006) propose that the sawing window ends when random cracking starts to occur. Raoufi et al. (2007) have suggested that the sawing window ends as cracking transitions from stable to unstable at the saw cut,

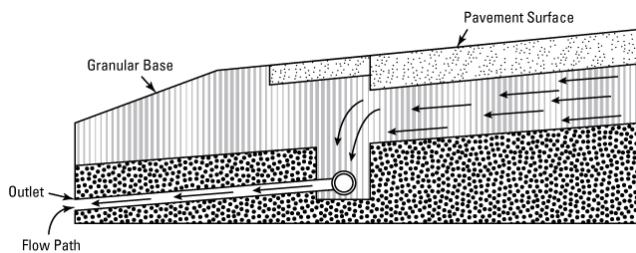
Figure 4-1. Example of shortening drainage path to an outlet

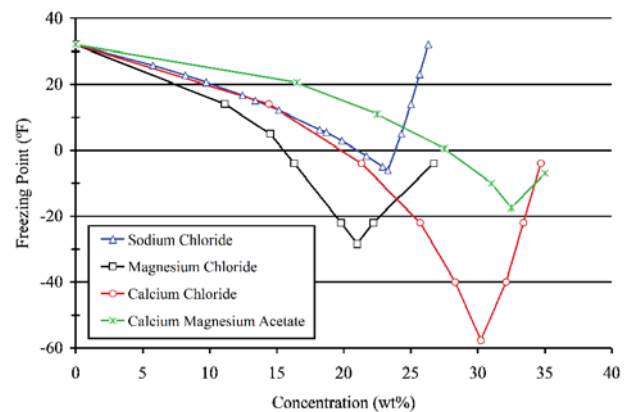
Figure 4-2. Partial phase diagrams for mixtures of water and common deicing/anti-icing salts. The freezing point of the water-salt solution (brine) is plotted as a function of the concentration of salt, in weight percent. Note that for all salts, a minimum freezing point is shown (Sutter 2008)

concentrations or rates will result in less damage to concrete structures. Note in Figure 4-2 that, as the brine solution concentration decreases to a relatively lower value (i.e., less than 5 percent by weight), the freezing points of the solutions become quite similar. This means that, as the brines become more diluted (which occurs as snow and ice melt), the relative difference in effectiveness (i.e., freezing point) diminishes. Therefore, using higher melting point solutions (i.e., brines of $MgCl_2$ and $CaCl_2$) at lower temperatures accomplishes little in terms of maintenance, yet it exposes the concrete to the chemicals most known to cause deterioration.

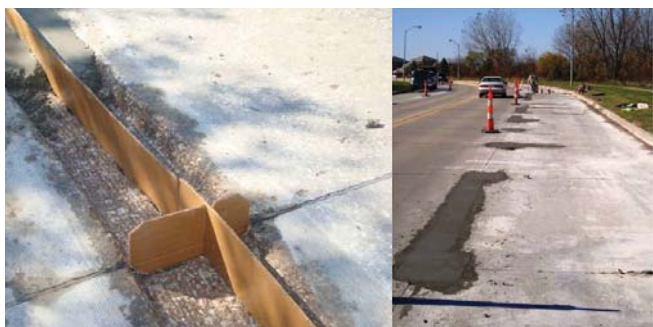
Figure 5-2. Milled joint for removal of spalling (left photo) and finished PDR (right photo, courtesy of City of West Des Moines, Iowa)

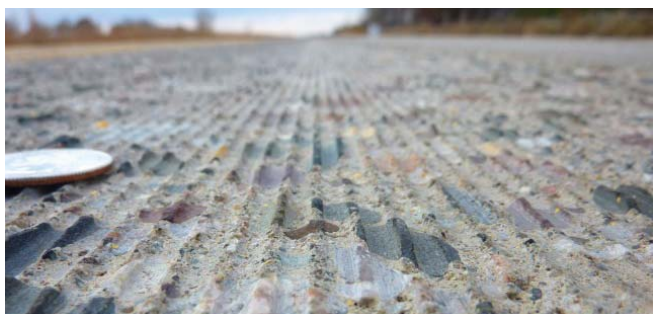
Figure 5-3. Diamond-ground pavement surface (photo courtesy of The Transtec Group)

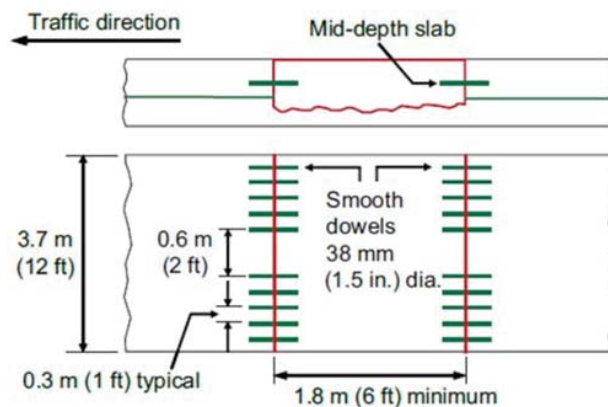
Figure 5-4. Example of FDR (plan view showing dowel bar layout)

Although FDRs can be designed and constructed to provide good long-term performance (see Figure 5-4), the performance of FDRs is very much dependent on their appropriate application and use of effective design and construction practices. Many FDR performance problems can be traced back to inadequate design (particularly poor load transfer design), construction quality, or the placement of FDRs on pavements that are too severely deteriorated.

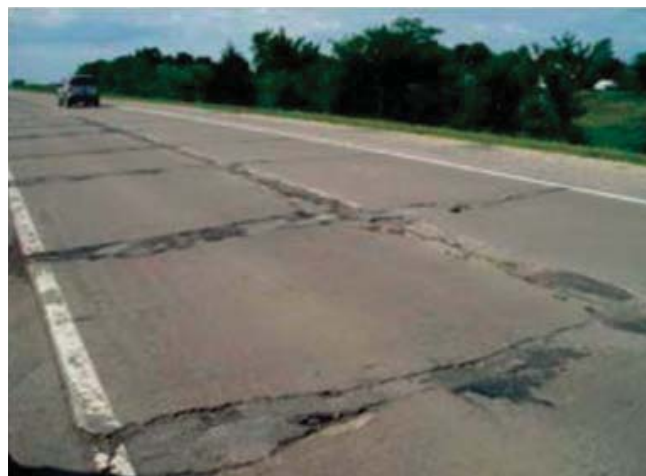
Figure 5-5. Concrete pavement with severe joint spalling (photo courtesy of Todd LaTorella, MO/KS ACPA)

Figure 5-5 shows a concrete pavement in Missouri with severe joint spalling. After careful examination of the pavement, it was decided to construct an unbonded concrete overlay. The

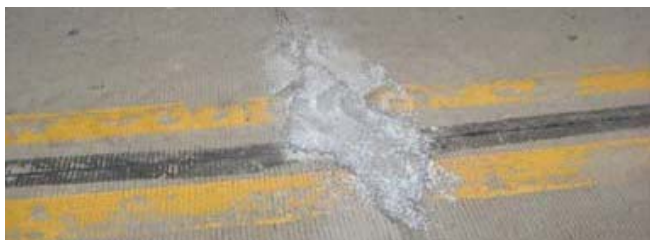
Figure 5-6. Pre-overlay repair of spalled joint (photo courtesy of Todd LaTorella, MO/KS ACPA)

spalled joints were milled and patched with a flowable mortar to fill the void (Figure 5-6). Bonding agents were not used for the patch, and the joints were not re-established.

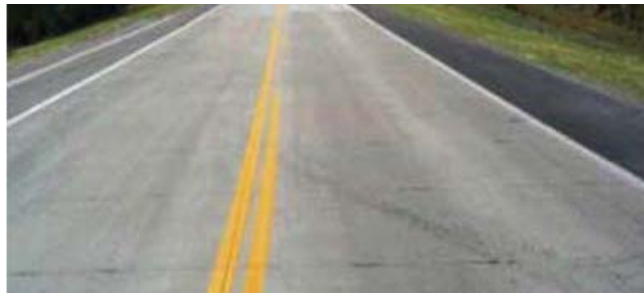
Figure 5-7. Completed unbonded concrete overlay (photo courtesy of Todd LaTorella, MO/KS ACPA)

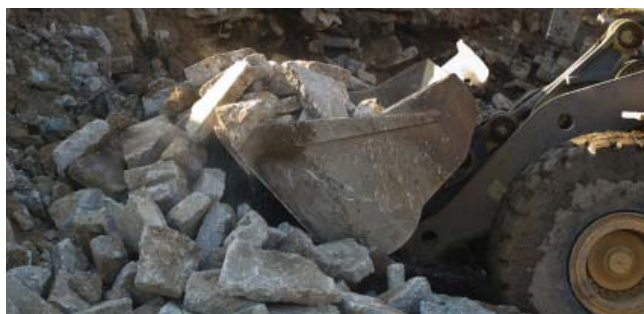
Figure 5-8. Concrete pavement for recycling (photo courtesy of Michigan State University)

In some instances in which pavement deterioration is beyond the state of feasible repair with PDR, FDR, or unbonded concrete overlay, appropriate option is reconstruction in place. Recycling concrete pavements into a base for the new pavement has proven to be a successful option. Recycled concrete aggregate (RCA), as a rule, is a high-quality material for unbound or stabilized applications such as bases compared to conventional new aggregate. An RCA has a rougher surface texture, higher shear strength, higher rutting resistance, and higher resilient modules (Van Dam et al. 2012) (see Figure 5-8).

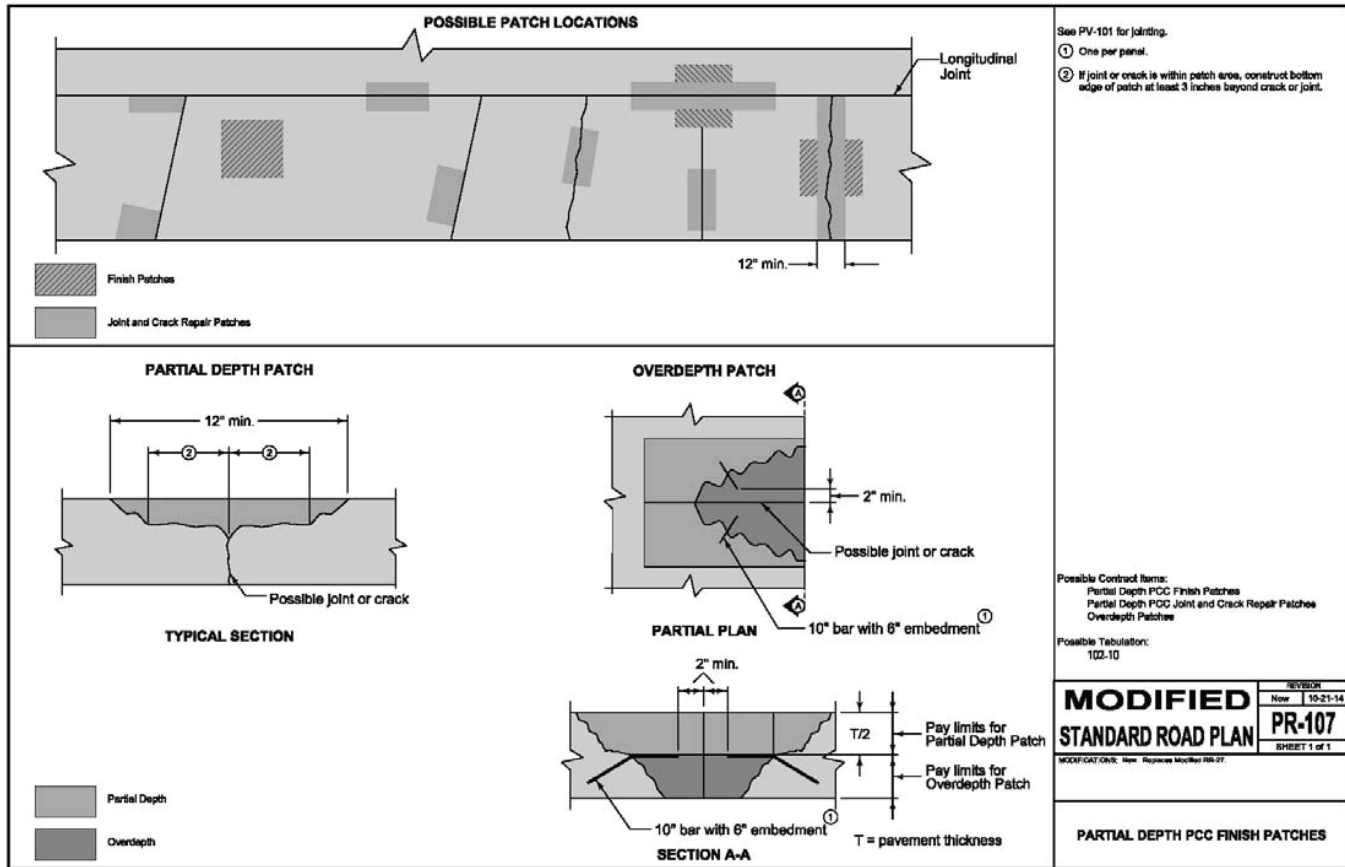
Figure 6-2. Modified Standard Road Plan PR-107

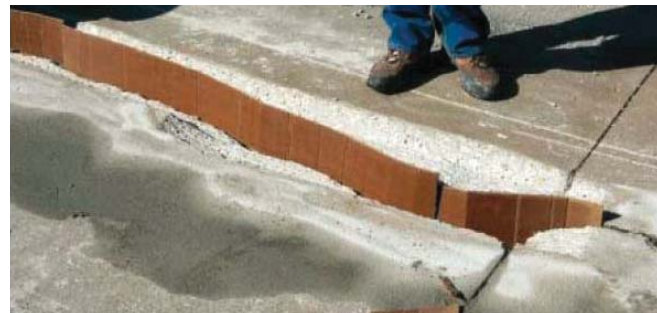
Figure 6-3. Joint board

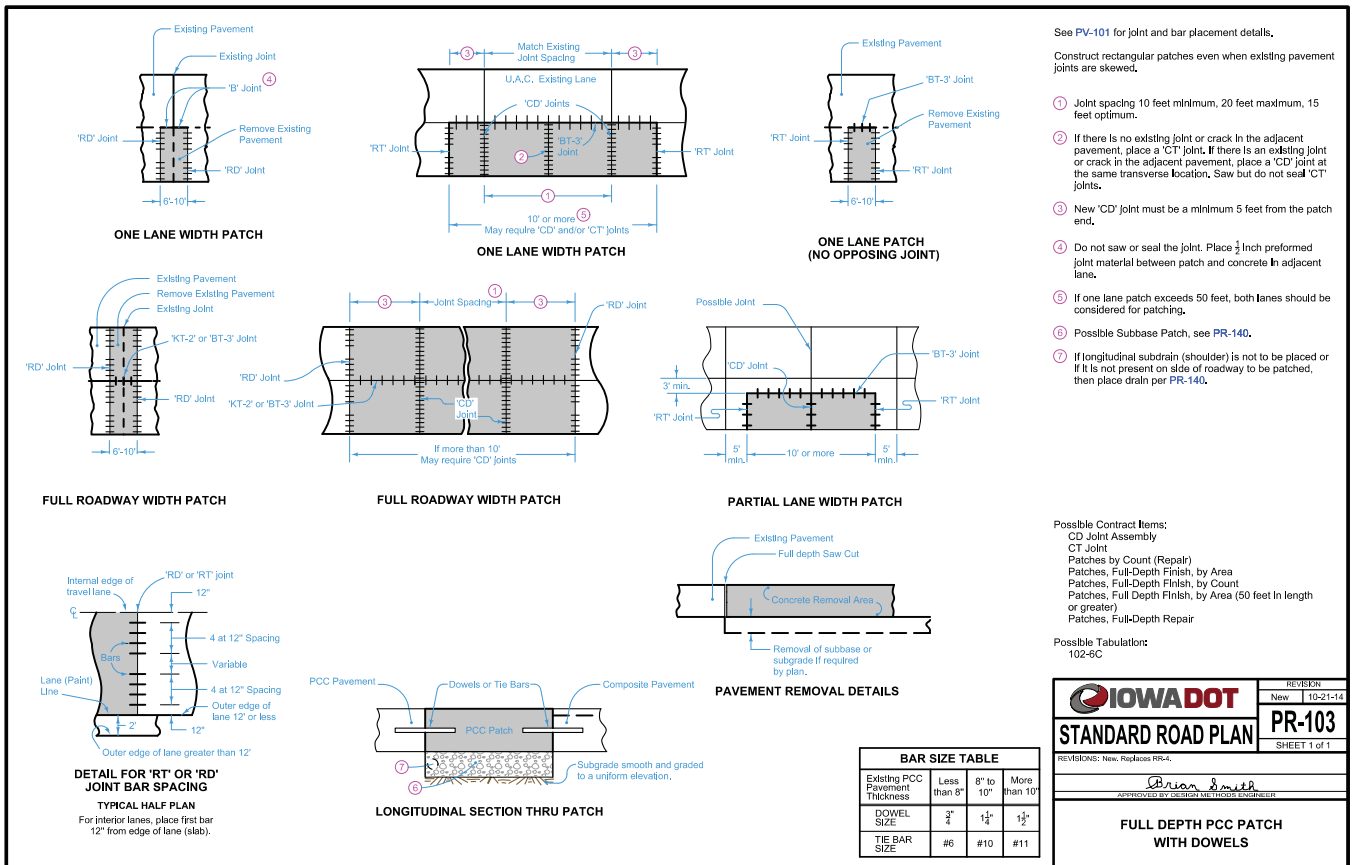
Figure 6-4. Standard Road Plan PR-103 for full-depth patches

Figure 6-4 is the Standard Road Plan PR-103 for full-depth finish patches with dowels. The Iowa DOT includes Standard Road Plans PR-101 through PR-105 for related technical details. Iowa DOT Specification Section 2529 covers Full Depth PCC Finish Patches for several applications including those listed here.
