Evaluation of Unbonded Ultrathin Whitetopping of Brick Streets

National Concrete Pavement
Technology Center

Final Report
June 2006

Sponsored by
the Iowa Highway Research Board (IHRB Project TR-466)

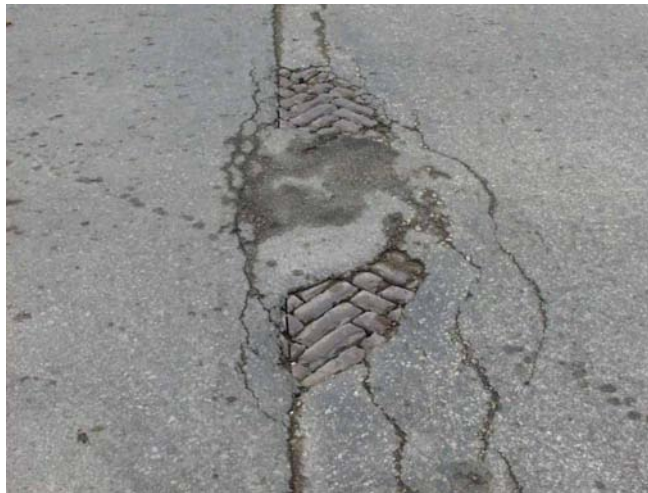
Figure 1. Asphalt surface with exposed brick

Many cities in Iowa have retained the original brick street surfaces in downtown areas and in older residential areas as the base for modern driving surfaces. The original brick surfaces were not built to handle current and future traffic loadings. In recent years, these surfaces have tended to shift and become uneven, creating problems with safety. Asphaltic concrete overlays have been the typical rehabilitation technique in these situations. This has proven to be a successful rehabilitation technique in some cases; in other cases, the combination of the movement of the brick and the flexibility of the asphalt has proven to accentuate the original problems. Figures 1 and 2 show exposed brick under the asphalt and the asphalt cracked in several places.

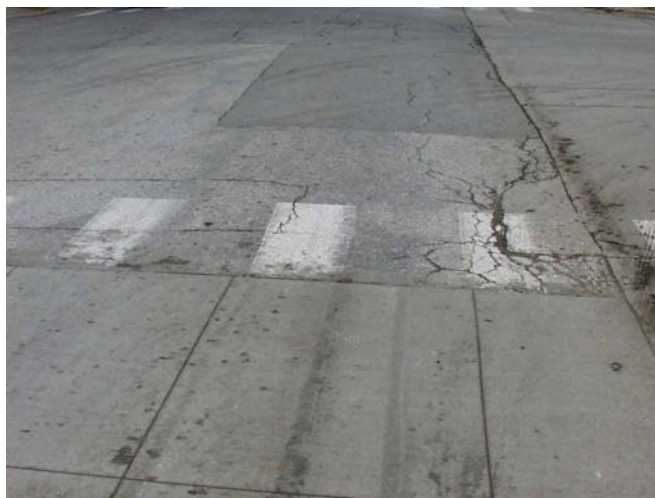
Figure 2. Deteriorated asphaltic concrete surface

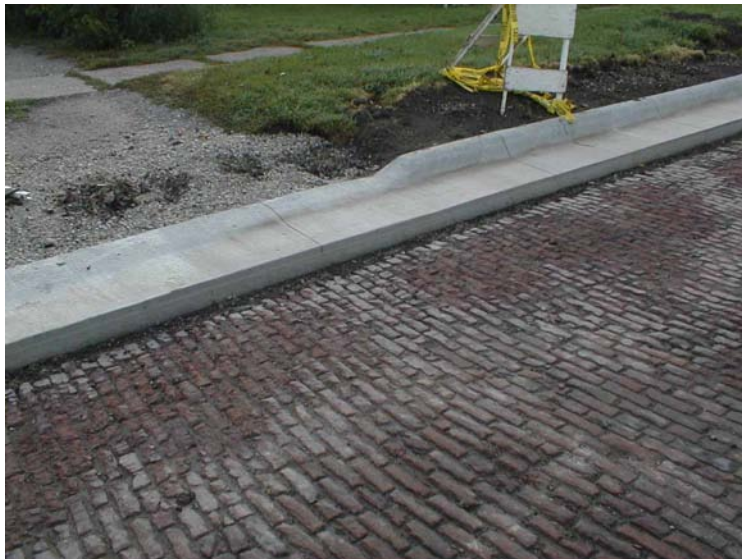
Figure 5. Finished curb and gutter unit

The contractor first removed the existing asphalt overlay by milling and air blasting. The goal was to allow an inch of asphalt to remain on top of the brick surface, but with the weight and vibration of the milling machine, all the asphalt came loose and was removed from the bricks. The existing curb and gutter were then removed and replaced, with the contractor raising the elevation to allow for four inches of concrete to be placed on top of the existing brick, as shown in Figure 5.

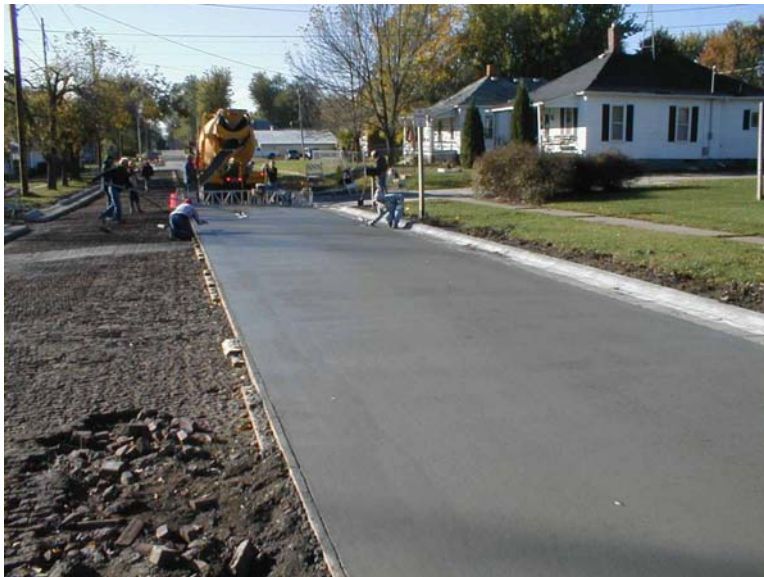
Figure 6. Southbound lane overlay paving

Construction of the overlay was accomplished by using a power screed. A wooden form was placed along the centerline of the roadway, and the gutter was used as a form along the outside edge. Paving was done by Steven's Concrete Ltd., and concrete was provided by Ideal Ready Mix from a nearby plant. On October 8, 2001, paving began by placing concrete in the southbound lane, going from the north and paving south through the railroad crossing. Three days later, the northbound lane was paved in the same area. On October 16, 2001, the rest of the southbound lane was paved; then two days later, the northbound lane was completed. Figure 6 shows the paving of the first lane. Figure 7 shows the first lane of paving completed.

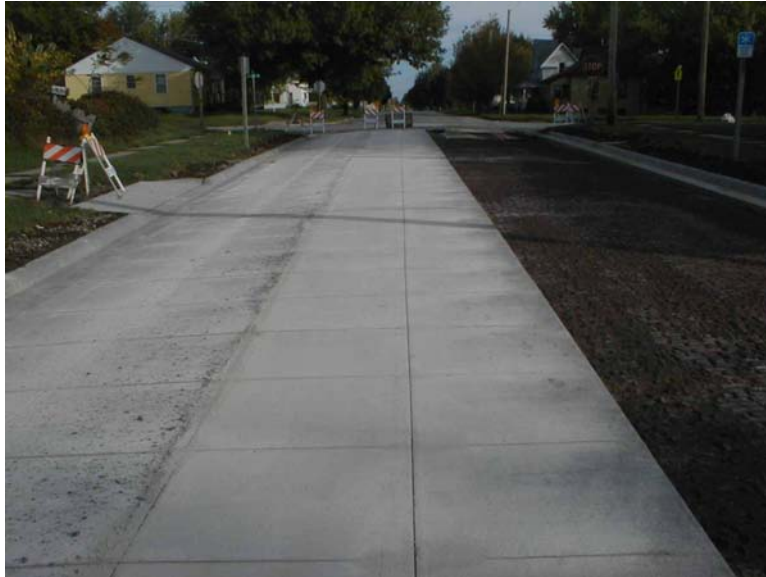
Figure 7. Southbound lane paving completed

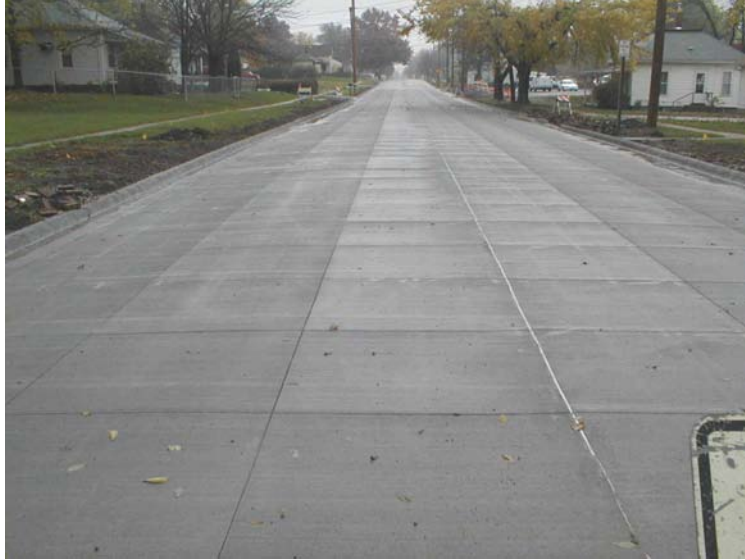
Figure 8. Completed jointing pattern

Joints were cut with a dry saw $\frac{3}{8}$ inches wide to a depth of $T/3$. The spacing of the joints from Station 0 + 32 to 3 + 82 was as follows: longitudinal joints were cut 59 inches apart and transverse joints were cut 48 inches apart. Curb and gutter sections were cut transversely at 72-inch intervals, which resulted in the curb and pavement joints matching at every third transverse pavement joint. The section from Station 3 + 82 to 4 + 42 is 10 inches in depth, with longitudinal joints every 84 inches and transverse joints occurring every 144 inches. From Station 4 + 42 to 5 + 94, longitudinal joints occur every 43 inches and transverse joints are spaced at 36-inch intervals. The section from Station 5 + 94 to 6 + 10 has longitudinal joints spaced every 43 inches and transverse joints cut at 69 inches, then 59 inches, and then another at 69 inches. In this area, brick was removed to allow for a thickened end. Figure 8 shows joints after saw cutting.

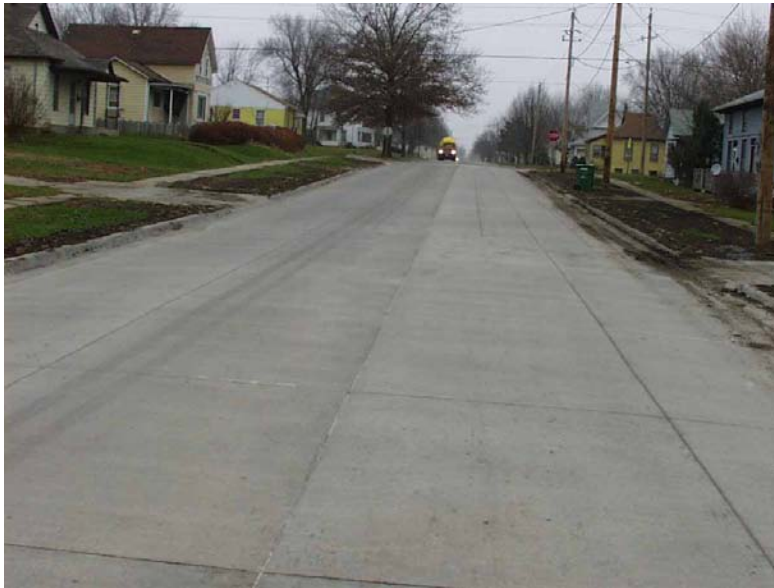
Figure 9. Completed project

The removal of approximately one foot of brick along each edge was done to allow for a thickened edge of concrete along the curb and gutter section. This posed a problem as heavy trucks drove on the brick, causing the bricks to shift and expose the sand and dirt below. A few areas were four feet square, which were filled with concrete to a full depth. Figure 9 shows the completed project.

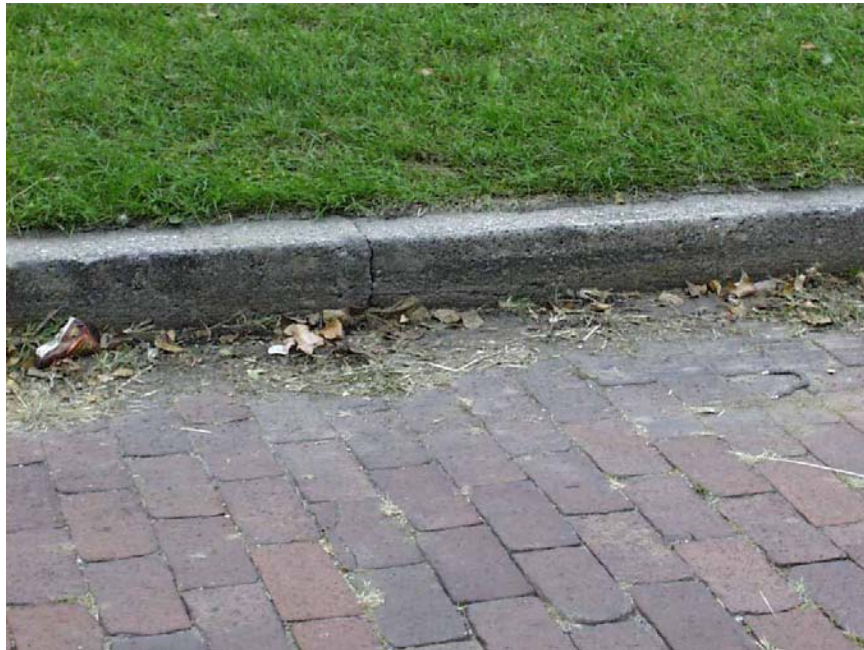
Figure 10. Existing pavement and bull-curb

The existing pavement consisted of an asphalt overlay (4–6 inches in depth) of a single layer of brick standing on edge. The brick was supported by a 4–6-inch layer of sandy gravel (3/4-inch diameter maximum size). The surface of the asphalt surface was rutted and, in places, portland cement or asphaltic concrete patches had been placed over utility repairs. Asphalt shoving was occurring at each end of the project where the vehicles were required to stop. The pavement edges were contained with a 6-inch-high bull-curb that turned out not to present a true grade line for the paving. This route also contains several manhole and water valve appurtenances in the traveled way. The width of the existing pavement was 25 feet from back-back of curb. All the asphalt was removed prior to the addition of the new overlay. The brick surface was air blasted to remove loose materials. Figures 10 through 15 illustrate the surface preparation process that was used prior to concrete placement.

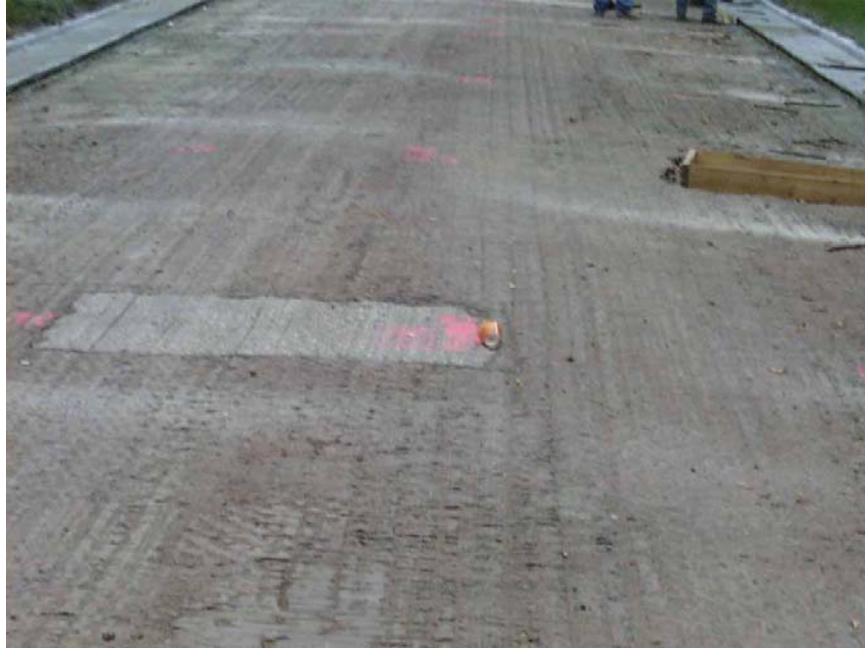
Figure 11. Milled surface and existing PCC patches

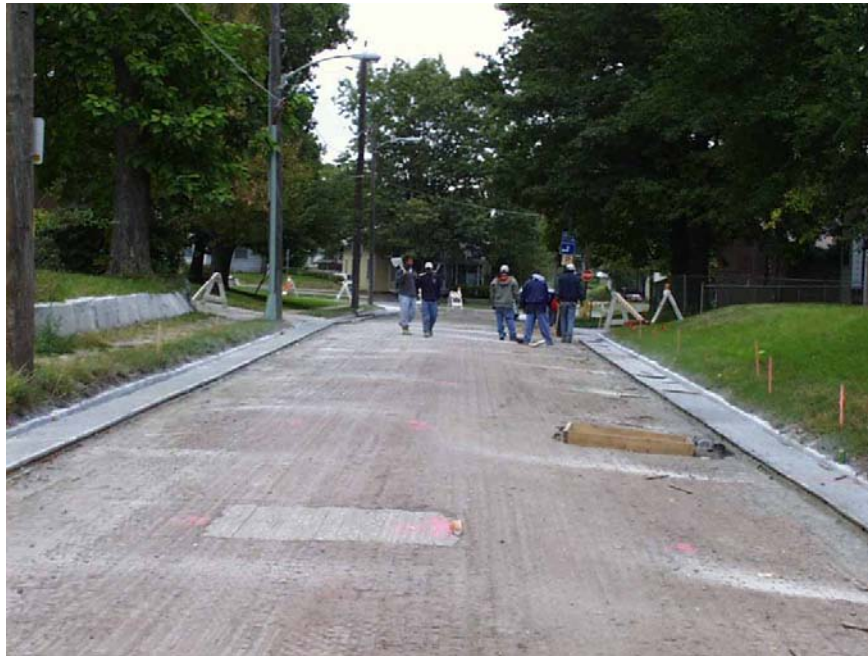
Figure 12. Replacement curb and gutter units in place

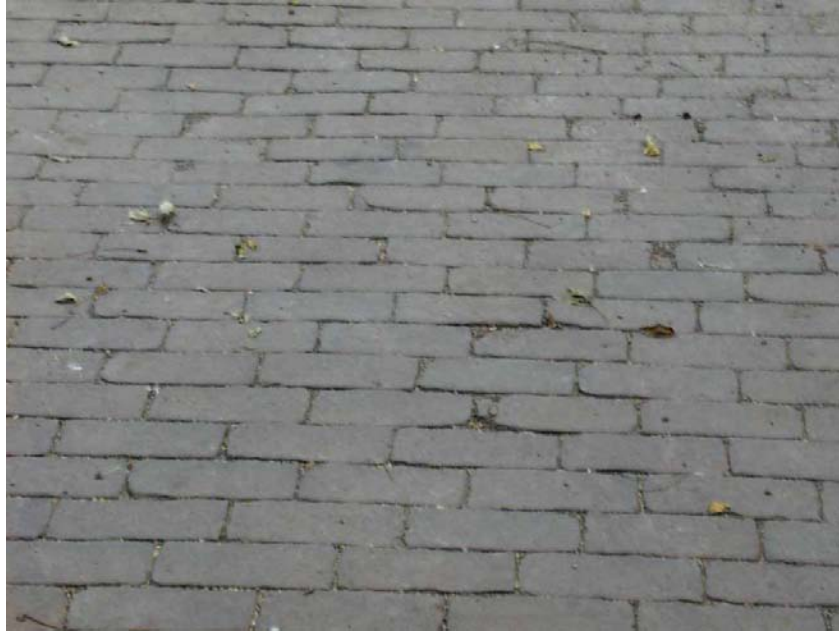
Figure 13. Air blasted surface

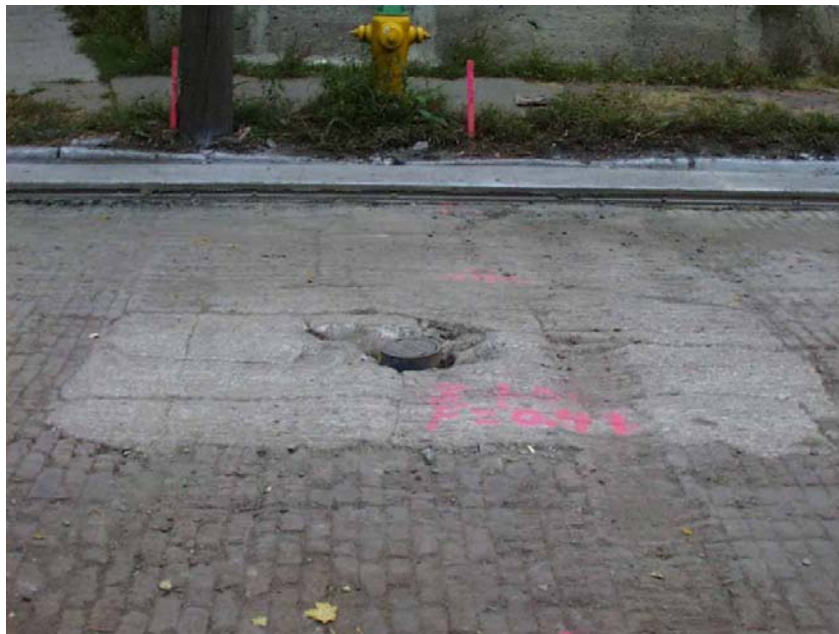
Figure 14. Water valve adjustment area

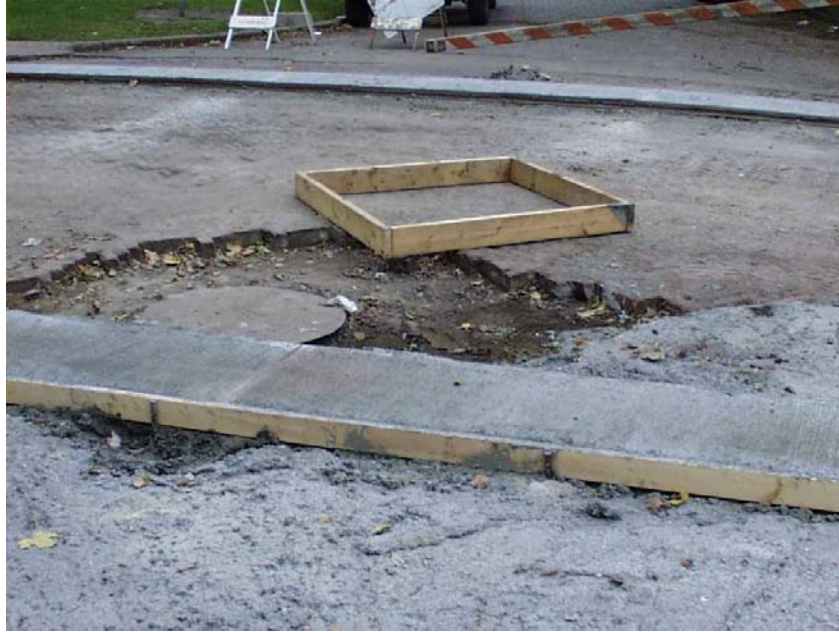
Figure 15. Manhole box out preparation

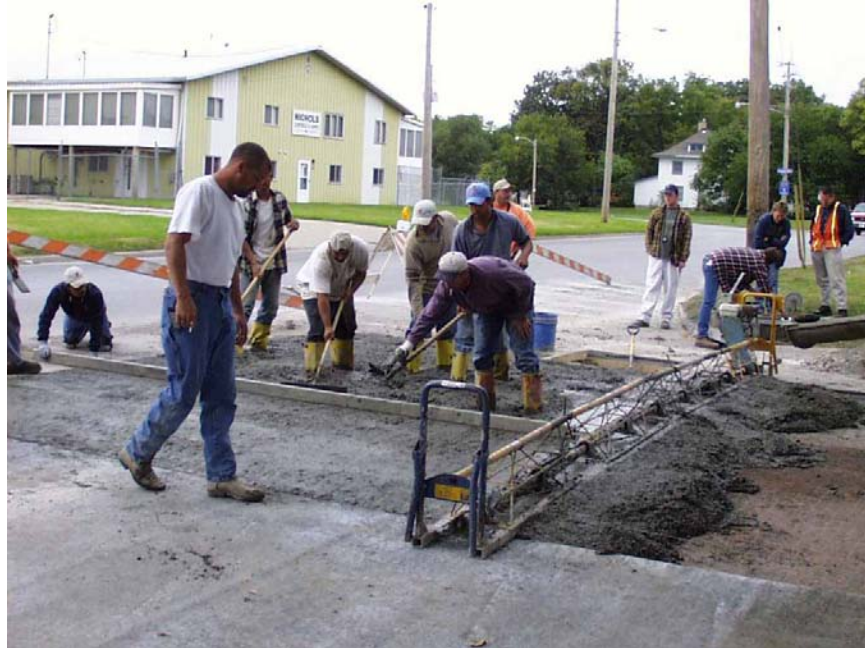
Figure 16. Initial concrete overlay placement

The project was constructed in September of 2003 with the use of readymix concrete delivery to a hand-operated power screed, as shown in Figures 16 and 17. The concrete placement proceeded smoothly from the south end to the north end. Special hand work was required at the north end on the second day due to the widened connection to an existing concrete pavement. Manholes and water valves were boxed out and the concrete was placed after the main pavement placement. The contractor was unable to achieve a good profile using the top of the existing curbs. The ICPA staff suggested that a 2-foot-wide gutter unit be placed on each side prior to the main paving. These units and the addition of a power screed with a built-in parabolic crown served to shape the concrete overlay to the required cross section and depth. With the existence of a 2-foot curb and gutter unit on each side of the pavement, the remaining 20 feet were cut into four equally spaced joints of approximately 4-foot squares. The change allowed for the gutter pavement surfaces to serve as the mainline pavement edge profiles. The change in joint spacing removed the longitudinal joints from the wheelpaths. An Iowa DOT standard C-4WR mix with 2.5 pounds of poly fibers added was used for the mix.

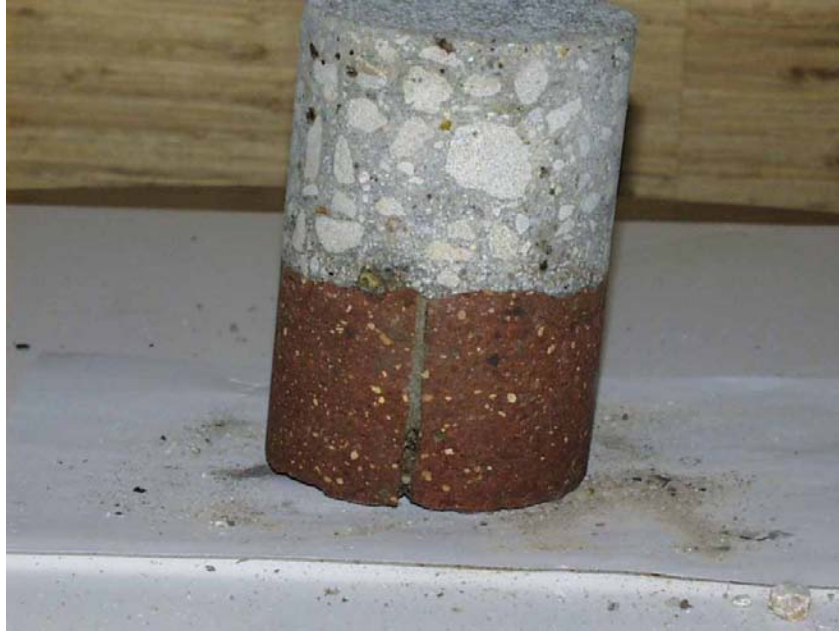
Figure 18. PCC over brick core

Two cores were taken at random locations on October 2, 2003, to review the bond between the two pavement materials. Perfect bond was found, as shown in Figure 18. A nominal three inches of concrete were placed over the existing brick.

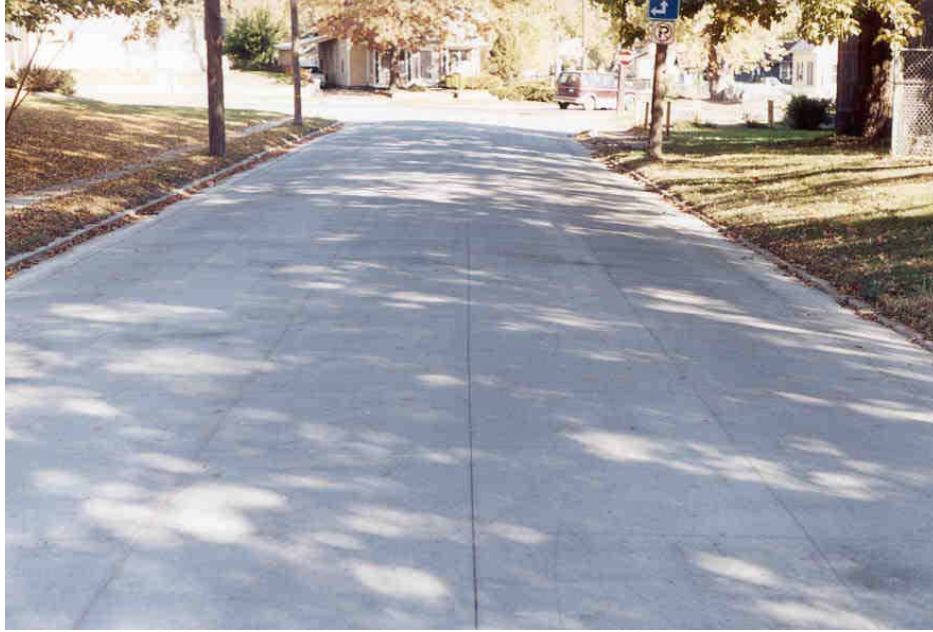
Figure 19. Finished project

The project development and construction went very well and the pavement overlay is performing well for the type of traffic that it is serving. A photo of the finished project, taken later in the fall after construction, is shown in Figure 19.
